SYDNEY HARBOUR NATIONAL PARK
MIDDLE HEAD HISTORIC BUILDINGS

CONSERVATION MANAGEMENT PLAN

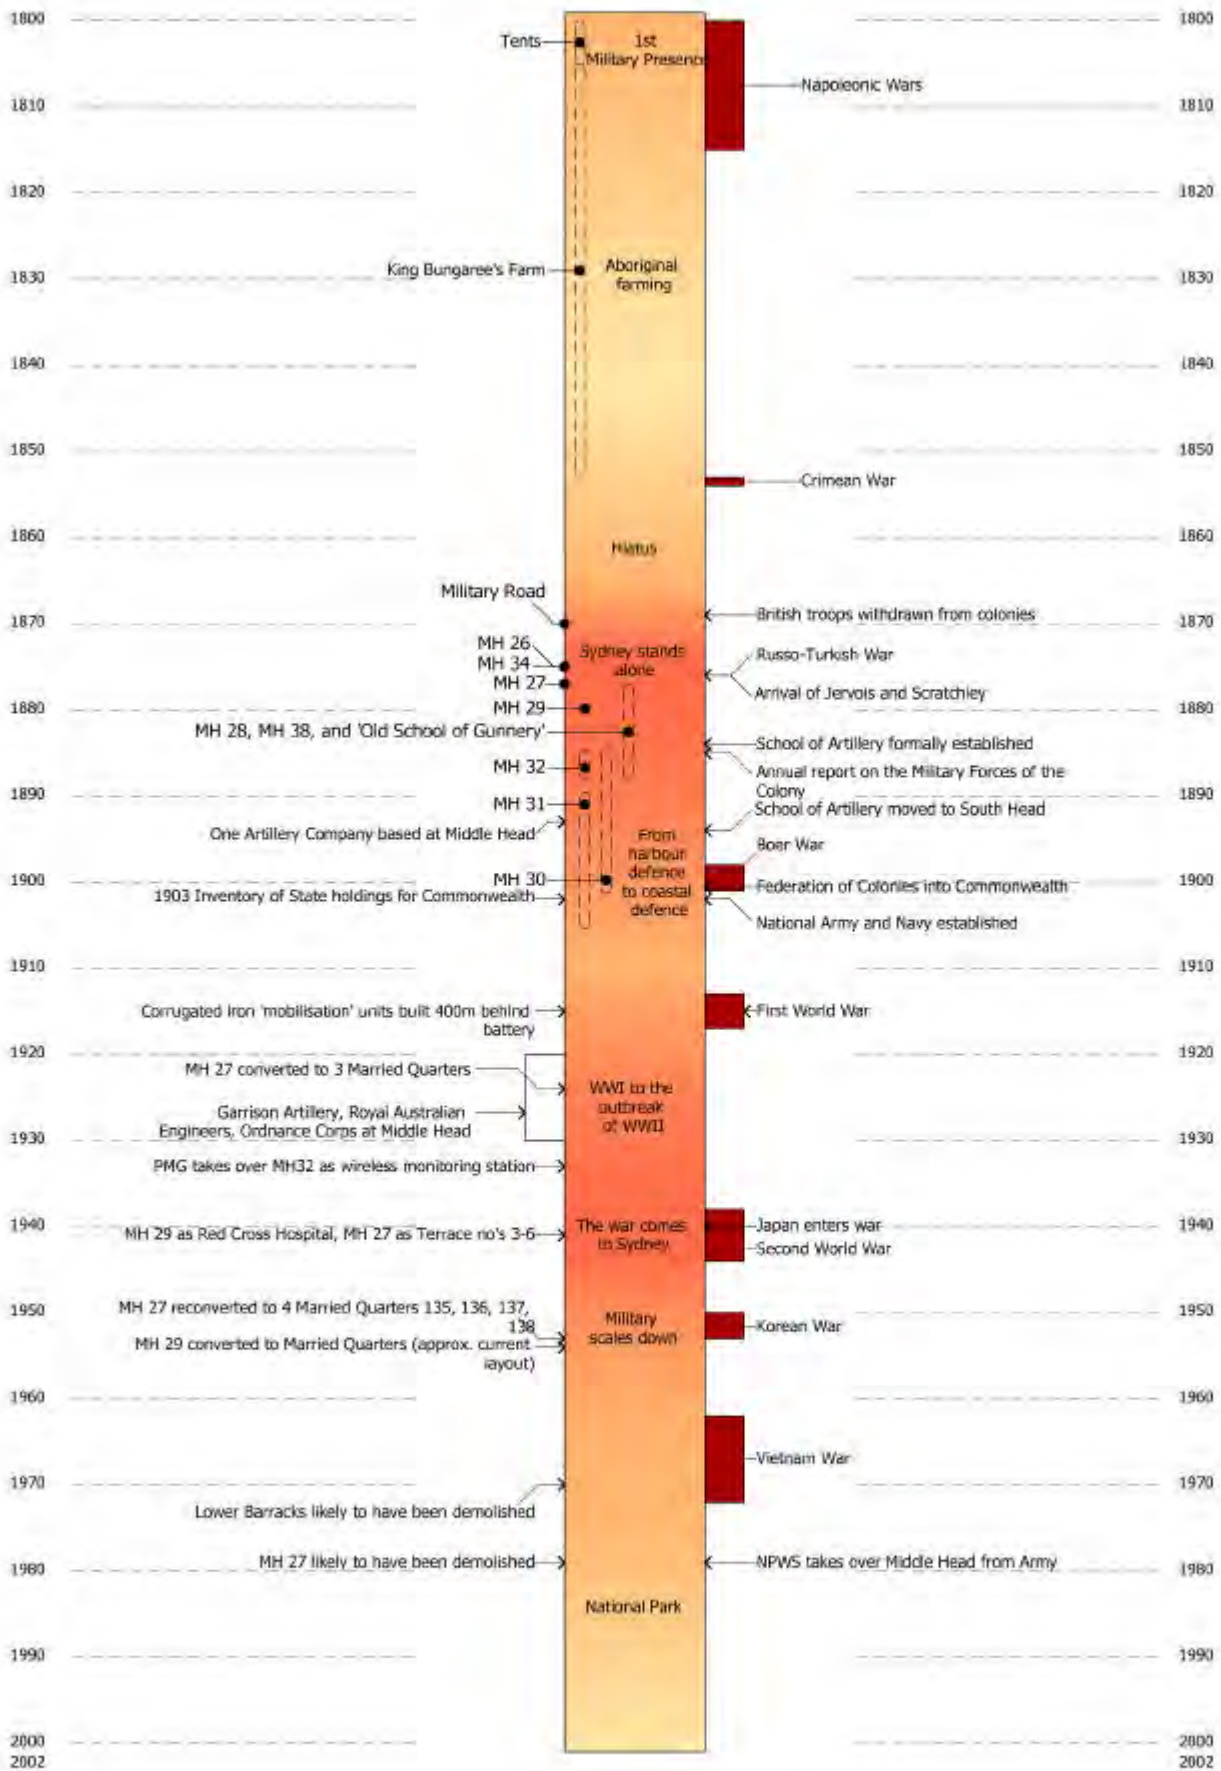
4.0 Physical Analysis and Condition

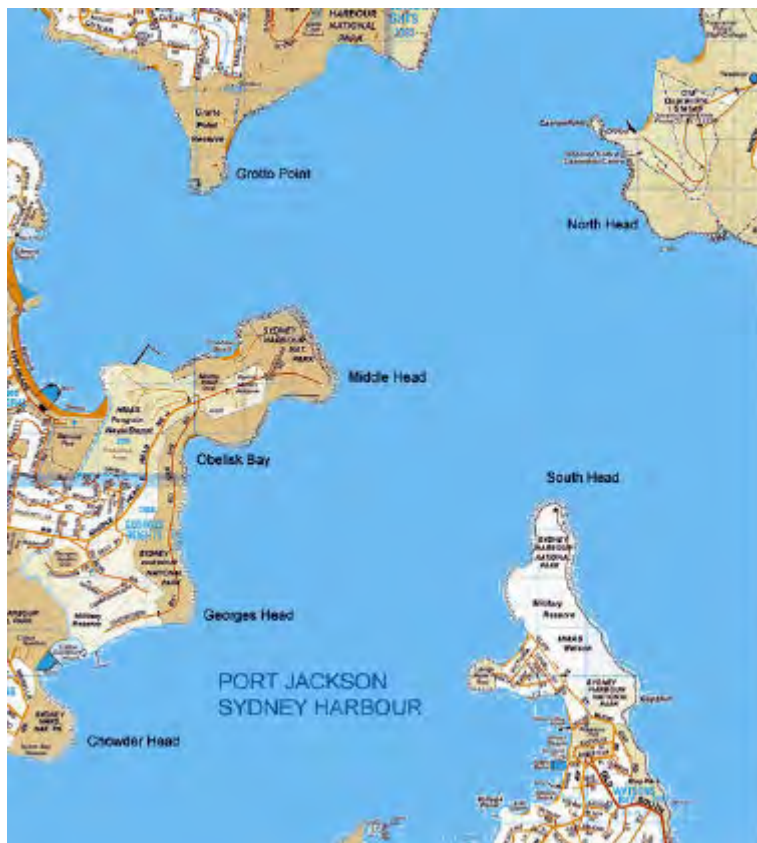
Fig 4.1 The wider context of Middle Head showing its strategic place in the defence of the harbour.
SYDWAY WEBSITE
(www.street-directory.com.au)

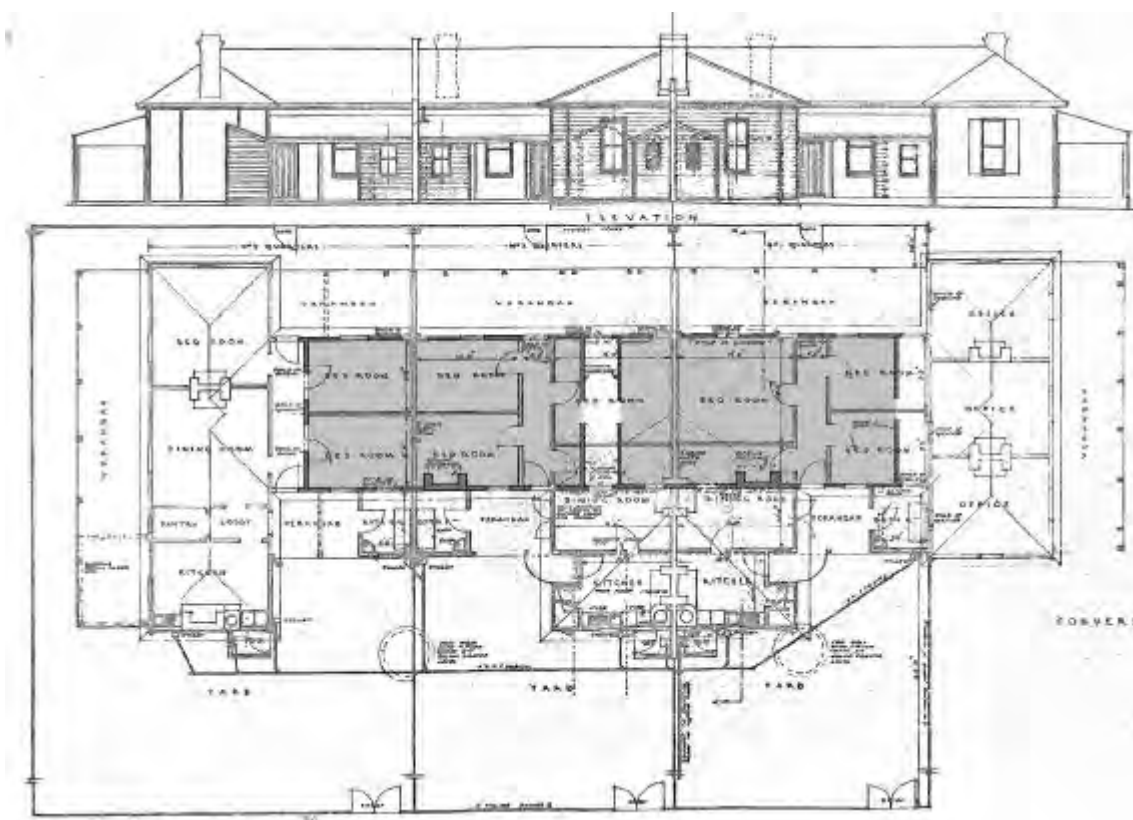
Fig 4.6 Plan of MH27 showing original works to convert it into 3 married quarters and rear elevation. The shading has been added to the plan to show the original configuration.

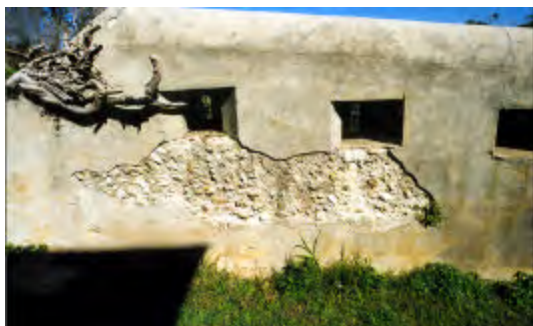
Fig 4.11 The defensive wall associated with the area of the moat around MH29 showing the “loop holes”. The mass concrete walls are in a relatively poor condition and are in need of conservation. Such things as plant growth, damp and being covered by soil are causing these important elements to deteriorate. PAUL DAVIES PTY LTD 2002

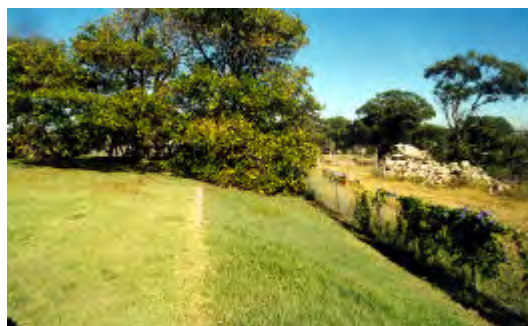
Fig 4.12 The section of the outer moat adjacent the tennis courts. This was once the site of the stables building. The moat has been infilled and built up to the head of the defensive wall, largely obscuring an important site feature and potentially endangering the wall condition. The fill used may contain sections of demolished buildings. PAUL DAVIES PTY LTD 2002

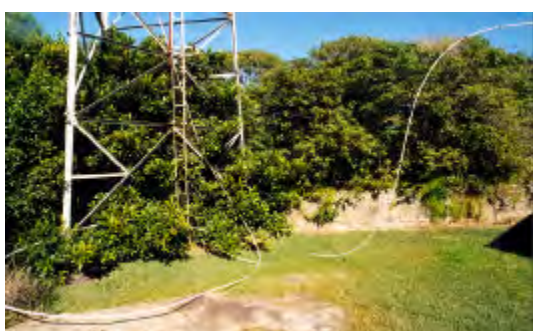
Fig 4.13 The defensive wall associated with the eastern end of the outer moat behind MH32. The unchecked growth of trees has largely concealed the moat and is largely obscuring the wall. PAUL DAVIES PTY LTD 2002

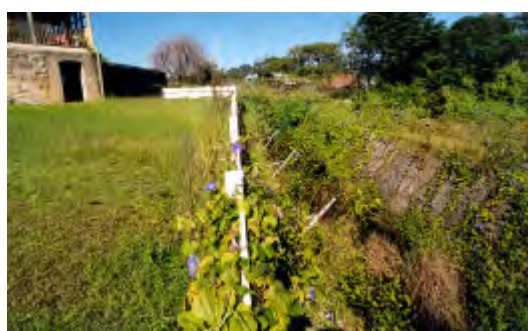
Fig 4.14 The only exposed section of the moat is that around MH29. This area is in poor condition and is substantially overgrown. PAUL DAVIES PTY LTD 2002

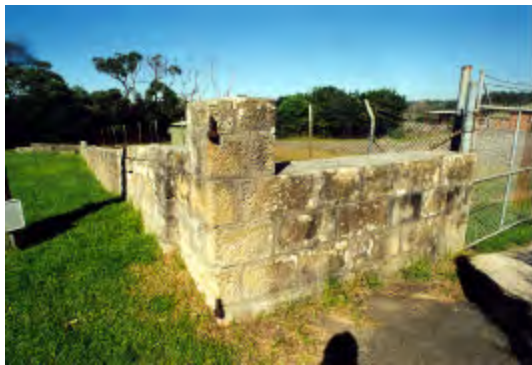
Fig 4.15 The stone front gates. The entrance to the site was once via a timber bridge over the moat, a far more defensive position than the present entrance.
PAUL DAVIES PTY LTD 2002

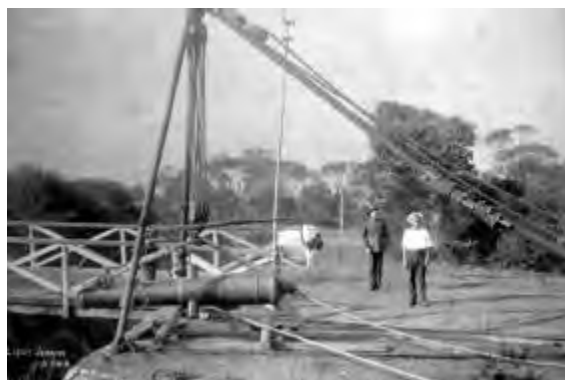
Fig 4.18 The original entry to the site was funnelled through this timber bridge. NPWS Slides

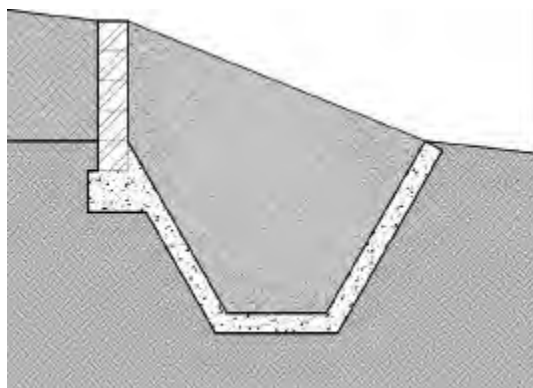
Fig 4.19 The present configuration of fill against the wall, obscuring the moat and wall. Not to scale.
PAUL DAVIES PTY LTD 2002

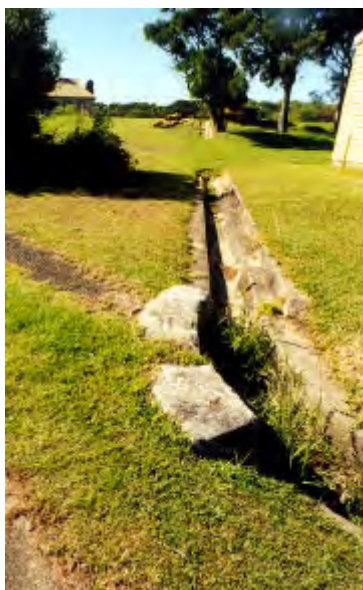
Fig 4.21 An early kerbing and drainage feature to a road no longer extant.
PAUL DAVIES PTY LTD 2002

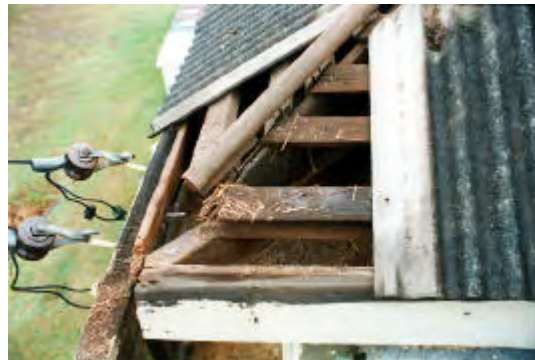
Fig MH26.11 The works uncovered tightly spaced roof battens. NPWS MAINTENANCE FILE F/590 - 2001

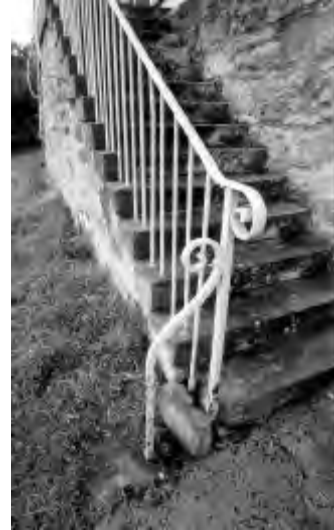
Fig MH29.20 External stairs showing corrosion damage to wrought iron and subsequent cracking to stone treads.
PAUL DAVIES PTY LTD 2002

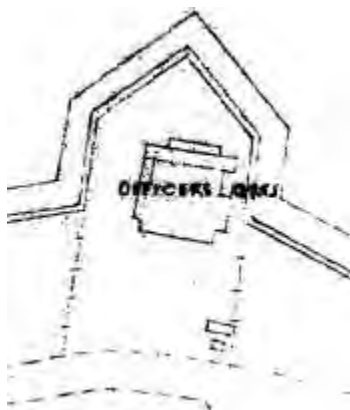
Fig MH29.21 Officer's Quarters on 1939 plan. The building was in use as an officer's quarters until the war. The sketch shows the front stairs, but is less precise about the rear configuration. NAA SP 857/3 PC/397

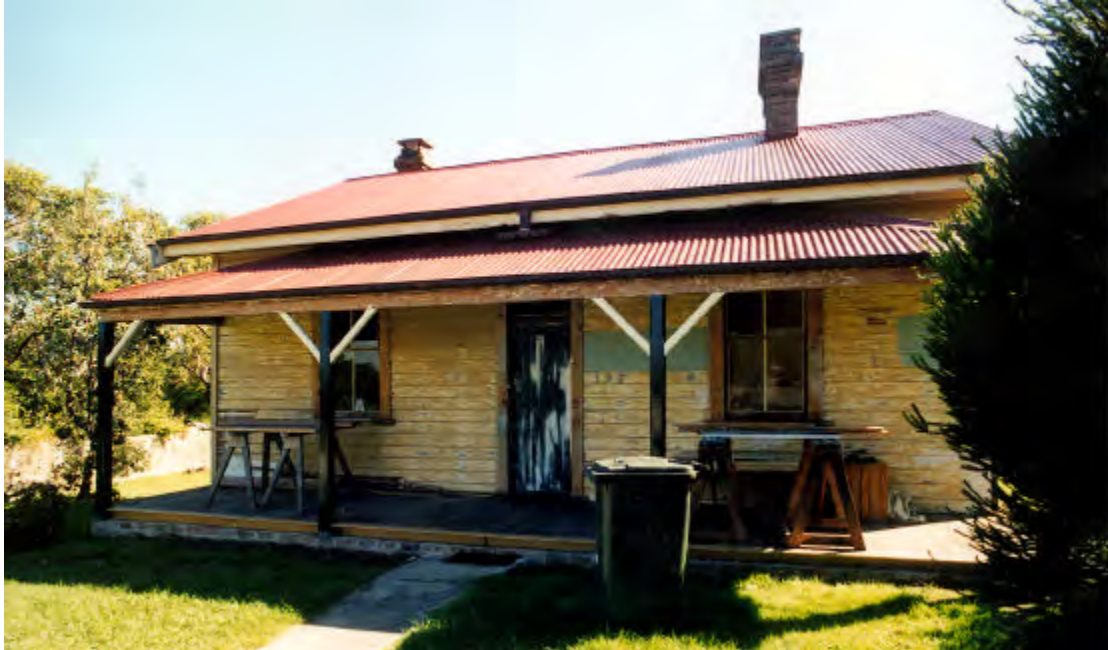
Fig MH30.2 The front (south east) elevation showing verandah and front wall in process of repair works. PAUL DAVIES PTY LTD 2002

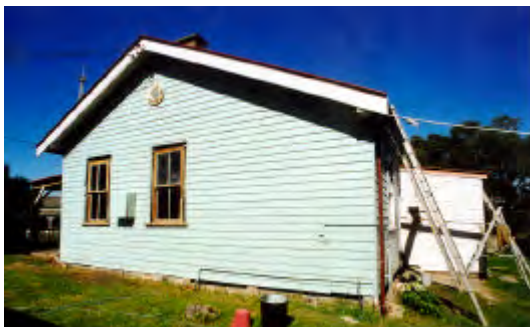
Fig MH30.3 The building from the north showing the unbalanced roof form. PAUL DAVIES PTY LTD 2002

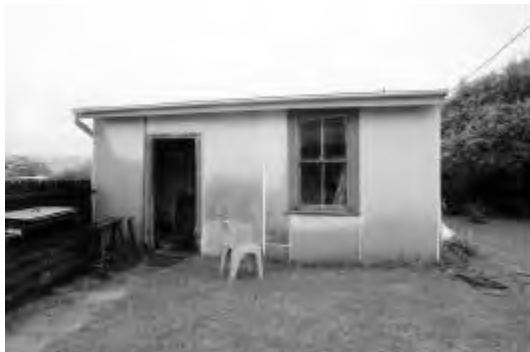
Fig MH31.23 The rear shed with a salvaged (or original) four paned window and ledged door. The FC sheet appears in fair to poor condition. PAUL DAVIES PTY LTD 2002

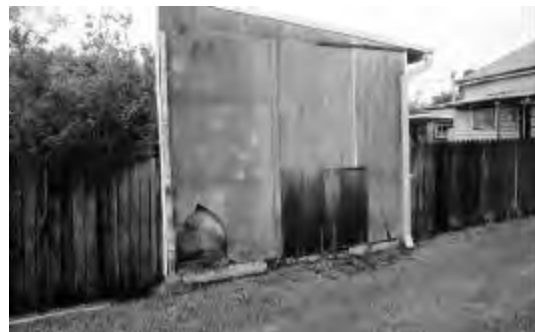
Fig MH31.24 The end wall of the shed is in a substantially poorer condition. PAUL DAVIES PTY LTD 2002

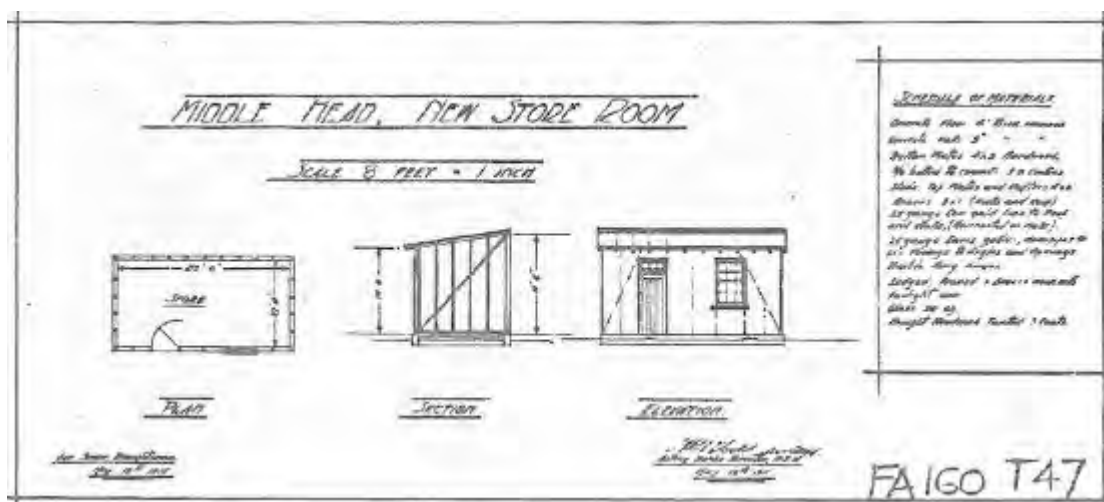
Fig MH31.27 1915 Plans of the shed adjacent MH31. Fig MH31.23 shows that either the plans were not fully carried out, or that some alteration has occurred. The present condition would indicate that the cladding has been changed at some point. FA160 T47

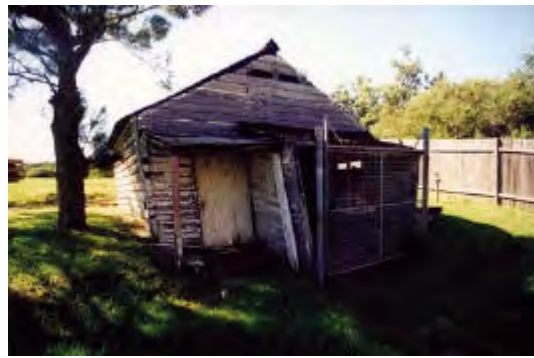
Fig MH34.4 Photo of front of coal store showing
general structural and cladding failure.
PAUL DAVIES PTY LTD 2002
