The NPWS Fortifications of Sydney Harbour and Botany Bay

A Strategic Plan

National Parks + Wildlife Service

Final Report
July 2007

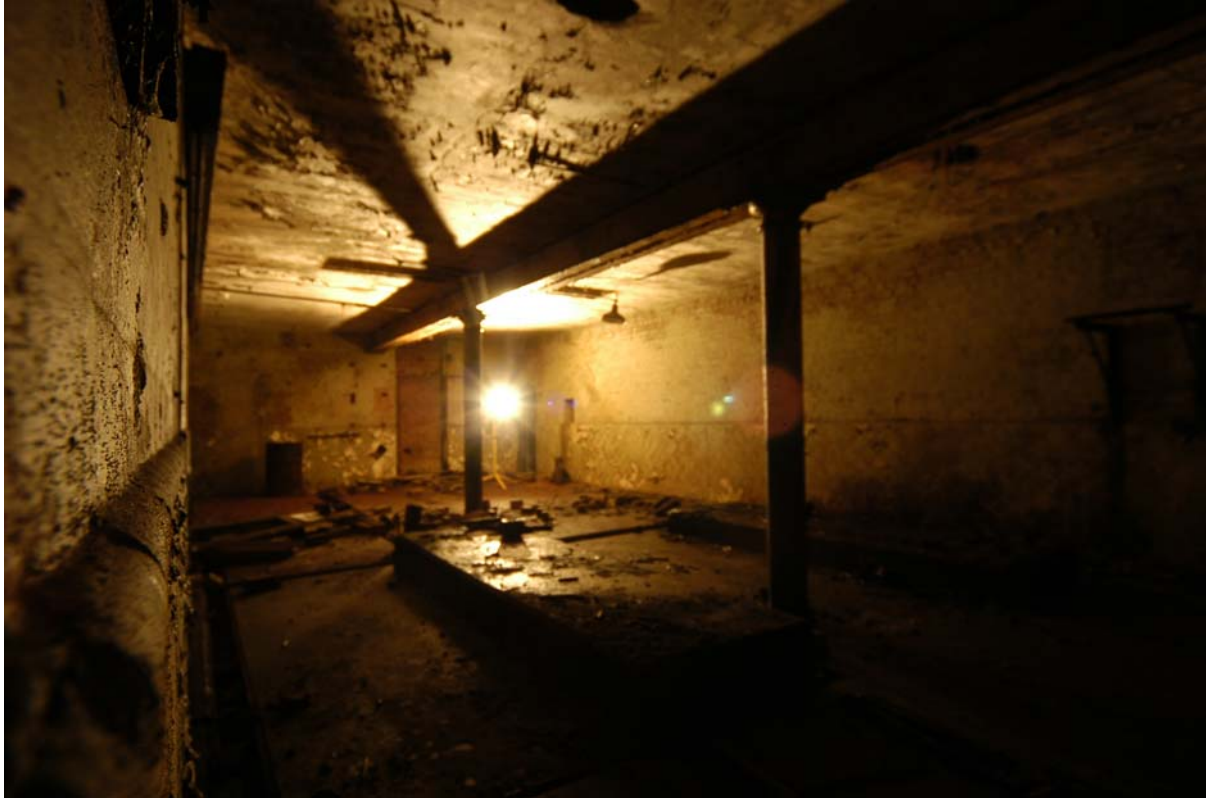
Figure iii Interior of the recently discovered below ground engine room at South Head, a very significant and exciting discovery that will require extensive work if it is to be accessible in the future. This space highlights the difficulty in bringing together significance with management of a very broad range of sites with complex conservation, access, security, interpretation, cost and OH+S issues. Photo Paul Davies 2006

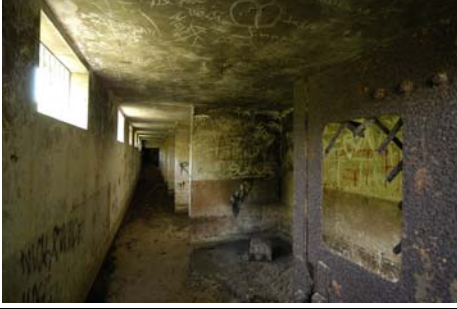
- c1940 below ground remains – engine room and magazines	The below ground elements are in generally sound but abandoned condition. There is remnant fitout from the second world war phase. These areas, at this stage, require no conservation works apart form security.	5 Prevent access to the below ground areas, access only on restricted and controlled basis.	HIGH

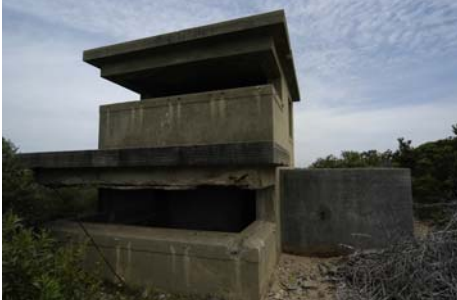
- c1940 observation posts and control rooms	The below ground structures are sound and require no conservation works. The above ground elements are deteriorated and suffering from concrete deterioration . Over time they will either need to be stabilised or removed.	6 Secure potential access areas, if necessary by removing the structure above ground and infilling (refer to recommendations under security).	HIGH

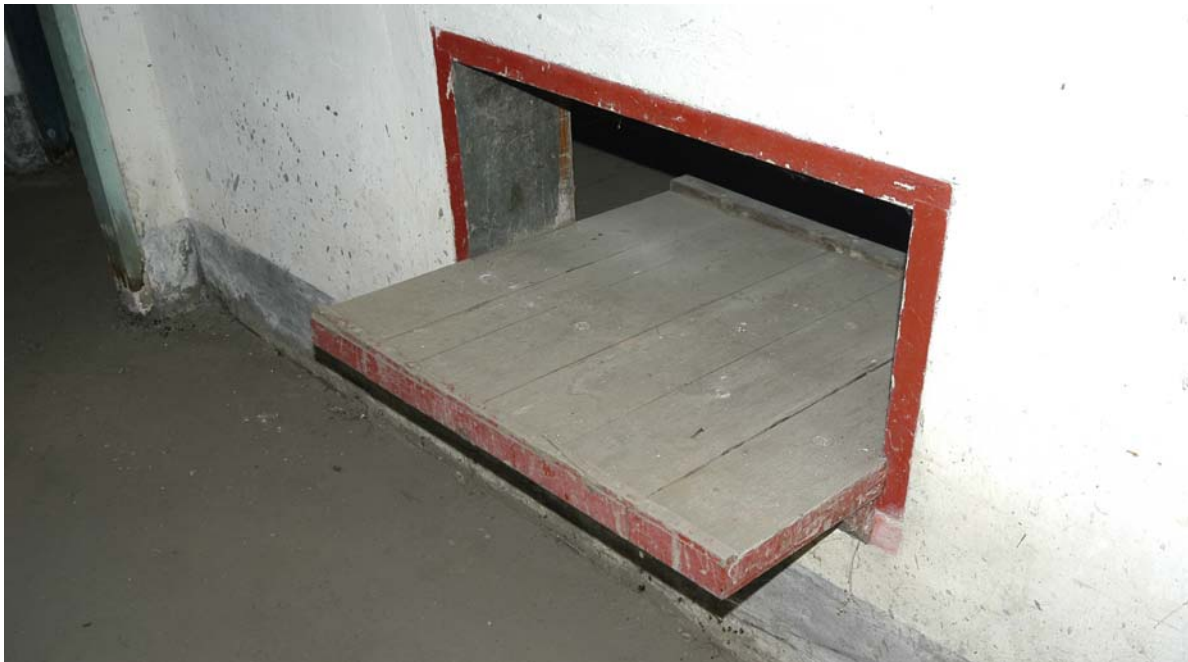
Figure x Conservation work to timber elements in the underground magazine at South Head to reinstate deteriorated elements based on careful research and site investigation.

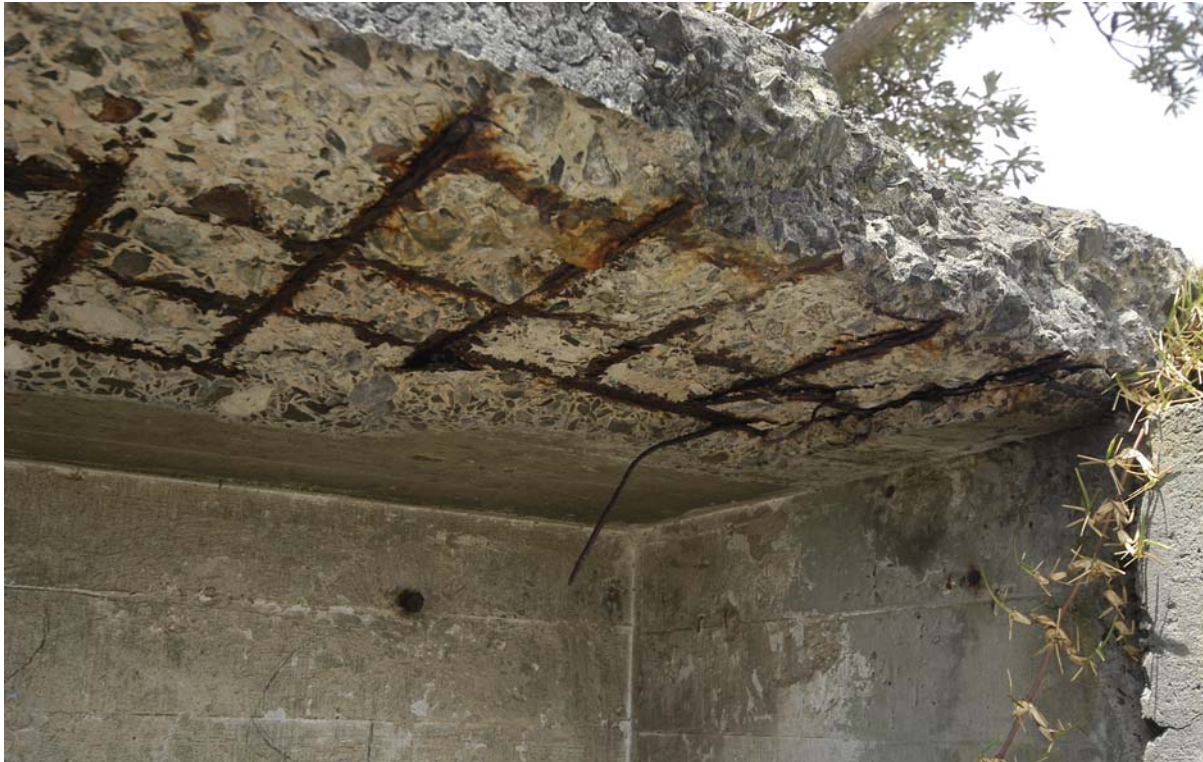
Figure xi An example of severe concrete deterioration at South Head which will in time if not treated cause structural failure of the element.

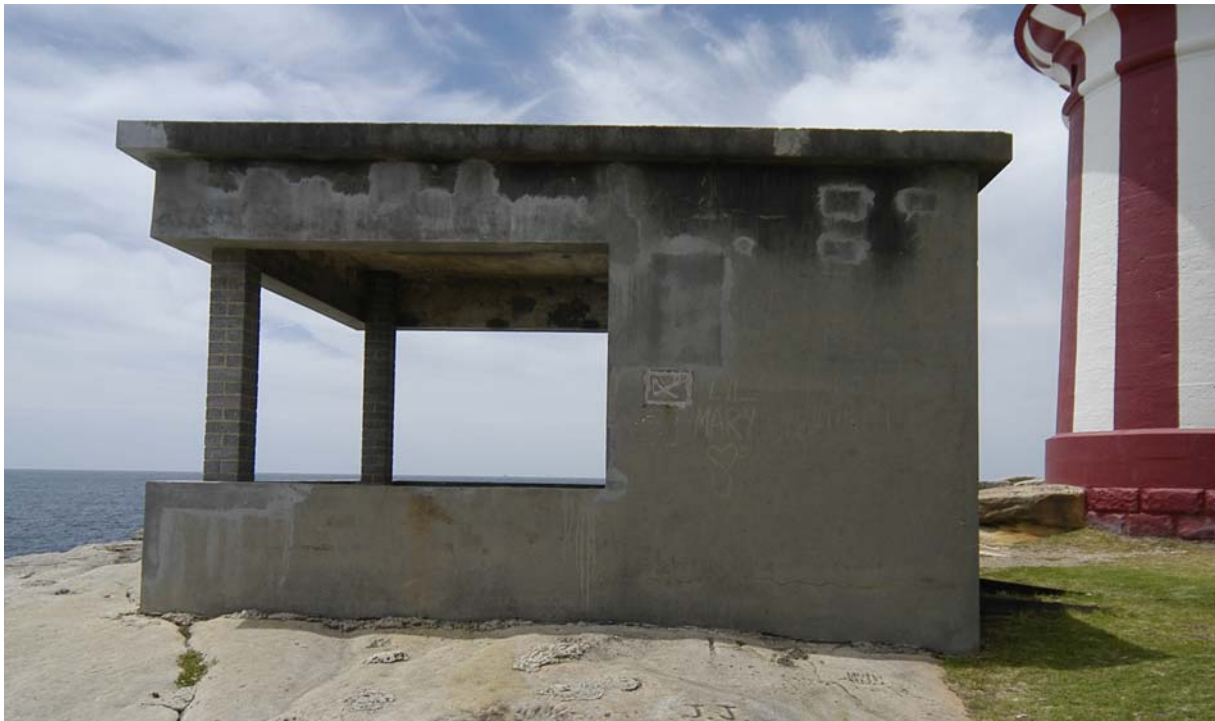
Figure xii Another example from South Head where extensive reconstruction of concrete has taken place and failed steel posts have been replaced with more robust concrete blocks to conserve this prominent concrete element.

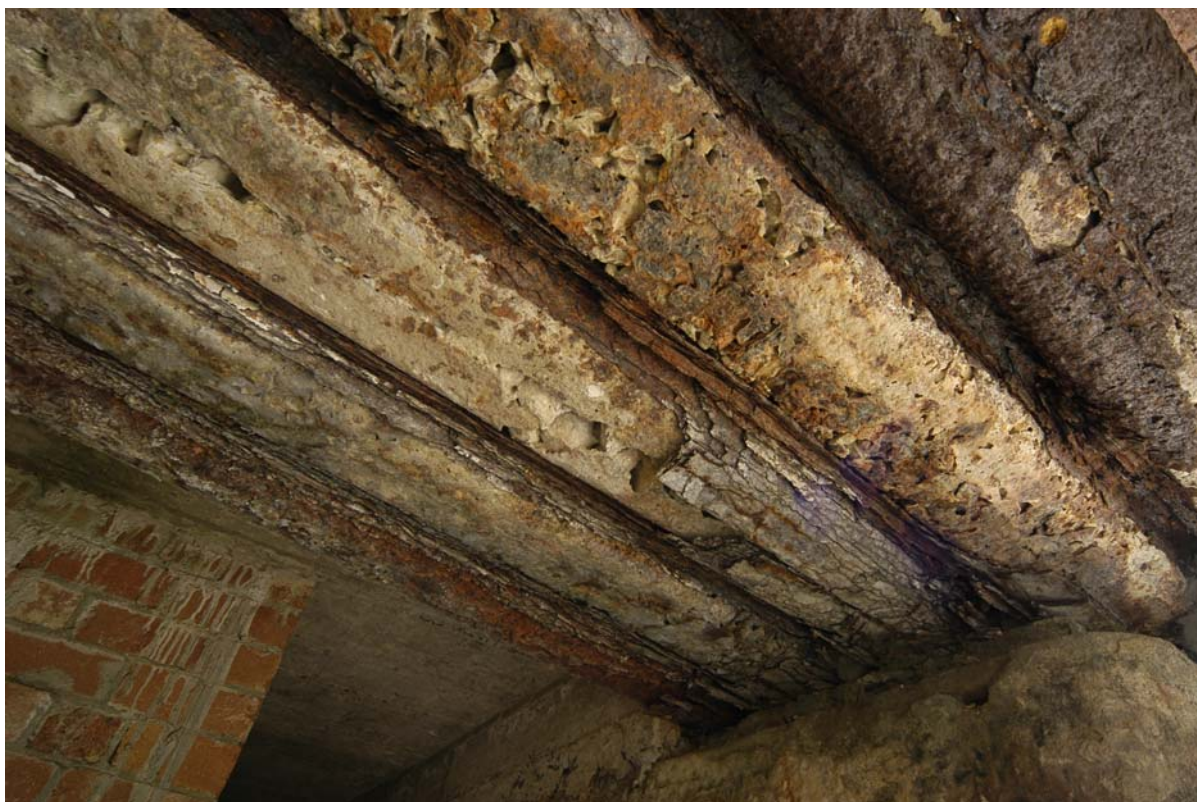
Figure xii An example of severe steel corrosion to Barlow Rail roof supports at South Head.

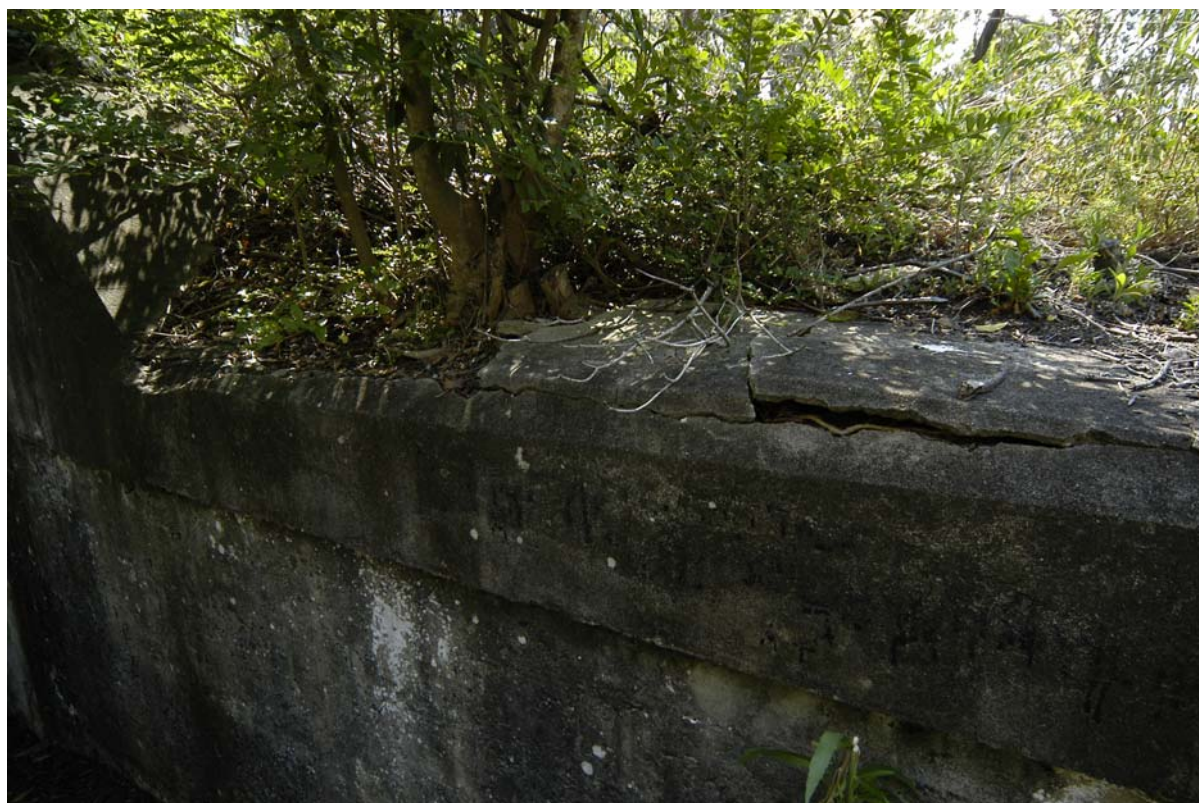
Figure xiii Example of damage from self-sown and unwanted plant growth around edges of structures. Inner Middle Head fortifications.

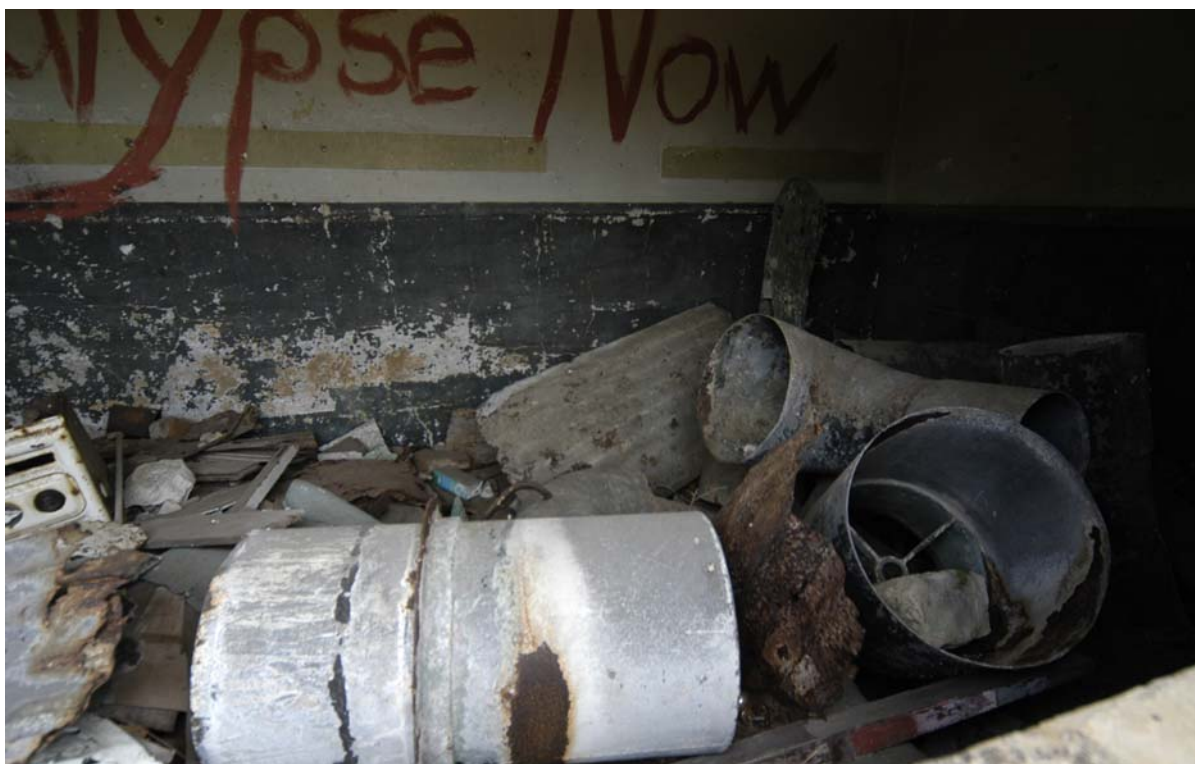
Figure xiv Cape Banks structure interior that is easily accessible and full of rubbish from the site, note the graffiti that features as this site.

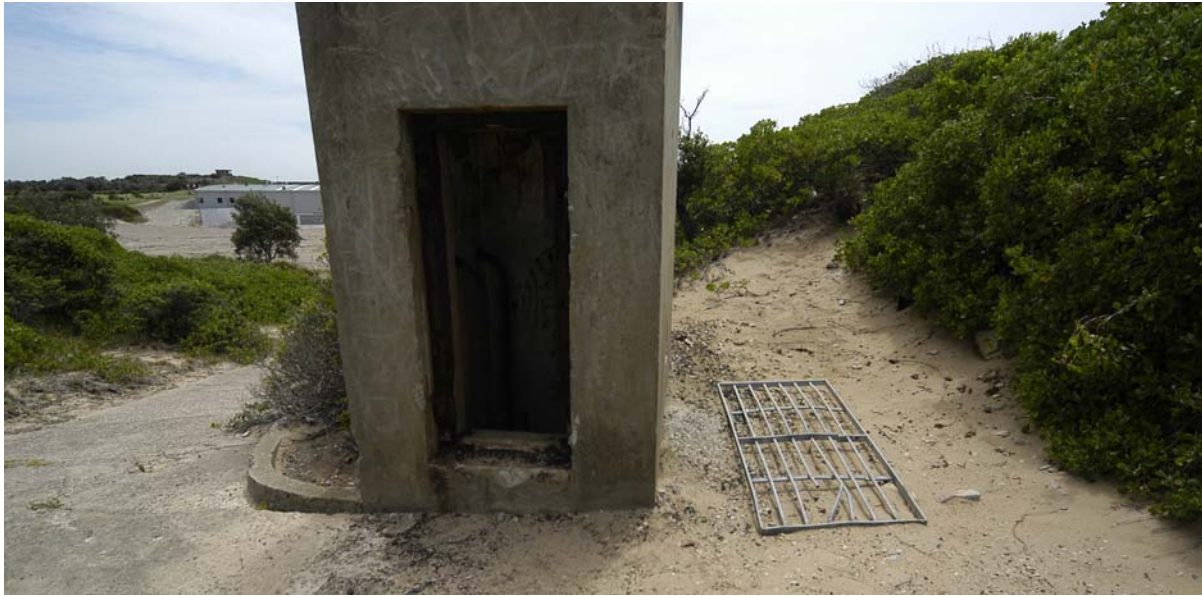
Figure xv A severe example of vandalism to gain entry to the below ground areas at Cape Banks. This not only requires repair but presents a serious risk to other visitors as there is a substantial drop with the gate removed. This type of activity needs to be monitored regularly and responded to quickly.

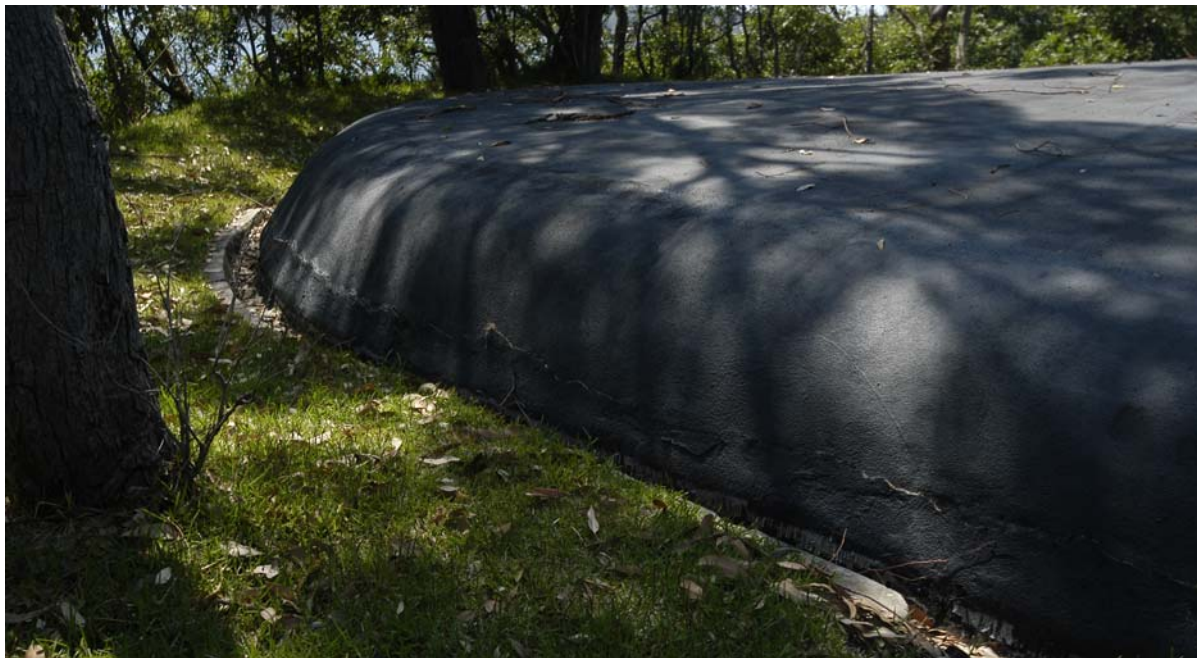
Figure xvi Membrane applied to roof of armoured casemate as part of previous maintenance works. Note the edge cracking and failure of the membrane through movement. Ongoing maintenance of areas such as this are essential to ensure that the fabric is conserved and that best value is obtained from conservation works.

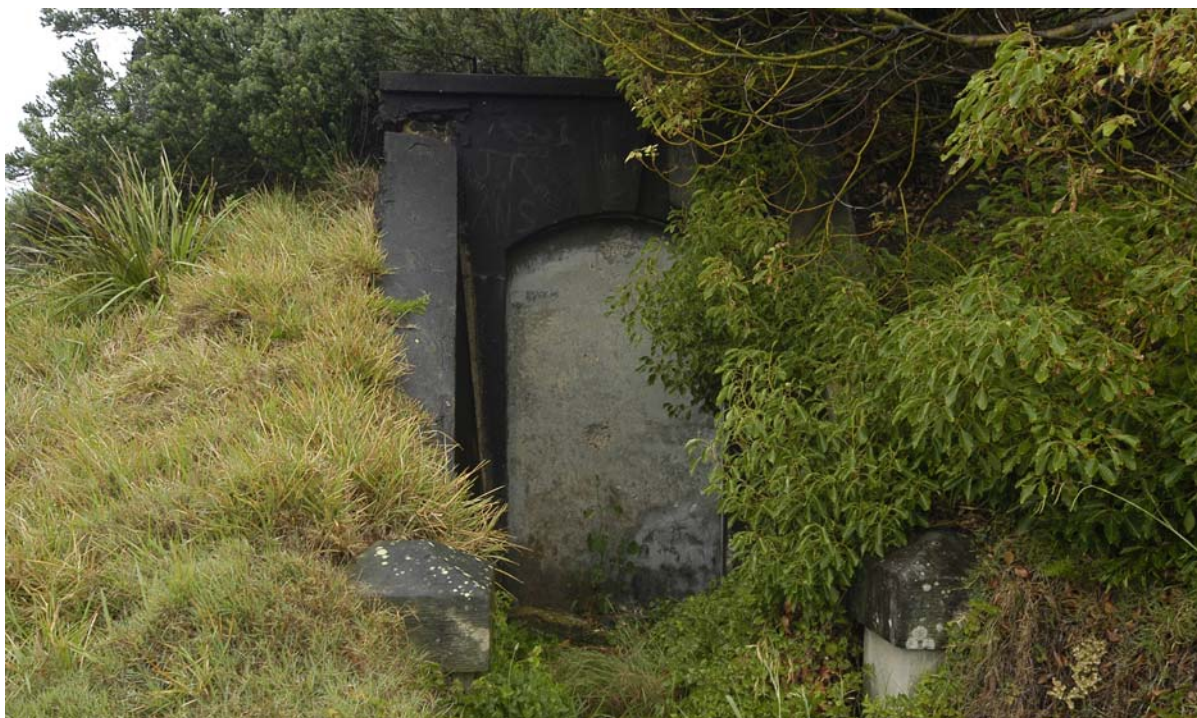
Figure xvii Entry to Green Point tunnels (blocked) with extensive undergrowth that requires maintenance.

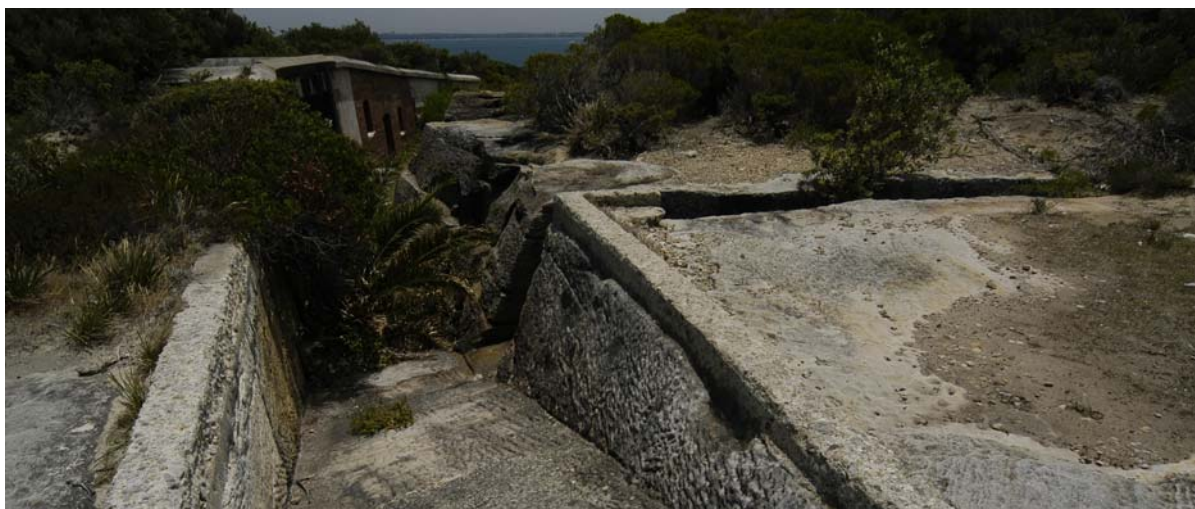
Figure xviii Regrowth at Henry Head in areas of stone cutting that are causing serious deterioration to very significant stonework, to access and interpretation.

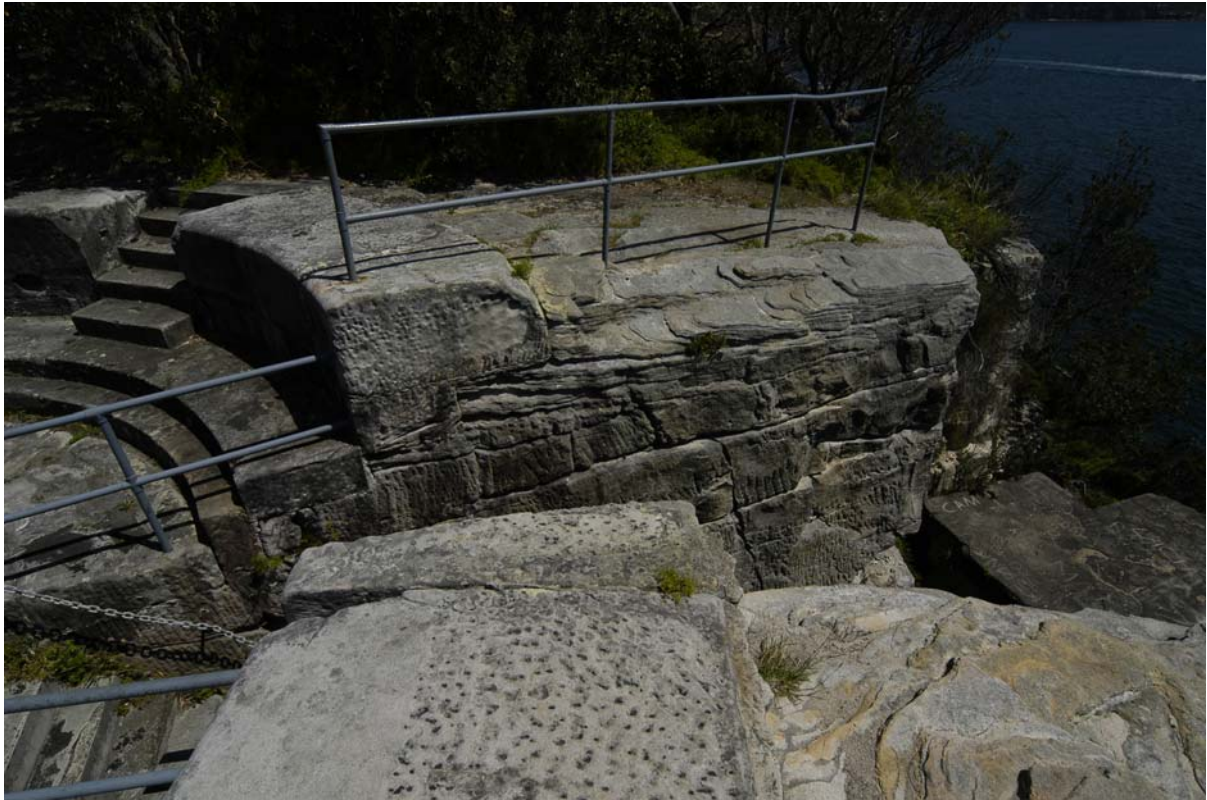
Figure xix Outer Middle Head showing a location where secure fencing is required as it is easily accessible and the drop-off is unexpected and dangerous. While the fencing is not complete in that it does not return, it marks a dangerous location adequately to warn visitors not to proceed past the edge of the fence. This is an excellent example of when to provide barriers. In contrast, the chain to the left of the picture is a handrail down a steep set of steps and it is not a suitable element and should be removed as it presents a danger to users in itself.

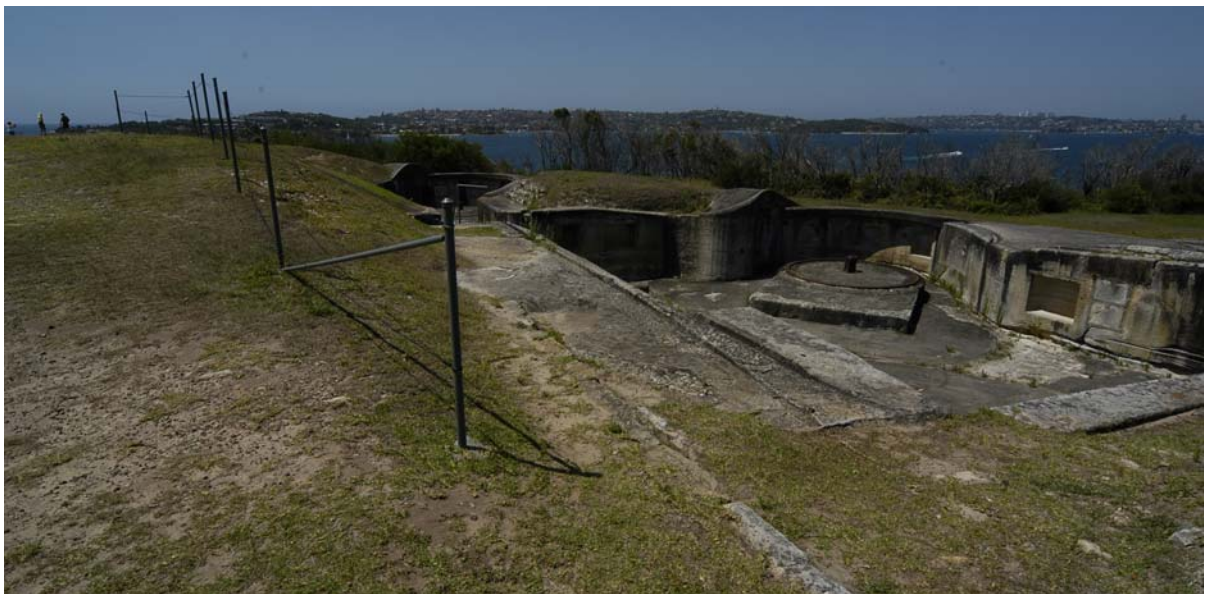
Figure xx Outer Middle Head showing more recent fencing that is properly placed at the top of the rise to prevent casual access to steep slopes. It does not prevent access but provides a suitable indicator to prevent a visitor from accidentally accessing a difficult area. While the form of fencing is not sophisticated, it is low key and works well.

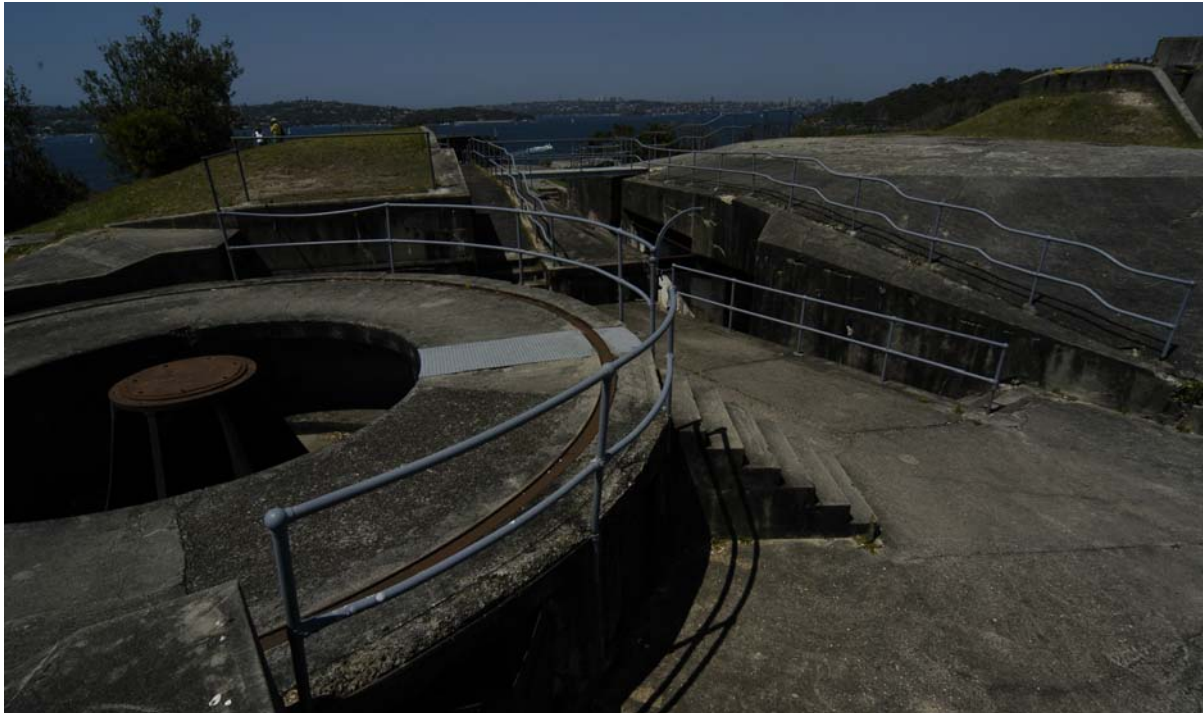
Figure xxi Outer Middle Head showing the extensive network of tube rail fencing installed in the past to protect visitors, however while some edges are fenced most are not. The fence in the immediate foreground for example protects a low drop-off, but other gun emplacements do not have fencing with a similar drop-off. Inconsistencies in approach may expose NPWS to claims as this fence clearly recognises a risk and that should be applied consistently. A better approach would be to remove some of this fencing and to only provide fencing where risks are high.

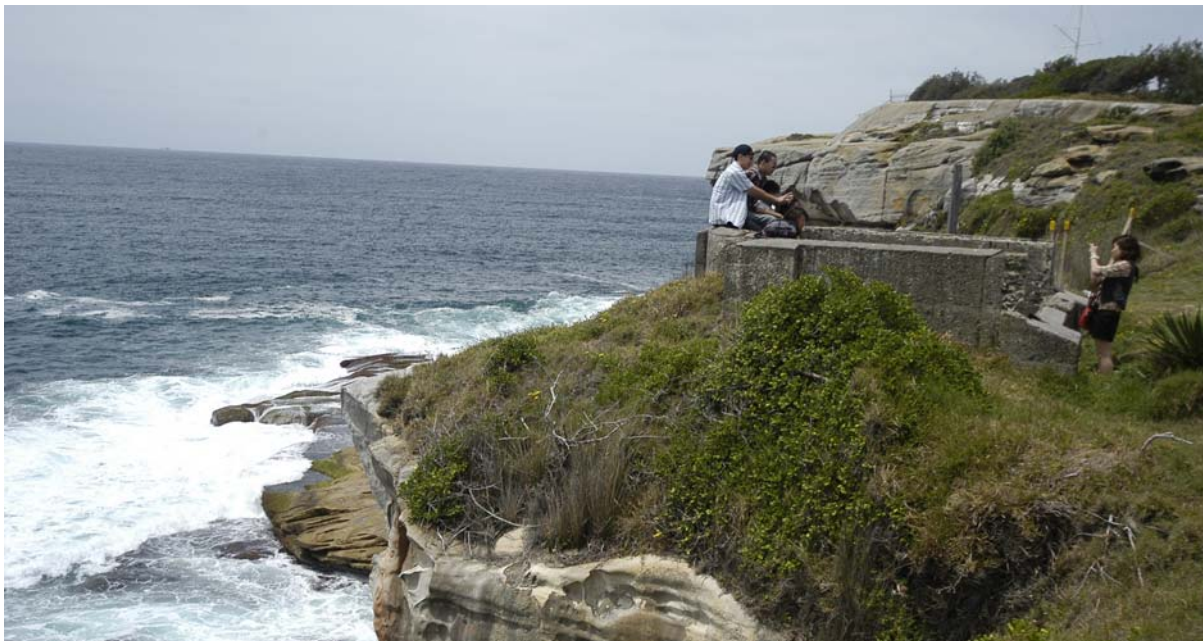
Figure xxii South Head adjacent to Hornby Light showing the difficulties of unprotected access to cliff top features. This is a highly visited location that is used for many photographs and has high risk due to the dangerous behaviour of visitors. Here consideration of a barrier, possibly low and behind this popular photo location would reduce risk.

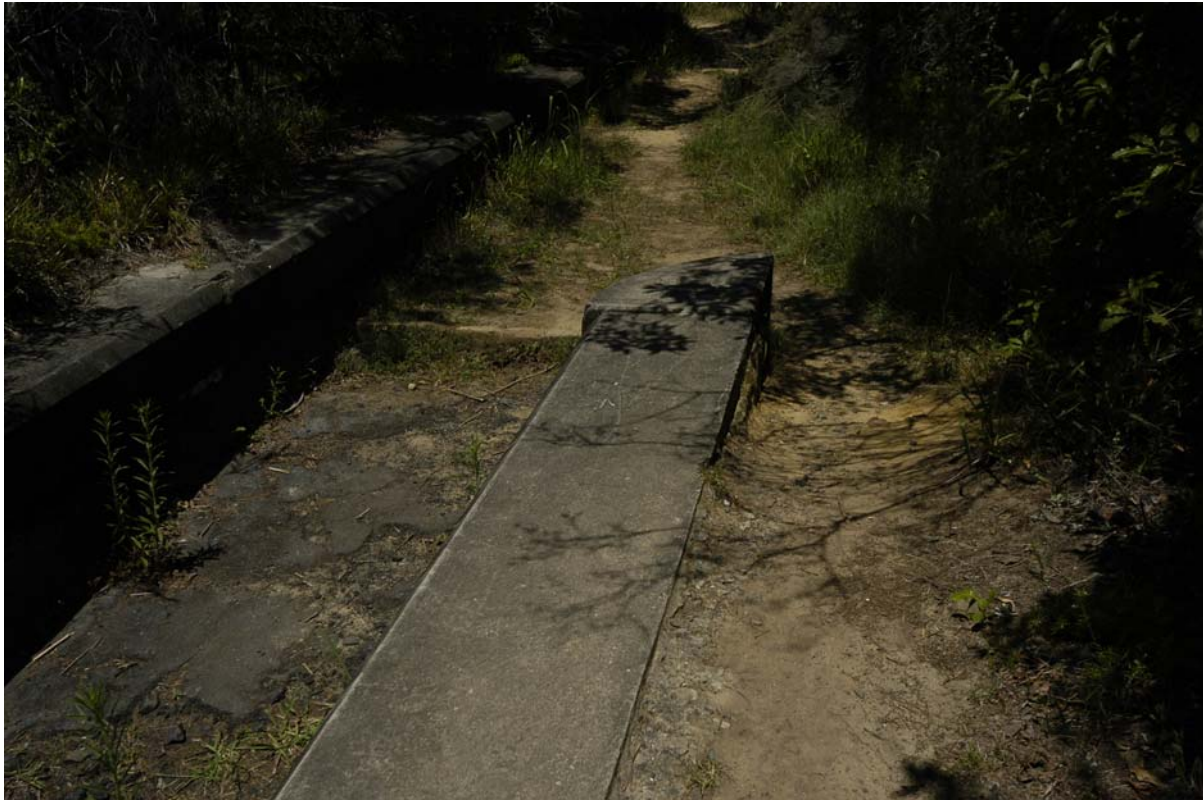
Figure xxiii The main walking track between the Inner and Outer fortifications at Middle Head with the informal linking track to the right of the retaining wall that visitors are required to find and use to complete a circuit of the area. The informal track is not suitable for general access, traverses the top of sensitive areas with below ground fortifications, is difficult to locate and is confusing to irregular visitors. Apart from general track maintenance, a clear route needs to be provided that is safe and without hazards.
