GOAT ISLAND

Conservation Management Plan

Volume 1

June 2011

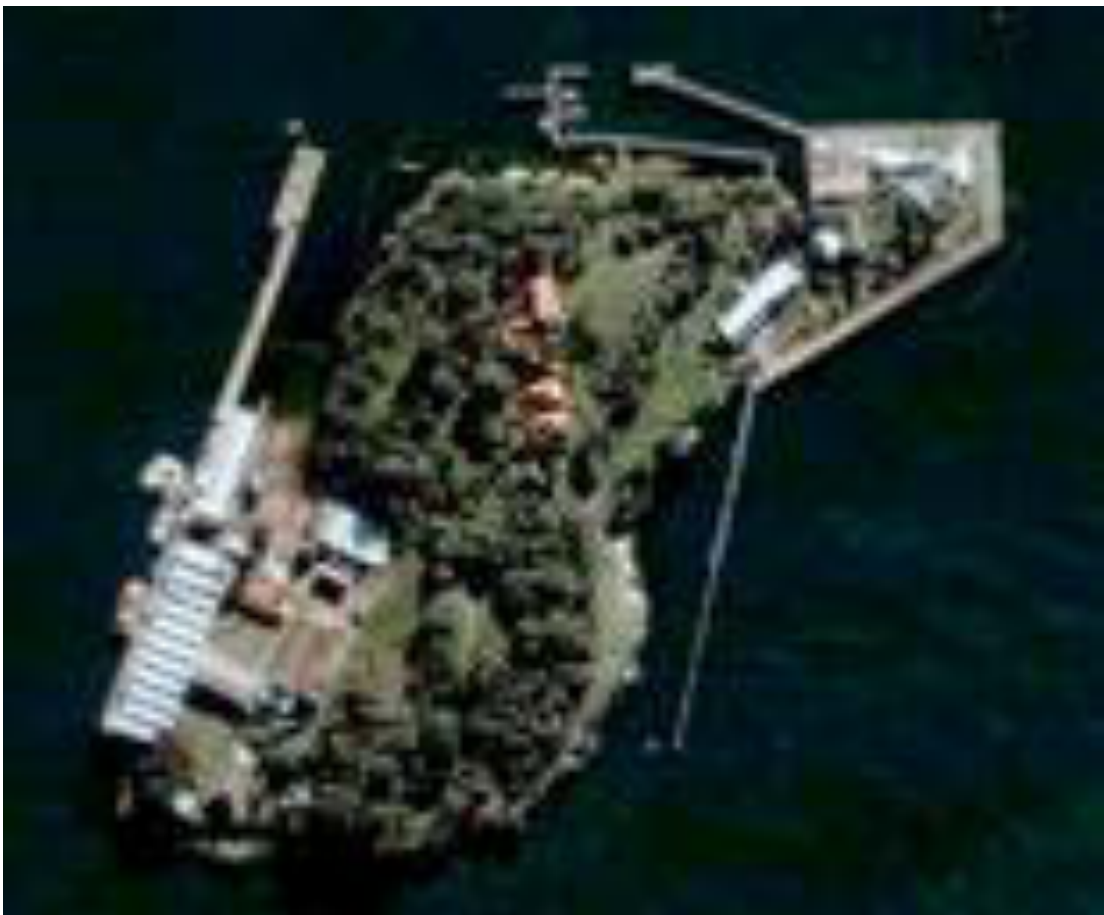
Figure 1.3 Aerial view of Goat Island 2004. The major features are the shipyard located to the bottom left, the Harbour Masters Residence and cottages with terracotta tile roofs running north/south in the centre of the island, the former Water Police Precinct with its ancillary MSB buildings on the knoll separated by Barney's Cut on the top right and the heavily vegetated landscape through most of the central area of the island. Note the extent of wharfage around the island.

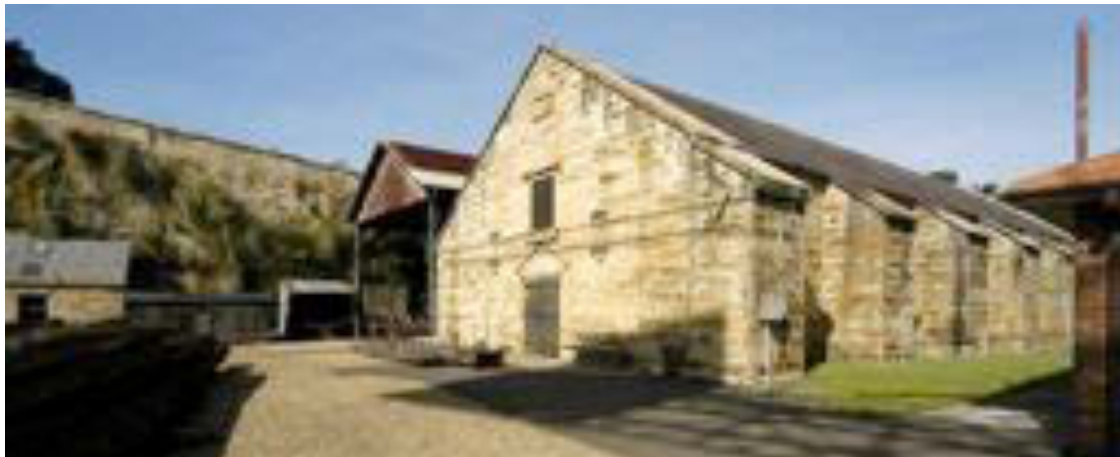
Figure 2.1 The Queen's Magazine is perhaps the most significant built structure on the island. It is unique, the earliest example of a military gunpowder magazine in Australia, largely intact and is an exceptional achievement in terms of construction finesse. It is located within its fortified wall, with all of the magazine buildings built in the 1830's still standing and retaining their relationships to each other (see Figure 2.2 below). It is also now located between the 1925-29 Scow Shed, 1948 and 1963 amenities buildings and a corrugated iron clad addition to the south end of the building from the 1940's. The 1943 Ship Repair Workshop and its extensions to the west largely cut off views between the harbour and the magazine. Each of these structures have their own significance in relation to the later shipyard development of the precinct, however, apart from the 1948 amenities building and the 1943 Ship Repair Workshop, none are now used in relation to the shipyard.

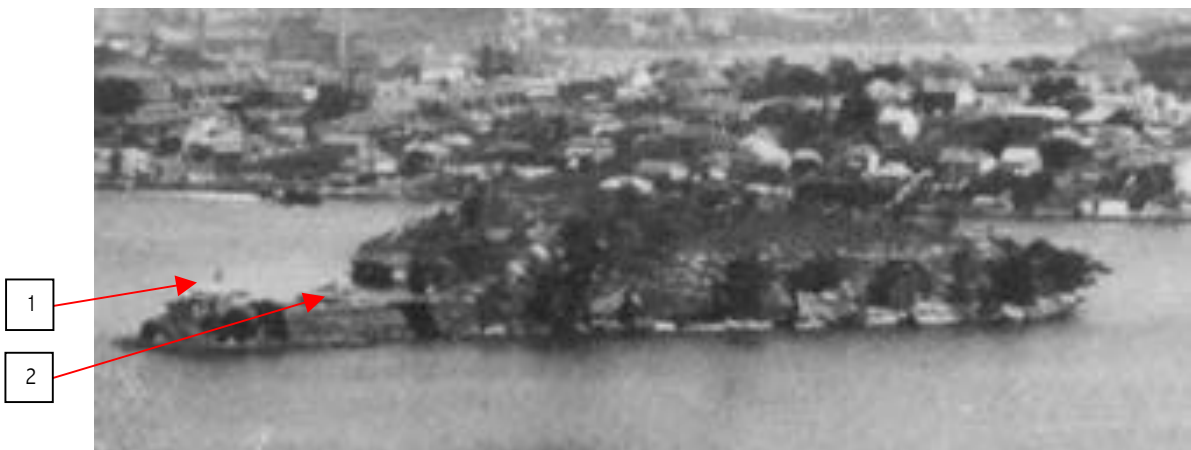
Figure 2.8 Detail of an 1892 photograph taken from the north shore (McMahons Point) shows both the Water Police Station (1) and the Artillery Sergeant's cottage (2) on the northeast tip of the island. The photo also shows the considerable thinning of natural vegetation when compared to the pre 1865 photograph at figure 2.7. (Source: City of Sydney Archives Image no. SRC 14960).

Figure 2.8, an 1892 photograph from the north, clearly shows the former Water Police Station (47) and the Artillery Sergeant's cottage (46a) on the north eastern tip of the island. The flag telegraph pole was presumably removed in 1865, as one of the changes made when the former Water Police Station was converted for use as a cartridge laboratory.

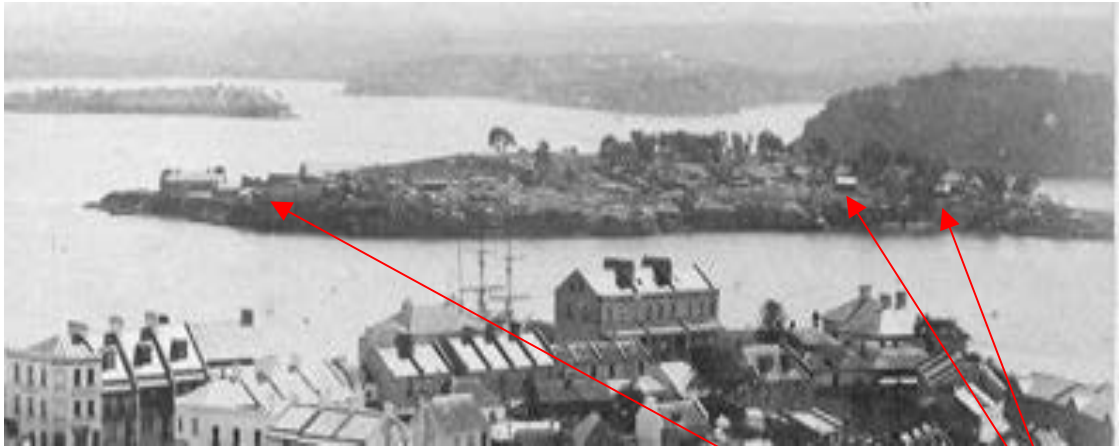
Figure 2.11 Detail of circa 1882 photograph taken from Sydney Observatory looking west shows the two 1870s explosives magazines (1 & 2) and the state of the south-eastern and eastern shore of the island at this time. An outbuilding (3) is visible behind the Barracks Kitchen. This photograph further illustrates the reduction in natural landscape on the island by the late nineteenth century. (Source: City of Sydney Archives image SRC 12220).

None of the magazines or other buildings constructed in the period 1870-1900 are extant. The two 1870s magazine sites remain as archaeological sites (81a and 131). Figure 2.11, taken circa 1882, shows the two 1870s magazines, as well as at least one extant outbuilding behind the Barracks Kitchen.

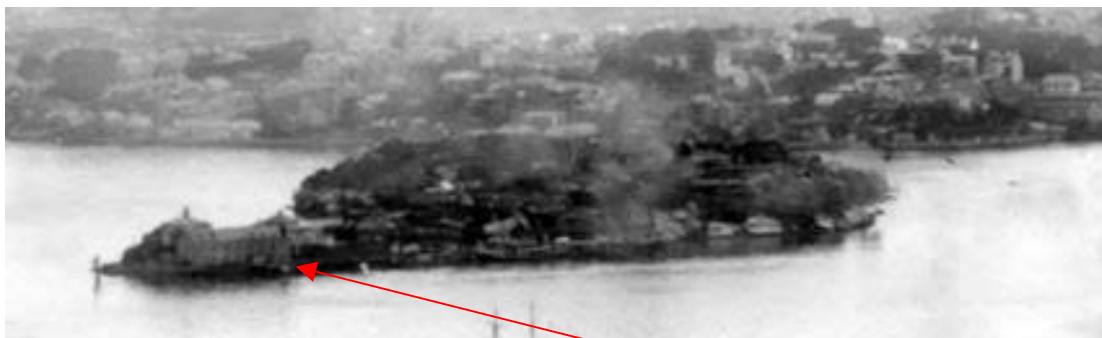
Fig 2.14 Detail of c. 1903-1911 photo shows a large 2-storey timber building (indicated by arrow) on the shore below the Water Police Station (demolished prior to 1943 according to aerial photos). The harbourmaster's residence is visible on the hill in this photo. (Source: Powerhouse Museum 85/1284-2651, 1/64 Tyrrell Inventory Number, 919 Kerry Studio Number, Glass negative, full plate, 'Balmain, from North Shore', Kerry and Co, Sydney, Australia)

Figure 2.14, a photograph of the island from the north taken between 1903 and 1911, evidences Sydney Harbour Trust activities at this end of the island in this period, as the photo shows the Harbour Master's Residence on the hill and a large two storey timber building on the northeastern shore of the island (demolished prior to 1943 according to aerial photos). This timber building is marked "Work Shop" on the 1924 plan of the island (Figure 2.15), and appears again on the 1929 plan of the island (Figure 2.16).

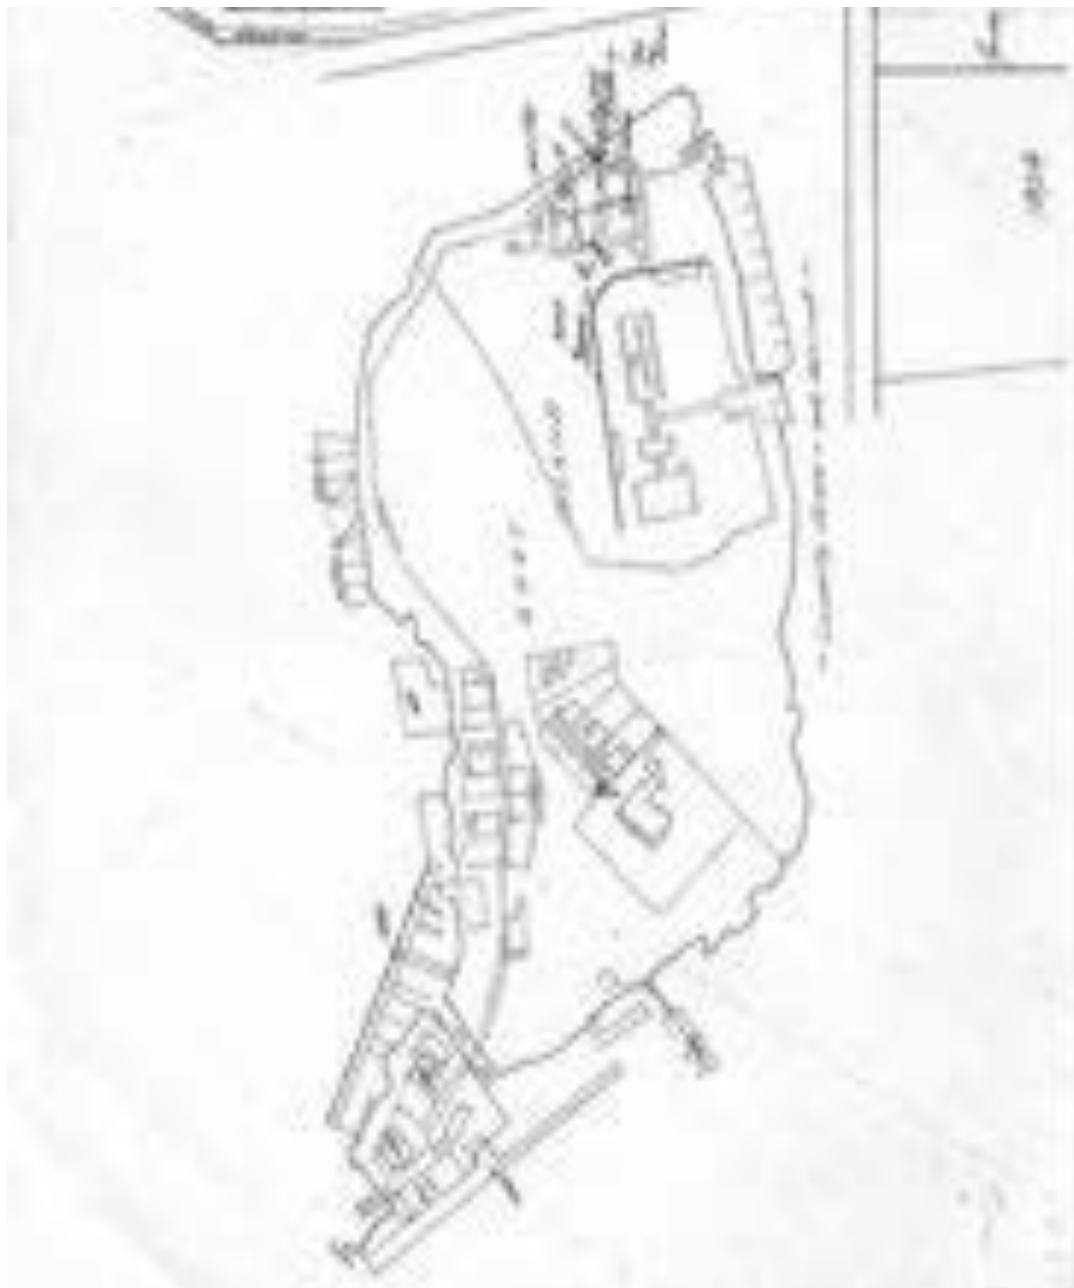
Figure 2.15 An informative 1924 plan of Goat Island, showing the extent of the Sydney Harbour Trust development just prior to their redevelopment of the magazine precinct. The Trust added the various residences on the ridge and to the east, added the fire brigade barracks, workshops and stores along the northern shore and converted the barracks and kitchen and the water police building for residential use. Many of the buildings built in this phase have been removed, including the workshop and stores buildings and six of the residences.

The wharves at this time comprise: the early stone jetties and wharves to the magazine precinct, an area of fill near the magazine in preparation for the new wharf construction, the first north wharf and ferry jetty, located with a parallel outer face, the stairs and jetty for the Harbour Master, the rough eastern wharf located off the shore line and several skeleton wharves further south braced off the cliff face. The only wharf elements remaining from this period are the stair to the residences and the alignment of the north wharf however both elements have been rebuilt.

A 1924 plan (Figure 2.15) still shows fences separating the magazine from the rest of the island reflecting the dual use of the island. However, by the end of 1925 the SHT had moved into the old Imperial enclave, and begun construction of a new shipyard, involving extensive excavation into the escarpment, filling of the foreshore area and construction of slipways, installation of cranes, reuse of the former magazine complex buildings for shipyard related uses, and the construction of two new buildings - the Scow Shed (16) in 1925 (taking advantage of the quarry face and wall of the magazine building to effectively form the walls of the new structure) and the Timber Store (22) c1930. A tramway system was installed and a new timber amenities building constructed around 1929. The barracks and barracks kitchen were converted to staff residences, two in the barracks and one in the kitchen with bathrooms, kitchens, new fireplaces and ceilings.

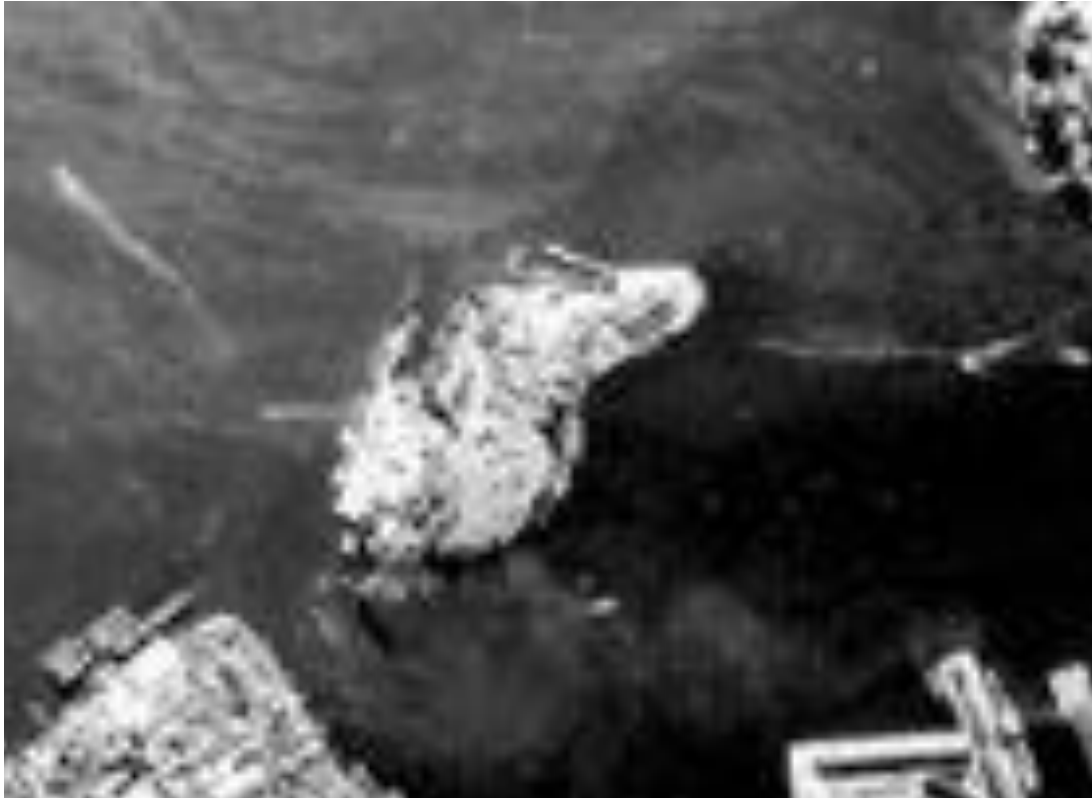
Figure 2.17 Aerial photo of Goat Island, May 1951, during MSB use of the island. Note the general lack of vegetation except on the western edge, and the manner in which the island is now virtually surrounded by wharves.

Figure 2.17, a 1951 aerial photo, shows Goat Island in the middle of the MSB phase, with extensive wharfage, large new buildings such as the 1946-49 Ship Repair Workshop, and the numerous cottages originally built by the SHT still providing housing for MSB staff.

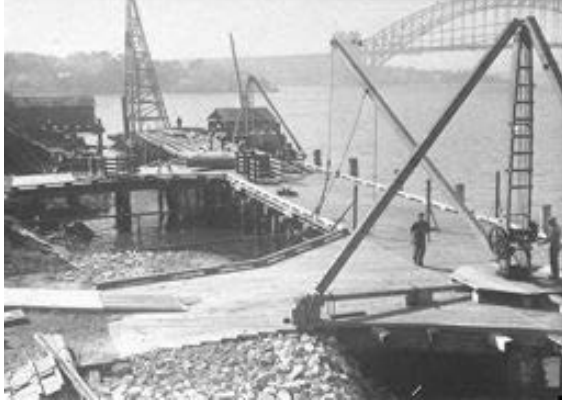
Figure 2.18 Reconstruction of the eastern wharf.

Comparison with the above photo clearly shows that this wharf was completely rebuilt at this time. May 1944. *SLNSW GPO1-07894*.

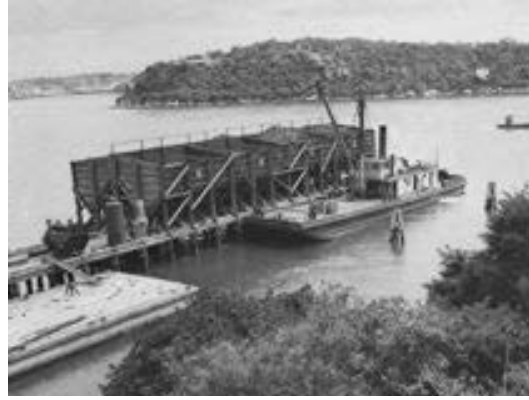
Figure 2.19 "Samson" Coaling. 9.1.1952.

This is the clearest illustration of the coal platform that has now been removed. Also note the dolphins that were replaced when the new slipway was constructed. *SLNSW GPO1-10051*.

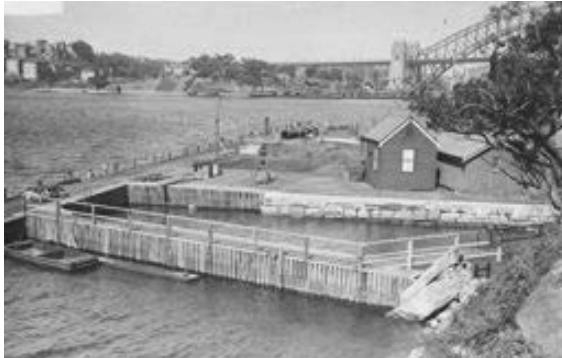
Figure 2.20 The completed shark-proof pool. 27.11.1941.

This informative photo shows the straight ferry wharf and the early northern wharf configuration prior to the new shore sheds in that area. The stone sea wall remains untouched from the c1901 phase of work. *SLNSW GPO 1-10268*

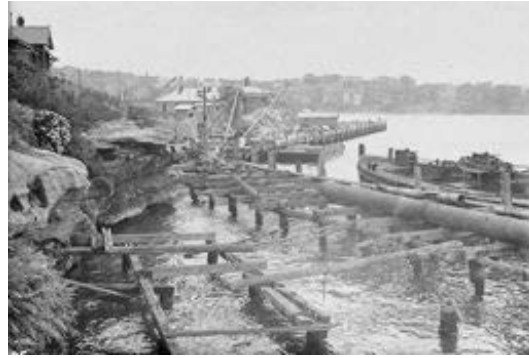
Figure 2.21 This photograph is entitled "New wharves". July 1944.

This is a view along part of the skeleton wharf (removed around 1969) looking towards the eastern tip of the island with the new broadside wharf in the background. *SLNSW GPO1-10052*.

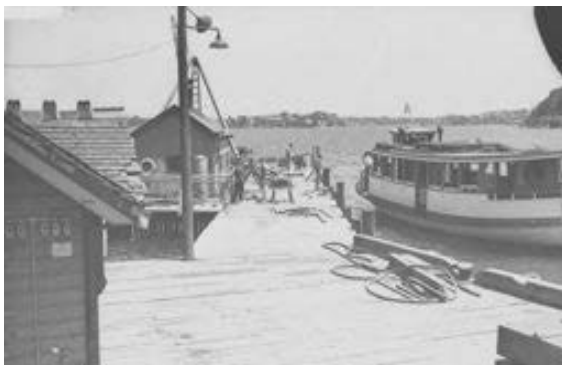
Figure 2.22 Wharf construction c1940.

This picture has been attributed to the 1920 period but the ferry wharf was not angled until reconstruction in c1945. The pool area is visible to the left of the frame. The shed to the west of the pool seems to have been moveable – it appears in a number of locations in various photographs as construction works are carried out. This also shows the wharf at approximately half its current length suggesting that the photo was taken during construction. There is no documentary evidence that this wharf was built in stages. *SLNSW GPO1-19371*.

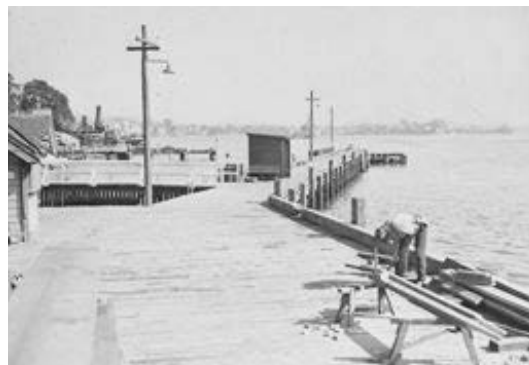
Figure 2.23 Construction of the ferry wharf. Undated

Most likely 1944 after the addition to the end of the wharf was complete. *SLNSW GPO 1-07969*

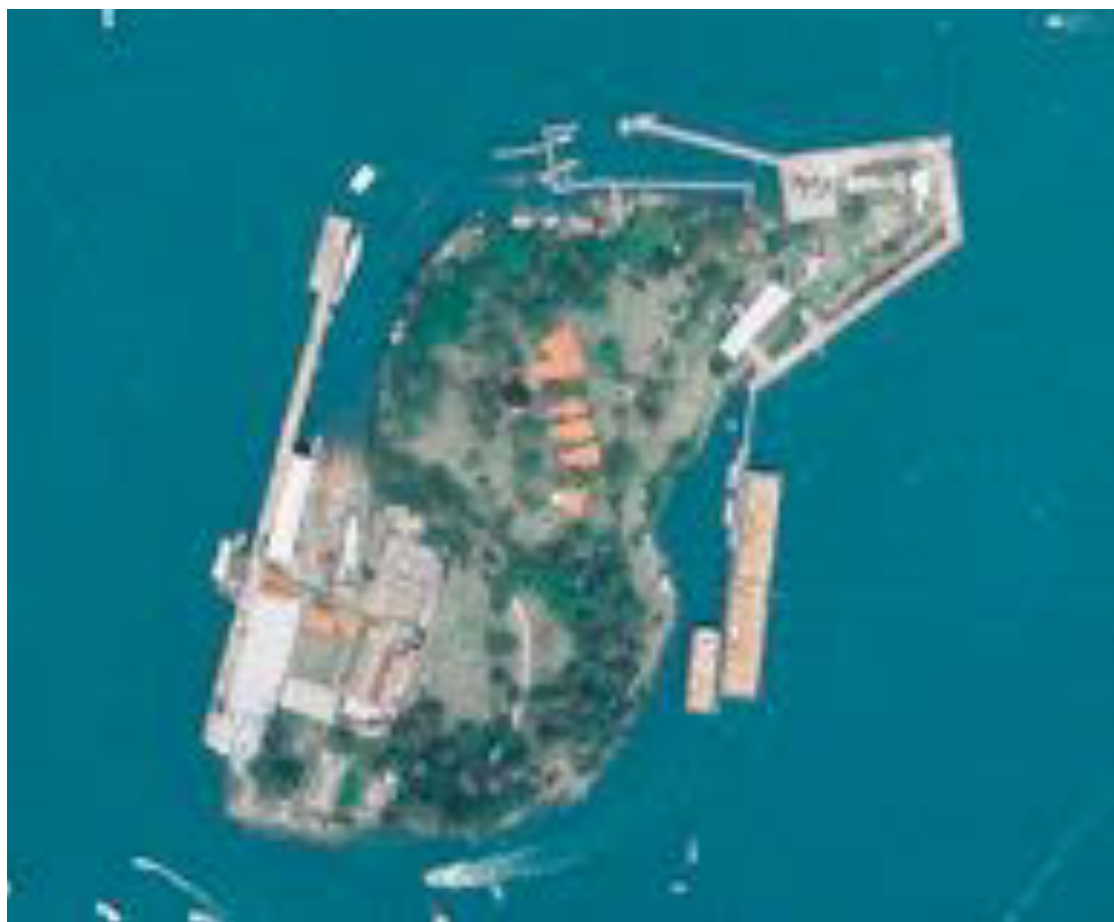
Figure 2.24 1999 Aerial photo showing the extent of buildings, wharves and the landscape early in the management of the island by NPWS. Note that wharfs are still being used for berthing at this time. (Source: DECC)

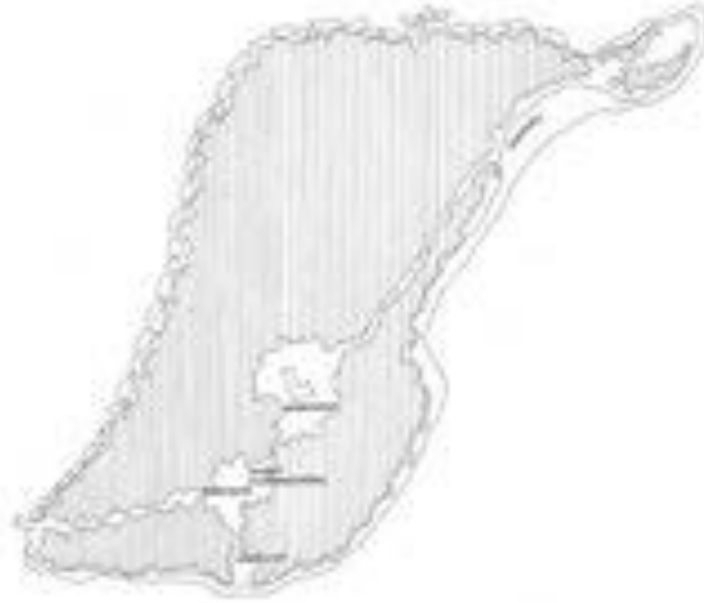
Figure 2.26 The extent of natural landscape on the island during the period of early quarrying - 1828 - 1833. During this period the open forest/woodland remained largely intact except for the eastern foreshore cleared for the quarry, a small area on the ridge cleared for convict barracks, and a small area near the southern foreshore cleared for a lime kiln. Selective clearing also provided wood for the kiln's fuel.

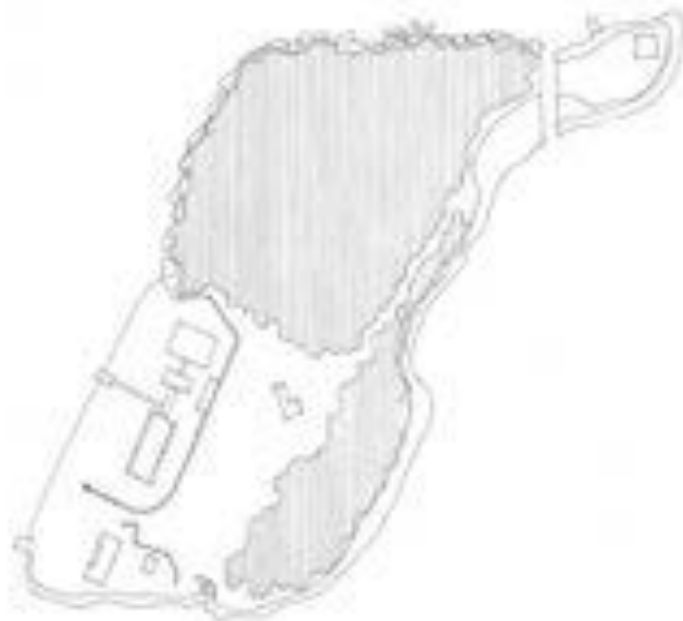
Figure 2.27 The extent of natural landscape on the island during the period of the Water Police and the Powder Magazine - 1833 - 1865. Quarrying in this period resulted in major alterations to the Western side of the Island with the construction of the Powder Magazine. Because of fire safety concerns, the Island's vegetation was cleared significantly from the southern section extending over the ridge to the eastern foreshore. During this period, the Barracks Kitchen Building Garden was established circa 1838.

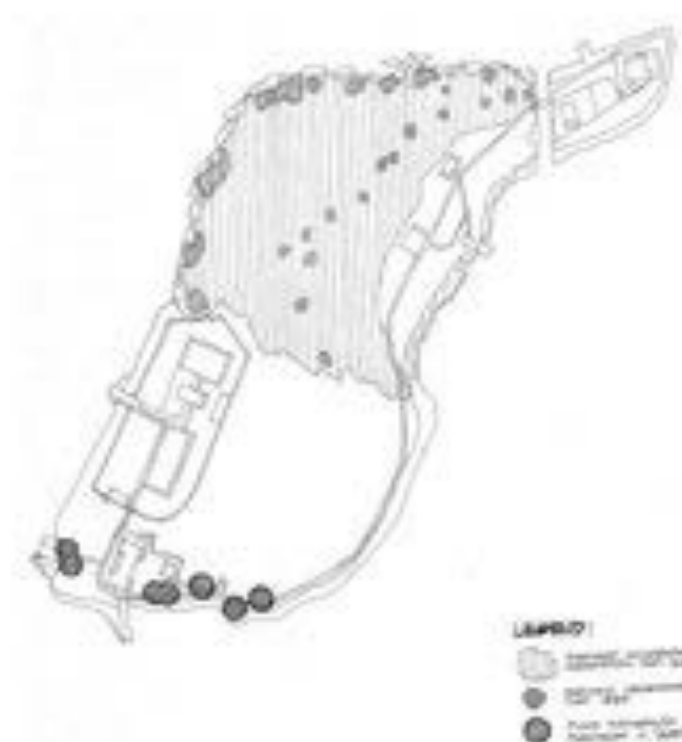
Figure 2.28 The extent of natural landscape on the island during the period of the Powder Magazine - 1865 - 1899. During this period most of the Island's remaining endemic open forest was cleared except for isolated pockets on the western side of the ridge and denser pockets on the north western foreshore. The Context report diagram indicates the pattern of these pockets and also indicates a group of *Ficus macrophylla*, planted circa 1885, in association with the Barracks and jetty.

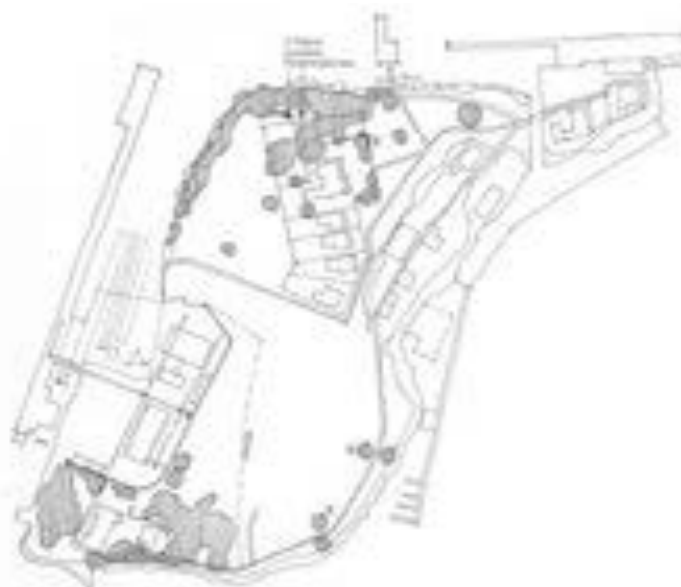
Figure 2.29 The extent of natural landscape on the island during the period of the Sydney Harbour Trust - 1900 - 1936. This period is marked by amenity planting associated with residences, the Barracks, and entrances. Detailed plantings are itemised below;

- The Coral Trees, planted near the Harbour Master's Residence, are directly associated with the building and this period, during which Coral Trees were a popular ornamental tree.
- Coral trees were also planted adjacent to the Barracks and Kitchen Buildings.
- Tree plantings of both indigenous and exotic trees and shrubs occurred adjacent to buildings, pathways and entrances to improve visual amenity.
- The former Formal Ornamental Garden in front of the Harbour Master's Residence was developed during the later period of the Sydney Harbour Trust.
- Federation Period Plantings included *Erythrina x sykesii*, *Ficus rubiginosa*, *Phytolacca dioica*, *Syragrus romanzoffiana*, *Phoenix canariensis*

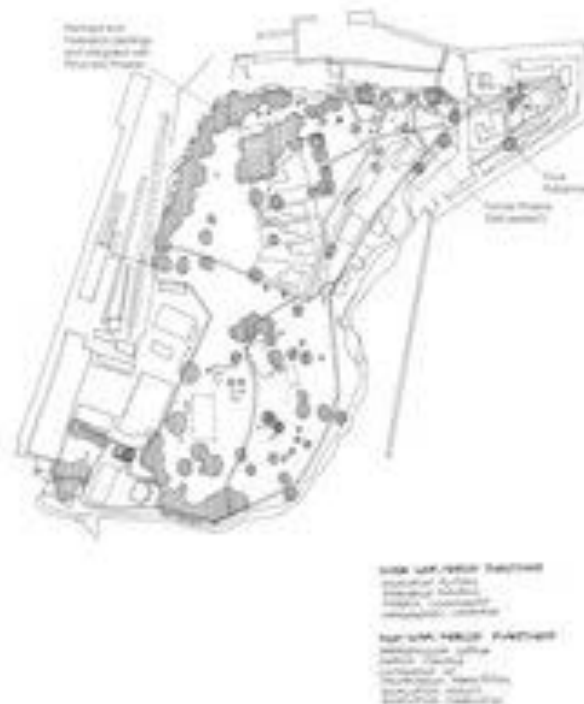
Figure 2.30 The extent of natural landscape on the island during the period of the Maritime Services Board - 1936 - 1968. Amenity plantings continued the pattern established in the previous phase as follows;

- Brush Box (*Lophostemon confertus*) plantings were dominant, mainly along the central ridge.
- Also in the 1940's a grove of Brush Box were planted adjacent to the Recreation Hall as a memorial to Mrs B.L. Bennett, the first Treasurer of the Goat Island Social Club.
- After connection to Mains water in 1937, further Inter War Period Plantings included: *Eucalyptus ficifolia*, *Eucalyptus maidenii*, *Phoenix Canariensis*, *Lophostemon confertus*
- Post War Period Planting included: *Harpephyllum cafrum*, *Agonis flexuosa*, *Cupressus sp.*, *Jacaranda mimosifolia*, *Eucalyptus nicholii*, *Eucalyptus cladocalyx*

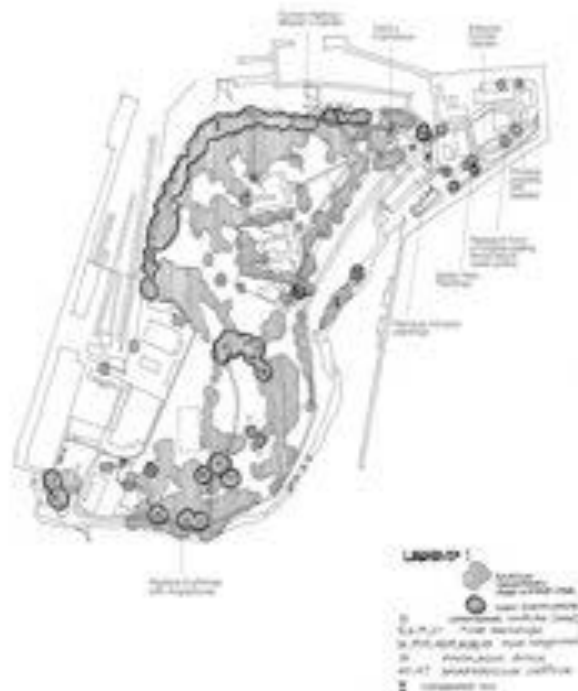
Figure 2.31 The extent of natural landscape on the island during the period of the Maritime Services Board/NPWS - 1969 - onwards. This period resulted in denser vegetation and resulting internal spatial definition. The species included: *Angophora costata*; *Eucalyptus botryoides*; *Eucalyptus haemastoma*; *Banksia integrifolia*; *Melaleuca armillaris*; *Casuarina cunninghamiana*; *Acacia spp.*; *Melia azederach*; *Westringia fruticosa*; *Grevillea spp.*

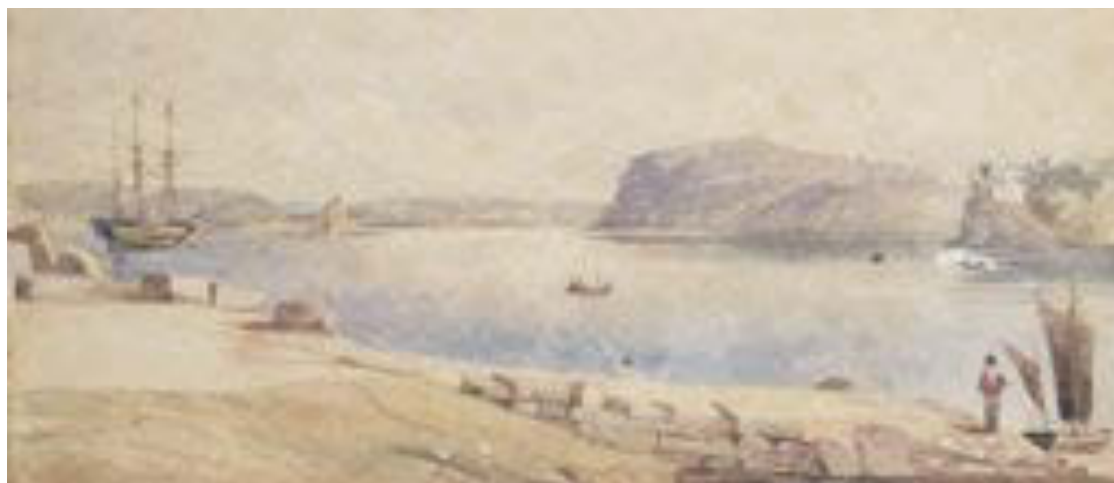
Figure 2.32 1841: Watercolour by Frederick Garling, Goat Island - place of punishment for prisoners, 1841 (Source: State Library of NSW, DG*D 14)

From the vicinity of Millers Point Figure 2.32 includes, in the background, left, a view of Goat Island where the 1838 Water Police building is prominent, with the remainder of the island obscured by ship's masts.

As intended by Mortimer Lewis, the building forms a picturesque accent on top of the sheer sandstone knoll with unimpeded views across the harbour. The Water Police precinct – which is shown as largely bare – seems somewhat disconnected from the rest of the island, which appears to be mostly grassy. A track is shown curving from the southern end of Barney's Cut up over the ridge towards, then away from, the site of the later Harbour Master's residence. To the right of the Water Police building, level with the waterline, is what appears to be a rectilinear feature, which is probably the stone jetty (98), surviving beneath the existing but structurally poor timber wharf now in this location.

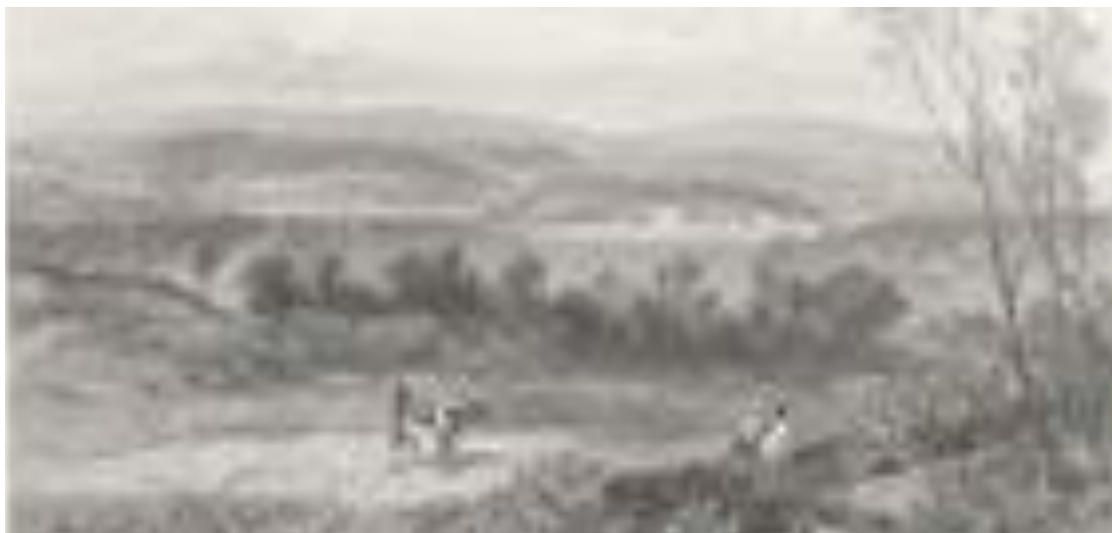
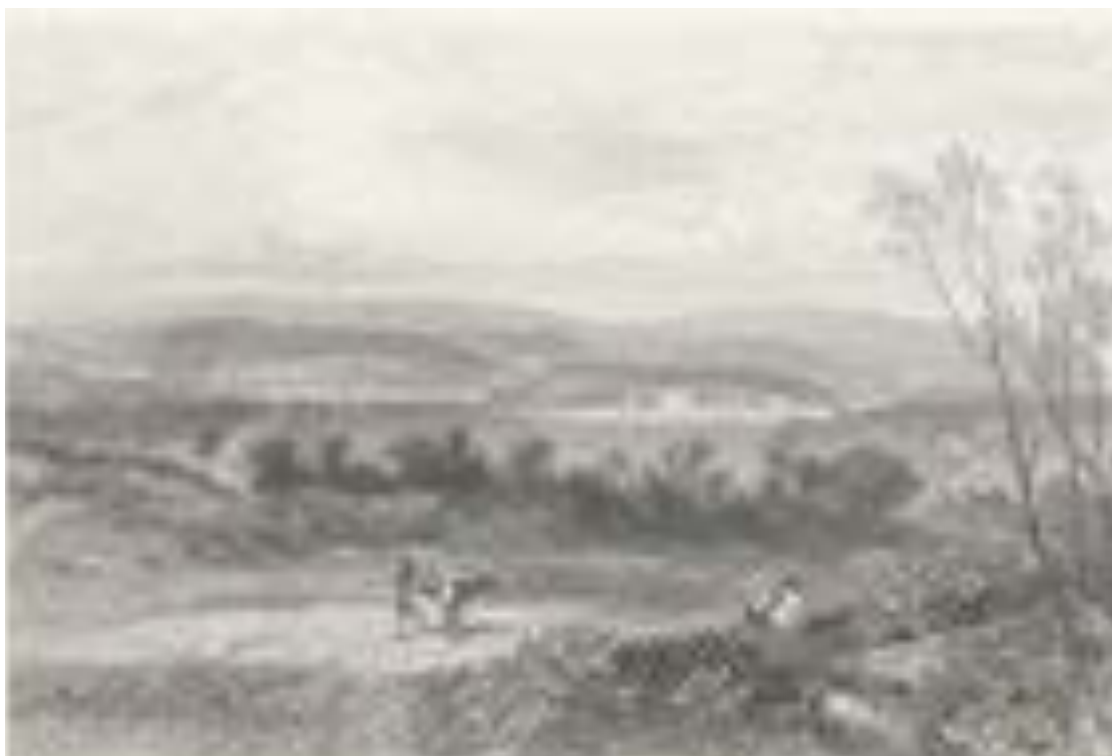
Figure 2.33 Ca. 1843: Watercolour by John Skinner Prout (Source: National Library of Australia nla.pic-an2431374)

Figure 2.34 Ca. 1843 Engraving by John Saddler of same view (National Library of Australia nla.pic-an7372827)

Figure 2.33, a watercolour by John Prout Skinner and Figure 2.34, the same view in an engraving by John Saddler, is a view from Balmain of Goat Island's western and southwestern sides where the 1830s magazine precinct is clearly shown. The scene includes an excellent record of the early geomorphology of the island as well as the fine group of sandstone buildings that read as a small village nestled below the hewn cliffs.

At least one building is shown at the summit of the island, which has the appearance of a low, long rectilinear building, possibly the earliest temporary barrack (demolished 1842). Gunner Davis' house was square or slightly 'L' shaped and so is unlikely to be this feature. Perhaps the most obvious characteristic of the depiction is that almost all of the island's taller vegetation has been cut down: only limited lines – presumably trees – remain at the northwest corner.

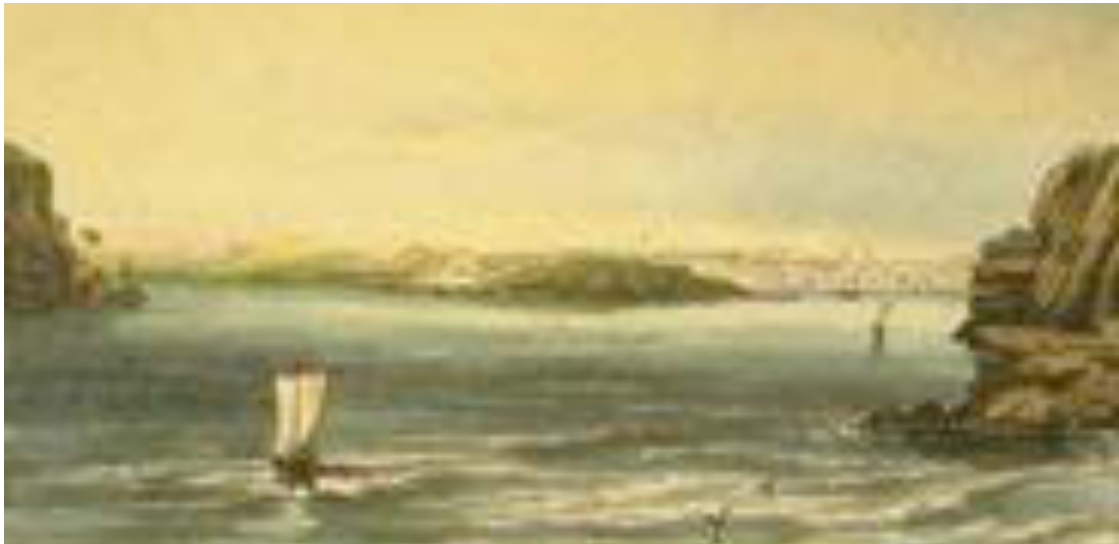
Figure 2.35 Ca.1848: Chromolithograph View of Sydney Cove, Goat Island and Darling Harbour by W. Gauci (printed by C. Hullmandel) (Source: National Library of Australia nla.pic-an813845)

Figure 2.35, a circa 1848 chromolithograph, is a view from the northwest looking across the harbour to Goat Island with Darling Harbour behind. The island morphology is well depicted, however the whole of the island appears to be shown with vegetative cover that contradicts the evidence provided in Figure 2.34.

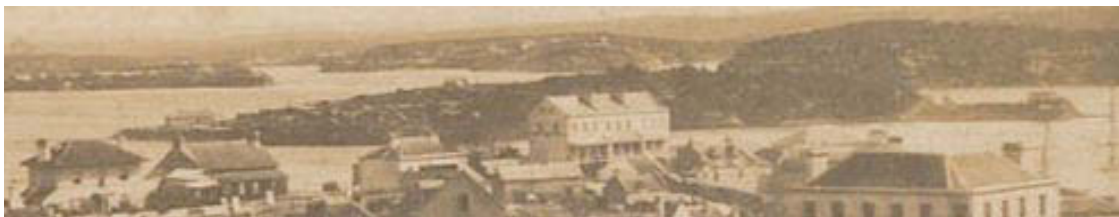
Figure 2.36 Extract from an 1860s (pre-1865): photographic stereopair, Australian scenery, Parramatta River (Source: SPF/919, State Library of NSW).

Taken from Observatory Hill to the southeastern side of the island Figure 2.36 conveys a sense of bareness for most of the Island – especially the Water Police precinct, which is rather desolate. Figure 2.36 shows Barney's cut clearly – without a bridge – and no cottage (and is therefore pre-1865). Also clearly shown is the Barracks (25) with the Barracks kitchen (now noted as the Kitchen Cottage – 26) adjacent. A building is obvious on the ridge of the island, where the Recreation Hall (73) was to be built later. It is therefore clear that by this time, the early barrack building on the hill had been demolished and the residence for Gunner Davis built. The Barracks area at the southeastern end of the island appears largely clear of vegetation.

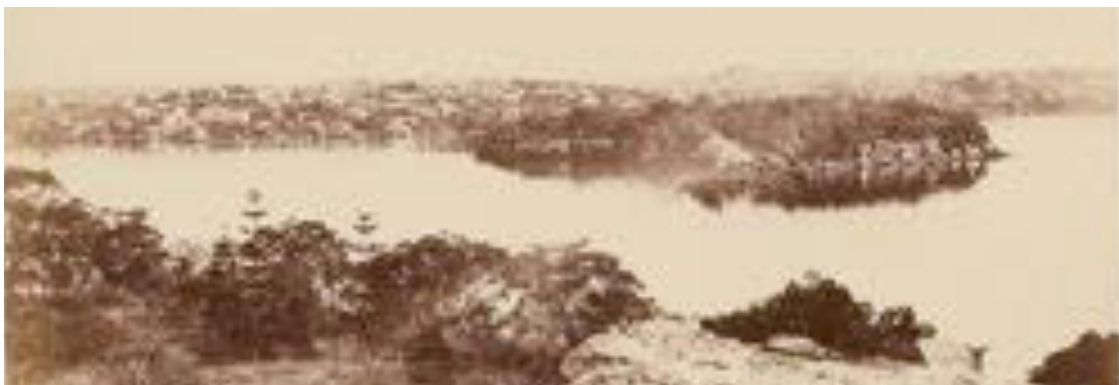
Figure 2.37 1870s: Goat Island from the North Shore (Source: State Library of NSW Pic. Acc. 1691 SPF/881)

Figure 2.37 shows the Water Police building, its fenced enclosure and the 1830s wharf on the northern side near Barney's Cut. The Island appears well vegetated along the northern side and across the central area and, where the upper area had been previously cleared (especially the southern central area), there are signs of much regrowth.

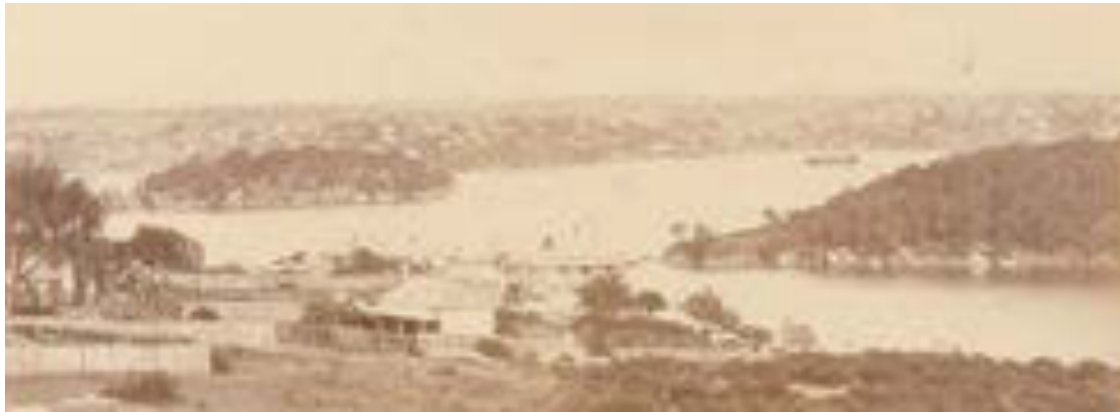
Figure 2.38 ca.1870s: Goat Island & Balmain from the North Shore (Source: State Library of NSW SPF/882)

Figure 2.38 shows most of the Island, though a willow in the foreground obscures the Water Police building at the extreme left. The 1865 cottage is visible as is the Cut and a bridge over it. Consistent with Figure 2.36, the northern and upper areas of the Island are shown as well vegetated with trees.

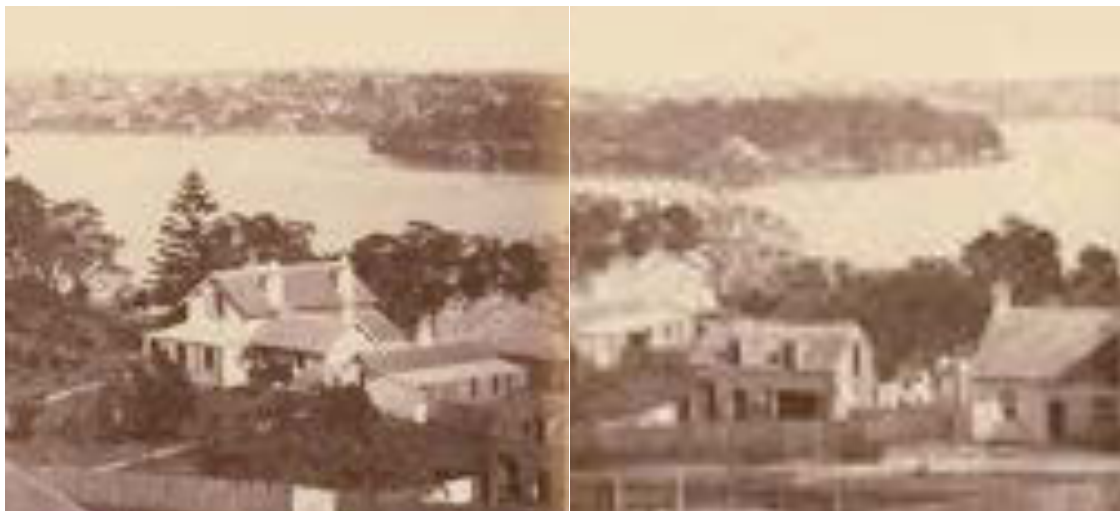
Figure 2.39 c.1873: Panoramic view (in two parts) of Blues Point looking towards Balmain and Goat Island (Source: State Library of NSW SPF/803 and SPF/804)

The photographs in Figure 2.39, taken from the north shore looking towards Goat Island and Balmain, show that the upper parts of the Island were very well vegetated (presumably mainly with locally indigenous tree species) at this time.

Perhaps these images even show the site vegetation at its zenith since the 1830s, as shortly later this vegetation steadily diminishes until almost totally cleared by 1900. The Water Police building, Barney's Cut and the small northeastern stone jetty (item 98 probably surviving beneath the existing timber wharf now in this location) are the only built features evident due to the angle of view.

part of Balmain peninsula visible to the far right, Darling Harbour behind the island, and Millers Point and the City of Sydney behind the island from the centre to the left of the photo. The date of the photograph in Figure 2.39 is after 1898 due to evidence from the City skyline beyond^{xix}.

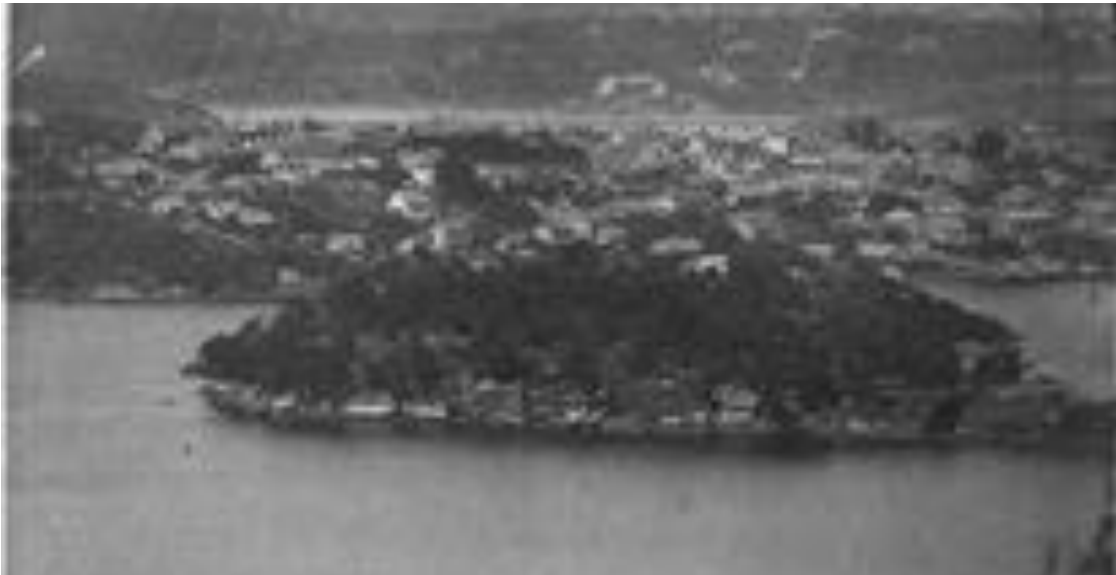
Figure 2.40 1870-1875: Looking from McMahon's Point across Goat Island to Balmain etc., American & Australasian Photographic Company (Source: Holtermann Collection, Mitchell Library; NB. Reverse image posted on SLNSW Website ON 4 Box 81 No 1. Also ON 4 Box 77 No. 33).

As a contrast to the state of the Island's vegetation only 20 years later, the photograph in Figure 2.40 shows surprisingly well-vegetated northern and central parts. The 1865 cottage above Barney's Cut – as well as the Cut itself - is clearly evident. The photograph suggests that the majority of the site's vegetation may be regrowth of locally indigenous species such as Bangalay (*Eucalyptus botryoides*) – a typical Sydney Harbour foreshore tree.

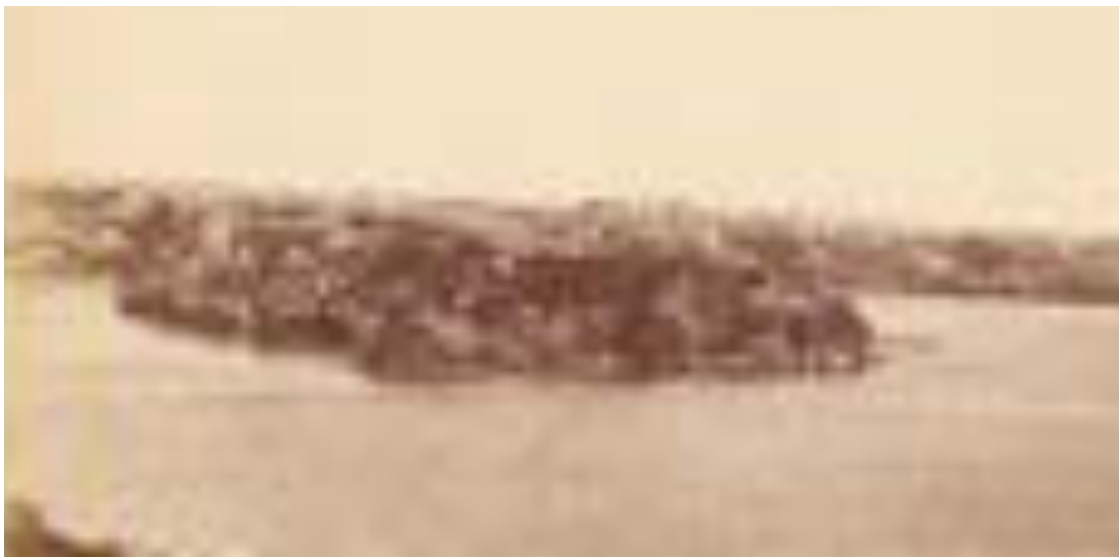
Figure 2.41 Ca.1875-1879: John Degotardi photographic panorama (Part 3) (Source: Mitchell Library, Pic. Acc. 5864).

Figure 2.41 is a fine image of Goat Island from the north shore, which clearly shows the Water Police precinct with its enclosing paling fences, Barney's Cut, the stone jetty (98) and possibly the steps to the jetty, the roof of the 1875 explosives magazine nearby (since demolished) and a largely grassed island with many rock outcrops and a considerable number of trees across the central and northern parts of the Island. The distinct silhouetted outline of a Port Jackson Fig Tree is visible at the extreme right (northwestern) edge of the island.

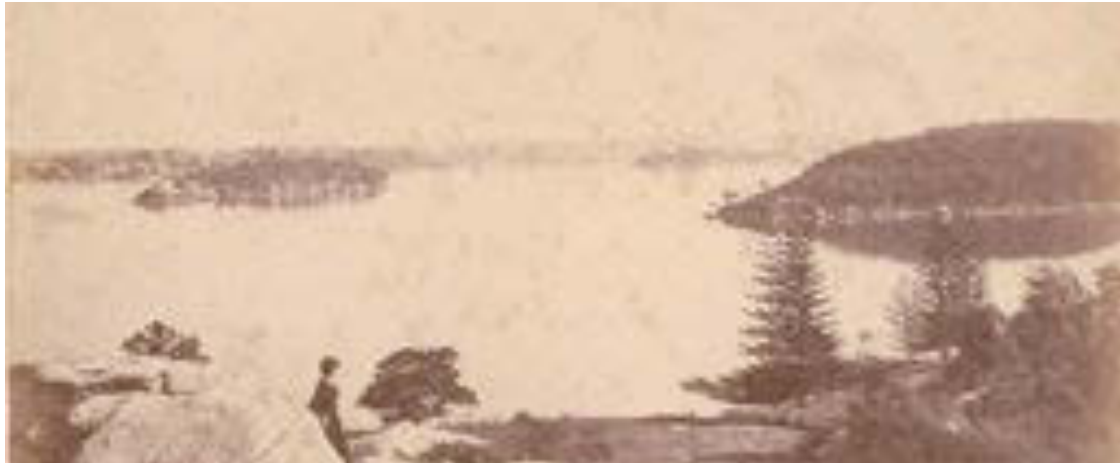
Figure 2.42 1878: Ball's Head and Goat island from North Shore [notated between 1860 and 1879] (Source: National Library of Australia nla.pic-an2449698). The same photograph is in the State Library of NSW collection (SPF/794) and notated ca.1878 (attributed to J.Paine & Charles Troedel & Co chromolithograph (State Library of Victoria) Berry's Bay and Goat Island based on the photograph of the same scene.

The view in Figure 2.42, with a young man standing against a sandstone outcrop in the foreground, shows Goat Island in the background with a substantial amount of tree cover – at least on the northern side. The Water Police building still appears picturesquely prominent on its knoll, which seems strangely detached from the remainder of the island.

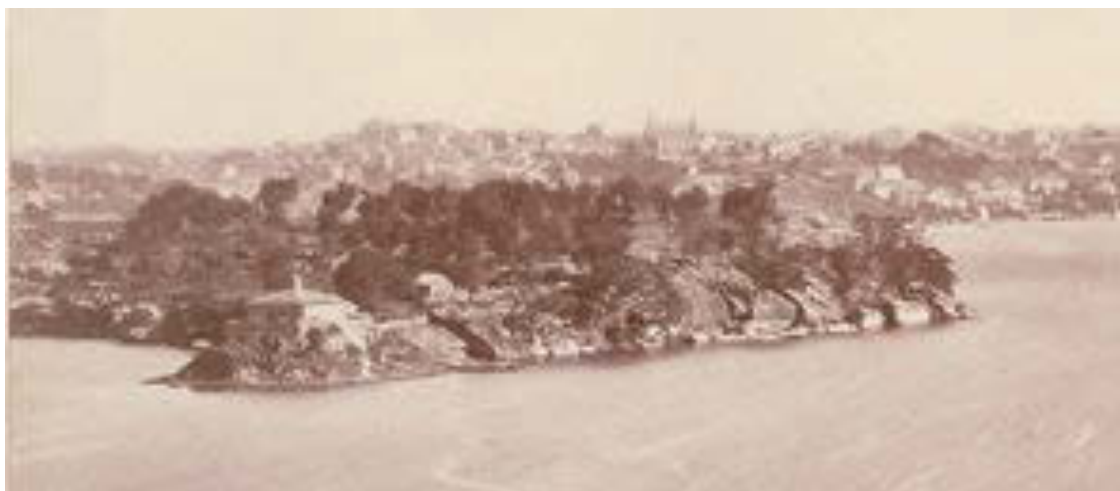
Figure 2.43 Extract of image 1875-1885 c.: Goat Island & Balmain from the North Shore (Source: State Library of NSW SPF/883)

Similar to various other images taken of Goat Island from the North Shore the photograph in Figure 2.43 clearly shows the Water Police building, the roof of the 1865 cottage just visible behind (to right of the Water Police Building's roof), Barney's Cut and the associated 1830s stone jetty as well as the small gabled building to the south of the Water Police building and Barney's cut (left of the Water Police building), which is presumably the 1875 explosives magazine (81a). Generally, the Island appears to have two main components of vegetation over the upper areas at this time – a grass groundcover and an open layer of trees. There is little evidence of a middle layer of shrubs or advancing regeneration.
