GOAT ISLAND

Conservation Management Plan

Volume 1

June 2011

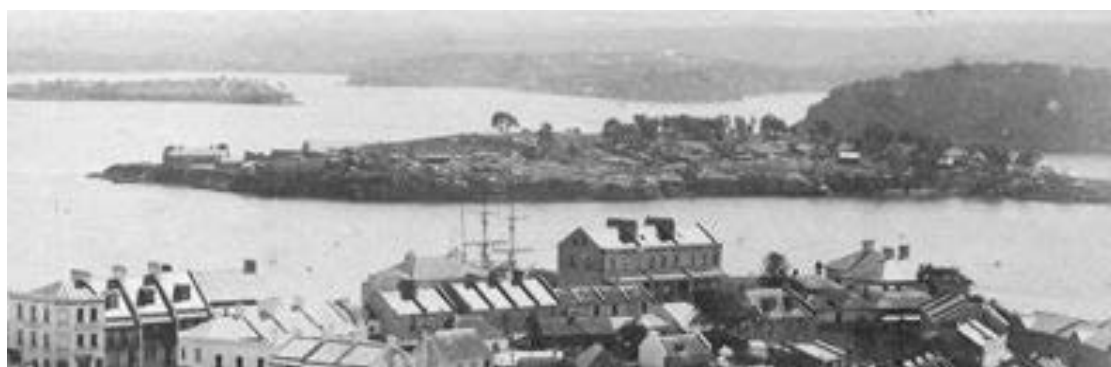
Figure 2.45 1882: View from Sydney Observatory (No. 7 in a series) (File 038\038617), NJ Caire, (Source: City of Sydney Archives Image No. SRC12220)

Figure 2.45 shows that by 1882 there is a noticeable decrease in tree cover across the upper parts of the Island compared with about 10 years earlier. The image shows the site to be mostly grass-covered with larger (presumably indigenous) trees towards the northern end and, significantly, no evidence of the fig trees to the south around the barracks area. Gunner Davis' residence has been demolished by this date. The clearing of vegetation at this time has been undertaken in response to the passing of the *Regulations* under the *Gunpowder and Explosive Consolidation Act 1876* (40 Victoria No. 1), which included:

The photograph in Figure 2.45 clearly shows the two 1870s explosives magazines at the northeastern end of the island, the 1875 magazine being the furthest north, with the 1878 magazine to the south (left of the 1875 magazine). The Barrack building (25), Barrack kitchen (later Kitchen Cottage – 26), a small outbuilding (since demolished) to the right of the Barrack

kitchen, and the stone jetty (66) associated with the Barracks, are all clearly visible. Part of the roof of the Queen's Magazine (15) is just visible to the right of the Barracks.

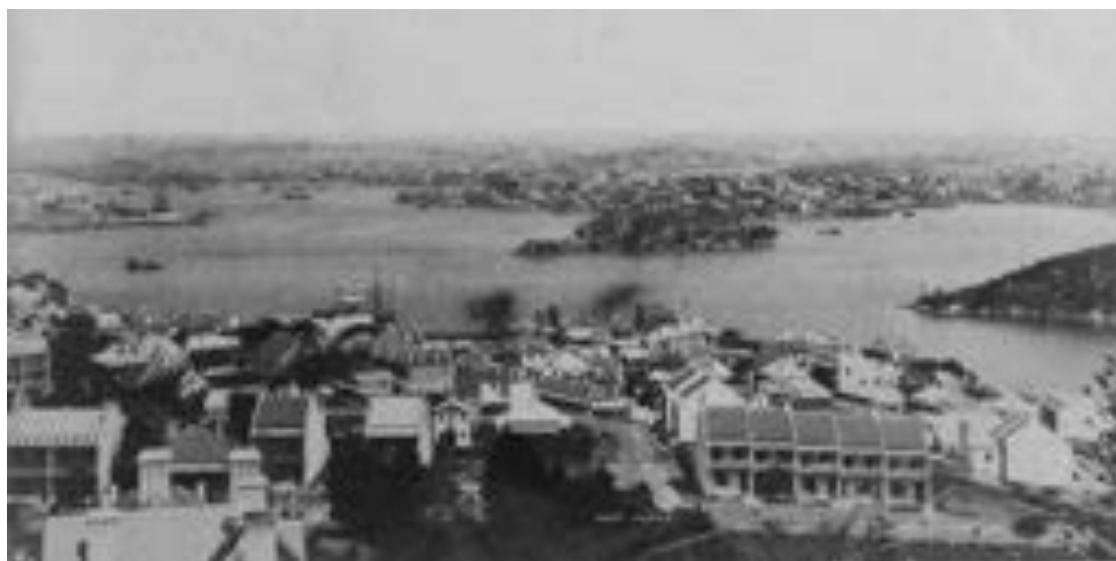
Figure 2.46 1892: View of Sydney Harbour from McMahon's Point (File 045\045015), c/- Lt Frederick RN (Source: City of Sydney Archives, Image No. SRC14960)

The photograph in Figure 2.46 shows the Water Police precinct, Barney's Cut and vegetation above the shoreline boulders along the northern side of the island as well as maturing fig trees at northwest side. The top of the island has large grassed areas though with some trees also.

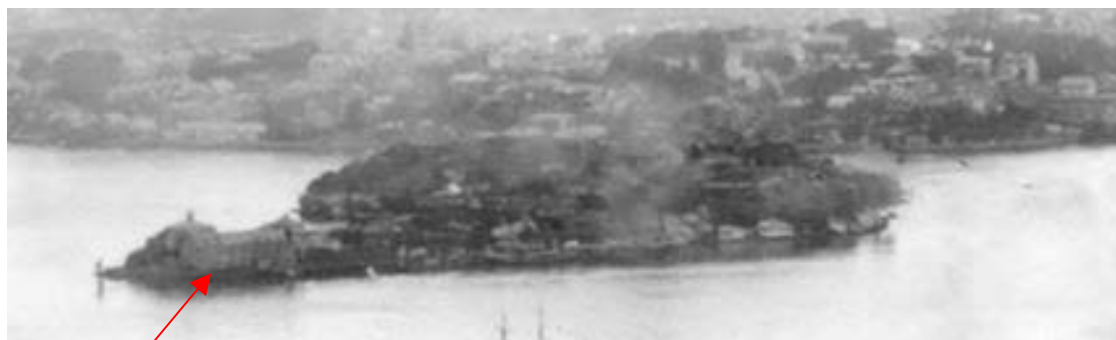
Figure 2.47, a photograph taken from the north shore between 1903 and 1911, is a slightly murky image with smoke or mist patches drifting across the scene. This particular image is the most curious of all, as it clearly shows a large two-storey building with dormer windows on the north side of the Water Police building on the shore. This building was demolished prior to 1929, as it does not appear on a 1929 survey of the island. The 1891 survey of the island also does not include this building. It is therefore likely that this building was a workshop constructed by the Sydney Harbour Trust in its earliest years of occupation of the island (e.g. 1901-1903).

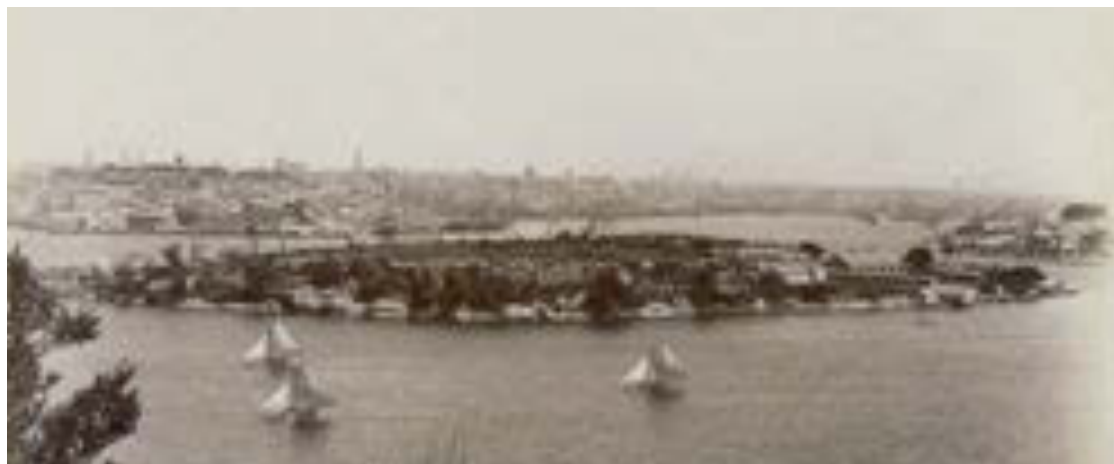
Figure 2.48 1898-1900 Albumen photoprint taken from Birchgrove or Longnose Point (Source: State Library of NSW, PXE 711/53).

Figure 2.48 shows the magazine in its final state as an explosives magazine. In the detail image of the magazine area (Figure 2.9) the following features are visible: the Colonial Magazine to the left, the Cooperage (19), the Queen's Magazine (15) the covered way to the shore connecting to the covered way between the Queen's Magazine and the Cooperage, the fortified wall (71), with the sentry box just visible to the right of a single storey building built against the northern side of the fortified wall (note this single storey building is believed to be the since demolished 1885 explosives magazine). Also visible are (since demolished) shore buildings and jetties, which served the magazine. The Barracks (25) is visible beyond the fortified wall to the right, with the fig trees (still extant), jetties and more shore buildings (some remains extant) to the right of the Barracks.

In terms of the island's vegetation, this is a very helpful image in that it shows a dramatic thinning out of the island's tree cover over the whole of the upper area – apart from several sporadic and ravaged-looking indigenous trees, the only large trees remaining are those around the north-western foreshores (Port Jackson Fig Trees) and southern benches (Moreton Bay Fig Trees).

The image in Figure 2.48 is the best 19th century image of the Powder Magazine complex on Goat Island (note Figure 2.9 is a detail of the Magazine Complex from this image). This beautifully clear image is taken from either Birchgrove or Longnose Point looking east, with

part of Balmain peninsula visible to the far right, Darling Harbour behind the island, and Millers Point and the City of Sydney behind the island from the centre to the left of the photo. The date of the photograph in Figure 2.39 is after 1898 due to evidence from the City skyline beyond^{xix}.

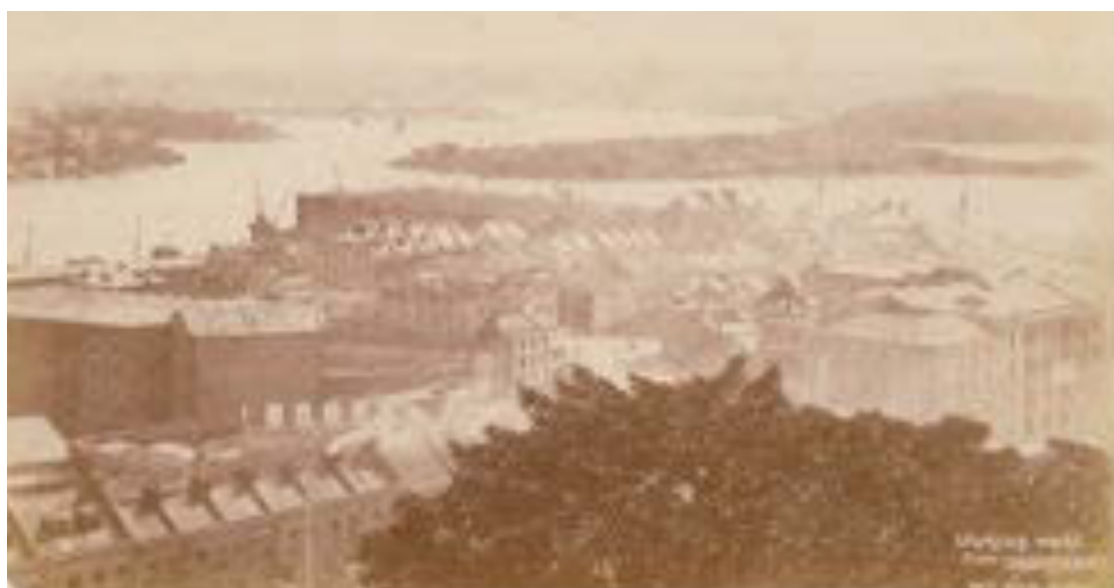
Figure 2.49 1905-1910: Looking west from [Sydney] Observatory, Kerry & Co, SPF/924, State Library of NSW

A large canopy is visible between the barracks and the barracks kitchen (Kitchen Cottage 26) indicating an earlier fig tree that is now missing. The canopies of the existing two Moreton Bay Fig Trees at the southwestern slipway are clearly evident and, given the narrow possible date range of the photograph together with about 15 years growth, this suggests the fig trees were planted in the mid-1880s.

The early 20th century photograph in Figure 2.49 records the large fig tree between the barracks building and the barracks kitchen, as well as the other fig trees to the west near the slipway. The Harbour Master's residence is just visible at the northern end on the hill, while the general state of vegetation across the upper parts of the Island confirms that much clearing has taken place since the 1870s.

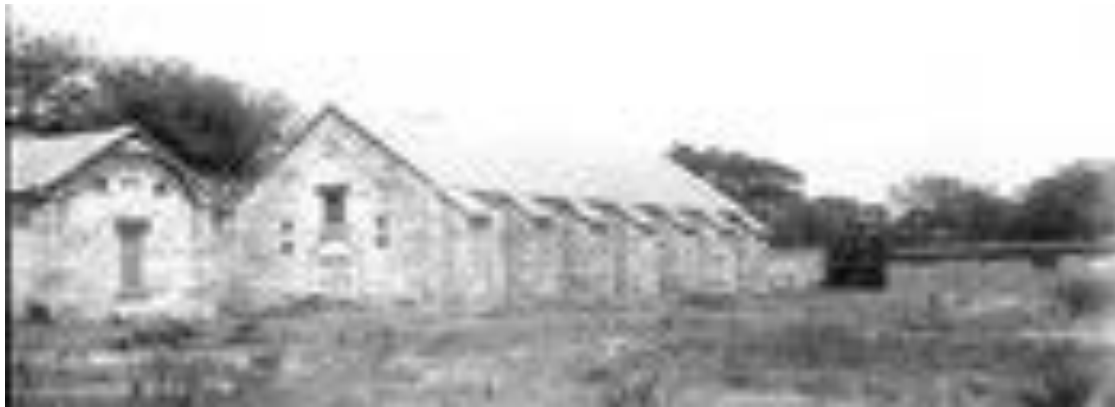
Figure 2.50 1923: 1836 powder magazine (Source: State Records NSW Image No. 9856_a017_A017000035)

Coral Trees are mostly visible in the photograph in Figure 2.50 providing a backdrop to buildings 15 and 19. Almost all of these trees have now been removed. Given the size and form of the trees in 1923 it is estimated that they may be about 10 years old, which suggests they were planted in the early 1910s.

Similar to Figure 2.51, the photograph in Figure 2.50 also shows Coral Trees beyond (south of) the 1830s fortified wall and sentry box. The umbrageous form of a fig tree canopy is clearly profiled beyond the magazine building.

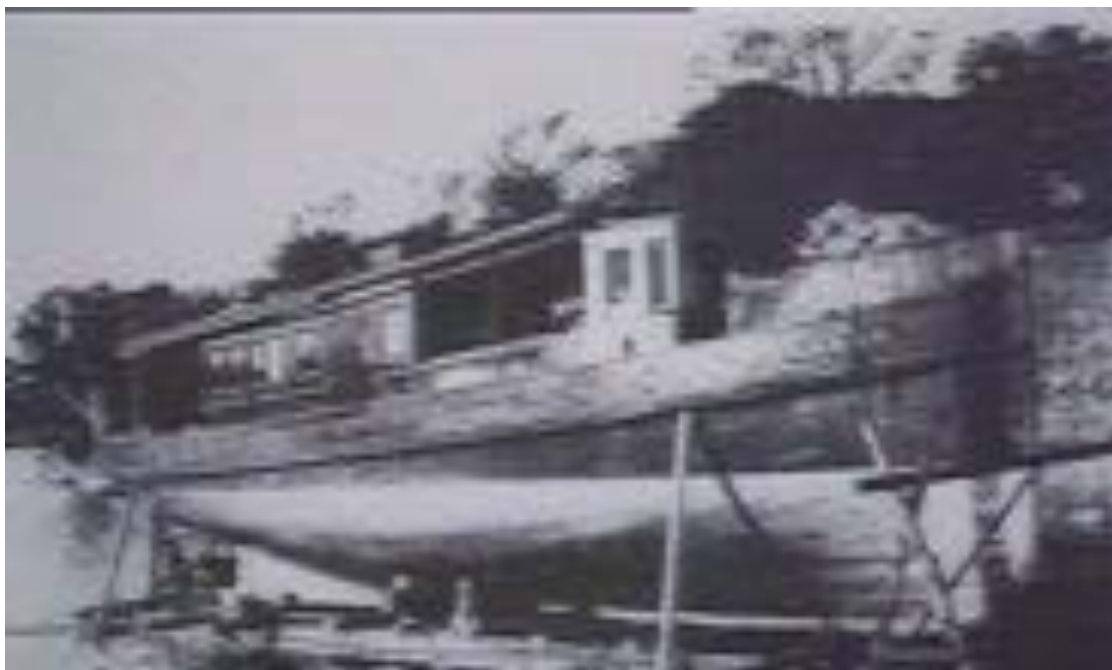
Figure 2.52 1930: Sydney Harbour Trust launch *Comet*, Goat Island (Source: State Library of NSW, GPO 1 – 19718)

In Figure 2.52, the launch *Comet* is shown on slipway blocks with the hewn sandstone cliff face (north of the 1830s magazine area) and part of the western shoreline beyond. On top of the cliff line a continuous line of silhouetted vegetation is shown that appears to be a mixture of indigenous plants and some emergent Coral Trees. At the extreme left of the photo the profiled forms of fig trees are evident at the shoreline.

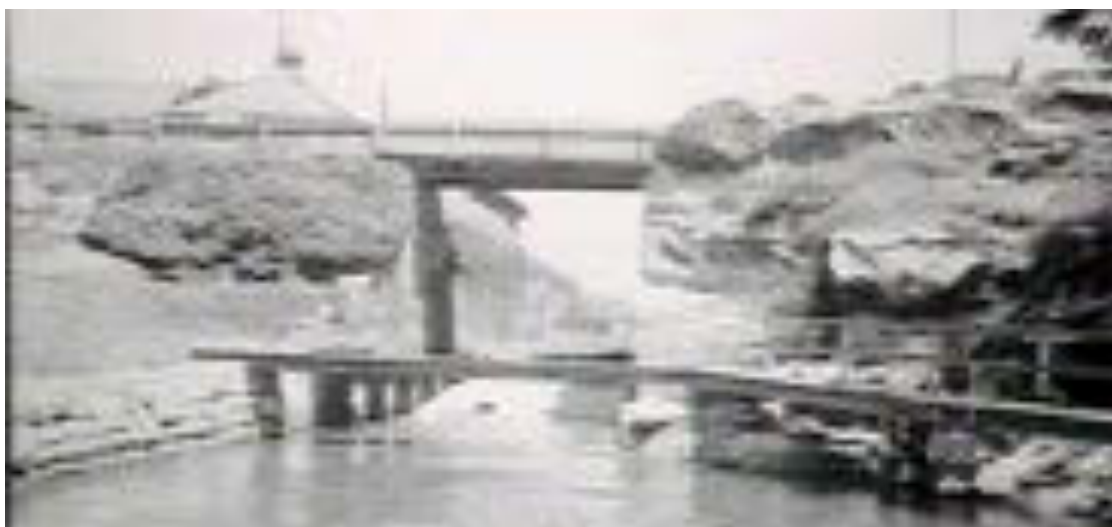
Figure 2.53 January 1943: Overhead bridge: Goat Island (Source: State Library of NSW, GPO 1 – 10039, MSBL966),

Taken from the decking to the immediate north of Barney's Cut the photograph in Figure 2.53 shows the relative bareness of the area around the Cut. The northeastern side of the Cut reveals some small-scale ornamental stone walling with a well-trimmed shrub (Lantana?) above it. The other side of the Cut shows virtually no vegetation at this time.

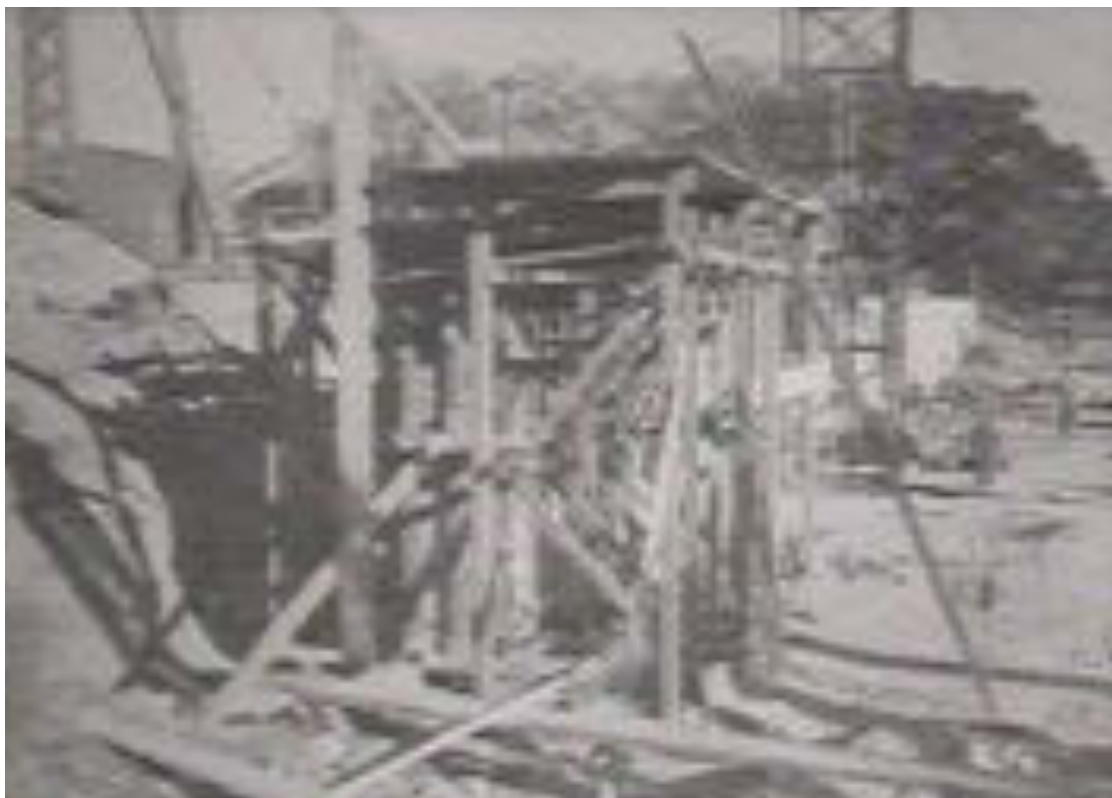
Figure 2.54 July 1946: Goat Island fitters shop & wall, Goat island (Source: State Library of NSW, GPO 1 – 10134, MSBL1450)

Figure 2.54 shows the maturing Coral Trees and Moreton Bay Fig Trees to the south of the sentry box. The size and form of the Coral Trees accords with a planting date of early 1910s while the fig trees are already showing considerable form and development consistent with an age of about 60 years.

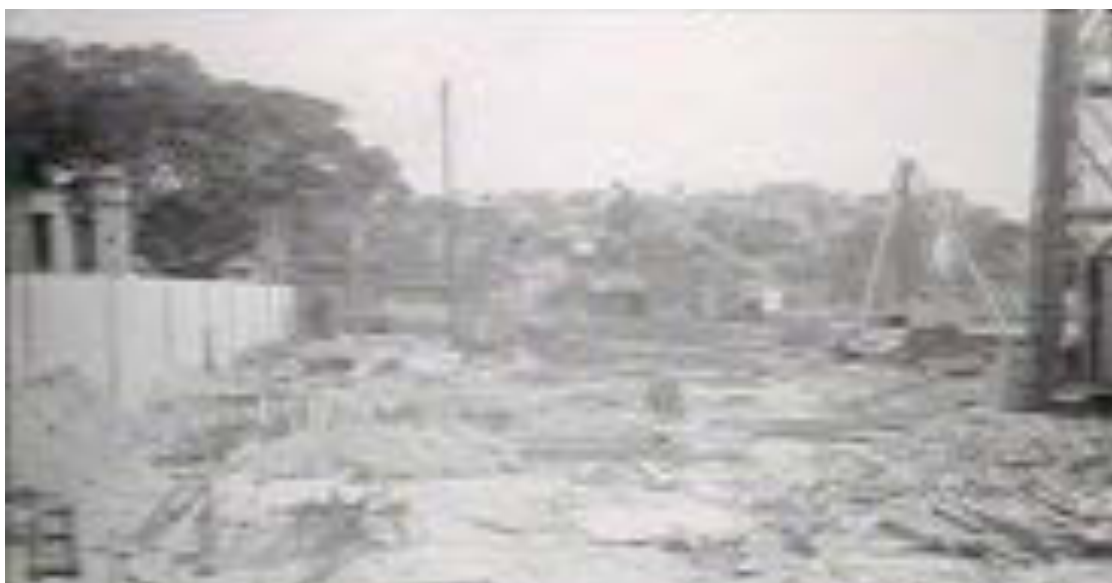
Figure 2.55 1947: Building construction: Goat island (Source: State Library of NSW, GPO 1 – 10054, MSBL958).

Taken just as the first steel framing is being erected for the MSB Ship Repair workshop, the photograph in Figure 2.55 shows the sentry box (left) the retaining wall that now sets the western edge for the magazine complex. Just beyond the sentry box some tall Coral Trees are visible and, further back again, the grand form of one of the present Moreton Bay Fig Trees. Given the size and extent of development of the fig tree it is estimated that it would be

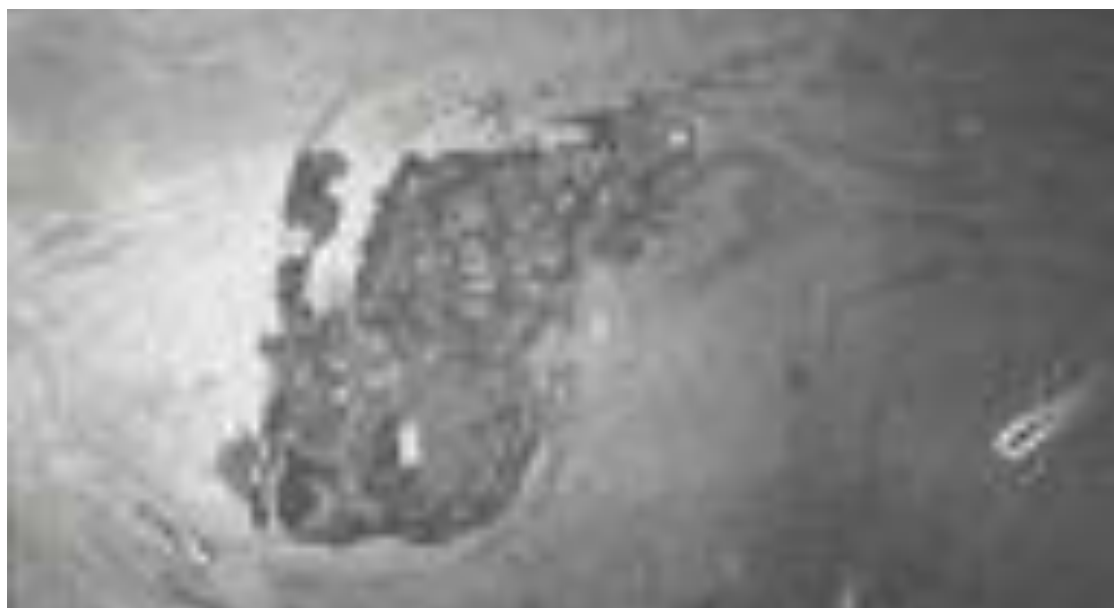
Figure 2.56 1949 Aerial photograph (Source: City of Sydney Archives, Image No. SRC2066)

Figure 2.56 shows the Coral Trees and fig trees at the southern end of the Island; the island largely cleared in middle though with dense vegetation (likely Coral Trees as canopies of this species appear in ground photos of the same period) to the immediate west of the former tennis court (presumably a windbreak). Lines of vegetation are visible around the perimeter fence of the Harbour Master's residence and sporadic vegetation along the northern and northwestern shoreline.

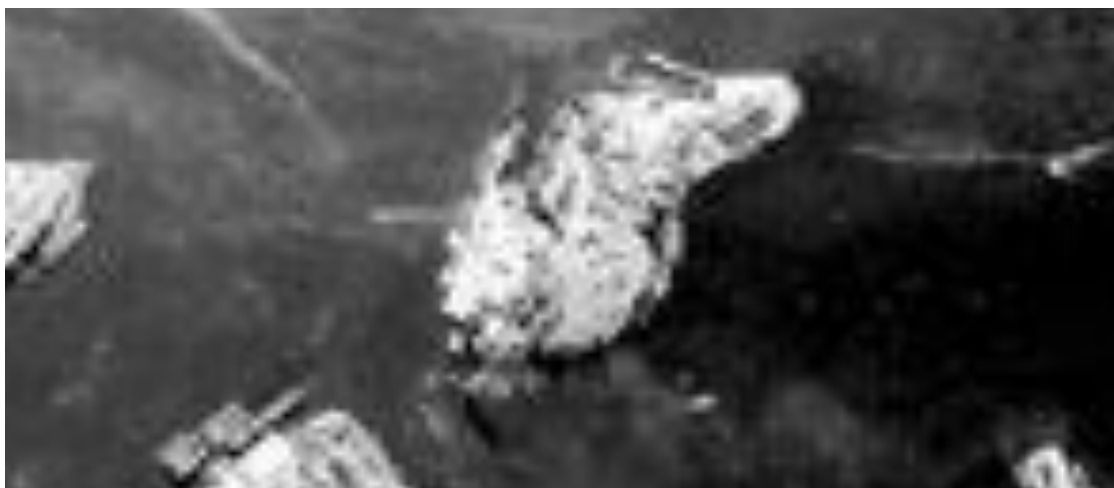
Figure 2.58 1951 Aerial photograph: Black & White (Source: DECC)

The 1951 aerial photograph in Figure 2.58 shows much vegetation around the southern end of the Island, consistent with the existing fig trees and the former Coral trees. It also shows vegetation around the Harbour Master's residence (Coral Trees and the Monterey Pine at the rear), dense vegetation along the western edge, a band of vegetation parallel to, and west of, the upper residences and sporadic dots of vegetation on the upper central part of the Island.

Included are the Brush Box group north of the Recreation Hall, the two date palms to the south of the hall and two fig tree seedlings to the southwest (now struggling Port Jackson Fig Trees of moderate size). Other vegetation in this area may include the fig trees on the eastern side of the former hall.

As far as the island's landscape is concerned the aerial photograph in Figure 2.60 is virtually a copy of that of the 1951 aerial photograph in Figure 2.58, and is only mentioned here to indicate that the basic landscape was static for this period. Later aerial photography demonstrates that the island's landscape character was to change rapidly and dramatically.

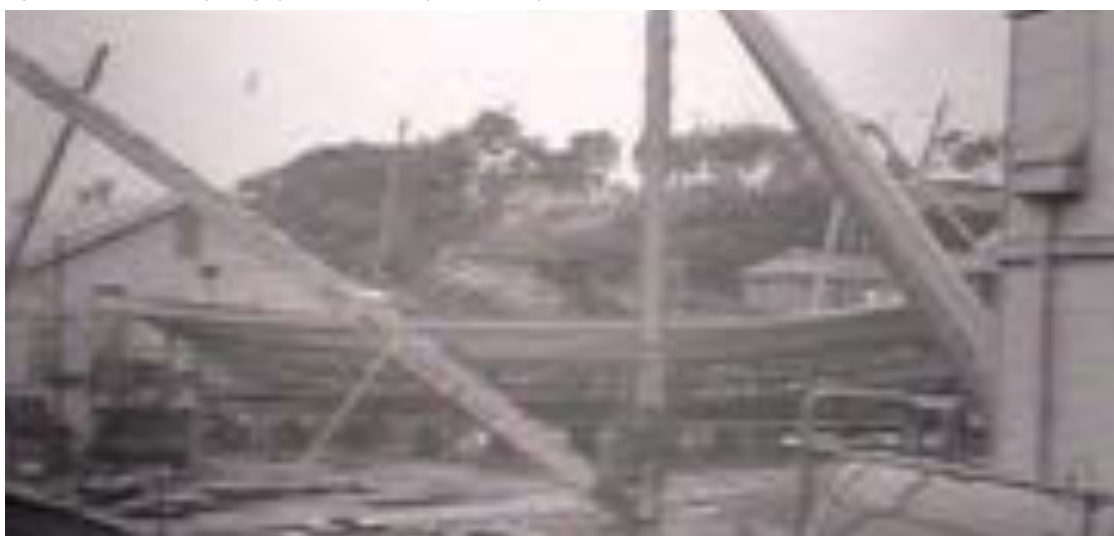
Figure 2.59 1951: Goat Island: Progress of new tug (Source: State Library of NSW, GPO 1 – 10044 (MSBL971)).

This fortuitous photograph in Figure 2.59 not only records the progress of the new tug construction but also records the now overgrown pathway that once linked the shipyard area with the Island's residential precinct. Clearly evident in the photo are the post and two-rail fencing and steps traversing the hill up to the Harbour Master's residence, the back of this building as well as traces of the other cottages. In the left foreground is the 1946-49 ship repair workshop and, in the right middle ground, the 1930 timber store (without a water tank tower). The pathway is shown curving past quite dense vegetation on the northwestern part of the Island with low, but dense, re-growth south of the path while along the top of the Island is the profiles of scattered taller trees.

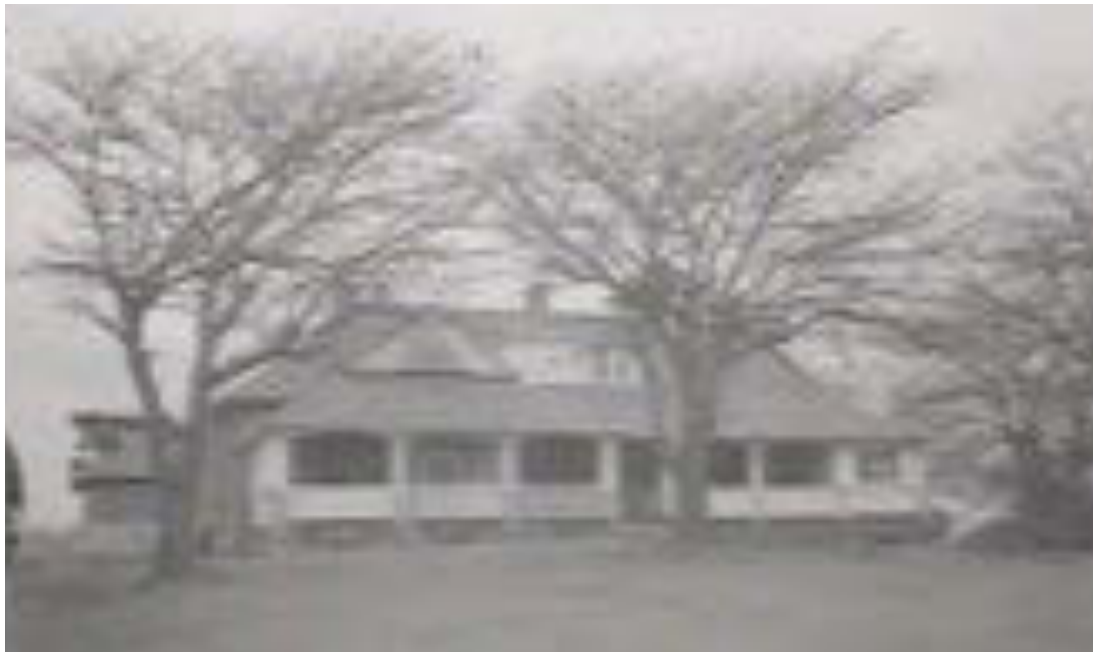
Figure 2.61 1968: Harbour Master's residence: Goat Island, (Source: State Library of NSW, GPO 1 – 10059).

Figure 2.61 shows the Coral Trees formerly at the front and northern side of the Harbour Master's residence, which dominate this view. All of these trees have now been removed for safety reasons. Behind the residence, at left, is the present Monterey Pine and, by its size, this image confirms a planting date of the 1930s. The Coral Trees around the residence may have been planted shortly after the house was built, but are more likely to date from the MSB period. While this kind of landscape can be seen in several locations on the island it is unlikely to be part of the planned setting at the time of construction unlike the low sandstone retaining wall to the north and the former perimeter fence (removed at least at the front by 1968) which appear to date to the construction period.

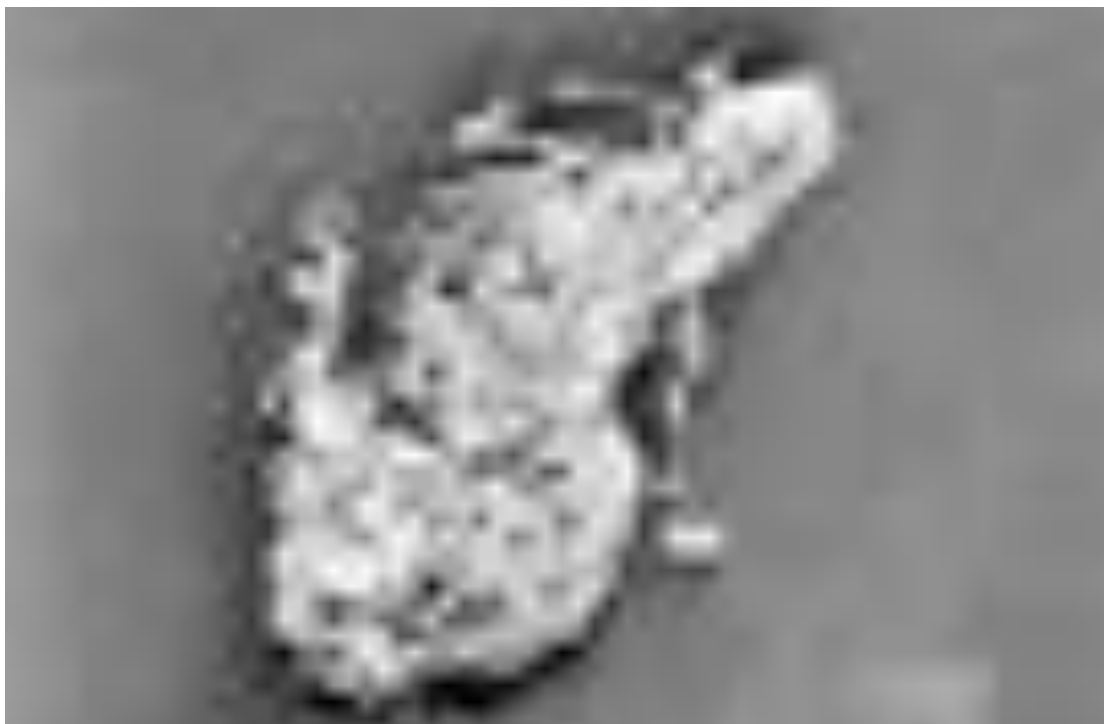
Figure 2.63 1972 Aerial photograph: Black & White (Source: DECC)

Figure 2.63 shows that even by 1972 the overall landscape context of the Island had changed little since the 1961, or even 1951. Obvious exceptions include the addition of more plantings around the apex of paths between the Harbour Master's residence and the Water Police building – presumably introduced in the 1960s. More vegetation appears around the back of buildings that subsumed the c.1875 magazines as well as along parts of the northern cliff line.

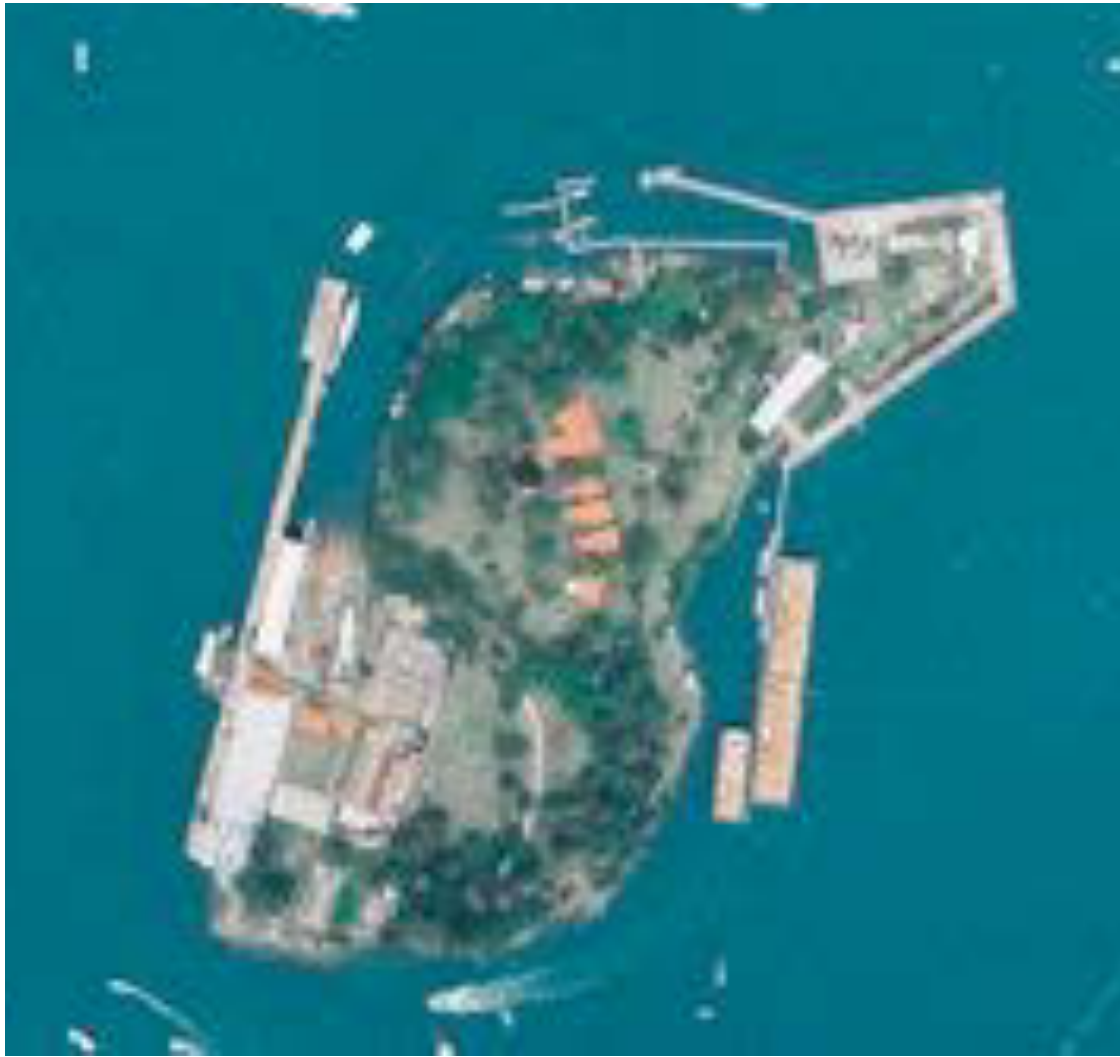
Figure 2.65 1999 Aerial photo (Source: DECC)

By 1999, as can be seen in Figure 2.65, something of the present landscape character of the Island is beginning to emerge, where re-growth of native vegetation and the self-propagation of exotic material is beginning to coalesce into large blocks of vegetation. This image emphasises the changes that have encompassed the island in the period of a decade. Since 1999 the progression of vegetative 'infill' has continued, such that areas that were known as distinctive open spaces since the 1830s have become transformed into a series of smaller spatial compartments. Without further intervention these spaces will be entirely reclaimed by vegetation.

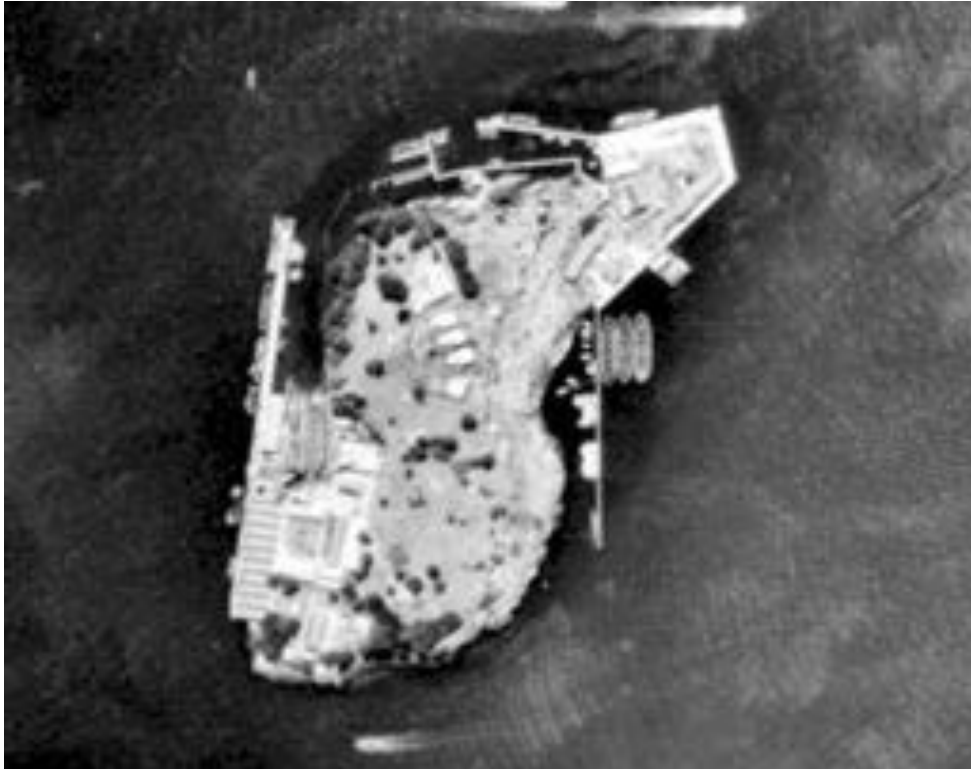
Figure 3.1 Aerial photo of Goat Island in 1980 (DECC)

Aerial photos in Figures 3.1 and 3.2 show how vegetated the appearance of the island in 2007 (Figure 3.2) compared even to the less vegetated form in 1980 (Figure 3.1).

Aerial photographs in Figures 3.1 and 3.2 illustrate the radical change in vegetation cover on the island since 1980. Various well-meaning, though less than desirable, phases of new planting have left many species across the Island that, collectively with other regenerating and self-propagating species, have begun to fill the hitherto distinctive open spaces on the island as well as colonise refuge areas of locally indigenous species.

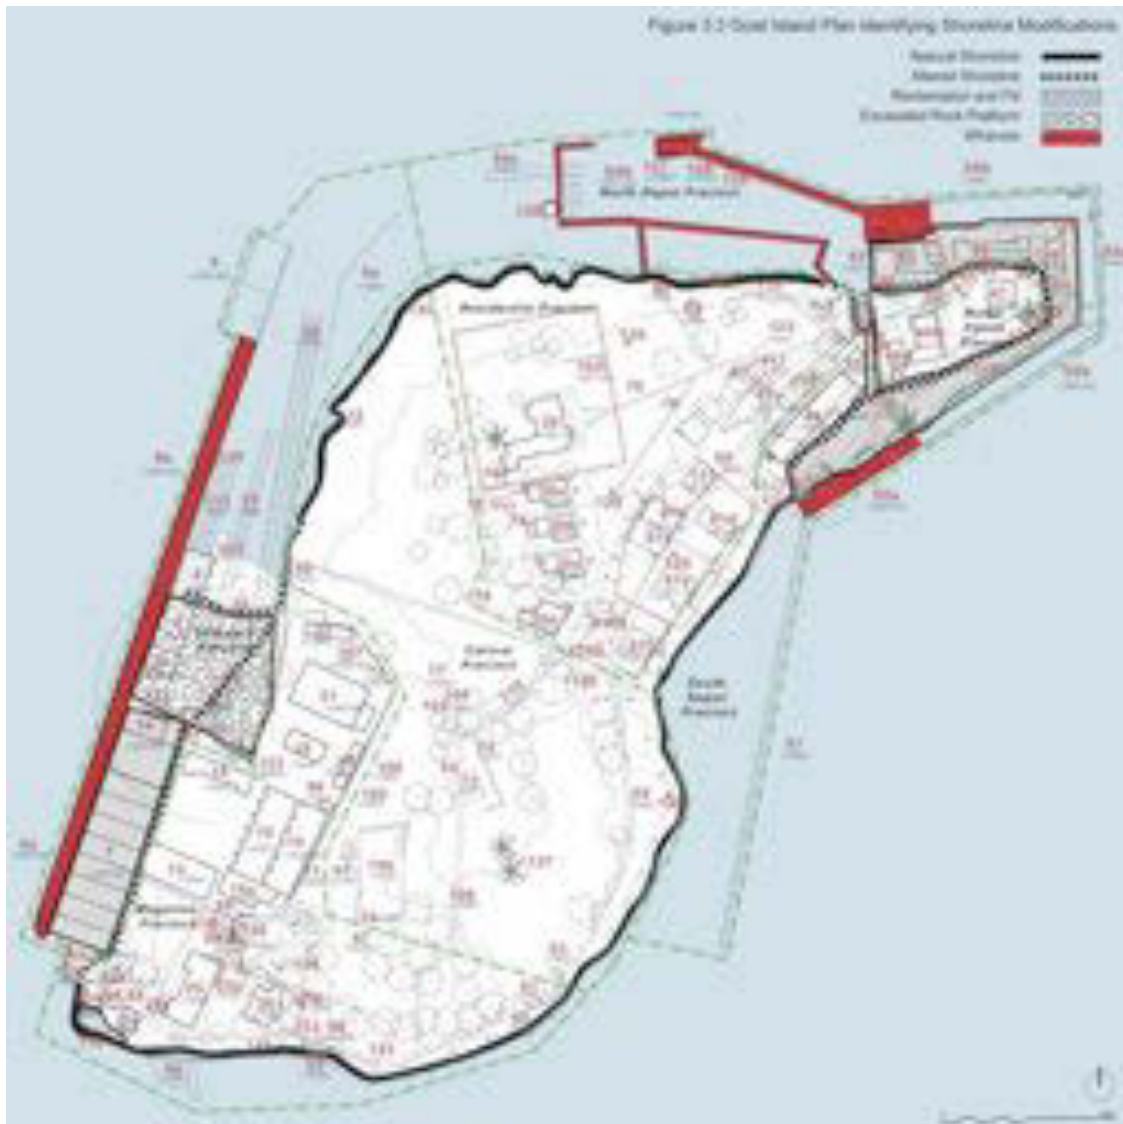
Figure 3.3 Plan of Goat Island showing the extent of modified and non-modified shoreline, areas of fill and excavation around the shoreline and the wharfs. This plan indicates that most of the shoreline remains intact or with only very minor modifications to the natural edge. This plan is based on the 2007 aerial photograph and it is noted that sections of wharfs 4a, 4b, 5 and 51 and wharves 52b, 54c, 55a and 55b have collapsed and been removed.

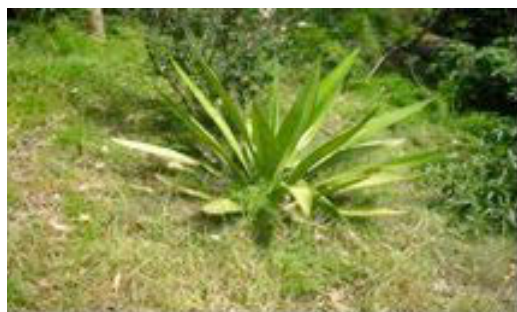
Figure 3.5 *Furcraea foetida*. This plant is to the north of the Harbour Master's residence, others to the east of the Recreation hall site are under tree canopies and are much darker green

Other species with the propensity to become a nuisance are likely to have been used as feature plants within garden bedding or otherwise innocently introduced as feature trees - eg. Giant Bird-of-Paradise (*Strelitzia nicolai*), *Furcraea foetida* and *Lantana*. The latter include many of the trees and palms that have become associated with various precincts. These species include the non-indigenous fig trees, Kaffir Plum (*Harpephyllum caffrum*), Brush Box (*Lophostemon confertus*), Canary Island date Palm (*Phoenix canariensis*) and the non-indigenous Wattles (*Acacia* spp.). Other species currently becoming a nuisance include *Convolvulus*, *Cestrum* and *Cassia*.

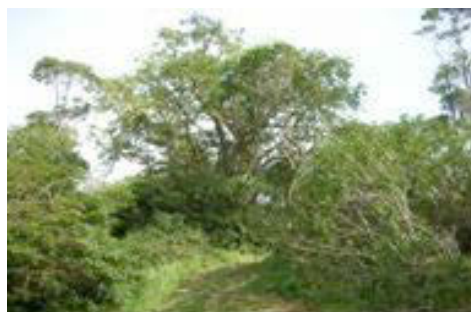
Figure 3.6 *Nerium oleander*. This plant at right is one of many oleanders near the southern part of the Island's upper central area

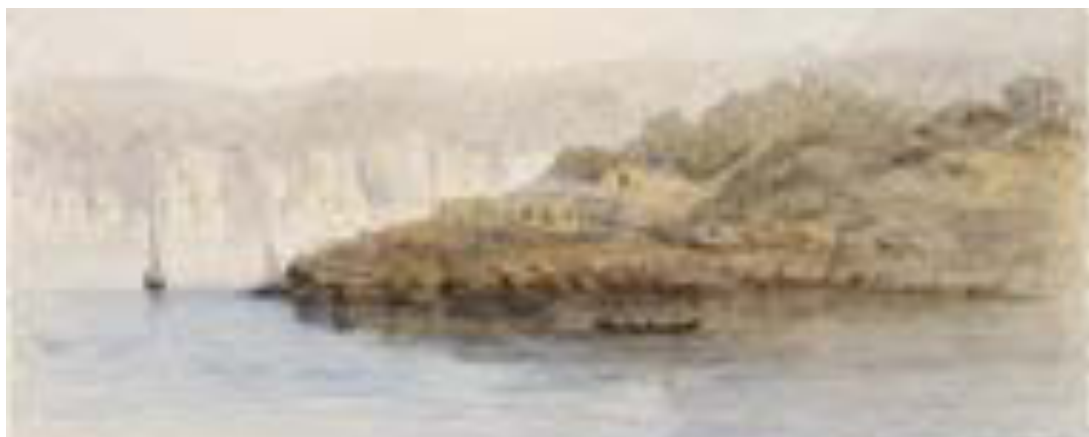
Figure 3.10 Rebecca Martens, a watercolour rendition of the same view, 1857. Note in this image, three outbuildings appear to the east of the Kitchen Cottage (which is likely to be artistic license: only one outbuilding is evident in this location in later photographic evidence). Note also the high cliffs in the background, which do not exist in reality, in the location of Balls Head.

The probable location of Gunner Davis' cottage is on the ridge rather than by the tennis court. This assertion is based on several factors - the presence of a cottage-like building on the ridge (as shown in Martens' 1857 illustrations Figures 3.9 and 3.10, and after the temporary barracks were dismantled in 1842), the 1870s Degotardi photograph, and the presence of the artefact scatter. Whilst Kerr appears to be confident that the footings by the tennis court belonged to Gunner Davis' houseⁱⁱⁱ, the photographic evidence does not support this. Identification of the archaeological sites may be possible through physical investigation but for the present, neither site can be positively identified as Gunner Davis' cottage.

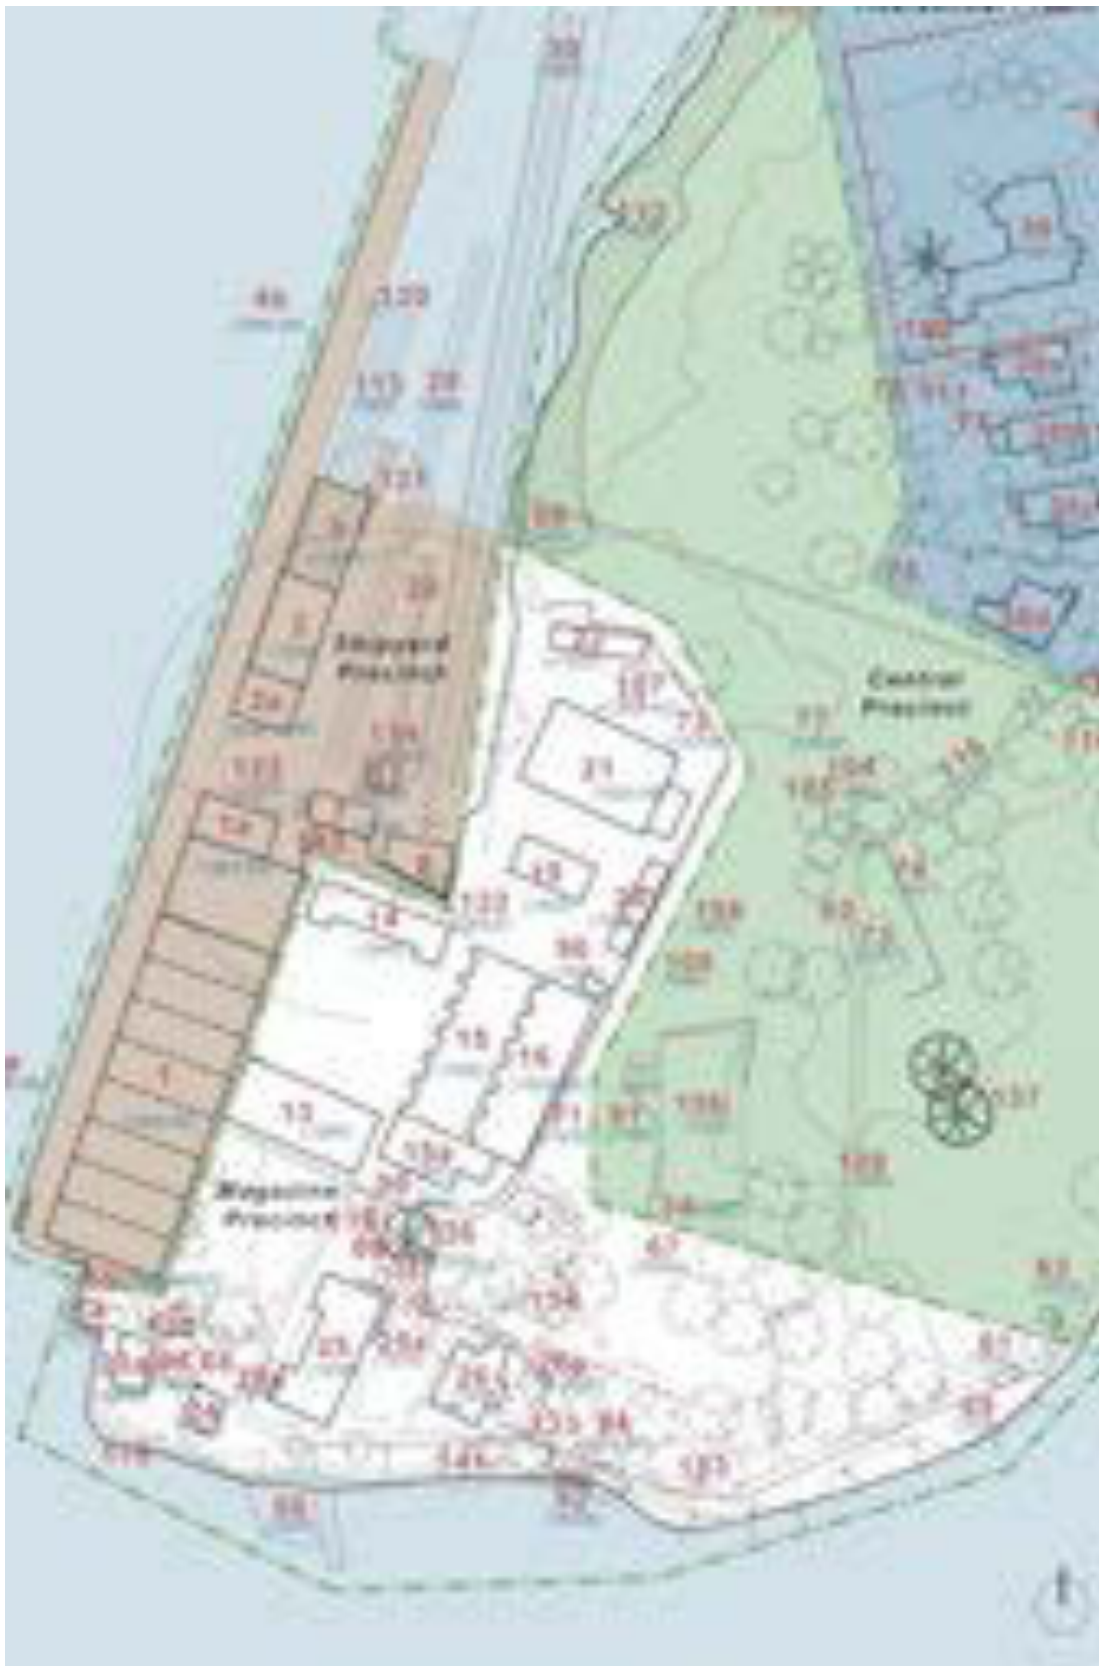
Figure 3.13 Plan of Magazine Precinct indicating the various elements with their date of (generally) first or major construction within the precinct.

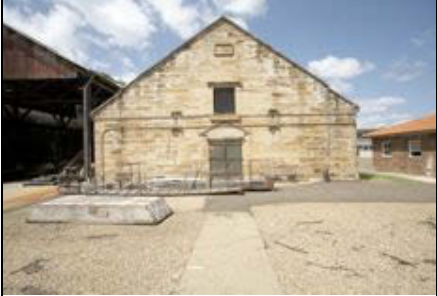
Item No	Date	Name	Level of intactness	Condition
Aboriginal Use and Contact				
-	-	-	-	-
Colonial Period				
15*	1836	The Queen's Magazine	Largely intact	Good/fair

<p>The Queen's Magazine is a rectangular shaped building of block sandstone construction with a gabled slate roof. An interior stone vault is supported by massive buttresses along the side walls. The main entrance doors, located on the north elevation, are original timber, sheeted over with copper on the outside. Directly above the entrance is a hood mould integral with the stone lintel. Above the hood mould are two sloping chases with two rectangular sockets at their outer ends. A broad sandstone block protrudes from the adjacent stonework directly above the pediment forming the sill of the upper level opening. The upper level shutters are screened by a grill of fine copper wires within a weathered timber frame and the opening has a hood mould above similar to that over the entry doors. Above this is a rectangular date plaque toward the apex of the gable. Two ventilation assemblies consisting of a hexagonal and single vertical slit, each with hood mould, are located symmetrically either side of the main doors. There are two rectangular openings in the wall close to ground level. Conduiting runs across the face of the north elevation, and on the west corner are a series of corroded metal fixings.</p> <p>The east and west elevations consist of a series of sandstone buttresses forming evenly spaced bays. At the centre of each bay are hexagonal and vertical slit with hood moulds over, matching those on the gabled elevations. Toward the base of the wall within each bay is an opening in the stonework. On the south wall (inside the corrugated iron shed one of these openings has a bronze grill). An upper opening and ventilation motifs similar to the north elevation are evident on the south elevation, above the roof the shed.</p> <p>The roof to the magazine is covered with weathered Welsh slates which are randomly scarred, quite extensively toward the ridge. The lower portion of the eastern roof of the gable is a darker colour than the rest of that roof. The ridge capping is lead and appears to be in good order. Copings to the gable ends and buttresses are broad stone cappings, some of which are weathered.</p>

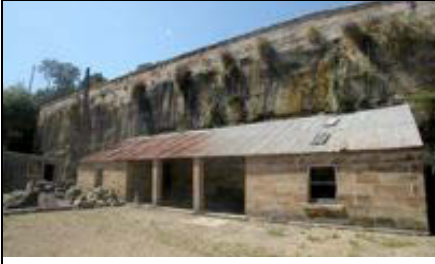
Item No	Date	Name	Level of intactness	Condition
20*	1839	The Stores Building	Largely intact	Fair

A dressed and coursed stone shed built adjacent to the quarry wall to house a new cooperage with a simple skillion roof with skylights now clad in corrugated iron. It was built by a contingent of 27 prisoners on commuted sentences from the Moreton Bay Penal settlement. Similar to the design of the barracks the building has a recessed verandah with two squared stone columns and a timber floor, a single room at each end of the building, the eastern room with a later window cut in and the western room having an early timber framed double hung multi-paned window.	
21*	1852-1859	The Colonial Magazine	Extensively altered	Fair/poor

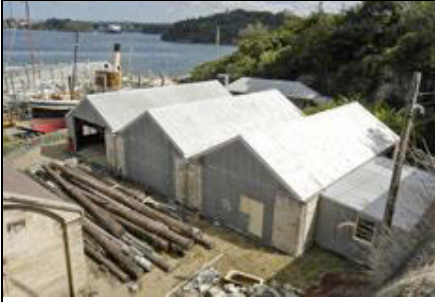
Originally a single bay gable roofed sandstone powder magazine designed by Government Architect Edmund Blacket, it was extended in 1859 by Government Architect Alexander Dawson with 2 additional sandstone bays to form a 3-bay building. In 1925-1931 under SHT control, most of the stone walls were removed leaving only some stone piers. At a later period at the southern end even the stone piers were removed, and the building was reclad in corrugated iron. It has a later corrugated iron skillion roofed addition to the north end and is now completely clad in corrugated iron with a concrete floor to most of the building. A small section of floor has been removed in one corner revealing the original stone foundations.

During this phase, changes to earlier buildings and features were also made including extensive changes to the Colonial Magazine including the removal of sandstone walls and replacement with corrugated iron walls.

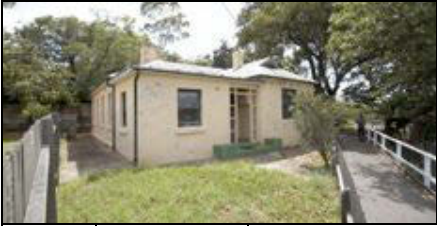
26*	1838, 1857, 1887	The former Barracks Kitchen, now known as the Kitchen Cottage	Extensively altered and extended	Fair

Originally a 2 room sandstone kitchen building located symmetrically behind the barracks building of sandstone with a hipped roof, it was converted and extended to 4 rooms in sandstone c1857 with a skillion roofed addition to the north side; again extended c1887 with rendered brick laundry/wc extension to northern end of west elevation; prior to 1924 the SHT undertook a rendered brick extension to the east and alterations to change use to a cottage; 1956 MSB sunroom extension and removal of sandstone walls to north.

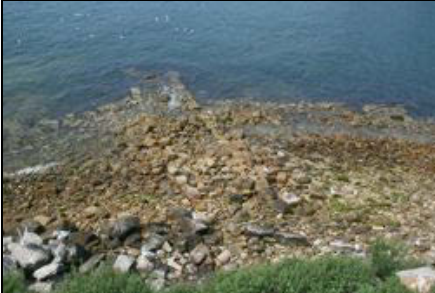
Item No	Date	Name	Level of intactness	Condition
66	1835c	Stone jetty remains	A ruin below high water mark	Ruin

<p>Located on the south western end of the Island, the jetty is almost completely destroyed although still well defined at both high and low tide. The 1985 survey identified at least three courses still standing while it appears that only one course now survives intact, the rest is rubble. It measures 16m x 2.5m and blocks have been robbed to create the swimming pool on the western side.</p> <p>Several authors suggest a range of dates for construction between 1840-1899. Hosty (HLA: 17) states the stone jetty dates between 1839-42 but it is not on plans dating to 1844. The HLA phasing plan places it post 1860 and Thorp dates it to phase three 1840-1899 and it does not occur on plan in Kerr's report until 1891.</p> <p>There is no evidence of access to the jetty.</p>	
67*	1830s	Remains of Blacksmith's Shop	Archaeological site, markings on rock face remaining	Good/fair

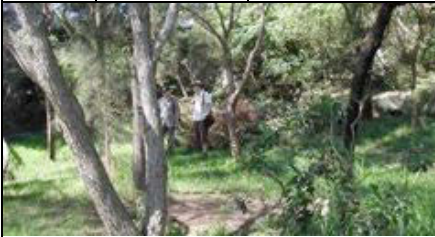
<p>Located on a rocky outcrop to the south east of the magazine wall, the site consists of a number of channels and slots cut into the rock face and a partially intact sandstone ashlar wall. The cut rock face appears to form the eastern wall of several structures including an 'L' shaped cutting indicating a structure built against the rock face and a wall consisting of six courses of ashlar sandstone extending from the cut rock face approximately 20 m to the north. The blacksmiths shop is not described in documentation nor is it located on any plan, so interpretation is speculative. No artifacts have been observed or recovered during any studies in the past. The retaining wall of the tennis court sits above the rock platform directly behind the rock face.</p>	
68	Pre 1830	Shell deposit	Remnant, covered by grasses	Poor
		<p>A small deposit of shells found within the root system of the southernmost fig tree by the path. The deposit may be a shell midden, but is more likely to be related to the operation of the kiln (item 95) directly below.</p>

At the completion of the quarrying operations and the magazine complex construction, a blacksmith's shop so close to explosives would not have been prudent and the shop would most likely have been decommissioned. The artifacts noted by Kerr were not visible on the surface during the last field survey, nor has there been any further historical research or survey to determine the layout, however cuts into the bedrock and the ashlar wall are still present. The item retains high archaeological sensitivity and clarification of the nature of the structure would enhance an understanding of activities carried out on the Island.

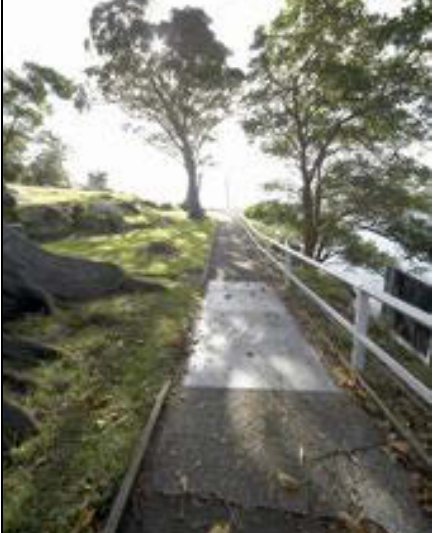
69*	1836	Magazine Walk	Alignment intact, reworked	Good

<p>It is likely that this alignment operated from the first development of the island as it connects the outbuildings (94), Anderson's couch and the lime kiln all from the 1830s and would have been the easiest and most level route between the ends of the island. Later the 1870 magazines were built on its alignment.</p>
