GOAT ISLAND

Conservation Management Plan

Volume 1

June 2011

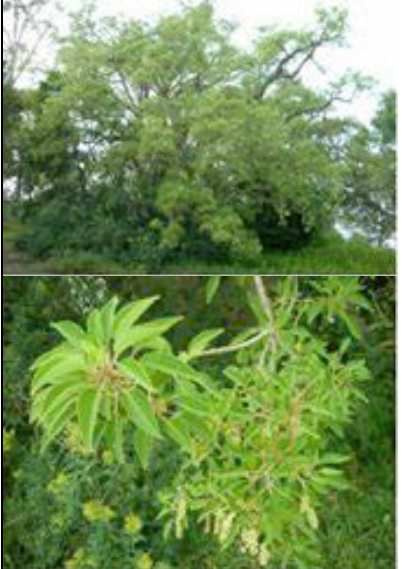
Mature <i>Phytolacca dioica</i> above and to the northeast of the 1838 barracks mess. Although common in its native South America, Ombu of this age are rare in Sydney – others of a similar size include an example at the Centennial Park eastern entry and one at Babworth House, Darling Point. This tree has oleanders growing around its base as well as much <i>Cestrum</i> . It is Item 13 in the 2005 arboricultural assessment of Naturally Trees Arboricultural Consulting.

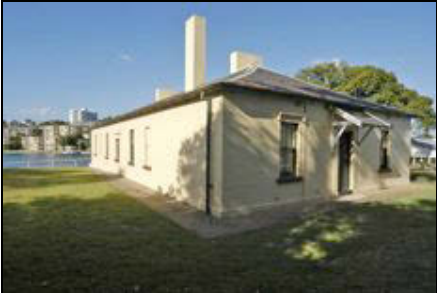
<p>These areas are now grassed and paved areas under which are likely to remain evidence of the additions made to the barracks building by the Sydney Harbour Trust in 1924, related to the conversion of the Barracks building into two residences (SHT residences 15 and 16) at the time.</p>		
65	1830s, 1925c	Stone jetty	Largely intact over earlier slipway	Fair

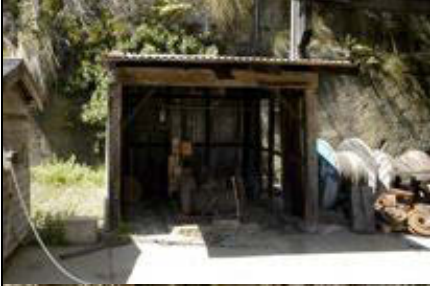
A simple timber framed corrugated iron clad skillion roofed shed located immediately north of the Scow Shed (16), housing the winch mechanism that powered the rope line, moving vehicles on the rail tracks from the wharf up the gentle slope to the magazine area. While the tracks have been removed or covered over, the winch and its housing and shed remain.

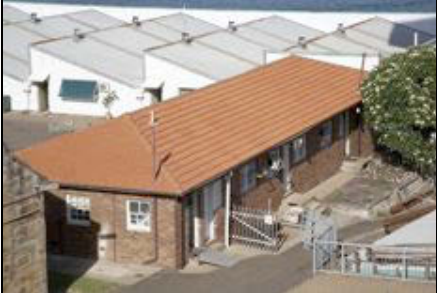
Built by the Maritime Services board as a amenity block for shipwrights and fitters it is a typical building from the period with a hipped tiled roof, mid brown face brick walls and classically proportioned with a recessed verandah to the south. The siting of the building is practical but intrudes into the forecourt of the magazine. The building features limited decoration and austerity in overall design.

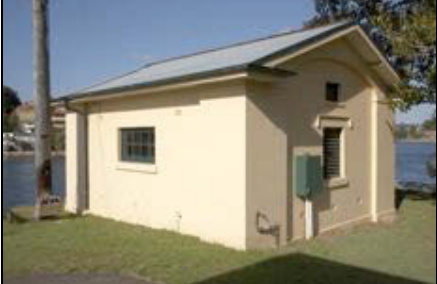
An inter-war Georgian style building that was designed carefully in relation to the adjacent barracks building reflecting design elements such as the use of segmental arch and label mold features of the earlier building. It is a simple rectangular rendered brick building with a gabled corrugated iron roof and symmetrically placed openings. The end walls feature the recessed arched form. The guttering returns around the ends of the building.

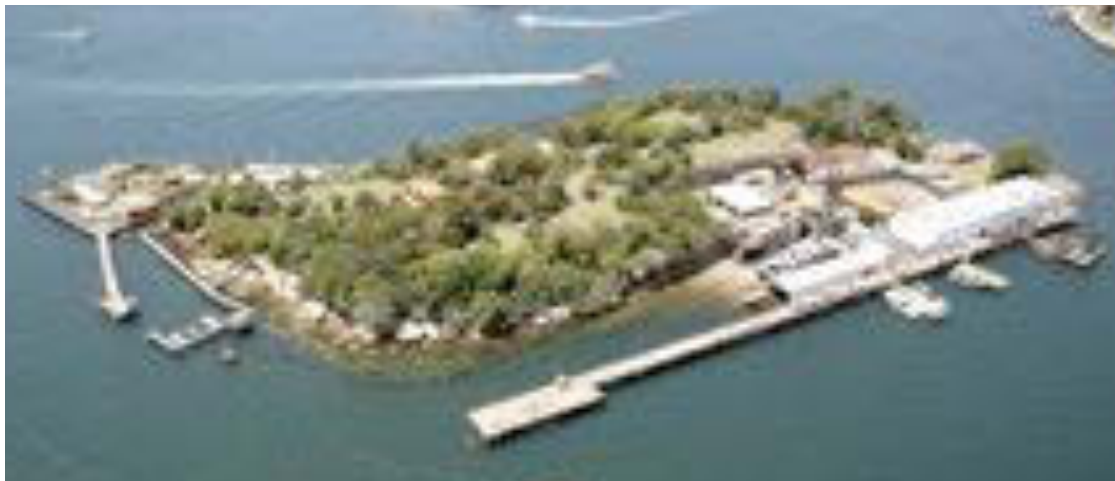
Figure 3.14 Aerial view of shipyard precinct on the lower right of the photo, note a number of wharves are no longer extant.

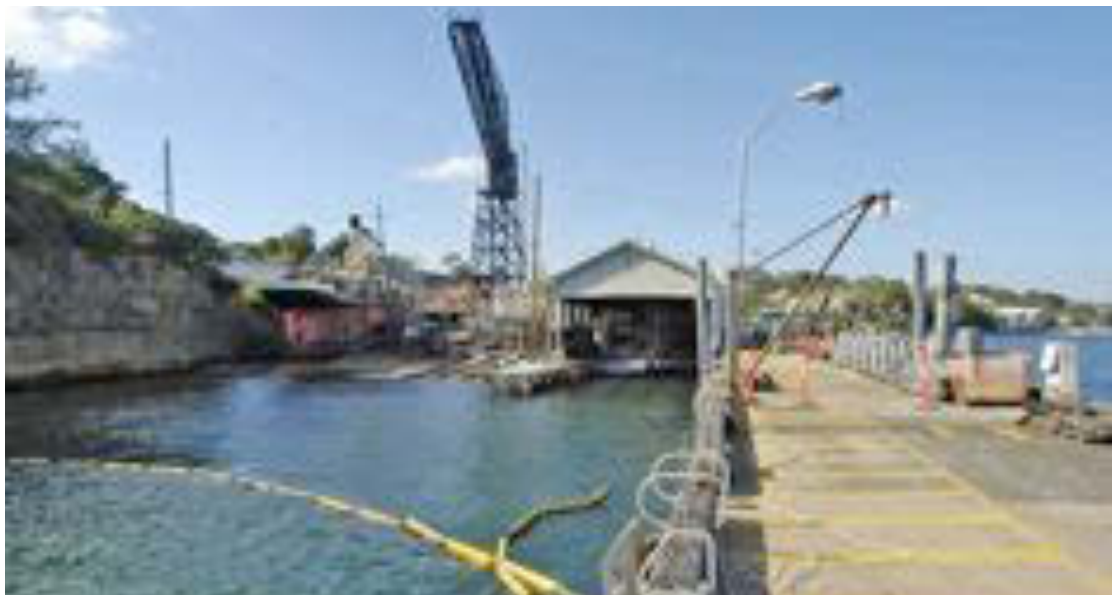
Figure 3.15 View of the shipyard precinct from wharf 4b

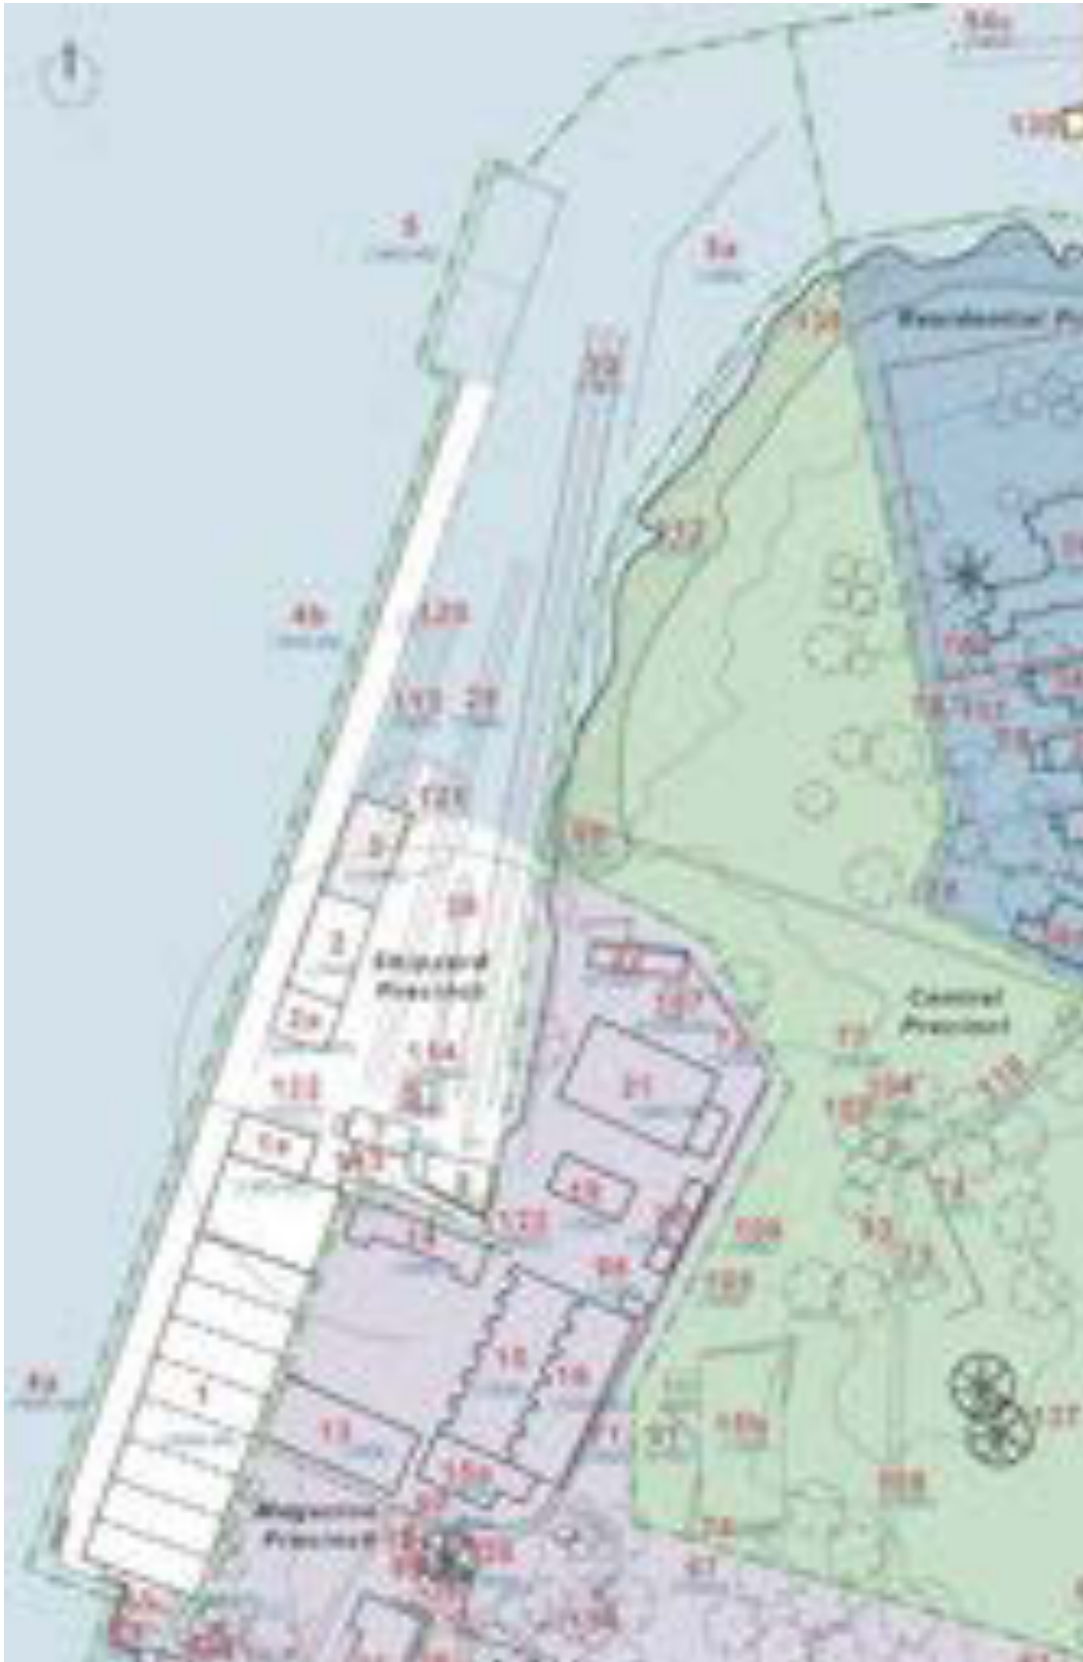
Figure 3.16 Plan of Shipyard Precinct indicating the various elements within the precinct.

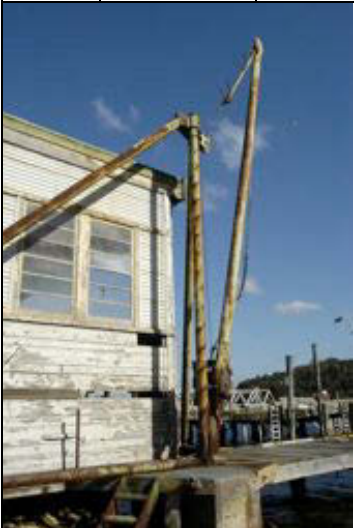
<p>A jib crane with braces located on a small section of wharf near the repair workshop. The crane appears to date from the 1945 period.</p>

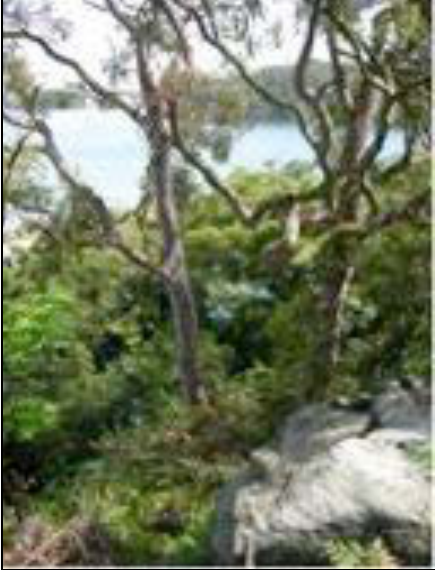
Item No	Date	Name	Level of intactness	Condition
Pre-Contact Period				
135	Ongoing	Remnant indigenous Sydney Harbour vegetation community along north-western edges of island		Good

Persistent representatives of the earlier vegetation community have remained around the northwestern edges of the island and include <i>Ficus rubiginosa</i> , <i>Eucalyptus botryoides</i> , <i>Angophora costata</i> , <i>Elaeocarpus reticulatus</i> , <i>Ceratopetalum gummiferum</i> , <i>Pandorea pandorana</i> (very large vine suggesting some age), <i>Banksia integrifolia</i> and <i>Pittosporum undulatum</i> .		
Colonial Period				
63*	1830c	Lime kiln	Partially intact and infilled	Fair

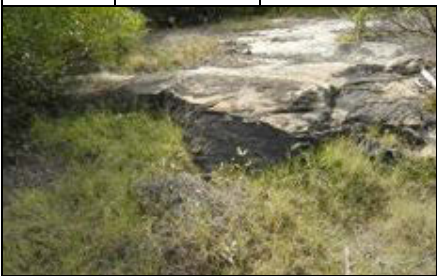
Remnant cut areas of rock along the ridge and extending down the western slopes from former quarrying.		
91*	1857c	Archaeological site 1	Archaeological site, sandstone footings	n/a

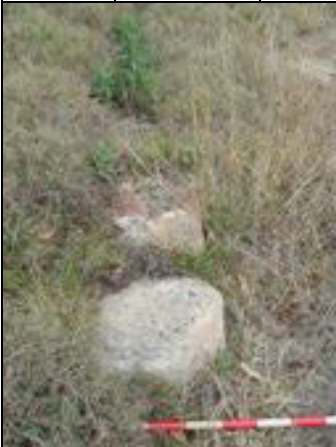
Sandstone footings directly adjacent to and west of the tennis court. The site is overgrown and the footings are aligned in such a way that they veer towards the tennis court. View south.		
93*	1830s	Artefact scatter	Archaeological site	n/a

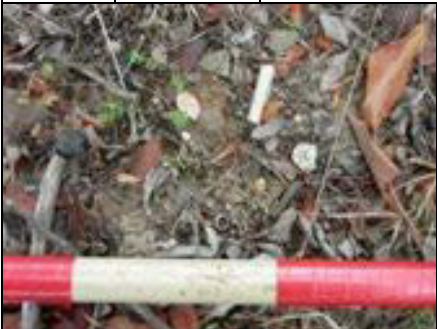
Artefact scatter – possible site of early building/"House on hill" - site of former 3 room weather board cottage (now demolished) on elevated ground in Residential Precinct. The artefacts in the scatter appear to date from between 1845 and 1900, and include a pipe stem, flint and ceramic sherds.

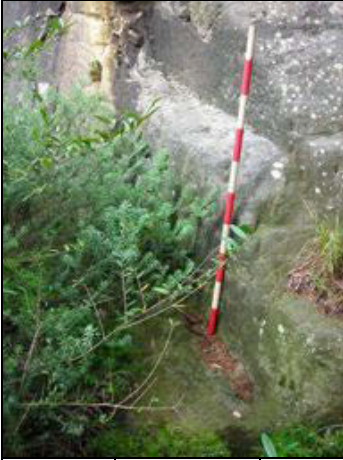
Item No	Date	Name	Level of intactness	Condition
110c	1840s c	Rock cut	Archaeological site	n/a

Function unknown. Likely evidence of early quarrying or related to a structure, now removed. Visual inspection limited due to vegetation overgrowth.	
112	1836	Quarry face	Archaeological site along cliff edge	Fair

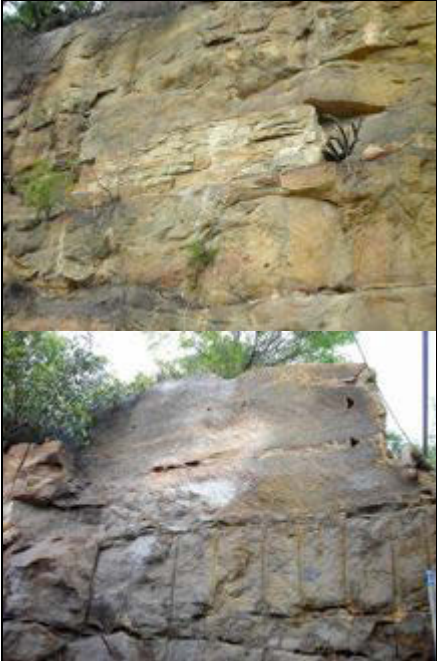
A distinctive area of quarrying on the western escarpment that is difficult to access. Part of the evidence of the extensive quarrying around the island.	
Maritime Period: Sydney Harbour Trust Phase				
60	1925	Path from shipyard to residences	Archaeological site, remnant path, poles and fencing	Poor

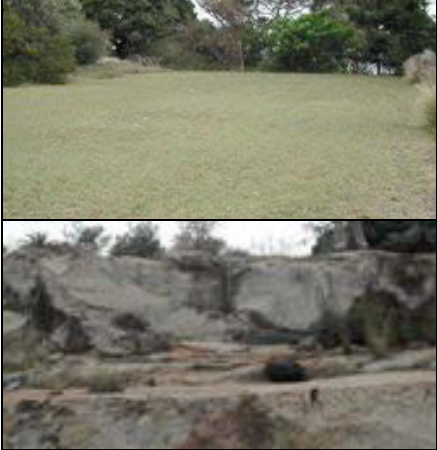
Item No	Date	Name	Level of intactness	Condition
Maritime Period: MSB Phase				
15b	1941	Tennis court foundation	Foundation intact, no longer in use	Deteriorated Poor
15c	1941	Tennis court pavilion site	Archaeological site, no extant evidence	n/a

Constructed in 1941 on what was probably a reasonably flat area to the south of the magazine precinct, the tennis court was the first of a number of recreational facilities constructed for the inhabitants of the Island. The court is assembled on fill and cut into the bedrock on the north eastern side, retaining evidence of modern explosives to remove the rock. A dry stone retaining wall supports the southern and part of the western side of the court. The bitumen surface is almost completely overgrown with only patchy evidence of the white lines intact. The 1985 survey identified a single net post still standing, however this no longer survives. The site of the pavilion was to the west of the tennis court, but apart from stone stairs cut in the rock platform, nothing of this building survives. 8 metres of sandstone block footings from an earlier structure (91) are visible on the western side of the court running under the tennis court at a different alignment.

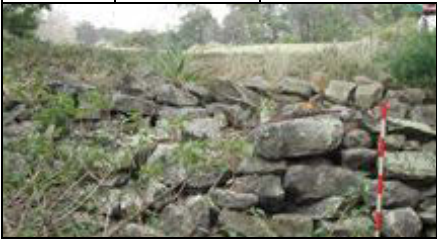
A series of low dry stone walls built from stone collected on the island and presumably from part of the quarrying activity used to bench the site to create leveled areas for recreational use. The illustration is the wall below the tennis court, other walls created a leveled area on the ridge line for the recreation hall building.	
103	1943	Seat on the ridge line	Intact	Good

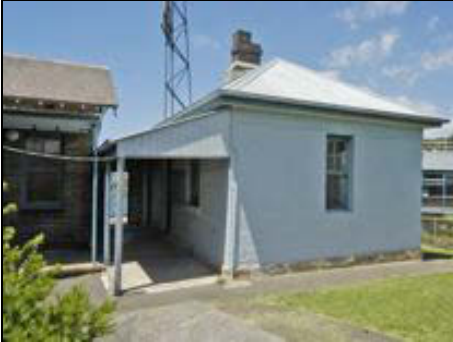
Item No	Date	Name	Level of intactness	Condition
Pre-Contact Period				
-	-	-	-	-
Colonial Period				
46a*	1865	Cottage (aka Artillery Sergeant's cottage)	Altered but reasonably intact externally	Fair

<p>A sandstone two-room building with a hipped roof and central chimney, associated with cartridge laboratory use of the Former Water Police Station, the cottage was built as accommodation for a Sergeant of Artillery. From 1912 when the adjacent Fire Brigade Barracks (46b) was built, the cottage was used as a Fire Brigade mess room. From 1963 the cottage was used as a wet-weather gear store for MSB Dredge staff (south room) and as a paint shop (north room). This involved installation of a pipe partition and coat racks to the south room (still evident). The north room appears to have later been used as a tea room for MSB staff (see kitchen fitout). The roof is now clad with corrugated iron (replacing slate) and the building's exterior has been painted over the sandstone. The verandah to the east elevation appears to be an early Sydney Harbour Trust addition, and does not appear on the 1891 survey of the Island. There are areas of archaeological potential in the vicinity of the cottage, being the sites of earlier structures including former additions, laundry and privy.</p>

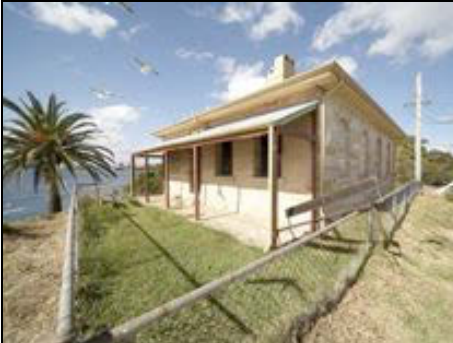
47*	1838	Water Police Station	Reasonably intact, additions removed	Fair/poor

<p>An ashlar sandstone walled Water Police Station designed by Government Architect Mortimer Lewis to an adapted design from Loudon's "Villa and Cottage Architecture". It was altered in 1865 after eviction of the Water Police for conversion to a cartridge laboratory. From evidence in documentary sources, the verandah to the east elevation appears to have been added during the 1880s. The building had a range of later alterations for SHT use, including the weatherboard addition remaining on the south elevation.</p> <p>The building has a hipped roof clad in slate, a simple front verandah and blind windows to complete the symmetry of the design. The side windows are set in arched recesses. Much of the joinery has been replaced. The building is unoccupied and requires considerable conservation work.</p>		
86*	1837	Barney's Cut	Reasonably intact but partially infilled	Good/fair

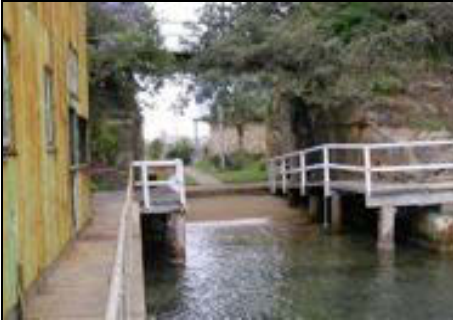
<p>Barney's Cut severs the eastern tip from the main part of Goat Island by a convict-excavated wet ditch approximately five meters wide. It was constructed to separate the Water Police from the western part of the island as a security measure, also providing a source of stone. The good quality stone excavated from the site was used to construct the Water Police Station completed in 1838. The Cut may also have provided a safe place for the storage of small boats. The cut has since been modified on the western side by excavation for the site of the Port Emergencies Services building. The Cut has featured a number of footbridges since at least 1865, the current footbridge being of relatively modern construction. Several slots and cuts within the flat well-finished walls suggest some type of attachments to the rock face.</p>

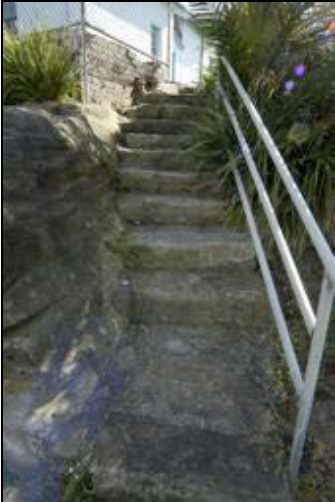
Item No	Date	Name	Level of intactness	Condition
87	Pre 1900	Stone steps	Largely intact	Fair

Set of steps partially cut into the rock and partially constructed connecting the knoll to the waterfront. Now fitted with a steel pipe hand rail.	
88	1865c	Access path	Intact	Fair

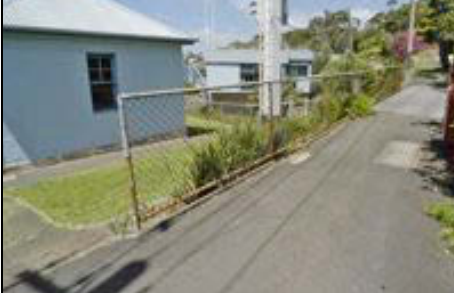
The early alignment of the access to the bridge over the cut which has been indicated in all plans as an access area. The current finish is asphalt, possibly overlaying earlier finishes.	
89	1865 and later	Access bridge	Current bridge intact, evidence of earlier bridges extant	Fair

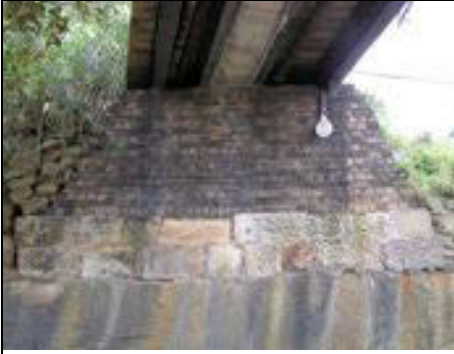
The first bridge over the cut was constructed in 1865 after the removal of the Water Police from the Island. The Water police station building was converted to a laboratory and a new store was constructed which required the cut to be bridged to provide access. Hand carts were used to transport materials from one end of the island to another. The current bridge is approximately 2.5 m wide and constructed of hardwood planks on steel beams with a metal and wire handrail. The original bridge was approximately 1.5 m lower than at present and was probably raised to its current height when it was rebuilt some time in the early 20th century as suggested by the English Bond brickwork. The metal and wire railings replaced earlier wooden palings sometime after 1945 (based on aerial photography).

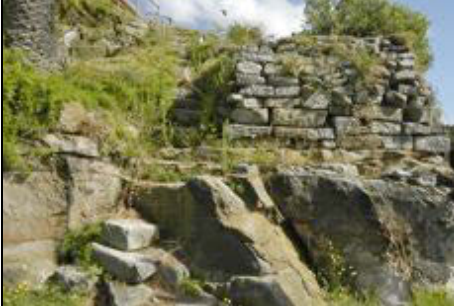
Item No	Date	Name	Level of intactness	Condition
101	nd	Stone steps and walls	Archaeological site, remnant elements remain	Poor

An early set of stone steps, probably dating from the time of construction of the water police station leading down to the point. The edge of the escarpment has been built up with dry stone walling to retain the upper level area in front of the building. The lower edge of the photo shows further excavation.	
Maritime Period: Sydney Harbour Trust Phase				
46b*	1912	Barracks	Altered but reasonably intact	Fair

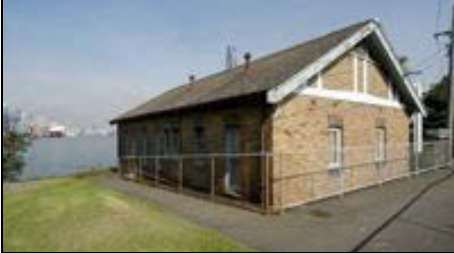
A rectangular facebrick building with a gabled slate roof with lead ridge capping, exposed timber rafter ends, and colorbond guttering. The building has a small wing facing the 1865 cottage with a later verandah. It has timber framed double hung windows with 4-pane top sashes, however a number of window openings have been altered, some with glass louvres inserted. The barracks was converted to an amenities building for Dredge workers by the MSB in 1963, resulting in extensive alteration to the interior.

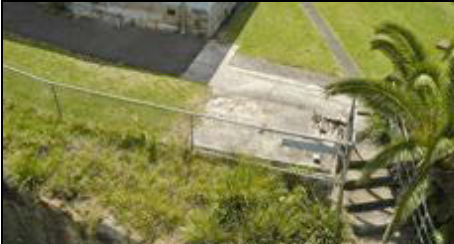
126	Post 1912	Amenities slab	Archaeological site	Ruin

The remains of a former outbuilding described as an amenities building with evidence of toilets and drainage extant. This location has been occupied with a structure of some form from the Trust period, although the exact nature of the building is not known. This is one of the few remaining visible slabs of buildings that were located throughout the area.	
138	SHT phase	Canary Island Date Palm (Phoenix canariensis)	Mature

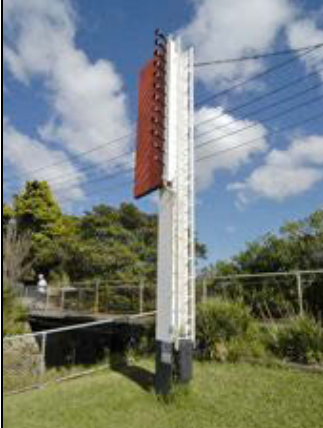
<p>This is the rear lead beacon for commercial vessels approaching from Darling Harbour. Steel framed structure with lights. Date not known but believed to be circa 1970s-1980s.</p>

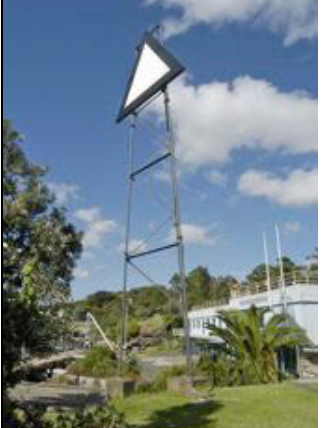
<p>Day marker for commercial shipping vessels approaching from the east. Steel framed structure, built over a former accessway to the water. Date not known but believed to be circa 1970s-1980s.</p>	
National Park Period

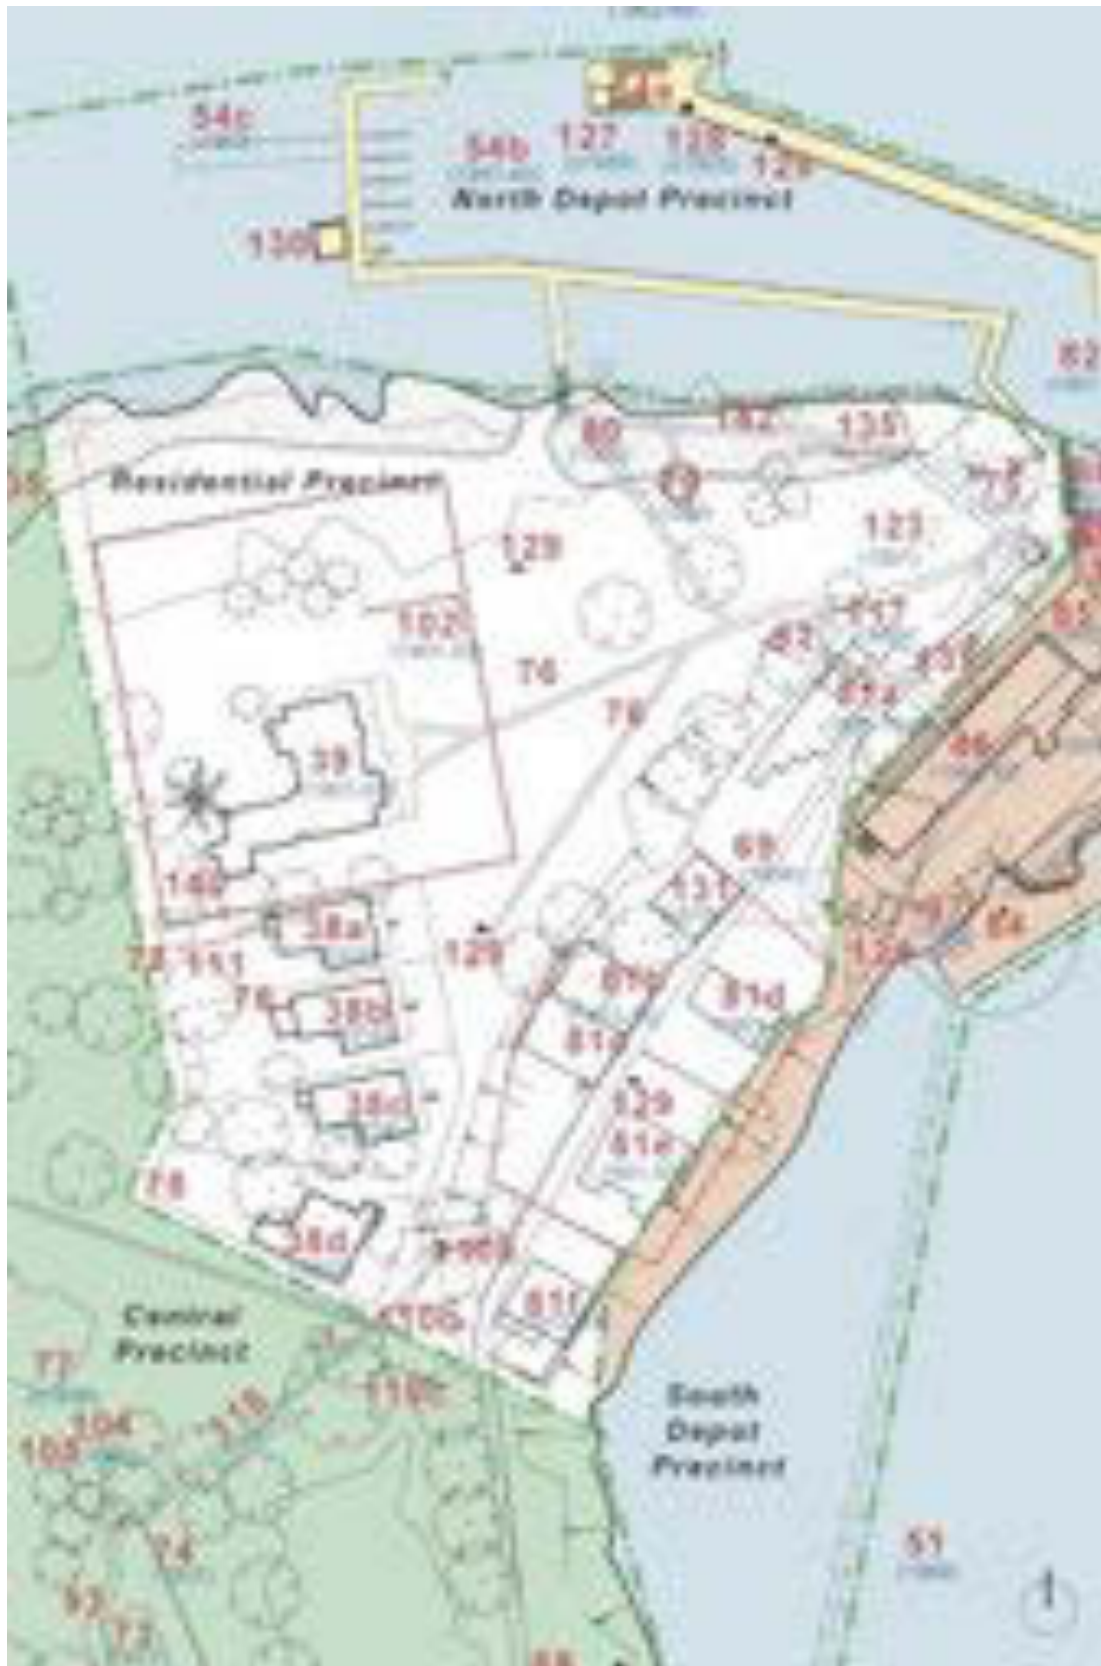
Figure 3.25 Plan of Residential Precinct indicating the various elements within the precinct.

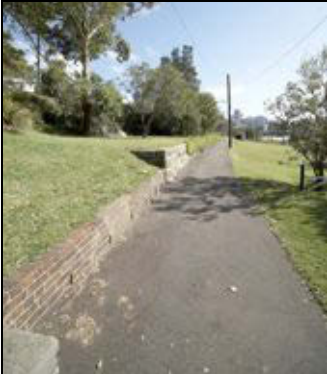
This section of the walk connected the lower group of residences and earlier the magazines to both ends of the island. The edge of the path is marked by retaining walls, rock cuts, stairs and various features providing access to the house platforms and yards.	
117	1875	Site of former magazine	archaeological site	Ruin

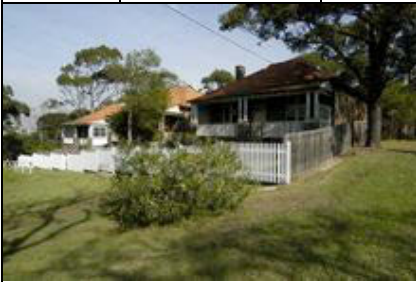
Item No	Date	Name	Level of intactness	Condition
Maritime Period: Sydney Harbour Trust Phase				
38a*	1916	Cottage No 1	Reasonably intact	Fair

<p>A group of three face brick Federation Queen Anne style cottages with hipped and gabled unglazed terracotta tile roofs with brick roughcast stuccoed chimneys. All three cottages are elevated, with timber steps up to front verandahs facing views east to Sydney Harbour. The cottages each have symmetrical front elevations, with a central front door with fanlight and sidelight and a pair of timber-framed double-hung windows to each side of the front door. Each cottage features simple timber framed double hung windows, plaster ceilings with ceiling roses but without cornices (some modern replacement ceilings), and fireplaces, generally retaining original timber surrounds. All three cottages have corrugated iron skillion roofs to the rear (west) over a laundry and toilet and are bounded by paling fencing to the rear and sides, with picket fences to the front (east).</p> <p>The front verandah and steps of no 38a have been replaced and a modern front door inserted. It has a small weatherboard addition to the rear (west).</p>

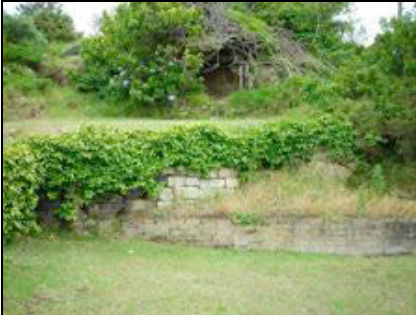
<p>Site of first dynamite store built in 1875, just to the west of the cut. The building was demolished in 1970 and there is only ephemeral remains of the building platform surviving. Originally a wooden structure with an iron roof, the building also functioned as an ammunition shed and the most easterly of all the residences.</p>	
81b*	1913-15	Sites of residence	Archaeological site	Fair

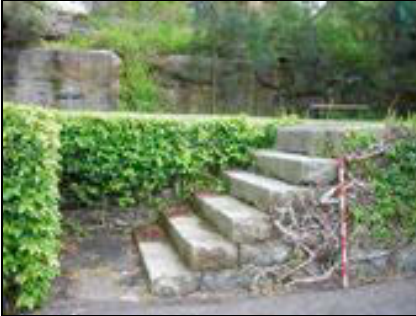
<p>Same as 81b site of the former duplex constructed in 1913 is the most indicative of all the residential sites. The area has been terraced and a stone retaining wall faces the path on the northern side. Concrete stairs lead up to the building platform which retains the concrete front veranda and evidence of the wooden railing at the front.</p> <p>At the rear, the green painted remains of the laundry floor are visible as well as several slots and cuts in the quarried rock face suggesting the position of a lean-to outbuilding.</p>

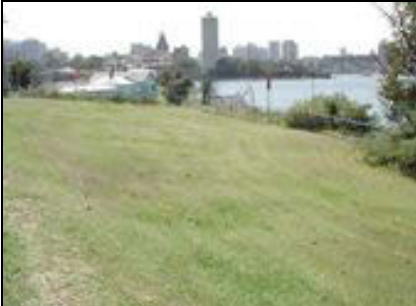
81d*	1901-03	Sites of residence	Archaeological site	Fair

<p>A grassed flat area that is more distinct as a building platform than the site to the west (81e). Demolished in 1970, there is no evidence of building material and there are no visible artefacts. Originally constructed of weatherboard and tile.</p>

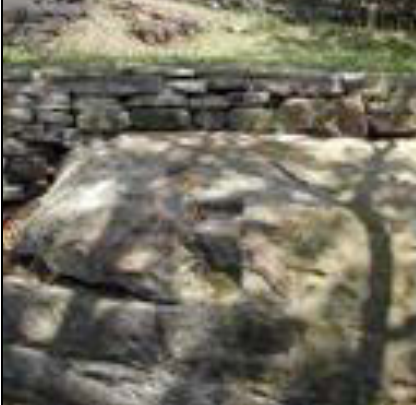
110a	nd	Archaeological site rock cut	Archaeological site	n/a

Stair cut into bedrock in front of Residential Cottage No. 3.

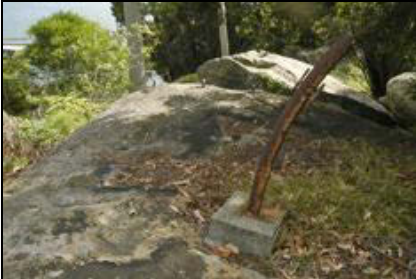
The signal mast set in a prominent location with clear views down the harbour comprised a steel post, now cut down, two sets of three guy points for signal ropes and four corner fixing points for stays. All of the fixings remain.	
140	1930s c	Monterey Pine (<i>Pinus radiata</i>)

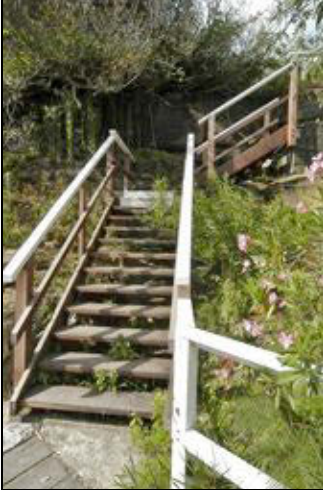
Timber access stair dating from the 1940 development but recently replaced to a modified design but in the same location. These stairs provided access to the bathing enclosure and the small boats area from the residences and to the waterfront when the Cut was infilled.		
76	various	Paths and retaining walls	Paths to public areas	Fair

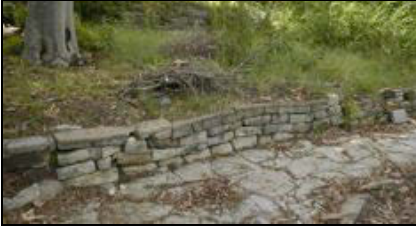
A network of paths extends through the precinct with a number of stone flagged paths, now in poor condition, dating from the later period of occupation. The paths along the northern edge are related to gardens that extended onto the rock edge and include stone retaining walls, steps and various decorative features.

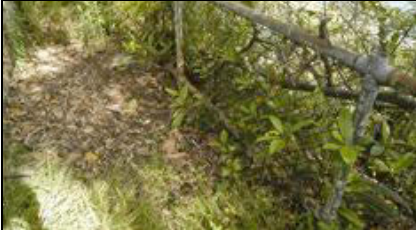
A range of fences from steel tube and mesh to painted timber post and rail are located throughout the precinct at stairs and to protect edges alongside access paths. Most fences are deteriorated and the paths overgrown.		
129	1970s-1980s	Navigation markers	Intact	Good

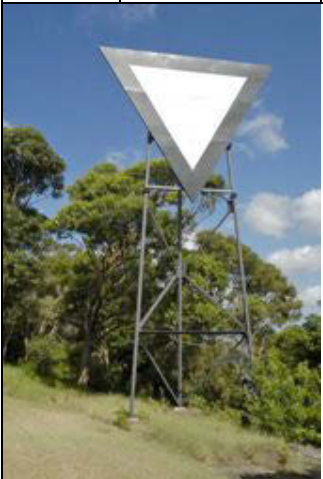
Day marker for commercial shipping vessels approaching from the east. Steel support structure with painted triangular marker. Date not known but believed to be circa 1970s-1980s.

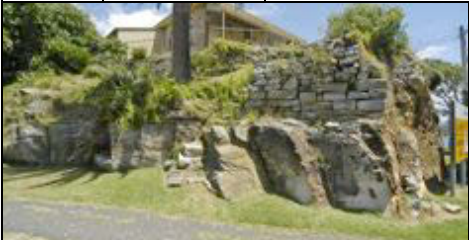
<p>The north-eastern edge of the island was originally in natural form but was gradually reclaimed and reworked from 1901. The rock faces appear to be quarried to "square-up" the end of the island related to reclamation works. A dry stone retaining wall is constructed directly above to provide a small grassed area in front of the water police building.</p>

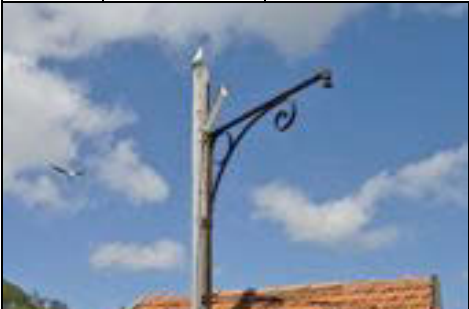
<p>A decorative steel light bracket fitted to a timber power pole on the ferry wharf that predates the present wharf construction and appears to date from the Maritime Period: SHT phase. It has a new light fitted directly above it.</p>

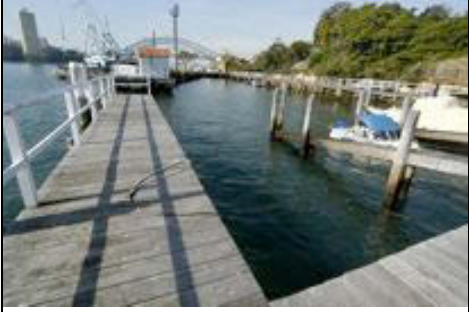
<p>The boat pens are located behind the ferry wharf and have been reconstructed a number of times, more recently in 1995 and again around 2005. The walkway and pens are in sound condition and are used to moor NPWS operational vessels. The remaining structures comprise a walkway supported on pairs of 350mm diameter piles with 350 x 350mm headstocks and 300 x 300 girders, 100mm deep timber decking with a painted timber handrail to the shore side (and Harbour side of the outer section), timber ladders providing access to small vessels that may be moored alongside and a series of pens with sloped access ramps, reconstructed as originally constructed. Various additions to this area have collapsed or been removed over time. A corner pile is missing from the walkway.</p> <p>A small shed remains at the western end of the pens supported on four detached piles and framing. It is a movable structure.</p> <p>An attached walkway and stair connecting to the top of the rock escarpment is known as the Harbour Master's Stair. It now forms part of the boat pen area but formerly, before the construction of the boat pens, connected to a separate wharf. The stair has collapsed and the walkway is in poor condition.</p>

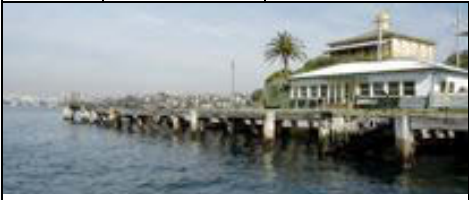
<p>A standard hardwood pile wharf (350mm diameter), two bays wide with timber superstructure of headstocks (350 x 350mm) and girders (300 x 300) attached to a stone seawall. The wharf extended for the full length of the reclaimed foreshore on the eastern face of the precinct and projected past this point to connect via a ramp to the eastern wharf. This was the last section of wharf to be built around this end of the island. The western end, providing access to the ferry wharf has been repaired, the remainder of the wharf has been demolished.</p>

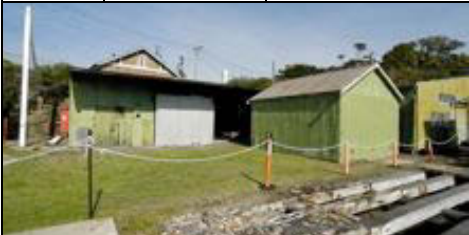
<p>A simple timber framed galvanised iron clad shed with gabled roof and access door but no windows. Built as part of the fire brigade precinct it was used for storage related to the brigade.</p>

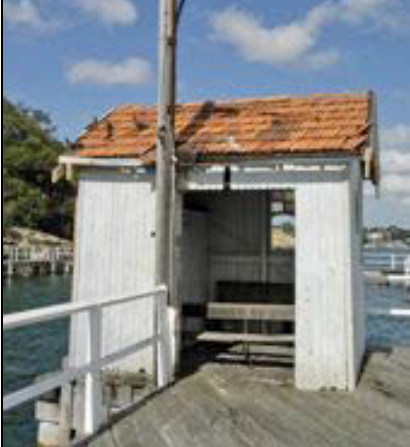
<p>A timber framed, waiting shed with vertical timber external boarding, a gabled tiled roof with projecting eaves, coloured glass window and seats built into the interior. It has an opening onto the wharf. It appears to have survived several wharf rebuilds and may date to the harbour trust period.</p>		
129	1987	Navigation markers	Intact	Good

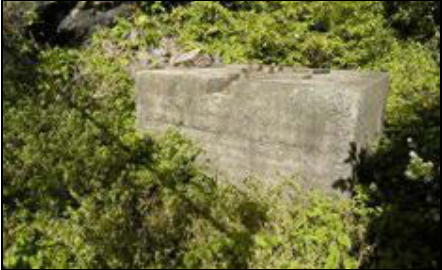
Item No	Date	Name	Level of intactness	Condition
124	1945c	Jib Crane Base	Reasonably intact	Fair

<p>The mass concrete mounting blocks for the 1914 period crane set over the first wharf and quarry base. Only two of the three bases remain, one being removed for the Port Services Building construction. They have holding down bolts for the steel superstructure still in place.</p>		
129	c.1970s-1980s	Navigation maker	Reasonably intact	Fair

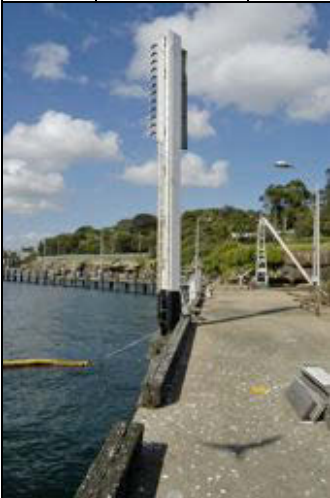
<p>Front lead beacon for commercial vessels approaching from the east. Steel structure with lights. Date not known but believed to be circa 1970s-1980s.</p>		
National Park Period				
-	-	-	-	-

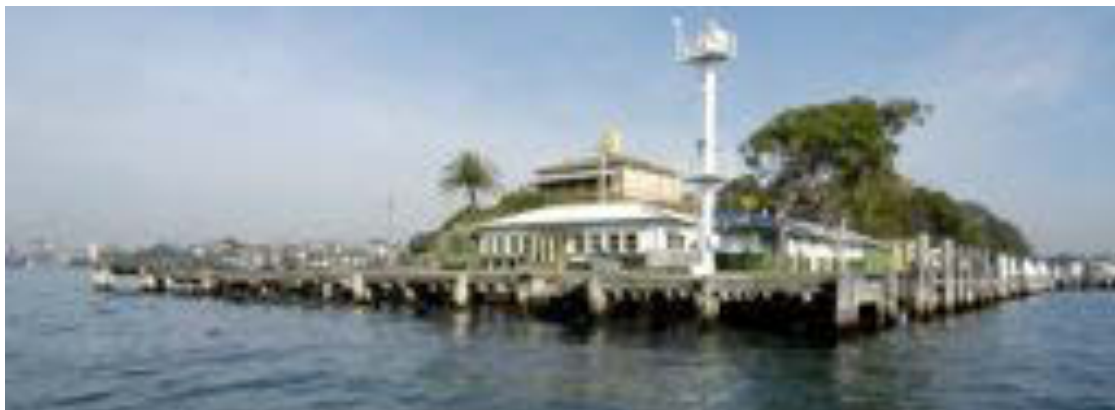
Figure 3.36 A close view from the Harbour of the north-east corner of the island. The immediate view was dominated by the wharves and later buildings around the foreshore. As the viewer moves east, the form of the island with its ridge and the Water Police Station (47) take more prominence. The close view reinforces the industrial character of the island, with the Maritime Services Board's Dredge Office (48) and Gear Shed (49) being obvious.

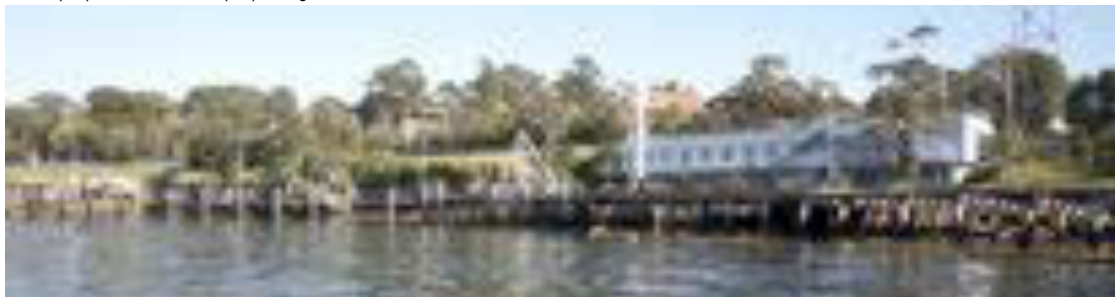
Figure 3.37 A close view from the north of the former eastern wharf (52) with the Wharf Mooring Floating Plant (51) visible on the far left. From this view position the wharves dominate the scene with the Port Emergency Services Building (45) being the most visually dominating element on the northern part of the island through its mass and light colouring, with the Harbour Master's Residence (39) visible behind.

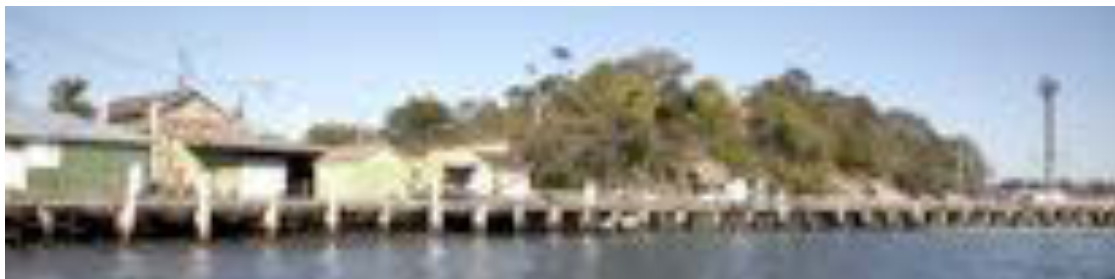
Figure 3.38 A close view of the ferry wharf (54a) and end of the northern wharf (55). This photograph illustrates the changes in visual setting of the wharves with the northern wharf closely related to built development along its edge and stepping up the hill where to the right the ferry wharf is set against the natural escarpment and the vegetated headland. MSB firefighting building (50), various sheds (56, 57) western end of Gear Shed (49) visible, with north elevation of the SHT Fire Brigade Barracks (46b) visible on the promontory behind. Note that the Harbour Master's Residence (39) is virtually invisible from this angle, whereas in the early 20th century it was prominent from this direction.

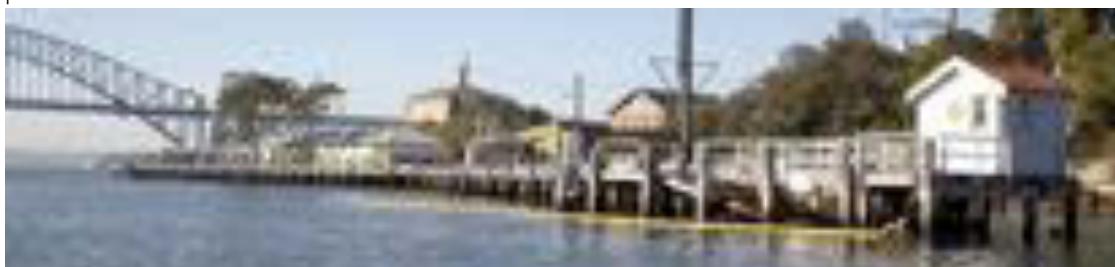
Figure 3.39 A close up view of the ferry wharf (54a) and former northern wharf (55) looking towards the east and the Harbour Bridge. This is an important view as it is taken from the main channel of the Harbour. The Water Police Station (47) is prominent centre left.

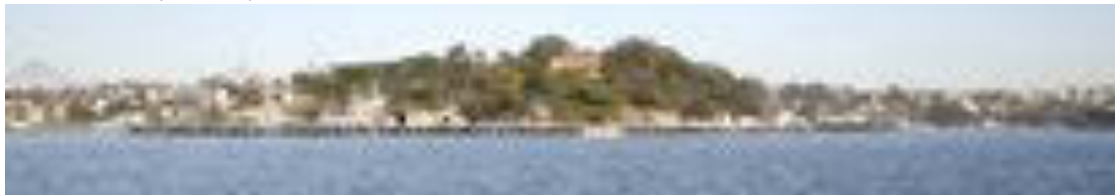
Figure 3.41 A more distant view from the north where the wharves provide the edge of the island with buildings seen inside the landscape canopy. The reason the wharves are defined is the deep shadowing under the decking that gives depth to the wharf edge. The main buildings visible on the Island are the Harbour Master's Residence (39), centre, and the Water Police Station (47), left.

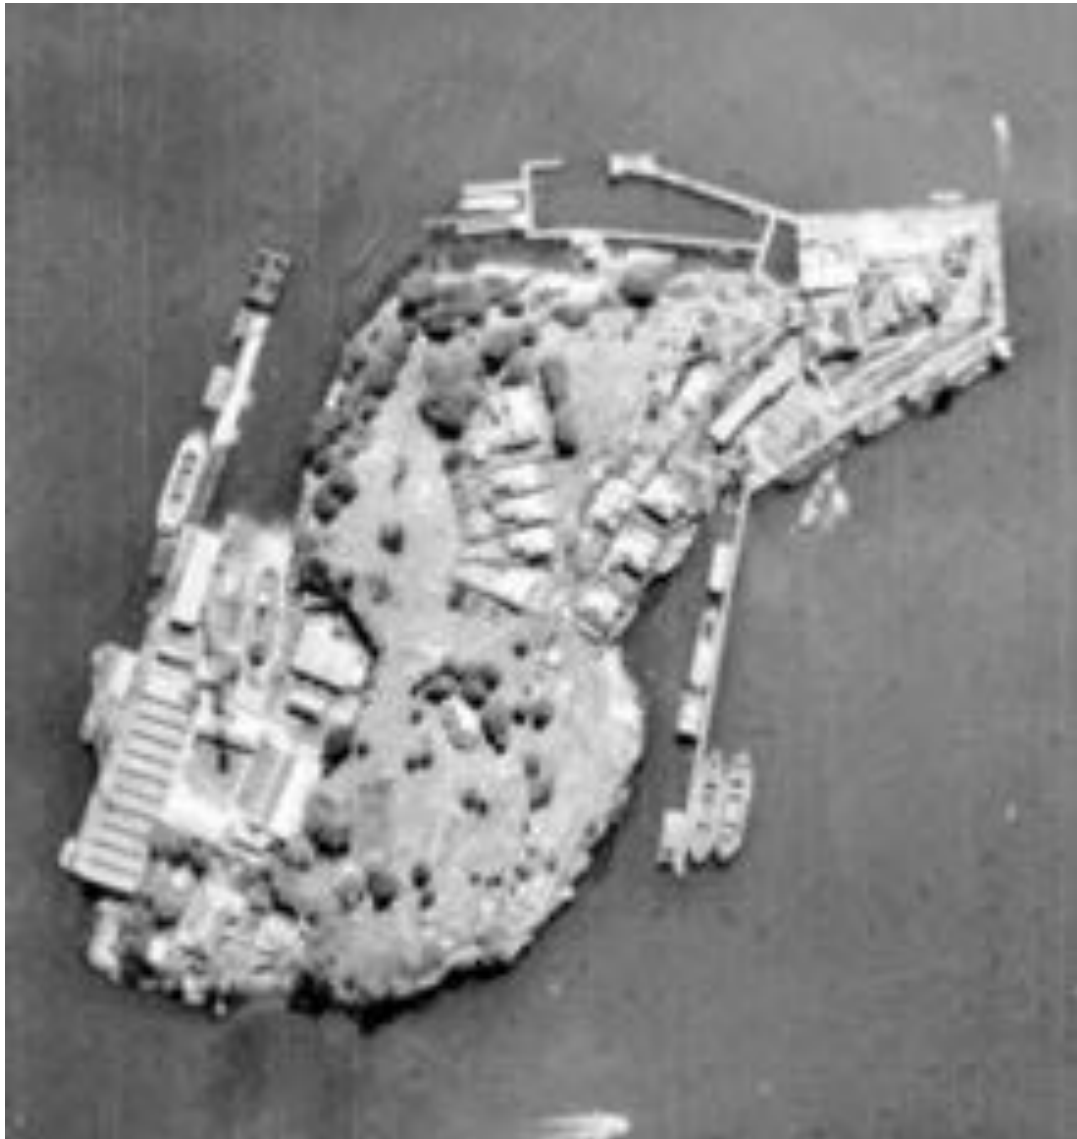
Figure 3.46 1968 aerial photograph of Goat Island, showing the maximum extent of wharves and buildings on the island

The 1960s amenities building within the Magazine Complex and the 1963 Port Emergency Services building (originally built for the MSB fire brigade) were the last major structures built on the island. By the end of the 1960s the island had its maximum extent of structures, with 16 occupied residences, a working MSB shipyard, MSB water fire brigade and dredging operation, and recreational facilities. This crowded island is evident in the 1968 aerial photo at Figure 3.30.

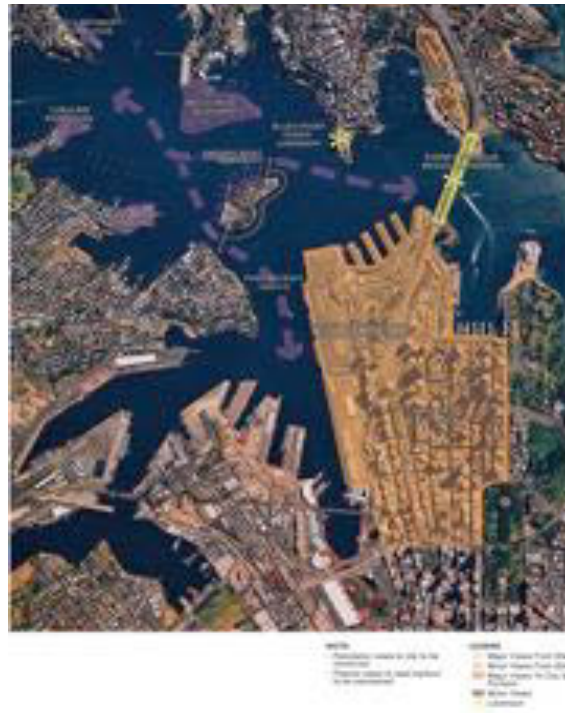
Figure 3.62 This plan identifies that the main views are elevated and look past the features on the island. The wharves play little role in views out from the island. (DECCW, 2007).

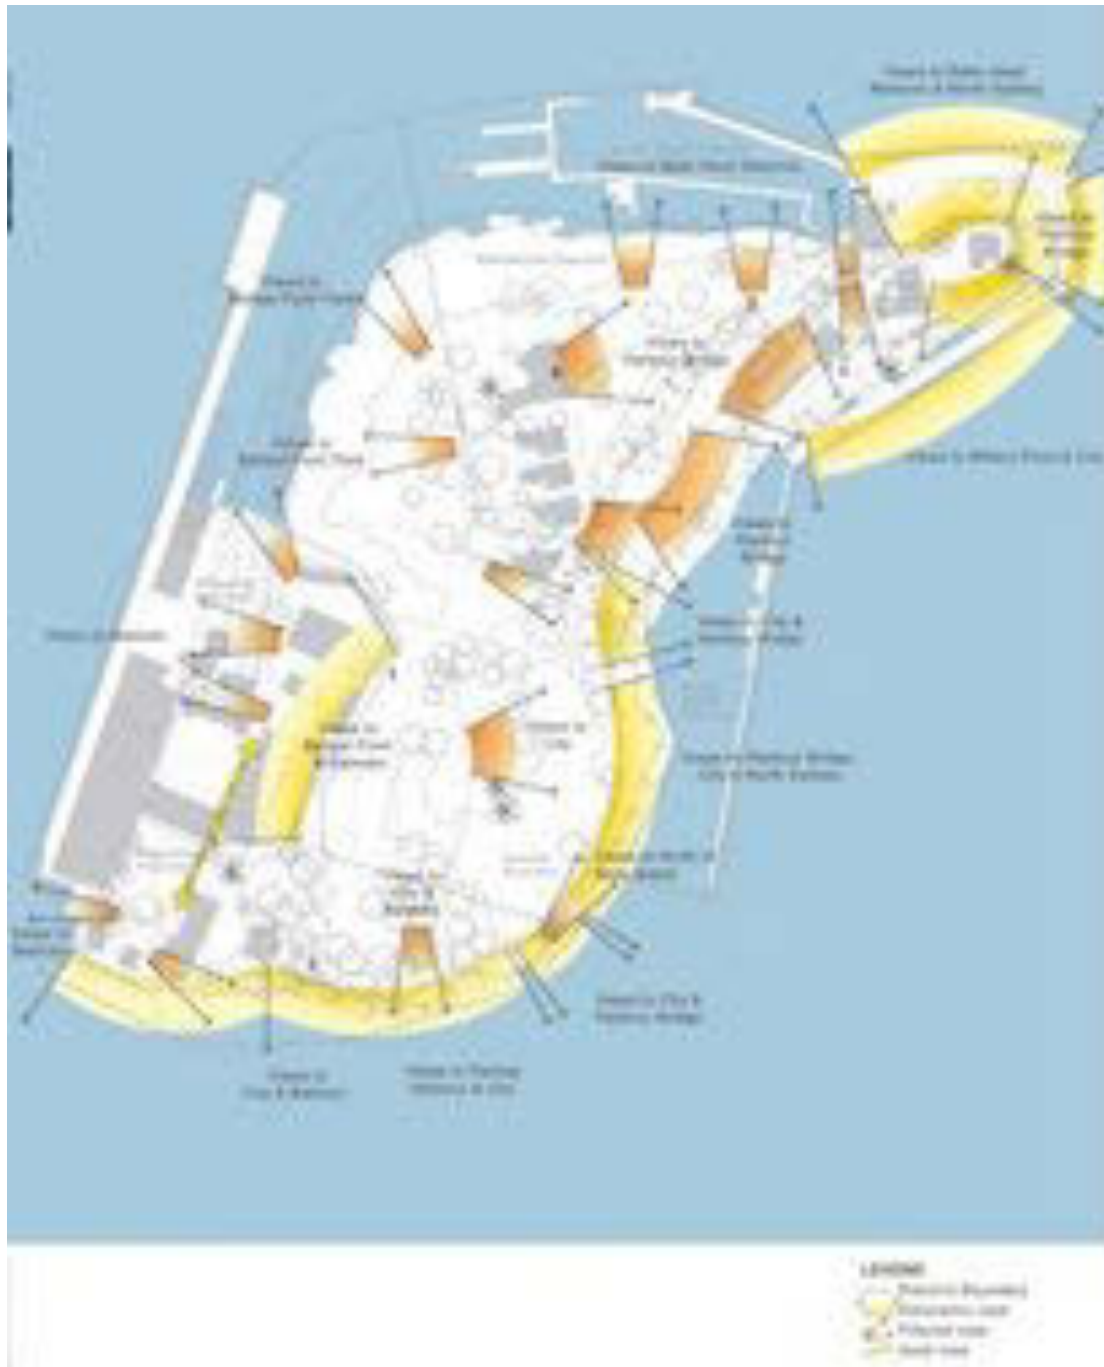
Figure 3.63 This plan identifies specific views. It is important to note the views from the wharves and that only the northern and eastern wharves are identified. It is also significant to note that the views from these wharfs are equally available from the shoreline immediately behind the wharves and that due to the removal of decking most of these wharves are now not accessible.

While the wharves frame the foreground for some of the views from the island it is the distant views that are identified as significant. (DECCW, 2007)
