GOAT ISLAND

Conservation Management Plan

Volume 1

June 2011

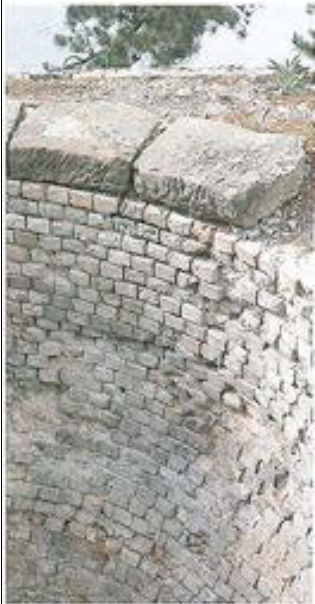
<p>Circular brick lined kiln with domed roof constructed at Port Arthur in 1854 on the shoreline. Burnt shell and limestone. One of only two remaining lime kilns on the Tasman Peninsula (the other being at the Coal Mines Historic Site). Port Arthur is listed on the National Heritage List, and is one of the Australian convict related sites to be proposed for World Heritage Listing.</p>
<p>Lime Kiln, Coal Mines Historic Site, Saltwater River, Tasmania (1833)</p>	<p>The Coal Mines site was established in 1833 to mine coal and as a place of secondary punishment for convicts. The site operated until 1877 (until 1854 with convict labour). The lime kiln near the ruins of the main settlement is one of only two remaining on the Tasman Peninsula, the other being at Port Arthur. The lime kiln provided lime for mortar. The site is on the National Heritage List, one of the Australian convict related sites to be proposed for World Heritage Listing.</p>

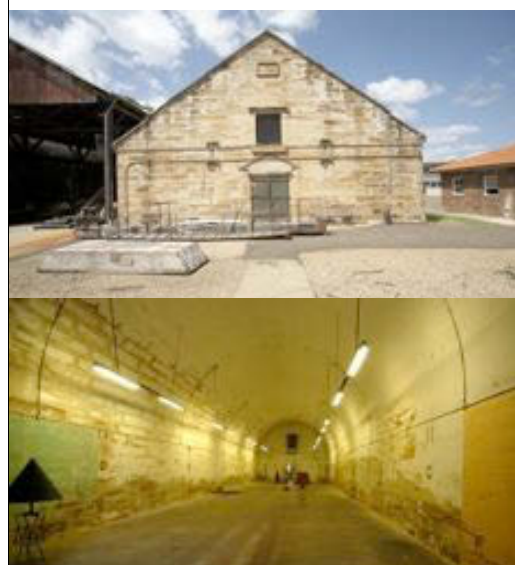
Location	Analysis
Goat Island 1833-1839 Queens Magazine & the Magazine complex	<p><i>Feature Type:</i> Government/Military/Royal Navy</p> <p><i>Description:</i> Magazine complex: sandstone Queens magazine. Buttressed, massive masonry, baffled vents, copper-sheathed doors, double shutters, copper screens, a single barrel-vaulted chamber, gabled slate roof (intact); sandstone 1st Cooperage (later cartridge lab) skillion slate roof (relatively intact); sandstone 2nd cooperage, gabled slate roof (relatively intact); sandstone magazine wall and sentry box with related early graffiti (intact); sandstone military barracks (some alterations); sandstone kitchen block (radically altered); sandstone wharf remains</p> <p><i>Analysis:</i> The Queen's magazine (and the associated buildings from the 1836-40 building phase) is the most complete, the earliest and the most comprehensive magazine complex in Australia. The buildings are remarkably intact and are able to demonstrate much of their layout and operation.</p>

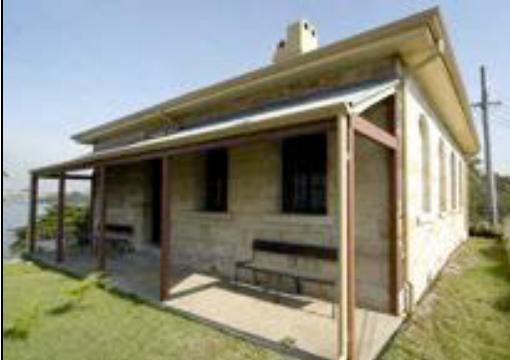
Item and Location	Analysis
<p>Goat Island 1838</p>

<p><i>Feature Type:</i> Water Police Station</p> <p><i>Description:</i> Design by Government Architect Mortimer Lewis, based on Loudon’s Village and Cottage Architecture, the building is located on a prominent knoll with expansive views around the harbour. Apparently designed in isolation of other structures its modest scale and floor plan soon attracted a range of outbuildings.</p> <p><i>Analysis:</i> The earliest extant water police building in Australia and the only structure of its type from the eighteenth century that was used as barracks, office and holding cells. It is also the only such structure to be located on an island.</p>

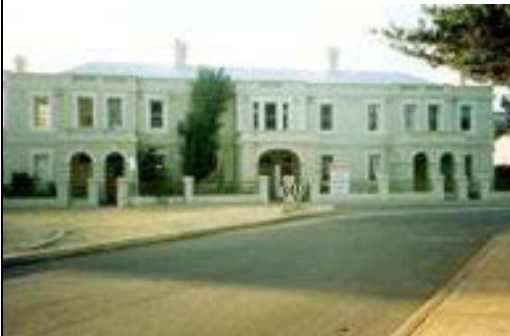
<p data-bbox="751 1525 1367 1592"><i>Feature Type:</i> Fremantle Water Police Station and Quarters</p> <p data-bbox="751 1592 1367 1682"><i>Description:</i> A federation period building, which replaced an earlier Water Police building on the same site.</p> <p data-bbox="751 1682 1367 1805"><i>Analysis:</i> This building represents the third phase of provision of Water Police buildings, Goat Island being the first and Hobart the second. It is not directly comparable to the Goat Island building.</p>

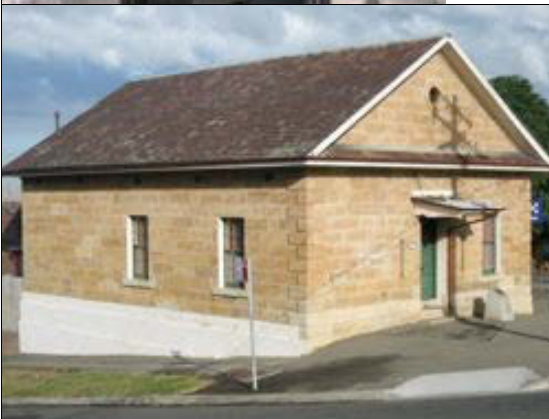
<p>Police Watch House (former) 808-810 Victoria Road, Ryde/Mortimer Lewis/1837</p> <p>Simple single storey rectangular sandstone Police Station.</p> <p><i>Analysis: Listed on the NSW State Heritage Register. Similar in age and purpose (but not design) to the Goat Island Water Police Station.</i></p>

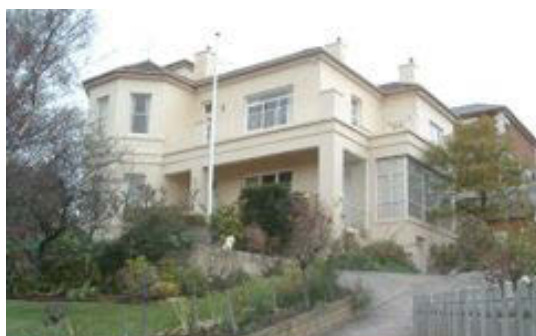
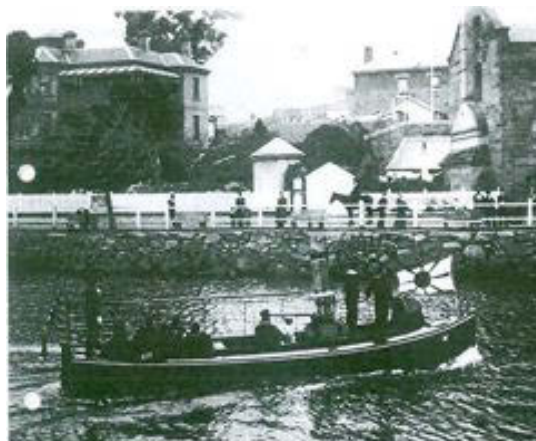
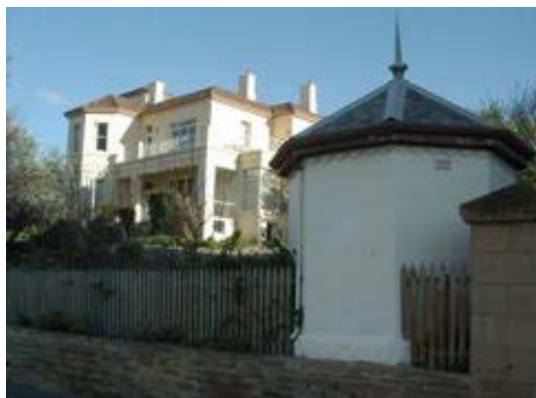
27 Castray Esplanade, Battery Point, Hobart, c.1880

Feature Type: Two storey Victorian Italianate Harbour Master's residence with tide house and separate cottage.

Description: Appears to be purpose-built (documentary and historic photographic evidence for earlier purpose-built Harbour Master's residence in Hobart 1851). A rendered brick typical Victorian Italianate style villa with the addition of an observation tower. The building is set on the former edge of the harbour with expansive views and a close relationship to the shore buildings. The building retains its overall form and much detail but has had numerous changes to accommodate later residential use.

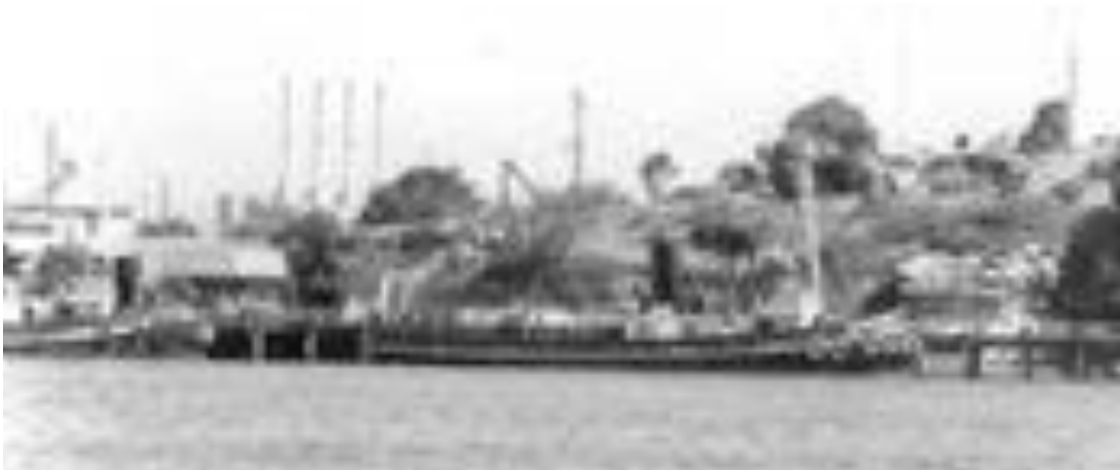
Figure 4.1 The firefloats Boray and Burrowaree moored on north side of Goat Island, 1969 (photo from MSB archives)

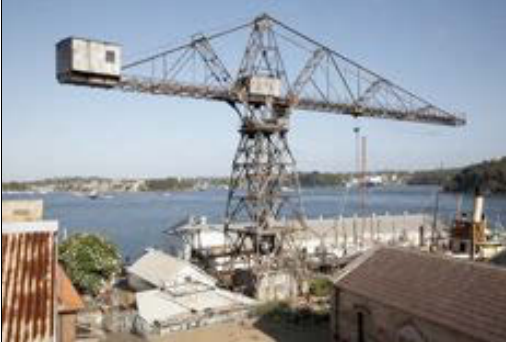
<p><i>Description:</i> 10-ton Hammerhead Crane Goat Island, 1924. Moved to Goat Island in 1963 from Mort’s Dock, Balmain.</p> <p><i>Analysis:</i> An early and prominent crane within Sydney Harbour, still associated with a working shipyard. Historically linked to shipyard.</p>

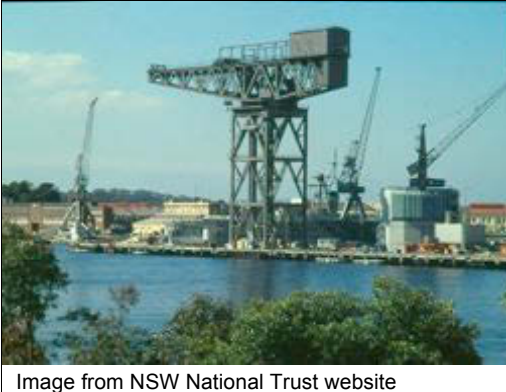
<p data-bbox="240 1937 748 1962">Image from NSW National Trust website</p>	<p><i>Description:</i> 250-ton Hammerhead crane, Garden Island naval dockyard, late 1940s. Retains association with shipyard.</p> <p><i>Analysis:</i> Largest crane in the Southern Hemisphere when built and remains unique in Australia. Landmark in Sydney Harbour. The most prominent crane in Sydney Harbour, and of social significance (active public campaign for preservation). Of national and international significance. Similar cranes on the Clyde River in the UK are heritage-listed.</p>

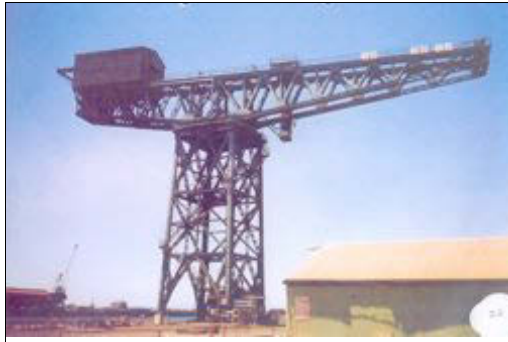
Description: 150-ton Hammerhead crane, Whyalla shipyard, South Australia

Analysis: Australian designed and built crane (Clyde Engineering Co., Granville) date unknown, used at BHP's Whyalla shipyard which operated from the 1930s. The crane was sold in the 1990s. Location unknown.

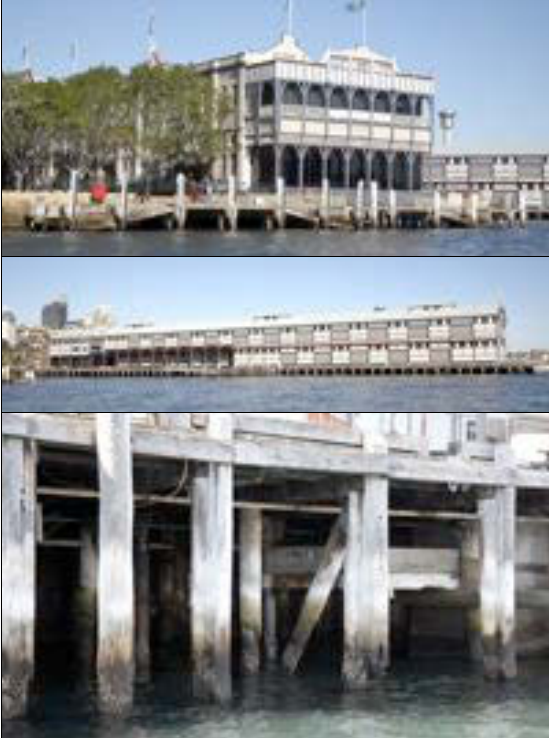
Wharf and location	Analysis
<p data-bbox="240 286 791 331">Walsh Bay wharves</p>

<p data-bbox="791 286 1359 331"><i>Feature Type: Finger and shore wharves</i></p> <p data-bbox="791 331 1359 555">The Walsh Bay wharves (with Woolloomooloo) are the iconic wharves of Sydney. Visually intact and dominating the Millers Point foreshore they are the key defining element of the southern edge of the Harbour. Their significance is well recognised and the extensive re-development has retained much of the original fabric, wharfage and provided for sensitive infill construction.</p> <p data-bbox="791 555 1359 600">They are visible from Goat Island.</p> <p data-bbox="791 600 1359 801">The wharf construction is similar to the Goat Island wharves with the use of piles, raking piles, headstocks and girders, the wharf decks are higher above the water and the wharves are substantially larger. The wharves all have buildings located on them in contrast to the Goat Island wharves.</p> <p data-bbox="791 801 1359 891">These wharves demonstrate the same wharf construction and technology as the wharves on the island and will be retained into the future.</p> <p data-bbox="791 891 1359 981">These wharves were constructed by the Harbour Trust so it is understandable that they are similar other wharves built under their control.</p>

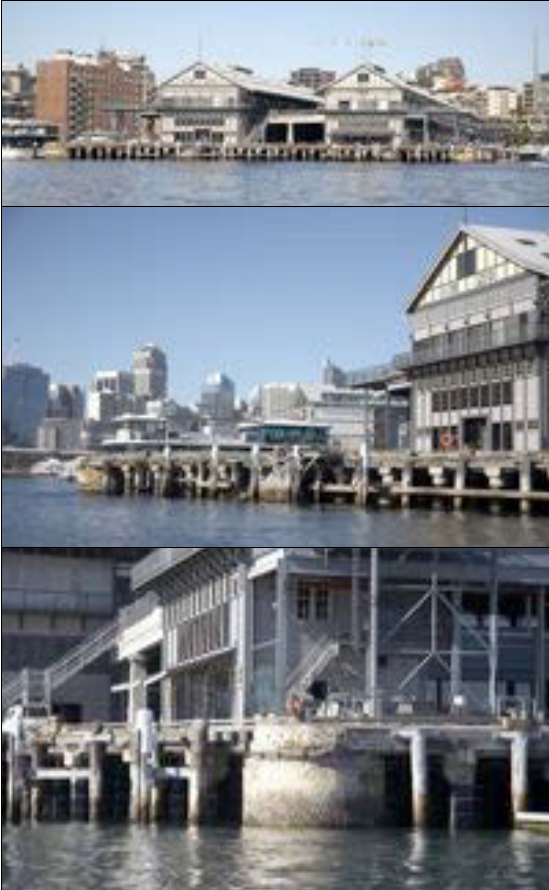
<p data-bbox="240 1075 791 1115">Jones Bay Wharves</p>

<p data-bbox="791 1075 1359 1115"><i>Feature Type: Finger and shore wharves</i></p> <p data-bbox="791 1115 1359 1254">These are the second group of wharves of similar design and construction to Walsh Bay. The same comments apply to this group of wharves in terms of their comparative value to the Goat island wharves.</p>

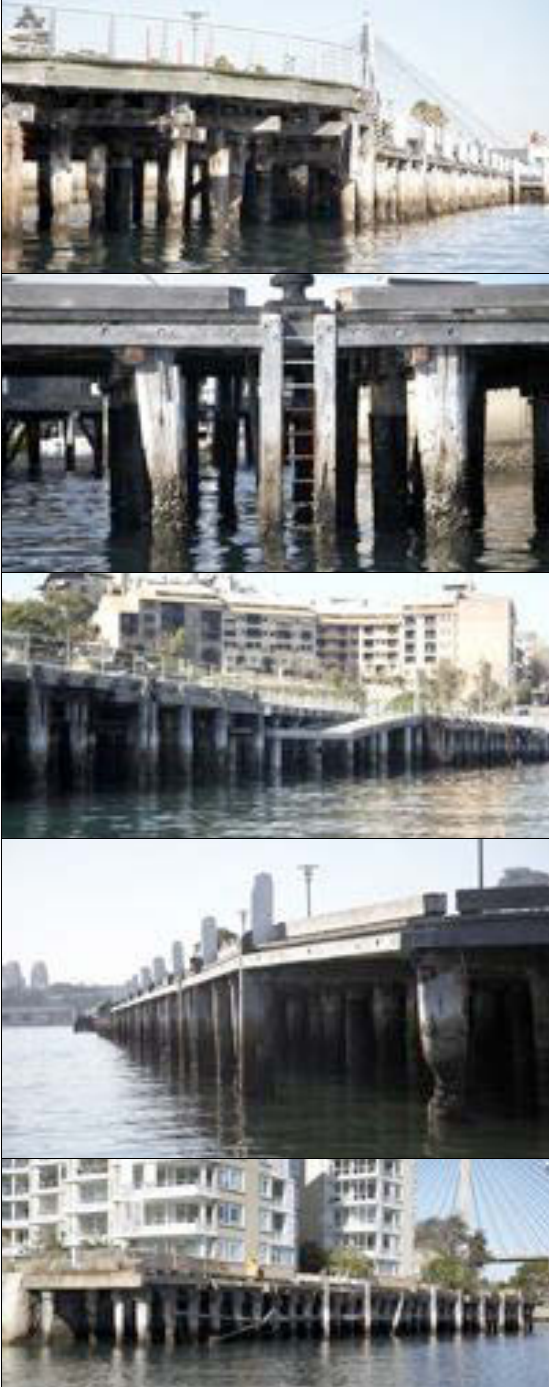
Wharf and location	Analysis
<p data-bbox="240 253 791 286">Johnston's Bay Wharves</p>

<p data-bbox="791 253 1356 286"><i>Feature Type: broadside wharf</i></p> <p data-bbox="791 293 1356 651">This section of wharfing is now detached from its industrial use and the buildings that once fronted the waterfront. The wharves comprise rebuilt and older sections of wharfage that now form a public access area along the former industrial waterfront. They are broadside wharves with the same basic construction as the Goat island wharves and provide a good publicly accessible example of this form of wharf construction. They have lost some of their context, as they are divorced from their setting. They most closely relate to wharves 4a and 4b, which continue to retain their relationship to shore buildings.</p>
<p data-bbox="240 1686 791 1720">Glebe Island Bridge Johnston's Bay</p>

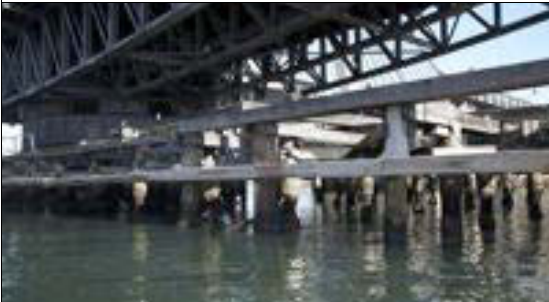
<p data-bbox="791 1686 1356 1720"><i>Feature Type: Skeleton Fenders and Piles</i></p> <p data-bbox="791 1727 1356 1921">The bridge is supported on a massive masonry structure but the guide rails and fenders are of traditional timber wharf construction with piles, baulks, rails and skeleton upper structure. There is no direct correlation with this structure with the elements on Goat island but it is a good example of skeleton style wharf construction.</p>

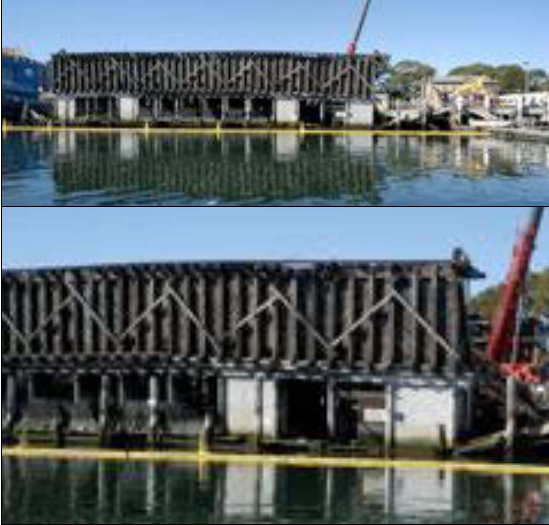
Wharf and location	Analysis
<p data-bbox="252 253 587 282">Blackwattle Coal Loader Wharf</p>

<p data-bbox="802 253 1342 282"><i>Feature Type: Coal Loader and Broadside Wharf.</i></p> <p data-bbox="802 293 1353 539">This structure is the last coal loader to remain in the Harbour and demonstrates the construction and technology of these massive structures. Although a heritage item of potentially State level significance, this structure is being demolished due to its poor condition. The structure is not dissimilar to the structures that would have been located on Goat Island with the final coal loader located on Wharf 5.</p> <p data-bbox="802 551 1353 663">Condition is a major factor in the survival of these structures. After demolition there will be no coal loader structures remaining in the Harbour except in remnant form.</p> <p data-bbox="802 674 1353 786">Detail of the superstructure and the timber wharf under. At the time of this photo the whole of the structure was being demolished as the water edge piles and structure above had collapsed.</p>

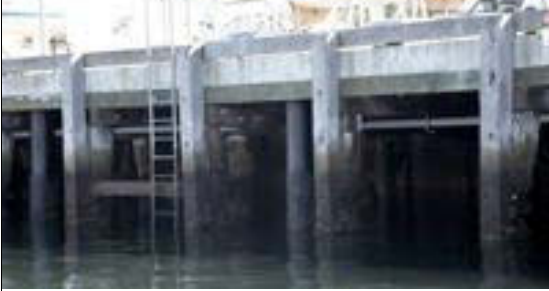
<p data-bbox="252 826 671 855">Blackwattle Bay Cement Loader Wharf</p>

<p data-bbox="802 826 1294 855"><i>Feature Type: Broadside and finger wharves.</i></p> <p data-bbox="802 866 1353 1057">A timber pile wharf of standard construction with a recent concrete superstructure. It has square timber fenders, raking piers and extensive repairs. The construction date of the wharf is not known. This wharf is of interest as it is one of the very few surviving operating maritime wharves in the Harbour that is not a broadside container wharf.</p> <p data-bbox="802 1068 1353 1202">It has some comparison with wharves 4a and b at Goat Island, which is an operating maritime wharf, however it is more heavily adapted with a concrete top. It is an important and distinctive element in Blackwattle Bay.</p>
<p data-bbox="252 1229 635 1258">Blackwattle Bay Commercial Wharf</p>

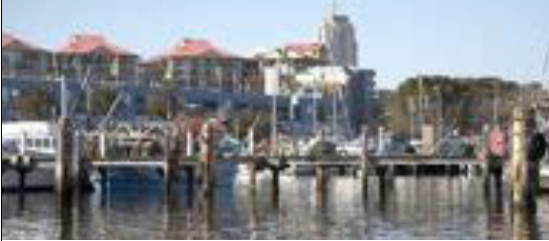
<p data-bbox="802 1229 1018 1258"><i>Feature Type: Pier.</i></p> <p data-bbox="802 1270 1353 1570">This is a minor access wharf for small boat moorage using commercial wharf construction techniques but not of the same scale as any of the wharves at Goat island with the exception of the boat pens. It is one of a small number of more traditional timber wharves that remain in the Harbour for commercial (in contrast to pleasure) mooring. The wharf does not relate to the wharves on Goat island although it is part of the dwindling number of commercial wharves in the Harbour.</p>

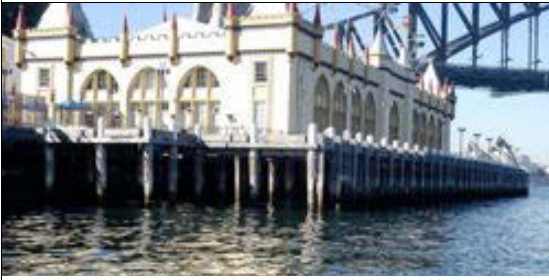
<p data-bbox="252 1588 608 1617">Luna Park (Lavender Bay) Wharf</p>

<p data-bbox="802 1588 1150 1617"><i>Feature Type: Broadside Wharf</i></p> <p data-bbox="802 1628 1353 1818">This is a long-standing wharf with an important history in a highly visible location attached to an icon structure. It is an excellent example of broadside wharfing but is not and was not designed as a maritime working wharf. It is one of the last broadside wharves to accommodate a substantial building that is maritime based.</p> <p data-bbox="802 1830 1353 1886">While a comparable broadside wharf in terms of construction it is dissimilar in terms of use.</p> <p data-bbox="802 1897 1353 1977">The detailed photo shows piles and later pairs of headstocks. Steel diagonal bracing is also used. The wharf shows many types of repairs.</p>

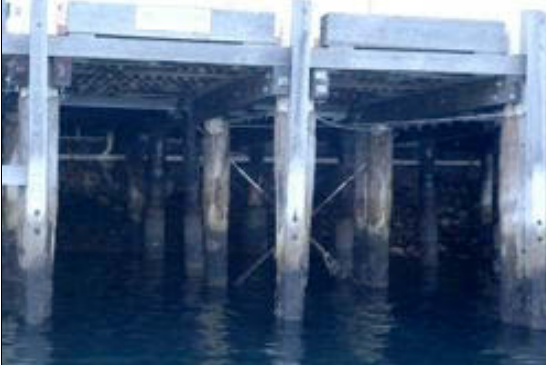
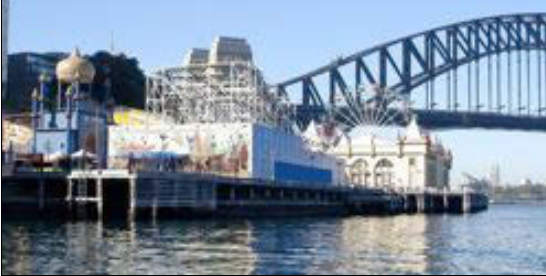
<p>This photo shows the two wharf sections supporting buildings and structures at Luna Park.</p>
<p data-bbox="240 904 788 943">Berry's Bay (Waverton Park) Public Wharf</p>

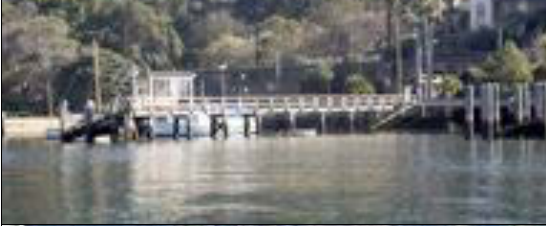
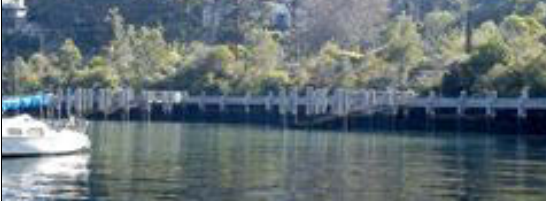
<p data-bbox="799 904 1351 943"><i>Feature Type: Public Wharf and Boardwalk</i></p> <p data-bbox="799 949 1351 1137">This is a relatively new wharf structure in two parts, one accommodating the ferry set on slightly raked piers with cross bracing, the shore wharf uses traditional timber wharf technology for a public accessway. It is a well-designed wharf but does not relate to the wharves at Goat Island, which have a history of maritime use.</p>
<p data-bbox="240 1379 788 1417">Berry's Bay Commercial Wharf</p>

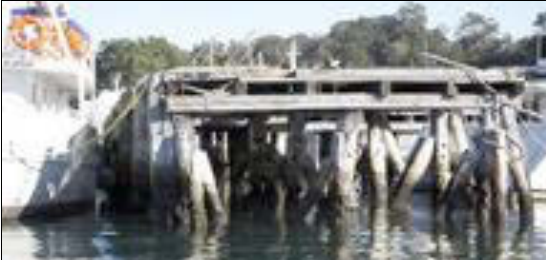
<p data-bbox="799 1379 1351 1417"><i>Feature Type: Commercial Finger type wharf.</i></p> <p data-bbox="799 1424 1351 1532">This wharf is more closely related to wharves 4a and 5 with their freestanding character, the use of raking piles and the general structure. It is also in relatively poor condition but still operational.</p>

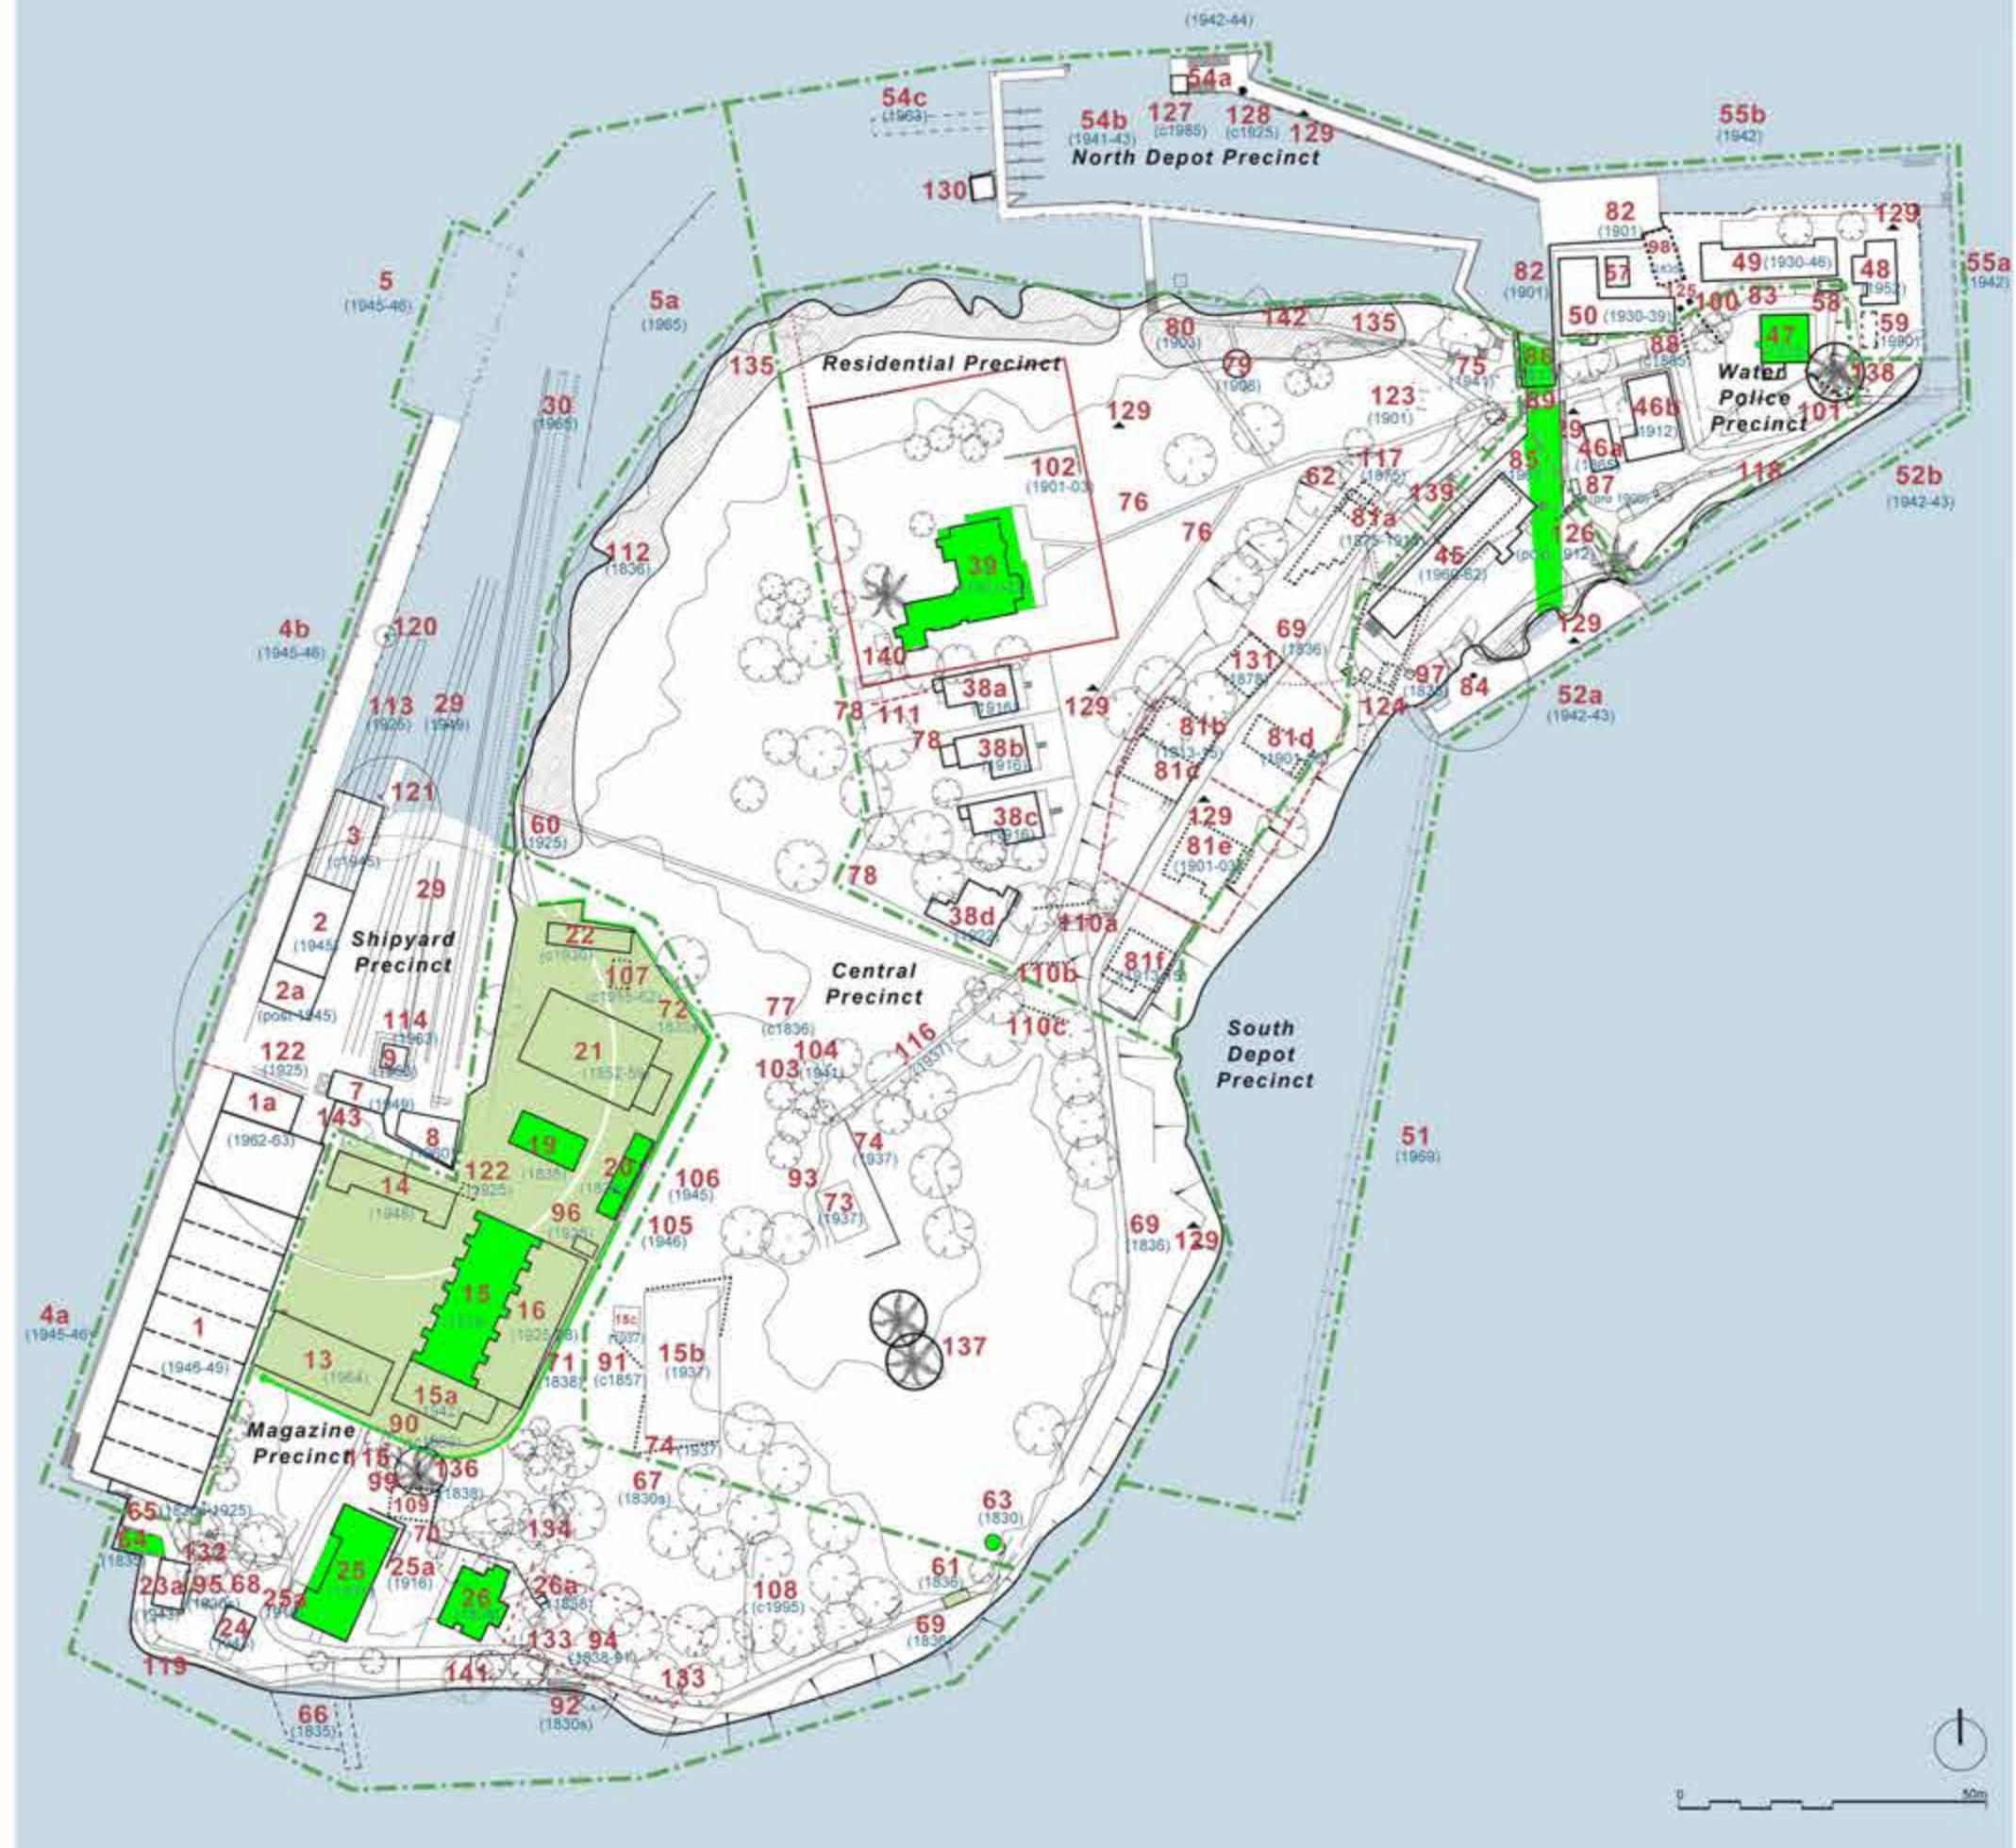
Figure 5.1 Goat Island Plan identifying features of Exceptional Significance

Built Items - Dark Green
 Archaeological Sites and Landscape Features - Light Green

- Figure 5.1 Features of exceptional significance - elements coloured green (archaeological and landscape items light green)
- Figure 5.2 Features of high significance - elements coloured pink (archaeological and landscape items light pink)
- Figure 5.3 Features of moderate significance - elements coloured yellow (archaeological and landscape items light yellow)
- Figure 5.4 Features of little significance - elements coloured blue - and features that are intrusive - elements coloured purple (archaeological and landscape items light blue)
- Figure 5.5 Goat Island Archaeological zoning plan
- Figure 5.6 Views of exceptional and high significance

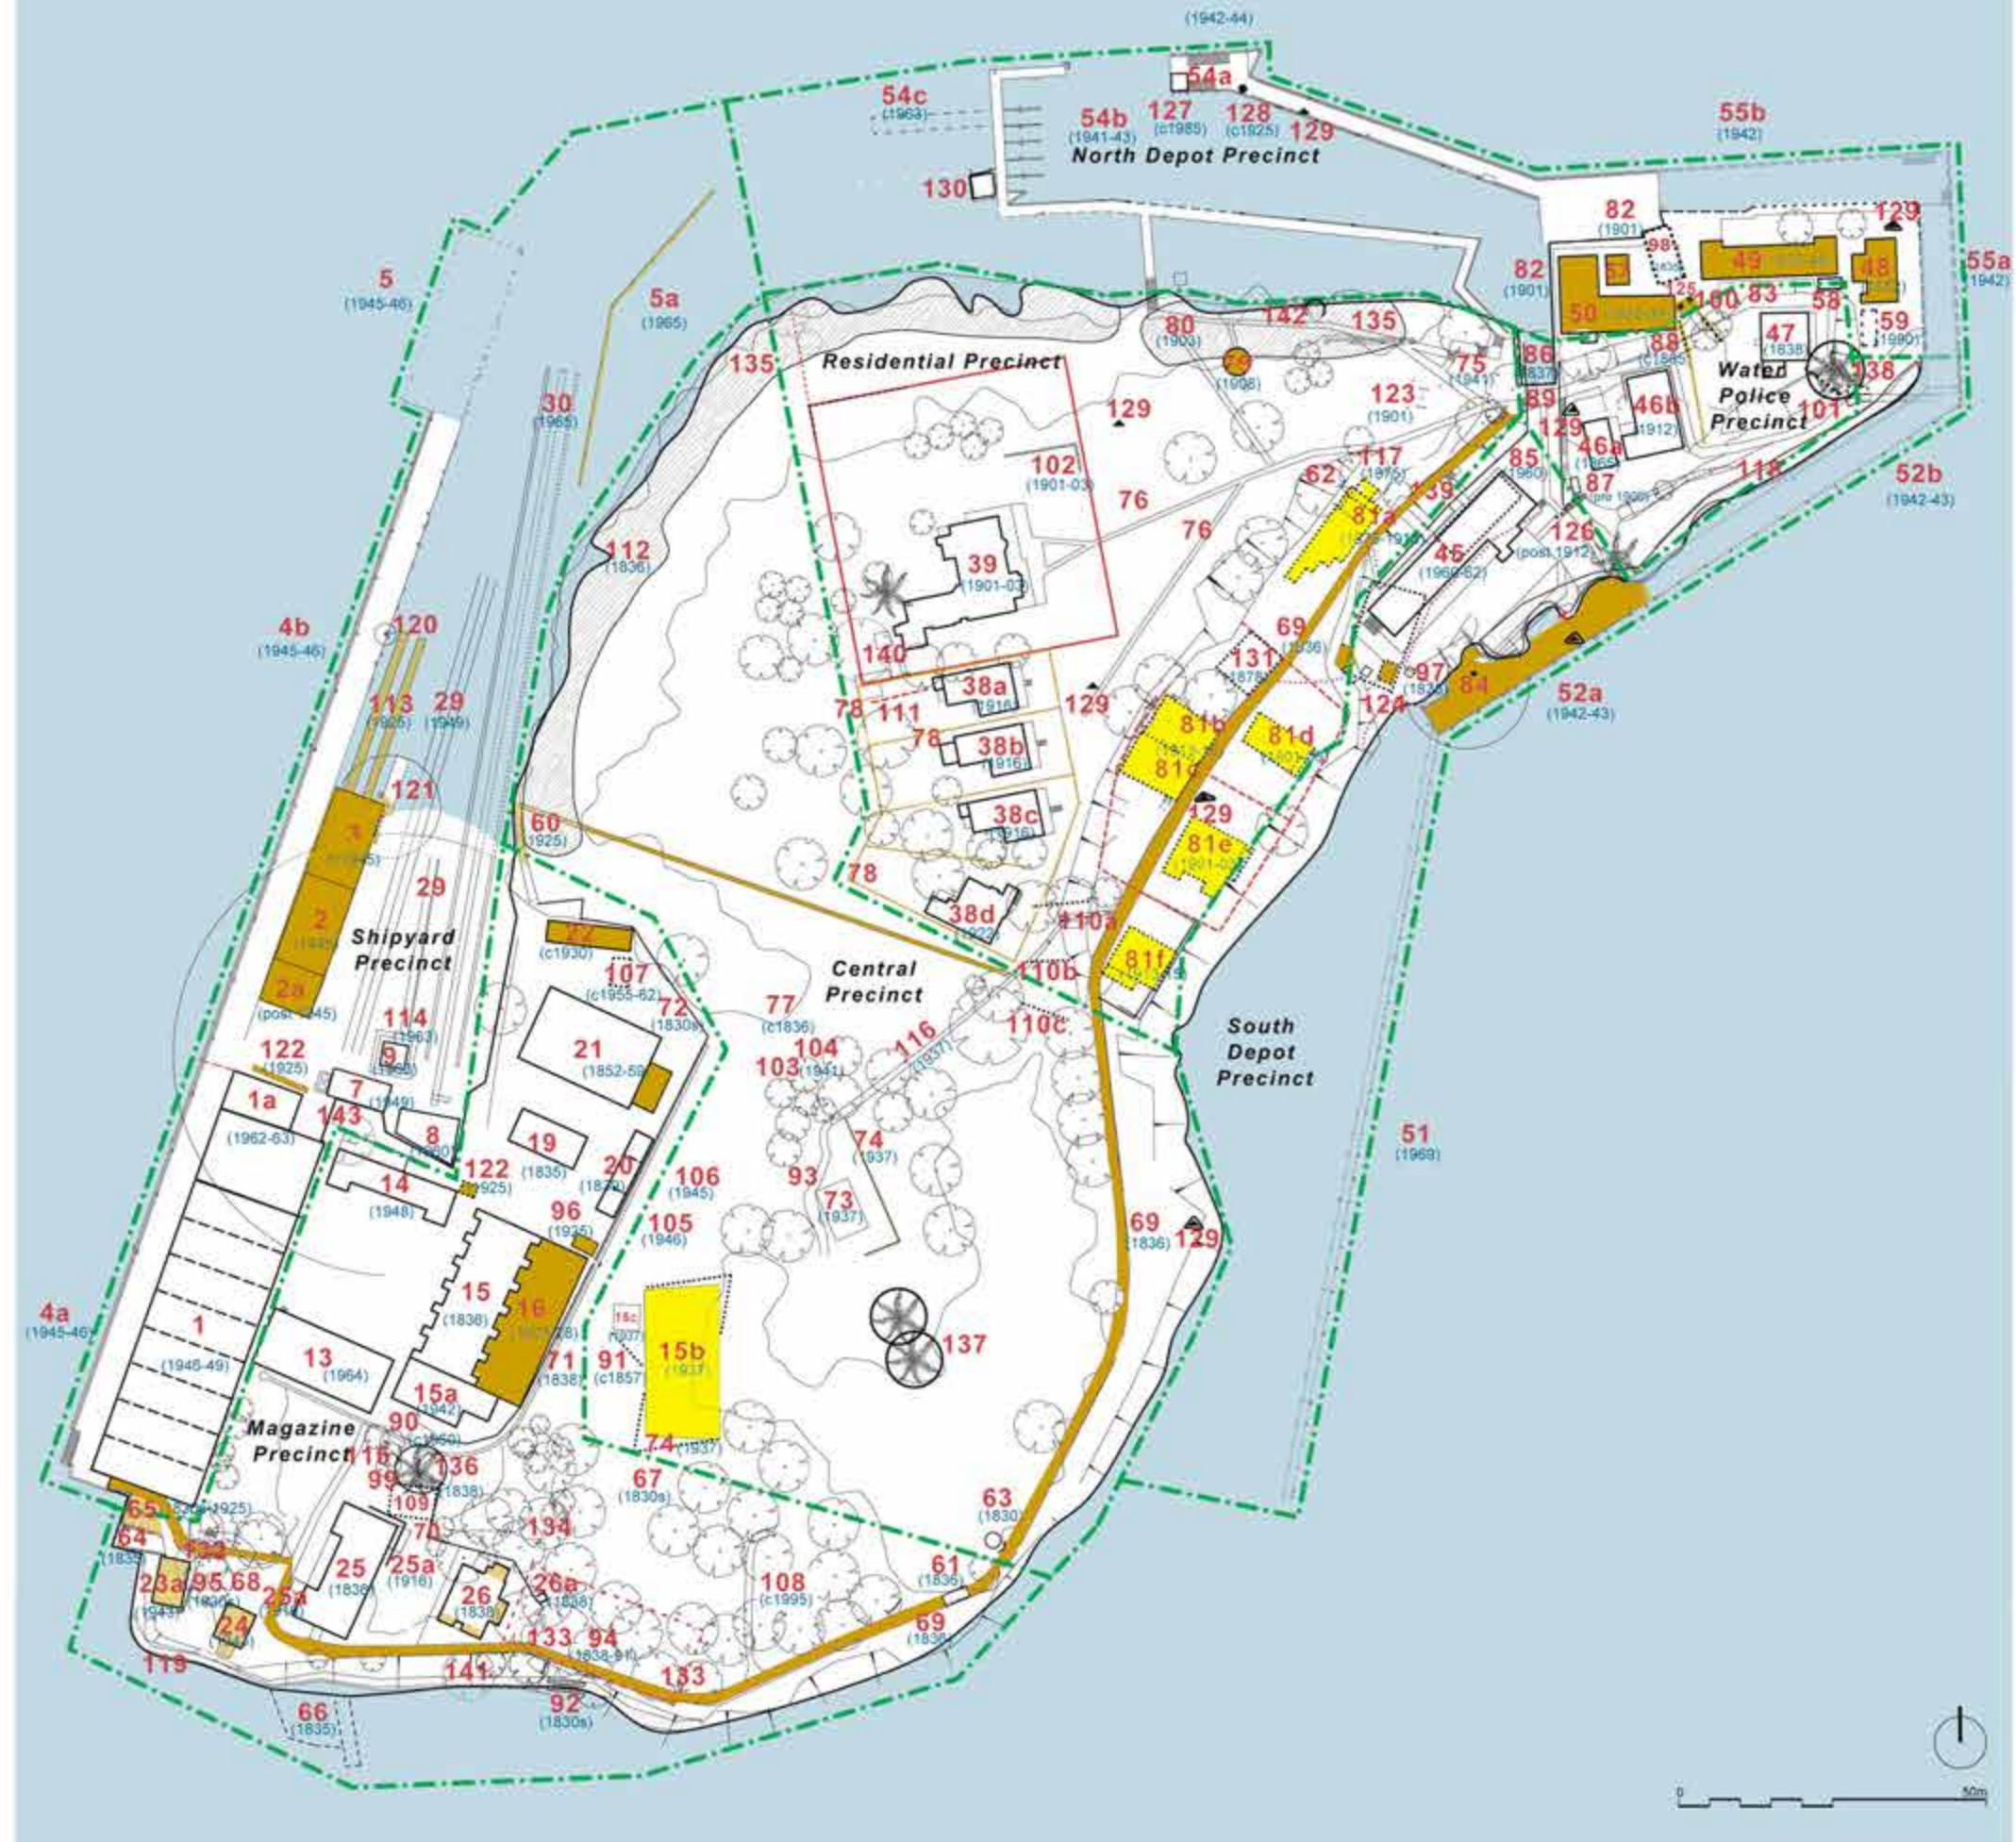
Figure 5.3 Goat Island Plan identifying features of Moderate Significance

Built Items - Dark Yellow
 Archaeological Sites and Landscape Features - Light Yellow
