**FORMER KINCHEGA STATION SITES • KINCHEGA NATIONAL PARK
CONSERVATION MANAGEMENT & CULTURAL TOURISM PLAN
VOLUME 1 • THE PLAN**

PREPARED FOR THE
NSW NATIONAL PARKS & WILDLIFE SERVICE
BY:
PETER FREEMAN PTY LTD
CONSERVATION ARCHITECTS & PLANNERS
CONSULTANT TEAM

FINAL
SEPTEMBER 2002

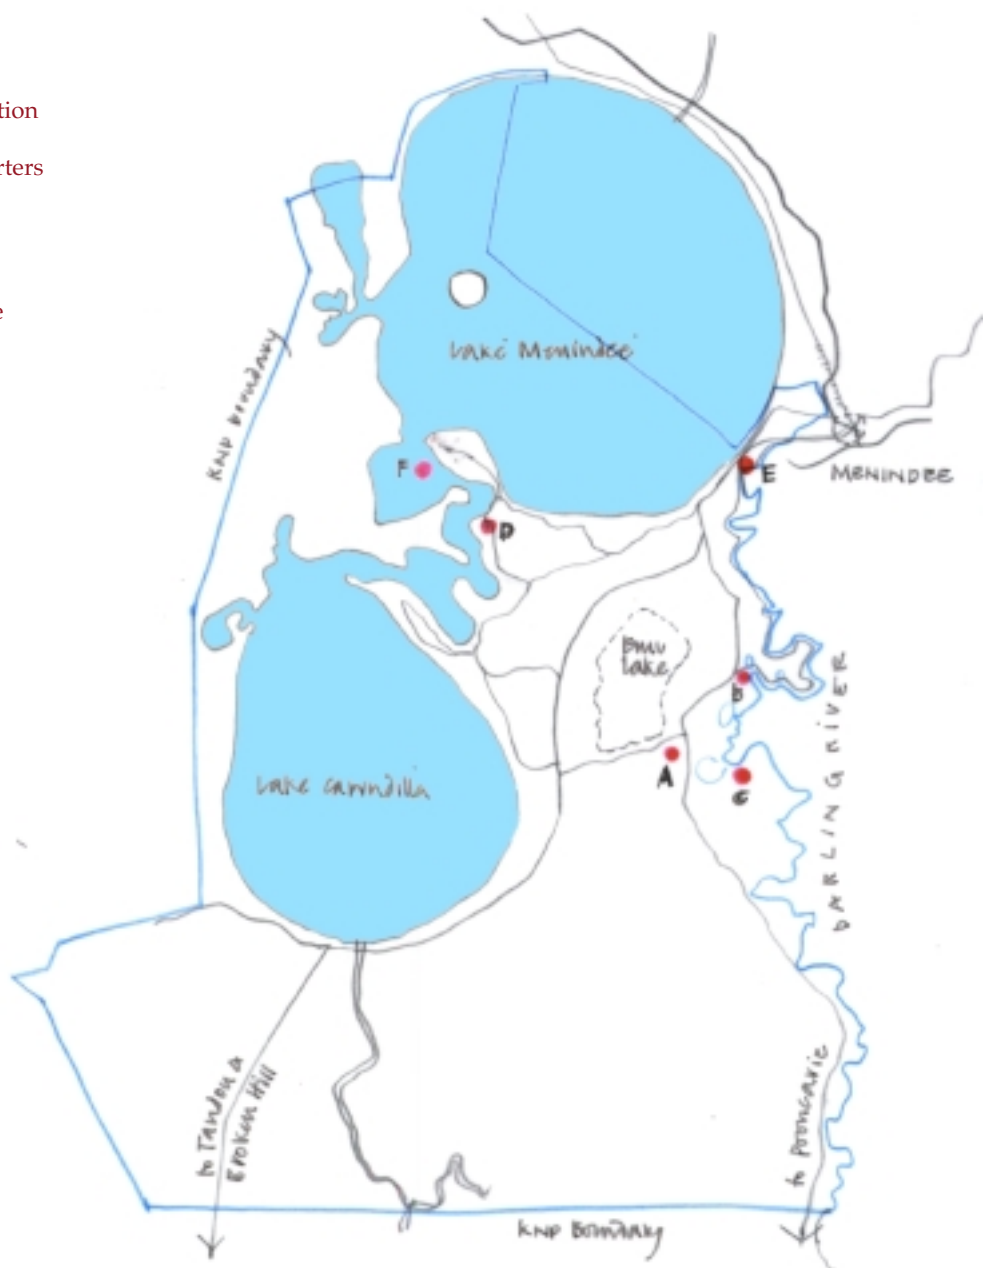
Figure 3
The Kinchege National Park Station Sites
A: Woolshed and Shearers' Quarters
B: Homestead[s] and Billabong
C: Woolshed Wharf and Related Precincts
D: Morton Boulka Picnic Area
E: Regulator & Menindee Bridge
F: Stockyards
PF 2001 Plan

As a result of Analysis completed as part of this Plan, an earlier Kinchege Homestead site has now been identified; and is considered as part of this Plan. Refer **Figure 3** below for location of these precincts.

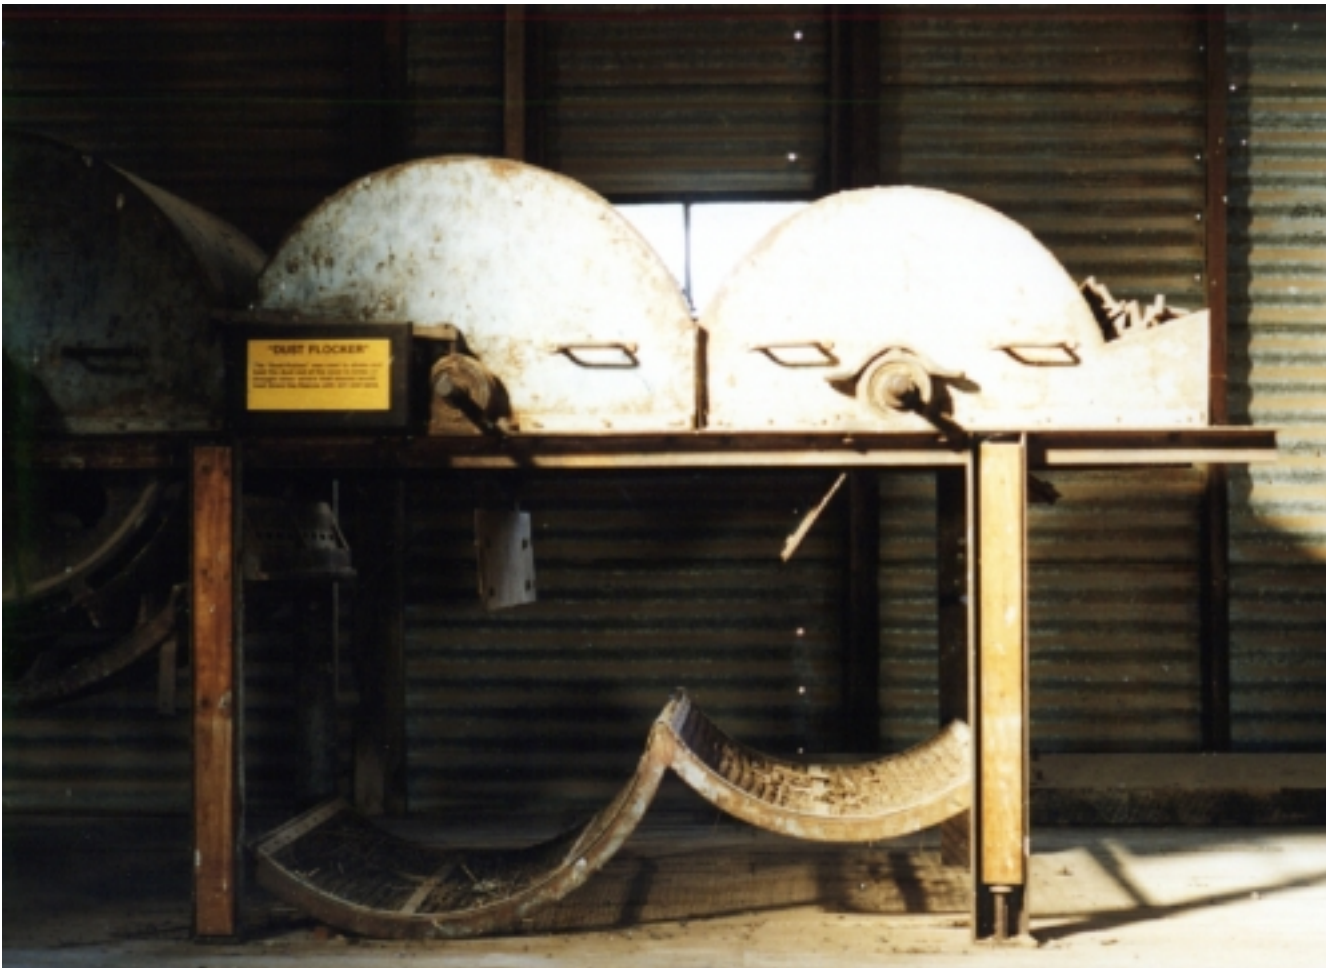
Figure 14
The dust flocker in the Kincheha
woolshed. This machine was used to
extract sand particles from the wool.
PF 2001 photograph

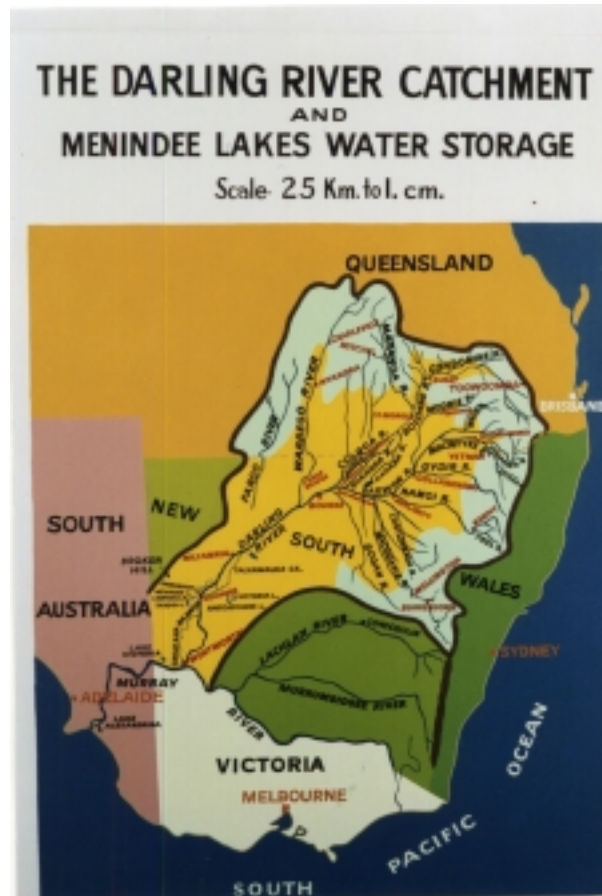
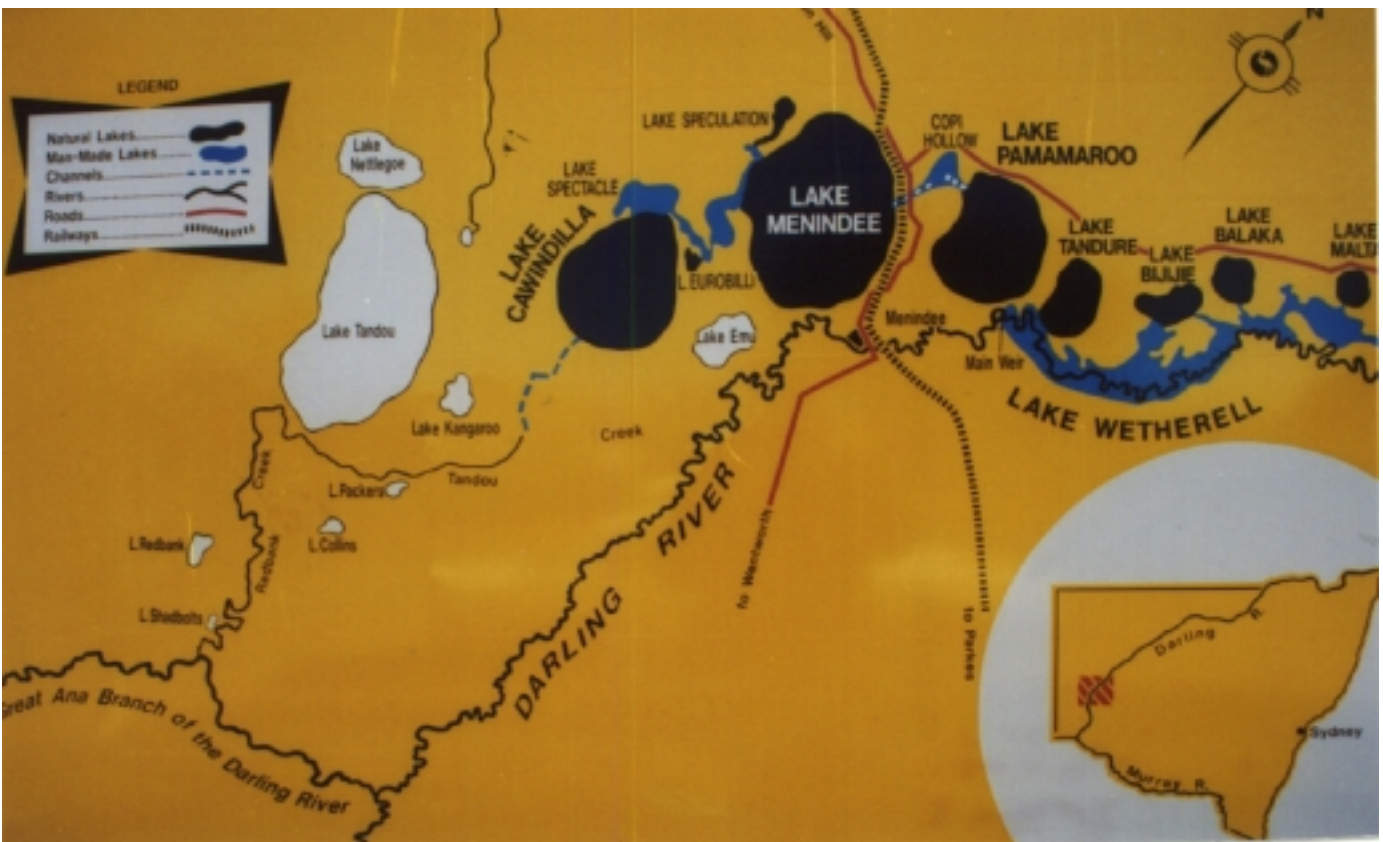
Figures 18, 19 & 20
 The Darling River catchment and
 Menindee Lakes water storage.
 The Menindee Lakes water storage
 scheme.
 Chart showing evaporation within
 the Menindee Lakes water storage
 scheme.
*Water Resources Commission
 [later DLWC] charts.
 DLWC Menindee*

EVAPORATION						
Megalitres (mm)						
LAKE	JANUARY	FEBRUARY	MARCH	APRIL	MAY	JUNE
WETHERELL	1077	1179	897	470	268	191
PAMAMAROO	531	502	338	228	132	93
WONGABEE	1277	1335	812	545	316	223
CANNINDILLA	683	737	433	294	169	120
TOTAL	3568	3853	2280	1540	886	627

EVAPORATION						
Megalitres (mm)						
LAKE	JULY	AUGUST	SEPTEMBER	OCTOBER	NOVEMBER	DECEMBER
WETHERELL	1518	328	543	697	940	1020
PAMAMAROO	86	159	264	338	450	487
MENINDEE	252	382	634	812	1096	1160
CANNINDILLA	125	203	330	436	587	622
TOTAL	650	1072	1771	2283	3061	3209

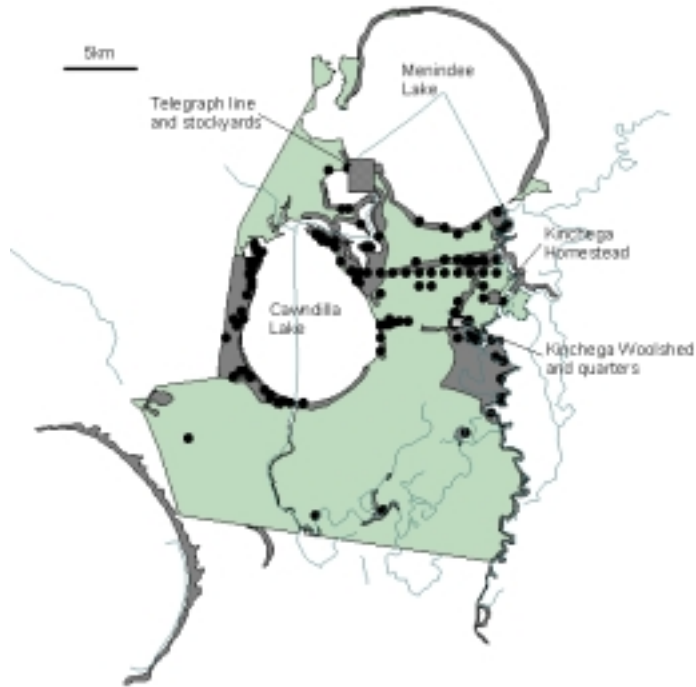
Figure 2
 Aboriginal archaeological sites within the Homestead and Woolshed Groups
 SMT 2001 plan

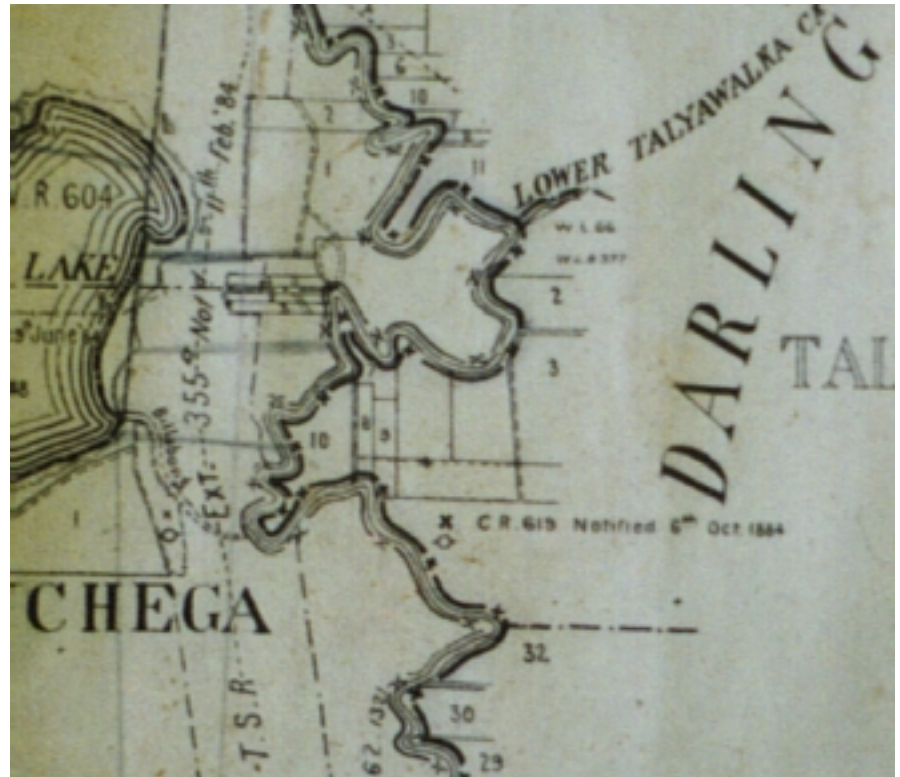
Figure 3
Kinchega Pastoral Station. Parish
map, 1911 [detail].
AONSW, Sydney

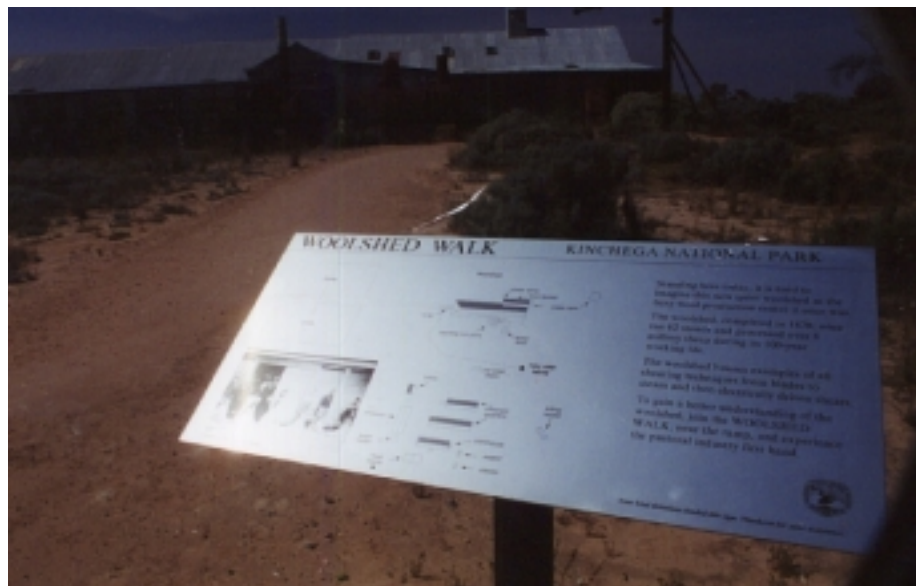
Figure 11
Woolshed Walk, the NPWS sign.
BN 2001 photograph

Flanked by recycling bins and the old toilets on its left, the path to the woolshed begins. The first thing on it is another 'donations' box. A few metres further on, a photo-etched aluminium panel introduces 'The Woolshed Walk'. It shows a plan of the woolshed precinct identifying the sheep yards, ramp, counting out pens, sheep spray, dust flocker, two water tanks, 'you are here' and the path of the recommended walk.

The panel also identifies the 'old toilet block', the shearers' quarters, cookhouse, toilets, showers, meat house, 'expert', 'classer', and killing shed. It displays an historic photograph of shearers with blade shears at Kinchega '...c1880'. A brief text gives the date of the building's completion as 1870, the maximum number of stands at peak operation, and the total number of sheep shorn there. It also states '*...The woolshed houses examples of all shearing techniques...*' It promises that the Woolshed Walk will give visitors a better understanding of the woolshed and enable them to '*experience the pastoral industry first hand*'. Finally, this sign thanks the visitor for the 'kind donation' that 'funded' it.

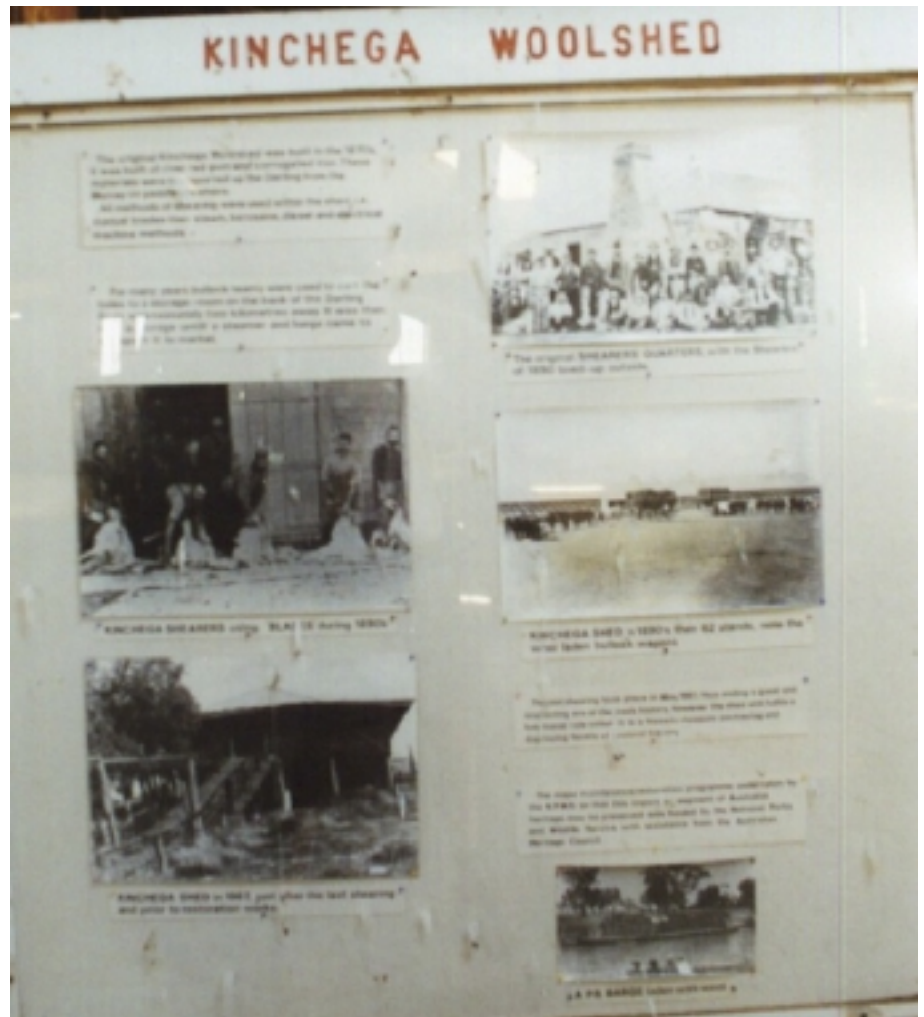
Figure 15
In the woolshed...an early interpretative panel. This panel is mounted high up within the shed and is difficult to read.
BN 2001 photograph

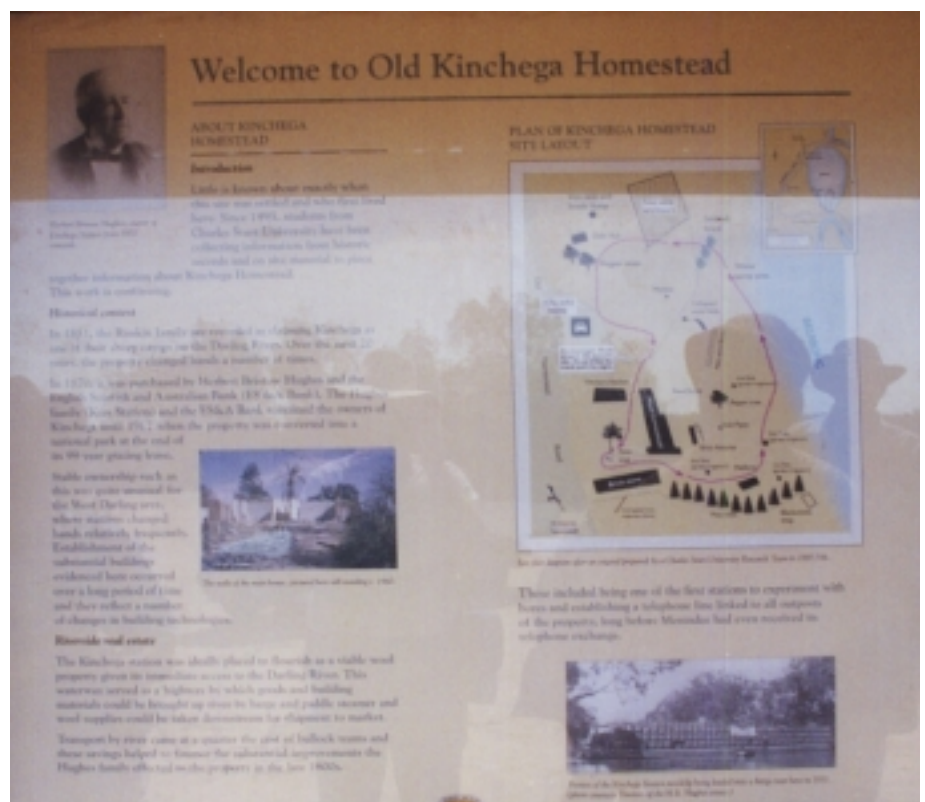
Figure 18
 Old Kinchega Homestead
 introduction panel
 BN 2001 photograph

The second column of this panel displays a large map entitled 'Plan of the Kinchega Homestead Site Layout' and captioned, 'Site plan diagram ...'. It identifies 'you are here' and various site features and landmarks and recommends a route for the 'Homestead Walk', asking visitors to follow the track and signs. A smaller inset map locates the site in

relation to Park roads and outlying features: the Cemetery, Wool Barge and Old Regulator. At the bottom of this column is a period photograph showing *'Portion of the Kinchege wool clip being loaded on a barge ...'*

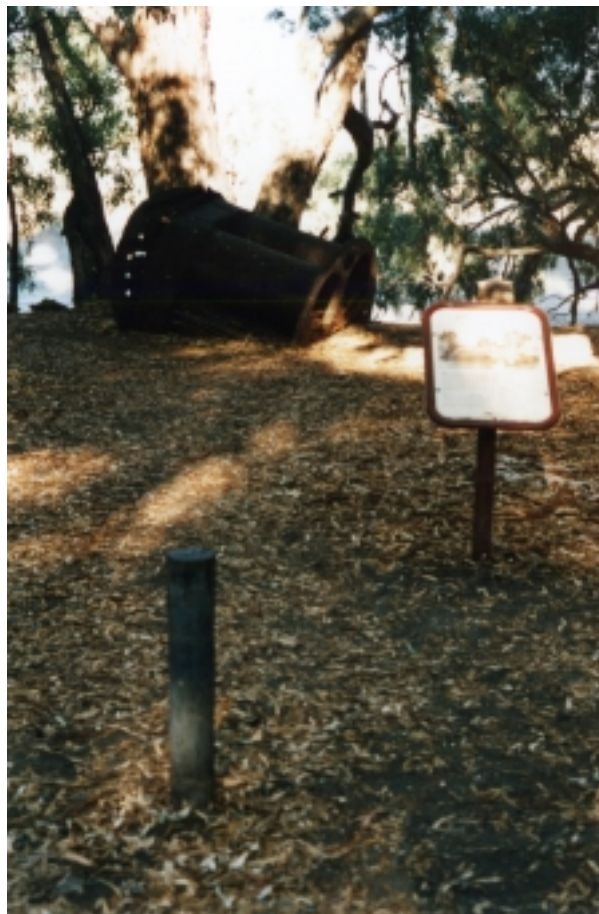
Figure 24
The *Providence* boiler.
PF 2001 photograph

Beside the 'Homestead Loop' of River Drive, the PS *Providence* boiler lies, partially buried, near the river bank. As noted, it is mentioned at some length and its location is identified in the *Visitor Guide*. The portions of the boiler exposed to the atmosphere, the elements and

public view are visibly deteriorating. The boiler is interpreted by a sign, devised by the Shire of Central Darling and of the same design as their Woolshed and Homestead signs. Unlike these other signs, however, the text of the Boiler sign contains unintentionally amusing errors in grammar and syntax. The name of the Chinese cook may be misspelled. The sign does not consider the possibility that the explosion was due to equipment failure rather than human error. The *Adelaide Observer's* colourful account of the tragedy which could usefully be cited verbatim is not referred to. This sign is illustrated with a period photograph of a paddle steamer on the river.

The condition of the boiler should be evaluated by a metals conservator and any recommended treatment undertaken to ensure its stability. It ought to be evaluated from the point of view of public health and safety and appropriate measures adopted to reduce Service liability. The text of the boiler sign should be expanded and redrafted to reflect recent thinking on the accident and, if possible, to point out evidence of the alleged design flaw on the thing itself. A new sign should be designed and installed to replace the existing one.

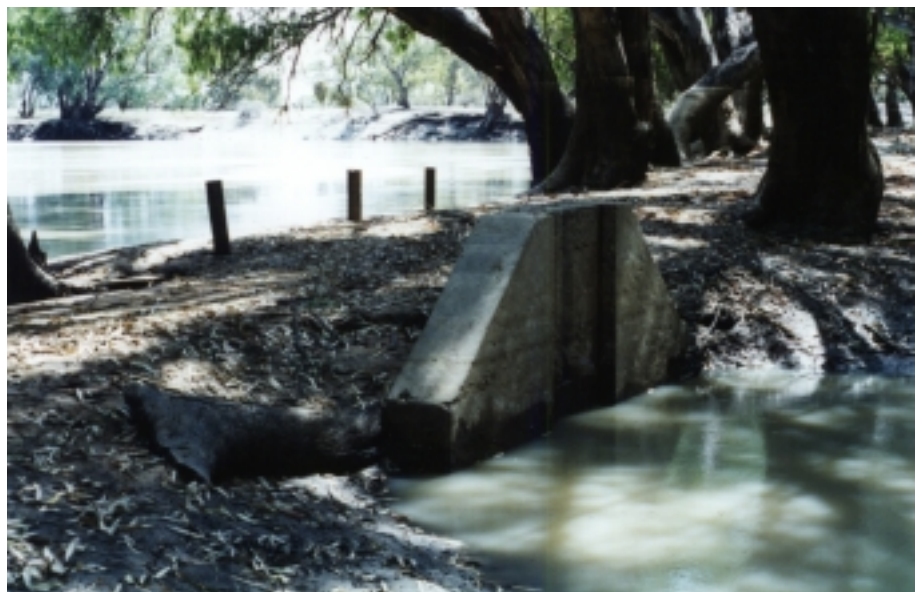
Figure 25
The Homestead Billabong Regulator.
PF 2001 photograph

The Billabong Regulator should be interpreted on-site. The existing, stored sign is, like the others of its family, awkwardly phrased. Its title is, perhaps misleading, as in this case, it is the water level of the Billabong, **not** that of the Darling River that is being regulated.

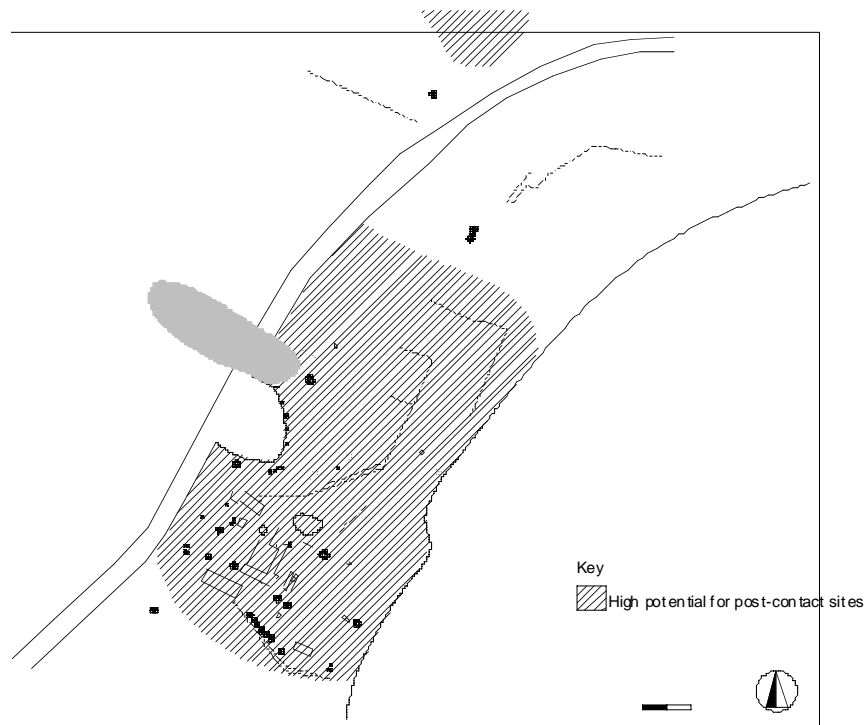
Figure 2
 This plan describes the areas of highest potential to contain sub surface archaeological material relating to the post contact period
SMT 2001 plan

The potential of this precinct to contain pre-contact Aboriginal deposits is illustrated by **Figure 2**. It is clear that the area immediately surrounding the homestead is likely to have been disturbed by day to day activities associated with the operation of the Station and that the greatest potential for intact pre contact deposits exist the further one moves from the homestead. Of particular interest is the dune already cut by the existing Homestead Drive and from which Aboriginal burials have already emerged.

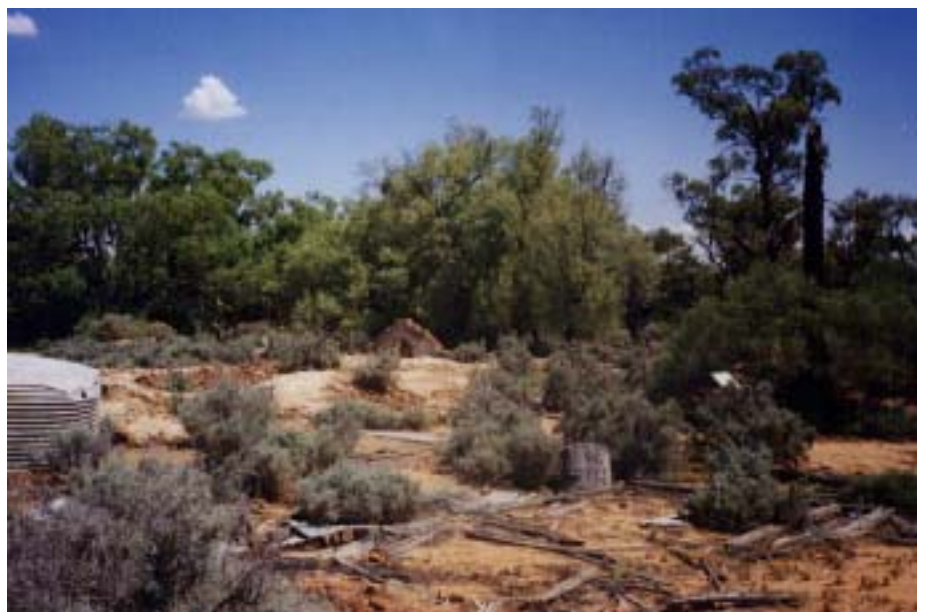
Figure 2

Athel pines behind the old chimney and some of the building materials that have become important habitat for a range of lizard species. The Homestead No. 2 is on the edge of the sand dune country, with the characteristic bluebush, and the floodplain country beyond characterised by taller black box and river red gum communities.
RT photograph 2001

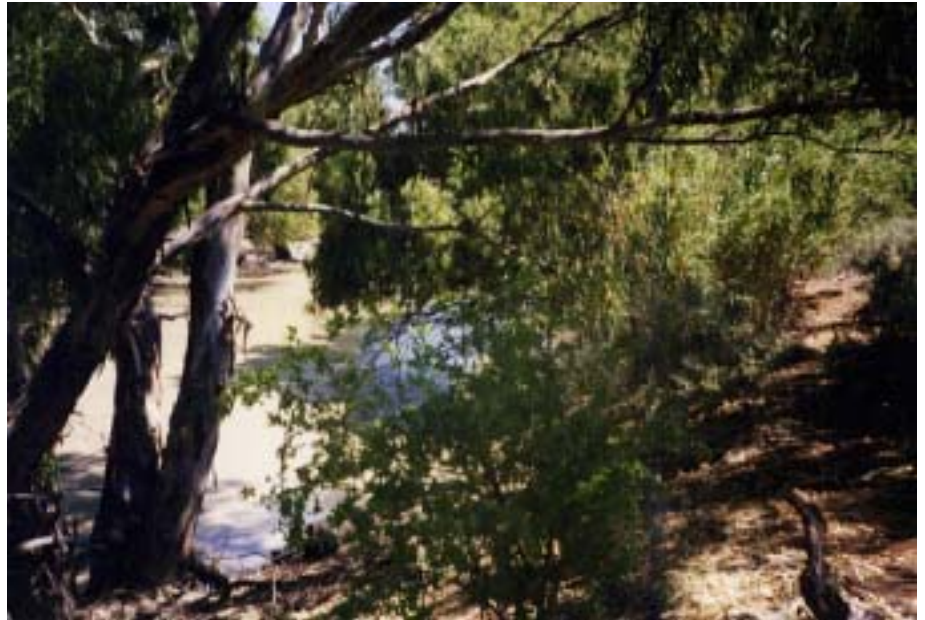
Figure 3
Box thorn in the foreground and bamboo behind, encroaching on the river red gum community along the homestead billabong.
RT photograph 2001

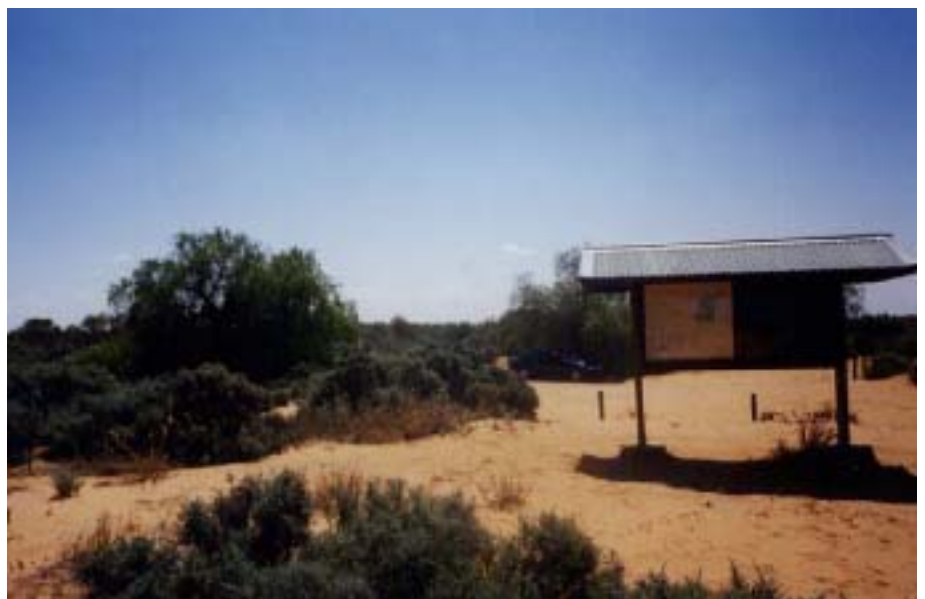
Figure 4
The impact of visitor use at the site in terms of soil disturbance and erosion. Note the pepper trees spreading into the bluebush country.
RT photograph 2001

stable, any significant increase in public usage would require some control of visitor movement to avoid damage to vegetation. Clearly defined tracks around the site could be established between interpretative points. The River Drive, particularly from the Regulator to the *Providence* boiler, is in fair condition; however there are also potential erosion problems at the Regulator and at the entrance points of billabongs which require monitoring and maintenance.

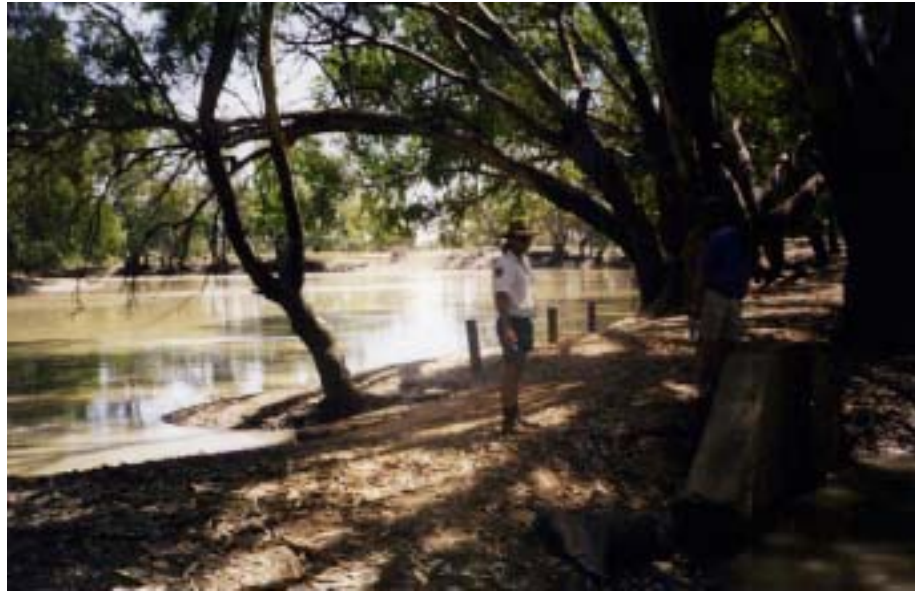
Figure 5
The regulator where the homestead billabong meets the Darling River. River red gum forests follow the river.
RT photograph 2001

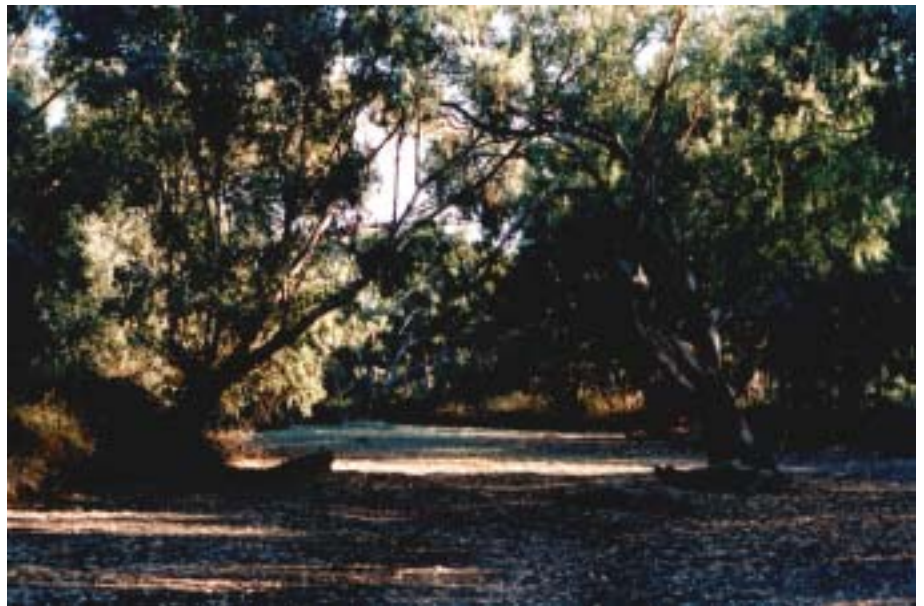
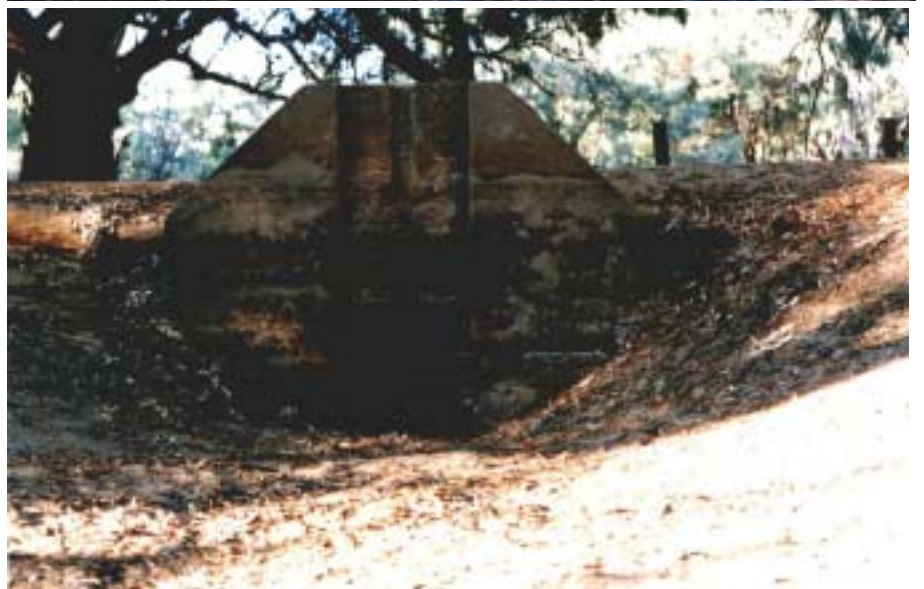
Figures 14 & 15
The Billabong and the Billabong
Regulator, **May 2001**
PF 2001 photographs

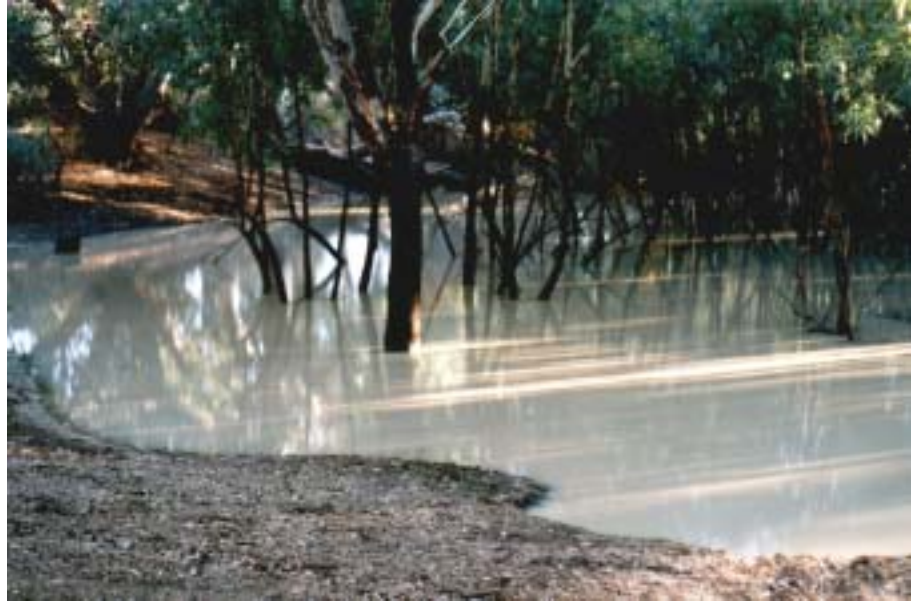
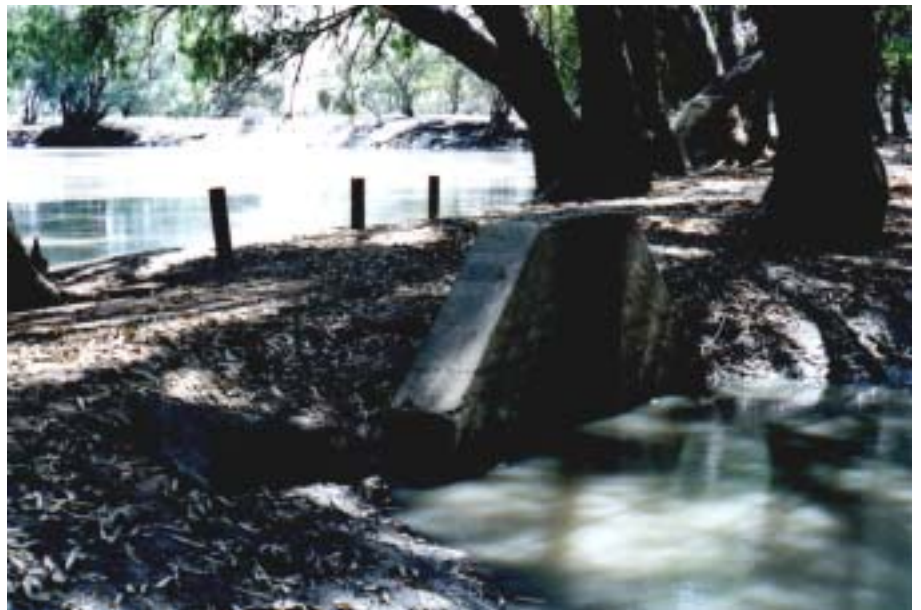
Figures 16 & 17
The Billabong and the Billabong
Regulator, **January 2001**
PF 2001 photographs

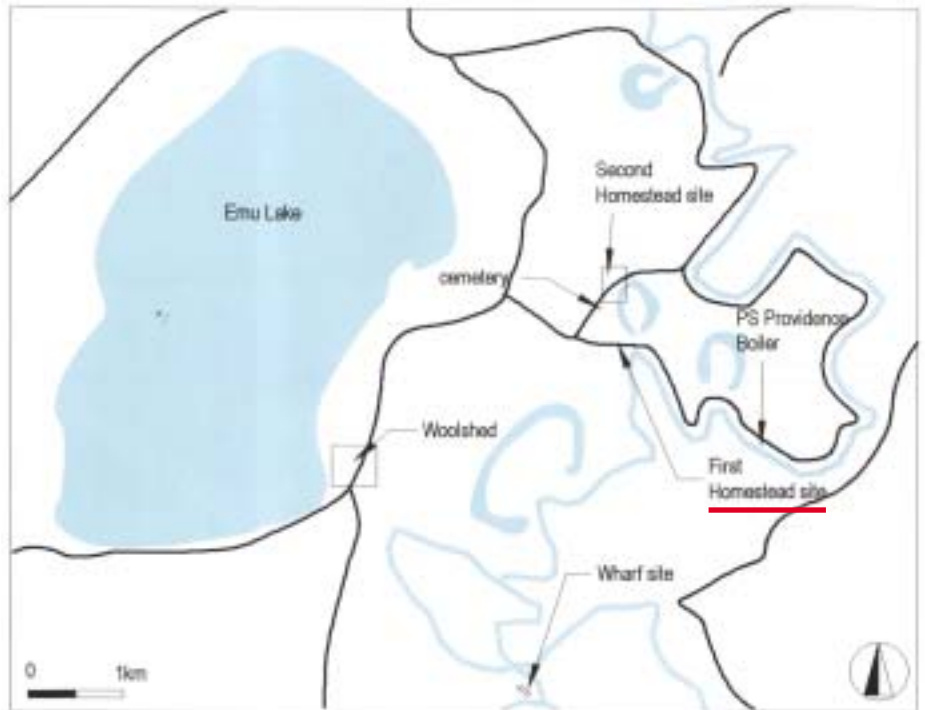
Figure 22
Location of Homestead No. 1 site
SMT 2001 plan

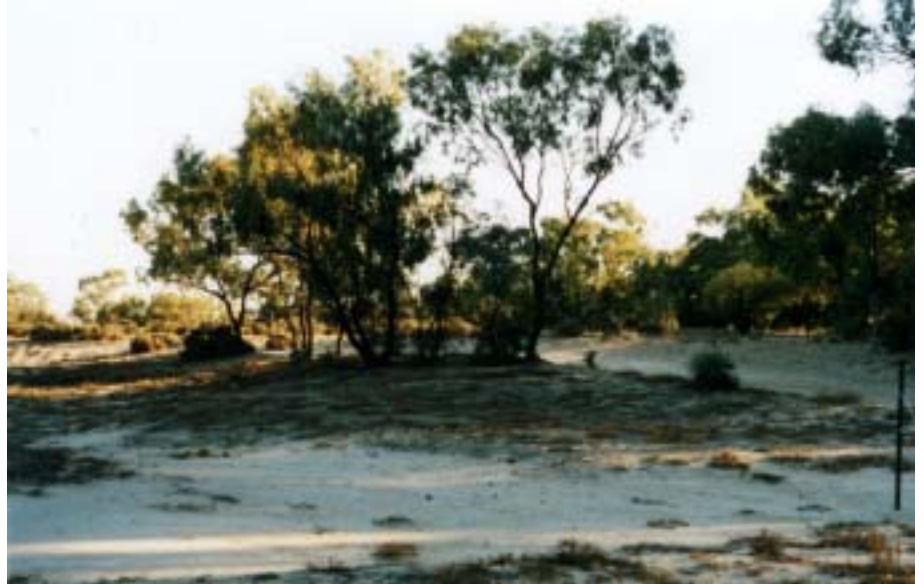
The Homestead No. 1 site is in poor condition. Roadworks have presumably diminished the integrity of the site to a large degree and a proper archaeological survey would be required to determine the extent of the historic remains.

Figure 23
Homestead No. 1 site.
The NPWS road is at right.
PF 2001 photograph

The homestead is an archaeological site. There are no standing features and the site could only be interpreted with any degree of accuracy after archaeological investigation. There may be *in situ* foundations below surface level. The road could be diverted around the building rubble possibly to the north. However given the sensitivity of this area the proposed road deviation should be subsurface tested prior to development.

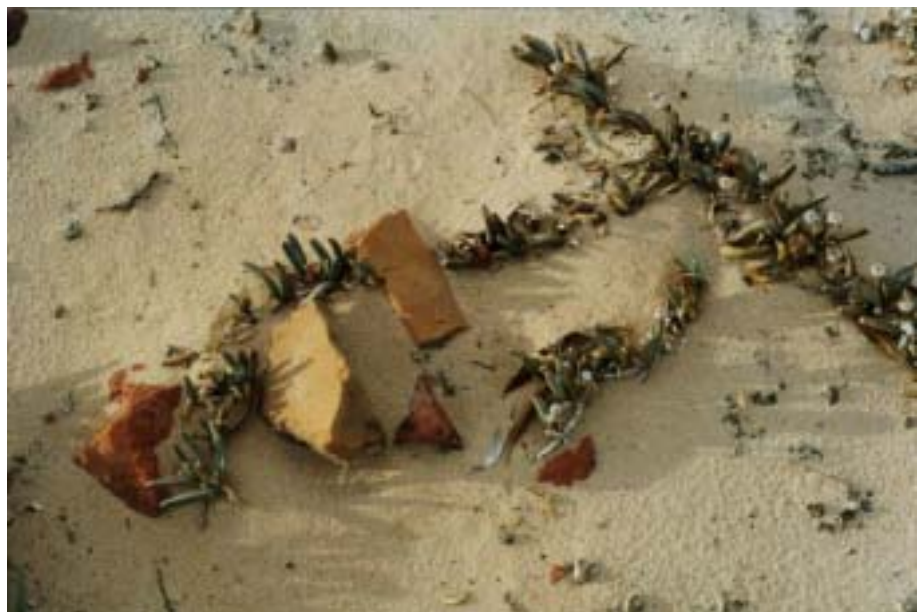
Figure 25
Detail of brick scatter.
PF 2001 photograph

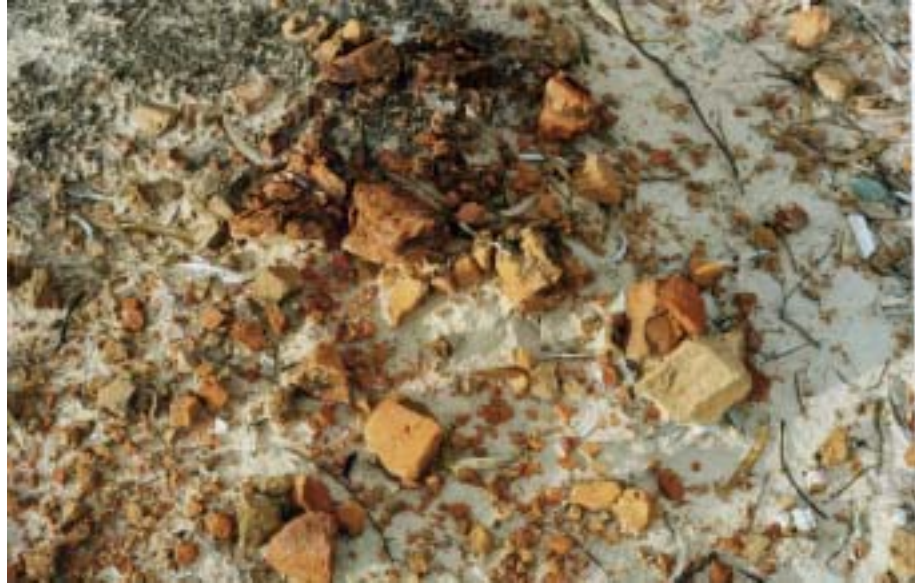
Figure 26
Homestead No. 1 site, brick scatter.
PF 2001 photograph

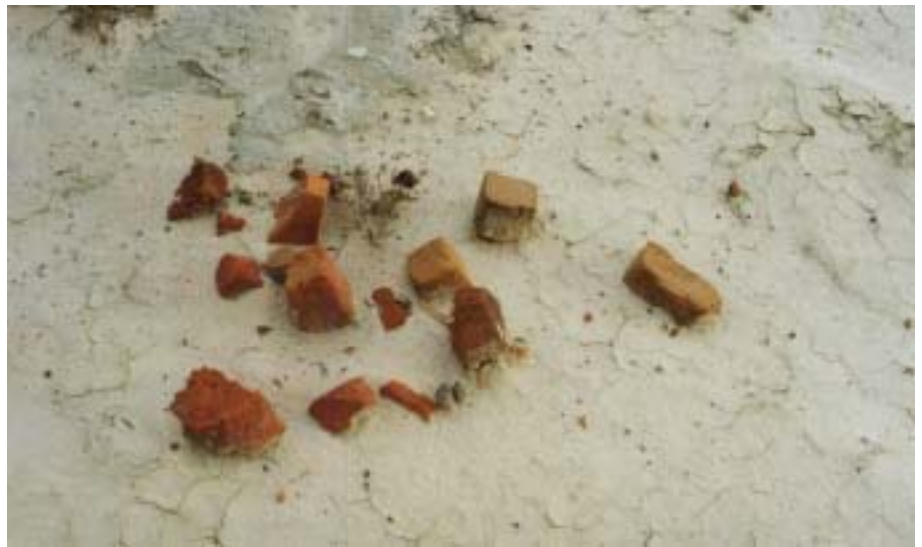
Figure 27
Homestead No. 1 site, brick scatter.
PF 2001 photograph

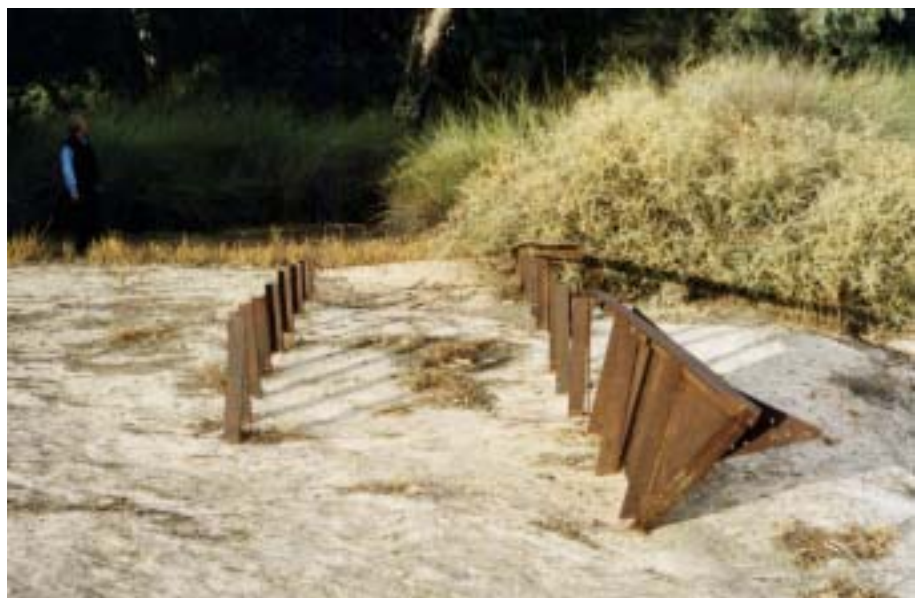
Figure 28
The remains of a barge, located to the
north of the Homestead No. 1 site.
PF 2001 photograph

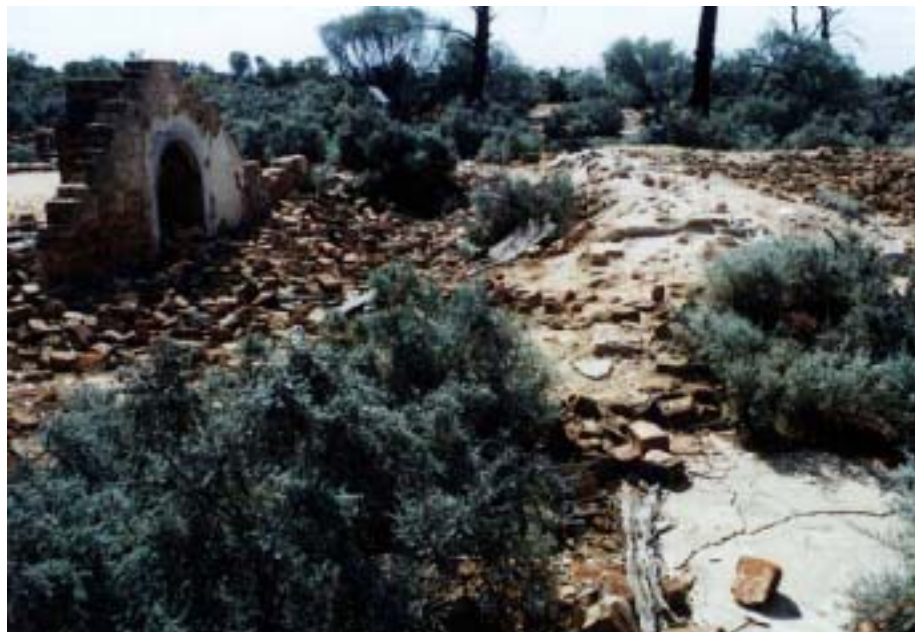
Figure 35
Homestead ruin. The most prominent structure standing is the chimney on the left. Note the trunk of the dead palm tree. The tops of the former walls have become the safest place to walk.
PG 2001 photograph

The remnant walls of the Kinchega Homestead should be capped to protect them from further damage. Reconstruct the walls for no more

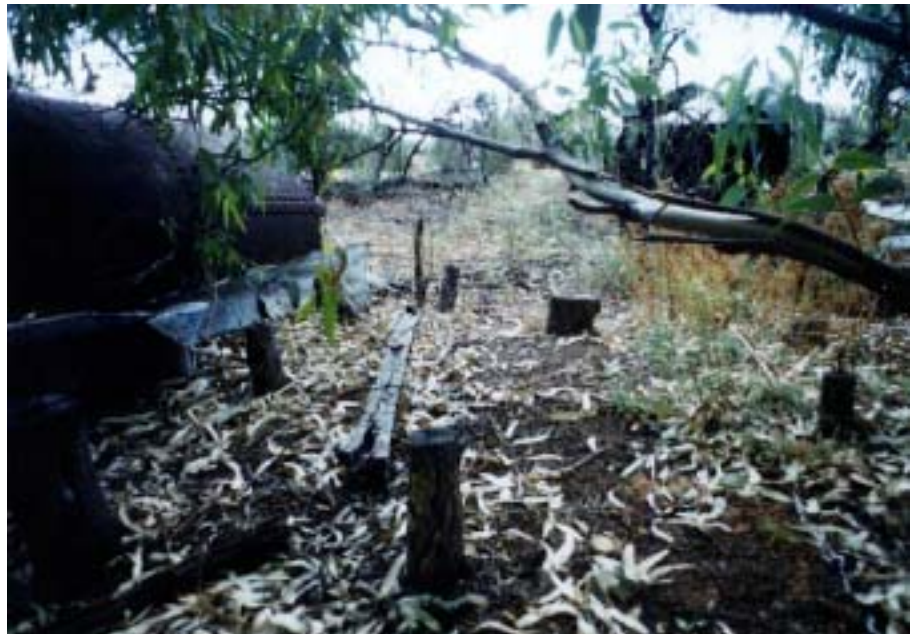
Figure 37
Possible Chinaman's hut site or,
given proximity of boiler and
location immediately above lagoon,
could be the pump house. Excavated
by KARP.
PG 2001 photograph

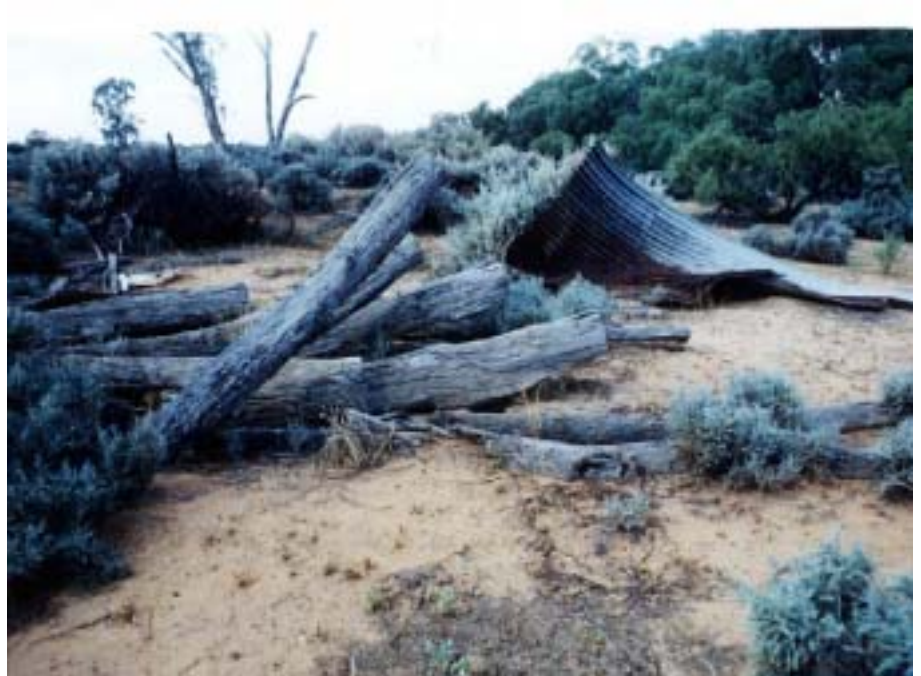
Figure 38
Collapsed water tank and stand
PG 2001 photograph

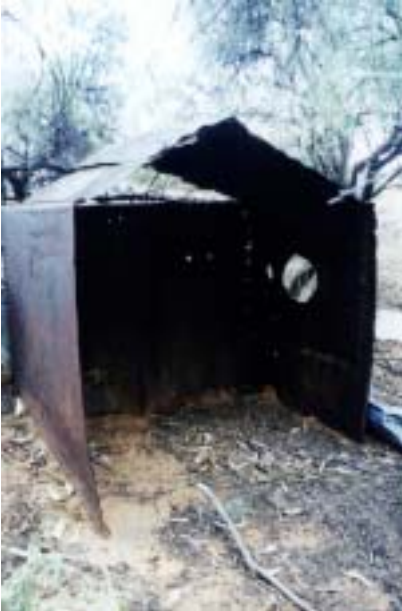
Figure 39
 Adapted water tank
 PG 2001 photograph

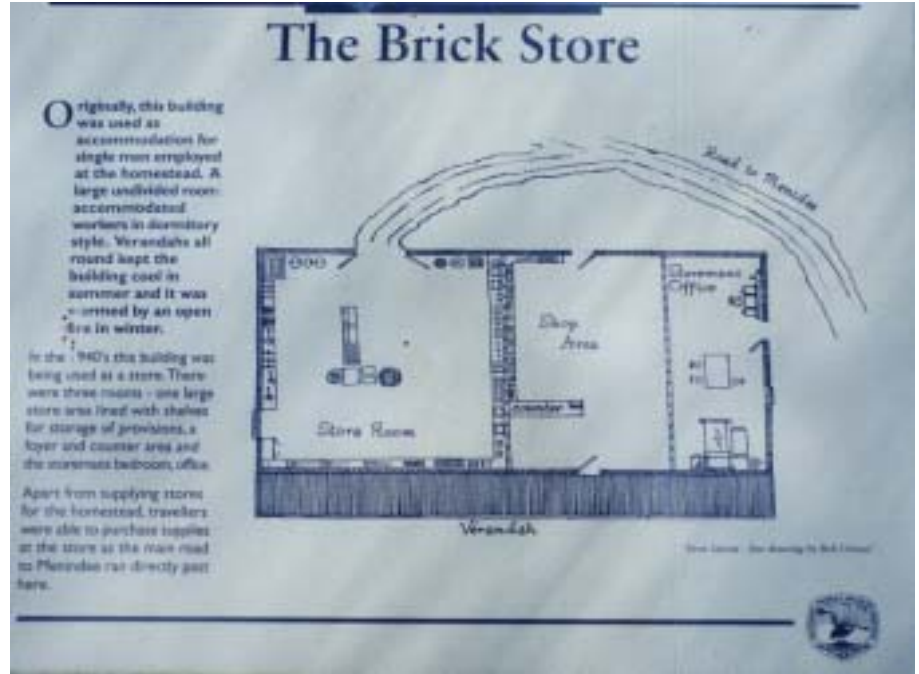
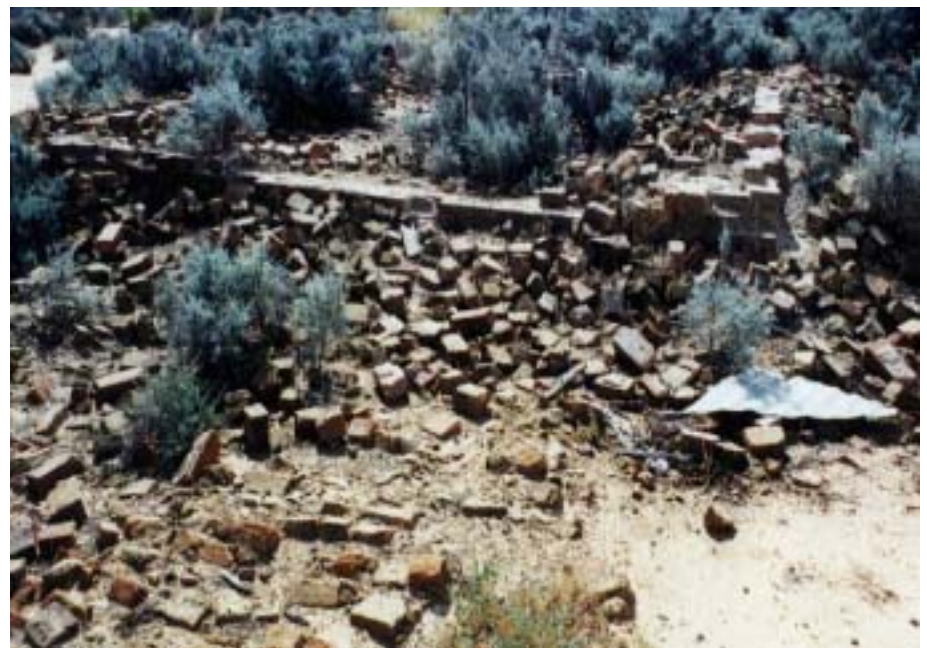
Figure 40
 Plan of the brick store building.
 PG 2001 photograph

Figure 41
 Remnant footings of the store. Note loose tin sheet.
 PG 2001 photograph
