**FORMER KINCHEGA STATION SITES • KINCHEGA NATIONAL PARK
CONSERVATION MANAGEMENT & CULTURAL TOURISM PLAN
VOLUME 1 • THE PLAN**

PREPARED FOR THE
NSW NATIONAL PARKS & WILDLIFE SERVICE
BY:
PETER FREEMAN PTY LTD
CONSERVATION ARCHITECTS & PLANNERS
CONSULTANT TEAM

FINAL
SEPTEMBER 2002

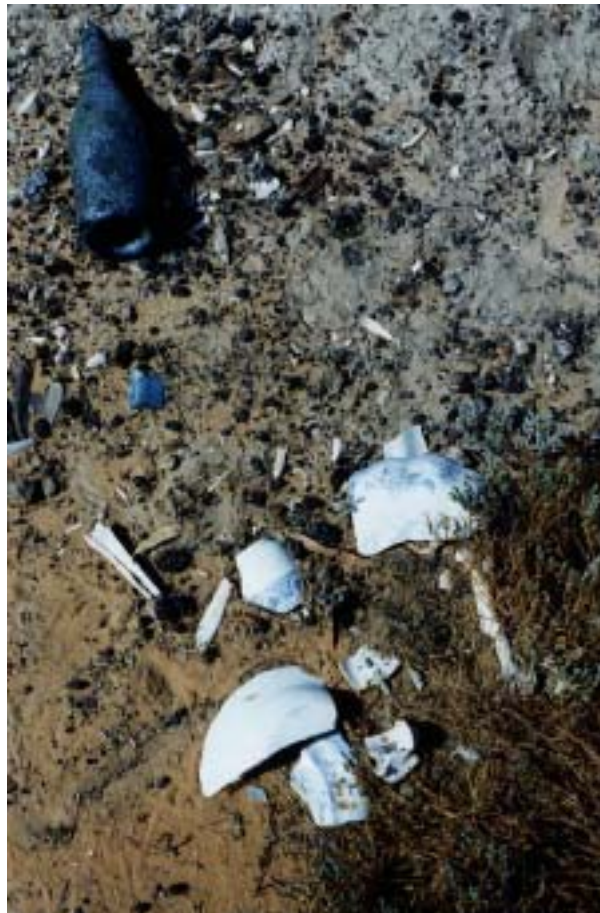
Figure 43
Dump area. Note mixture of bottles, ceramic fragments, ash and sand. The dump has been extensively disturbed and few if any large artefacts are visible.
PG 2001 photograph

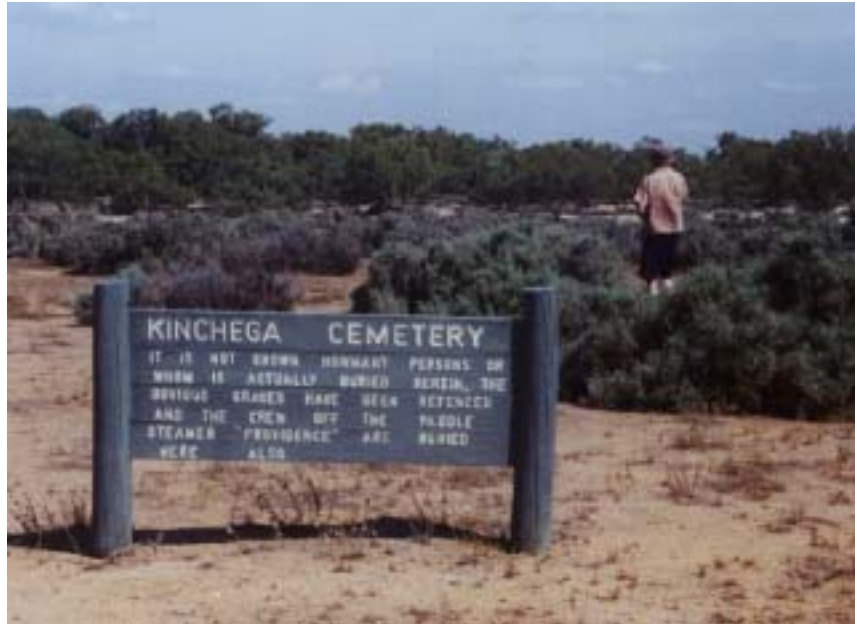
Figure 46
 Kinchega cemetery.
 Note the clumsy text of the sign.
BN 2001 photograph

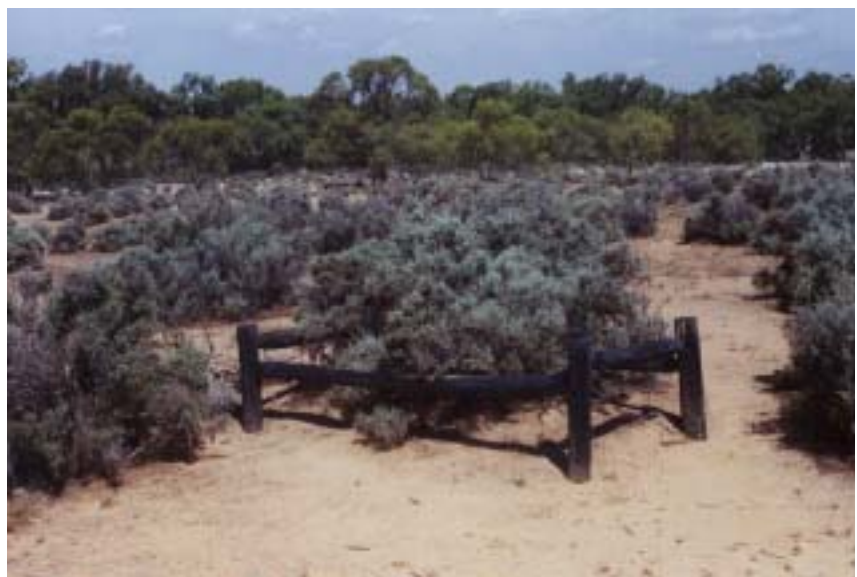
Figure 47
 Kinchega cemetery.
 Notelog grave markers introduced by
 NPWS.
BN 2001 photograph

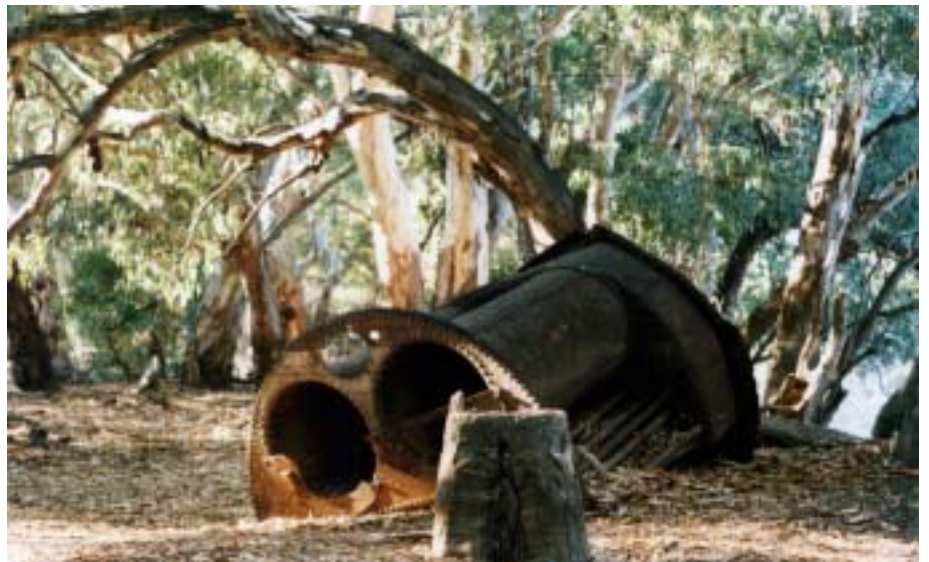
Figure 51
The *Providence* boiler, *in situ*.
PF 2001 photograph

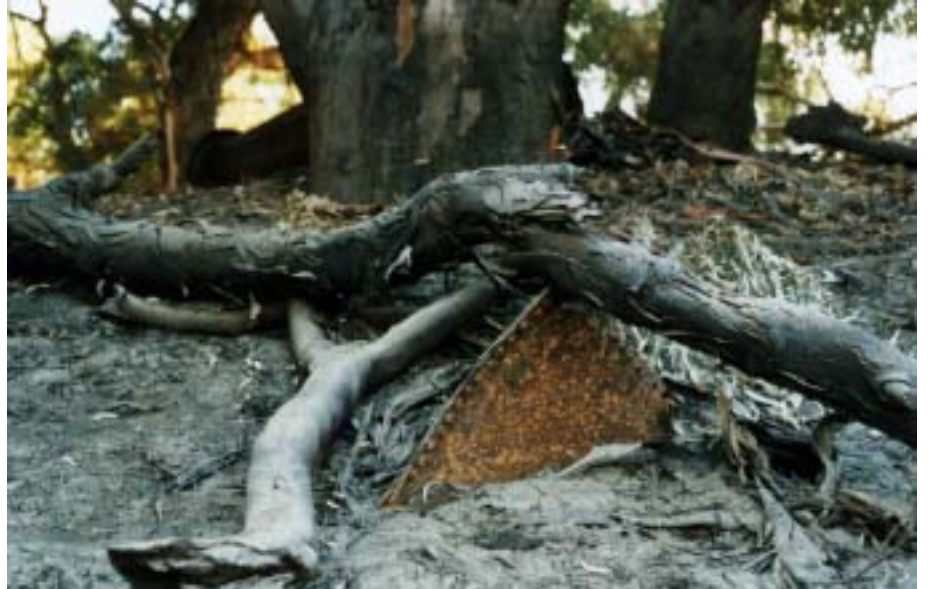
Figure 52
Remnant of the *Providence* boiler,
Darling River bank.
PF 2001 photograph

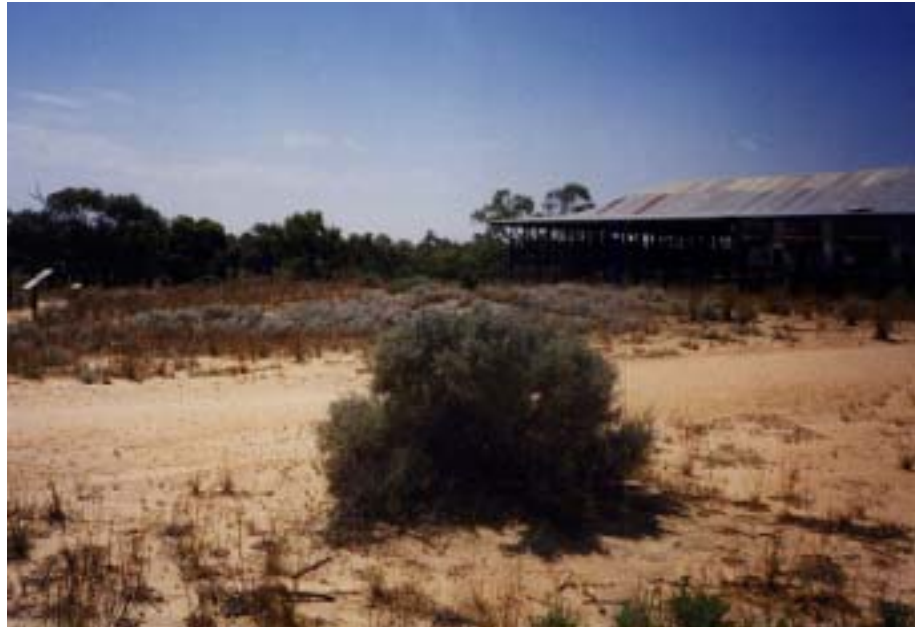
The Woolshed Group is located on the edge of the sandy country, which is subject to **wind and water erosion**, and overlooks the black soil floodplains. The sandy ridge country, around the woolshed complex has had a long history of impact by stock and more recently by visitors and people staying in the shearers' quarters.

Figure 3
 The impacted area around the woolshed, looking from the sand dune over the floodplain black box community.
RT photograph 2001

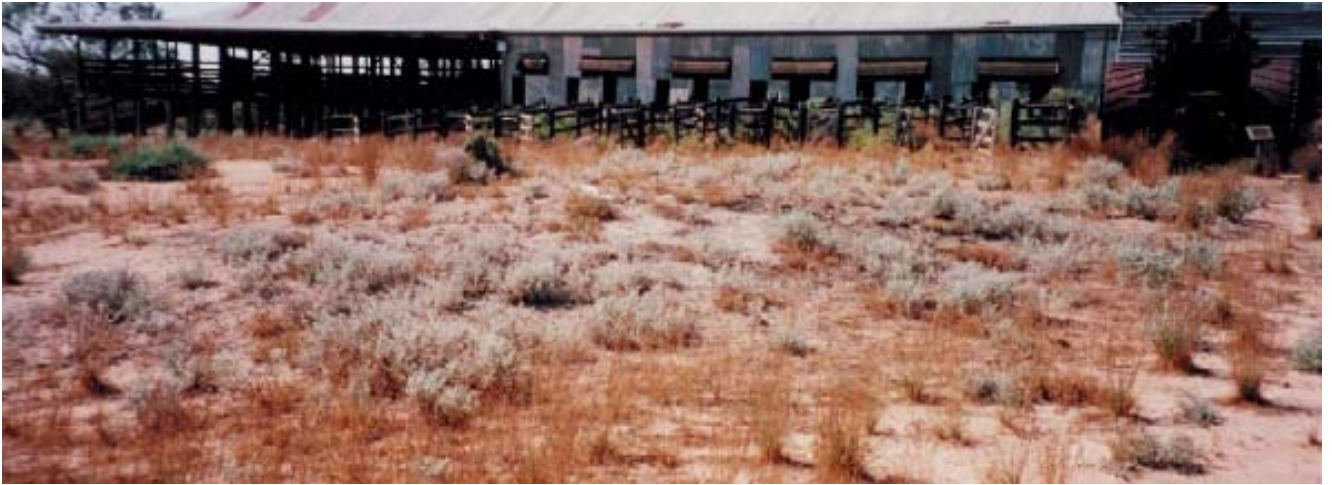
Figure 12
The large ashy mound near the woolshed.
SMT 2001 photograph

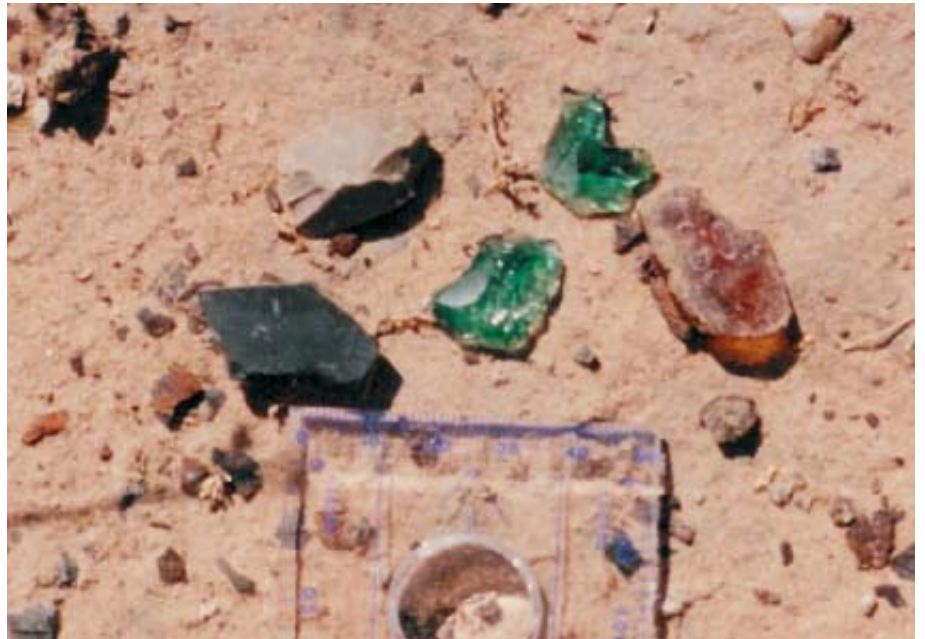
Figure 13
Glass artefacts located on the ashy mound near the woolshed.
SMT 2001 photograph

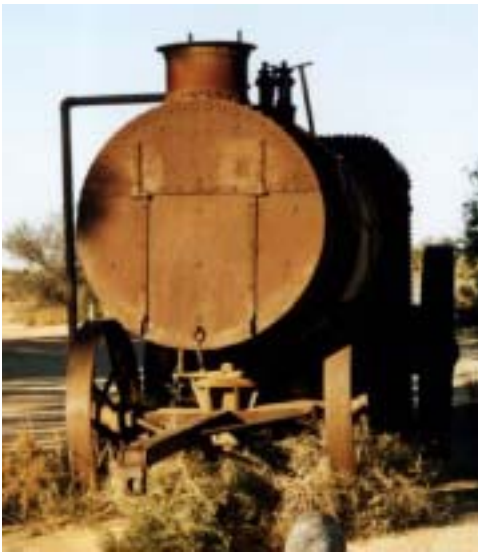
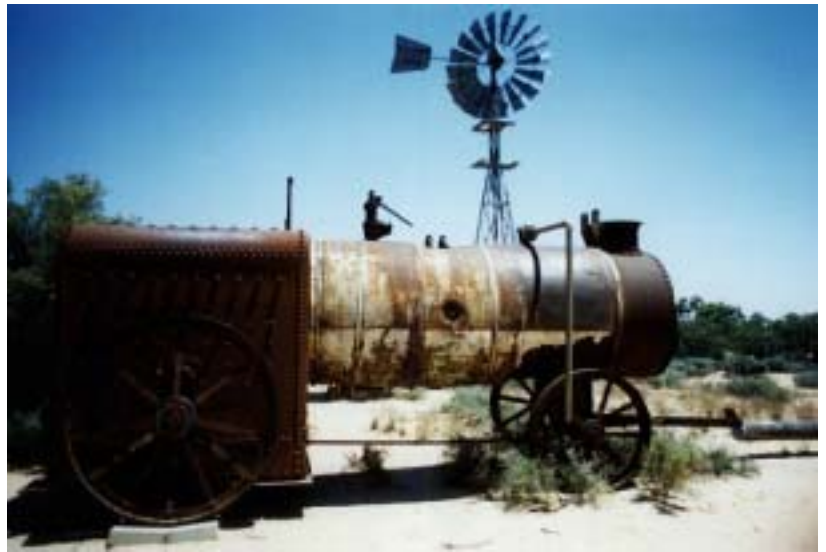
Figures 20 & 21

Large, wheel-mounted boiler. Provenance not known. In poor but stable condition.

A large wheel mounted boiler located in the carpark near the killing shed. Origin not known, condition poor but stable.
PF & PG 2001 photographs

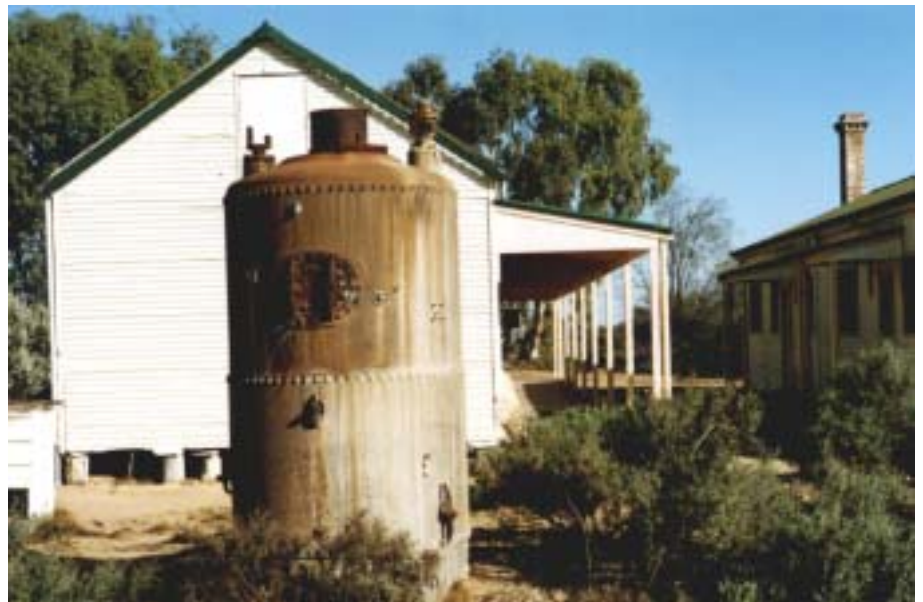
Figure 22

Large, upright boiler. Provenance not known. In fair condition.

Boiler near the shearers' quarters.
PF & PG 2001 photographs

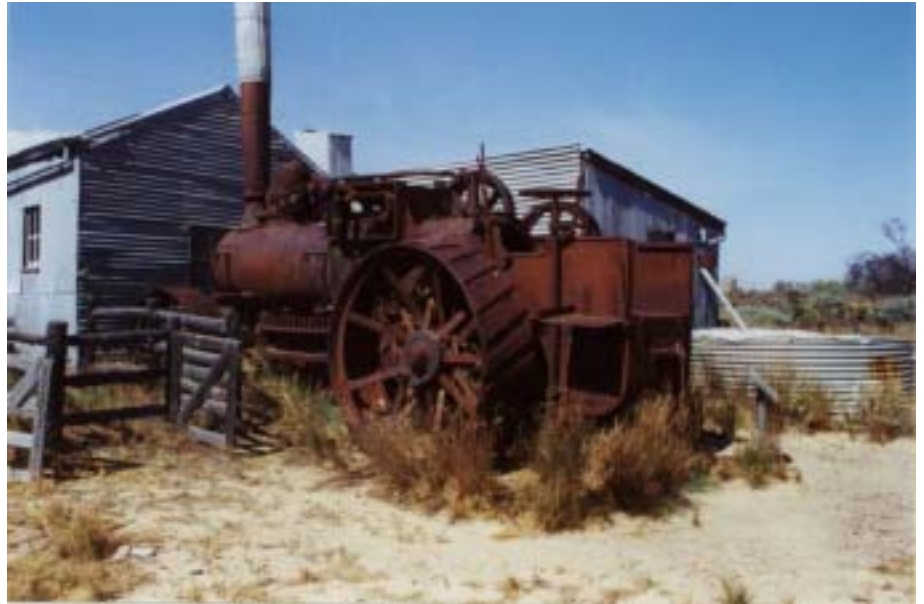
Steam traction engine, John Fowler & Co, Leeds, 1881, in fair condition.

Figure 23
Kinchega woolshed steam engine
PF 2001 photograph

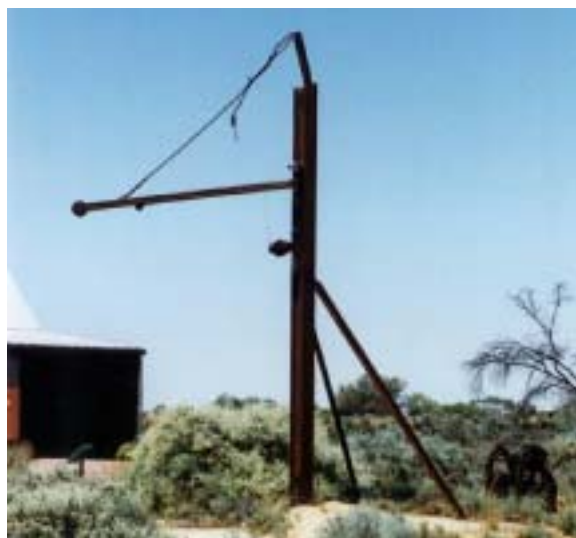
Crab winch and boom. In fair condition.

Figure 25
Crab winch and boom.
PG 2001 photograph

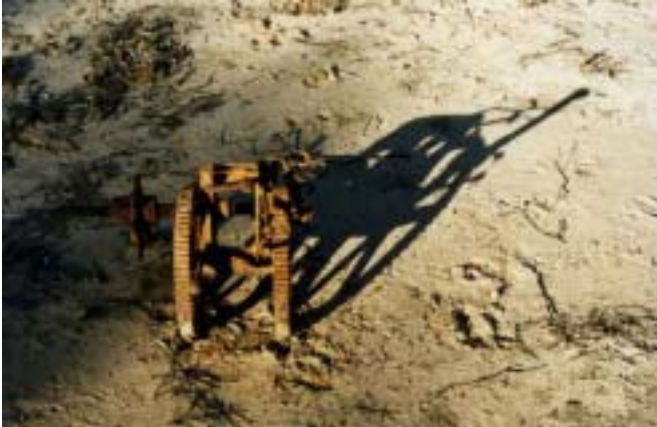
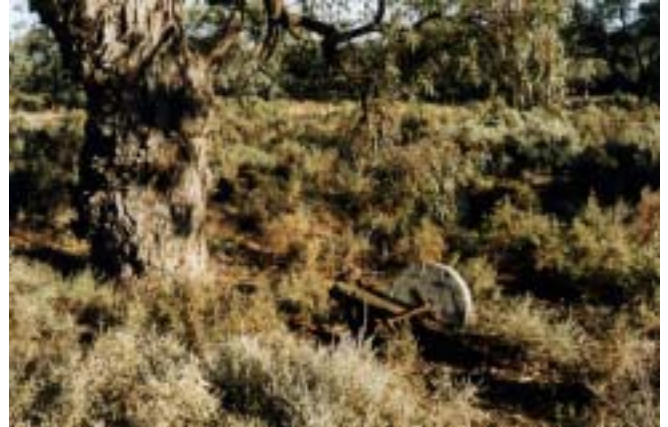
Figures 26 & 27
 Remnant machinery and grinding wheel at the former shearers' quarters site
PF 2001 photographs

SHEARERS' QUARTERS ARCHAEOLOGICAL SITE
 Unidentified items of machinery.
 Grinding wheel. Generally all items in poor condition.

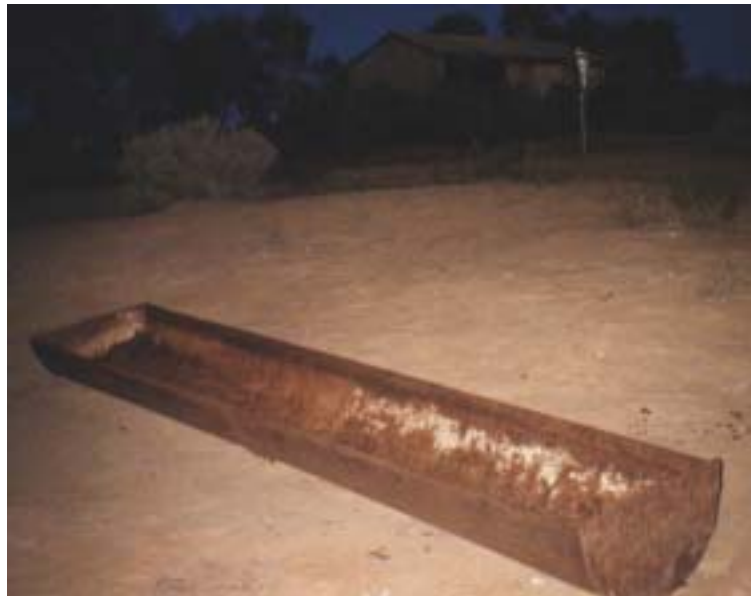
Figure 28
 Feed trough, north-west of the Killing Shed.
PF 2002 photograph

TROUGH
 Metal rivetted trough made of two horizontally halved 44 gallon drums joined end to end. Rivet holes provide evidence of where it was attached to a supporting frame. The trough is approximately 4 metres long and is rusted at its lower end. It is located in a gully immediately below the Killing Shed [north-west].

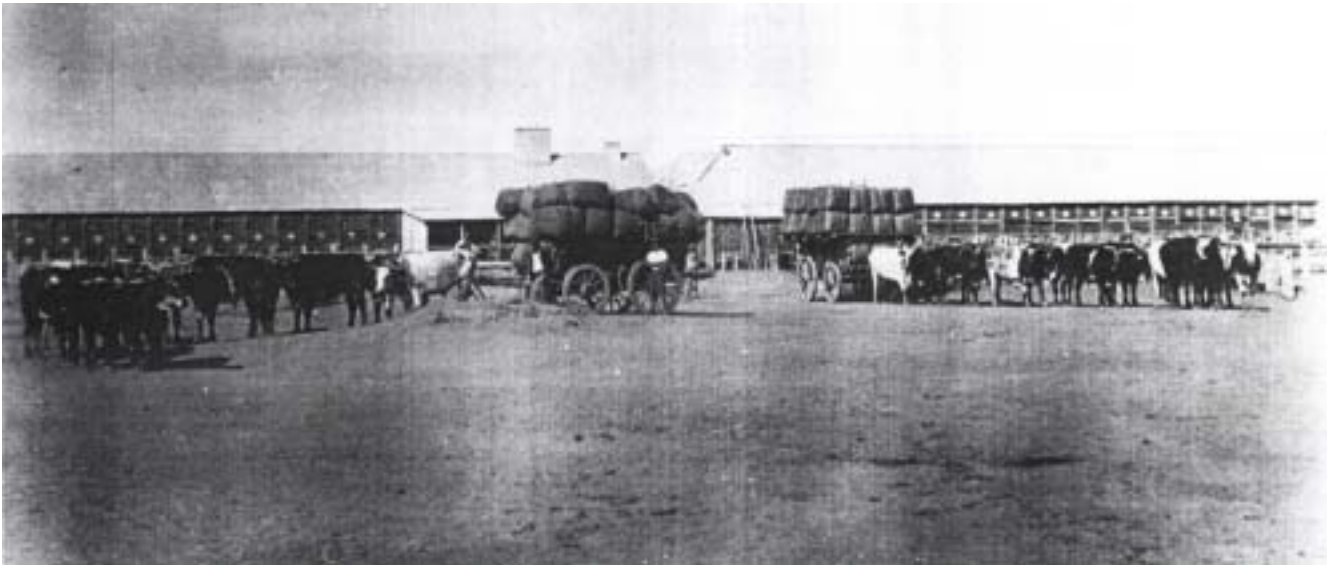
Figure 31
North elevation, Kincheega Woolshed.
The demolished portion is at right.
ND but c1890.
John Hughes, Kars Station

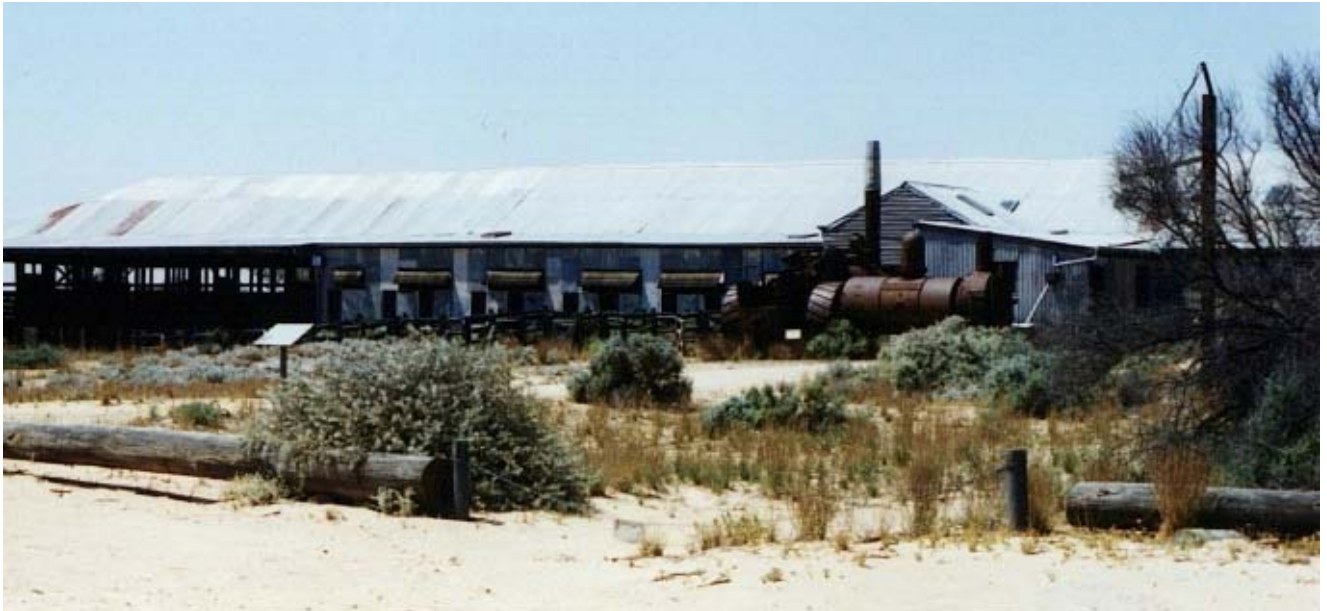
Figure 41
Locomotive boiler and old steam plough still *in situ* adjacent to the engine room, north elevation. During shearing time this part of the site would have been very much a rural industrial landscape.
PG 2001 photograph

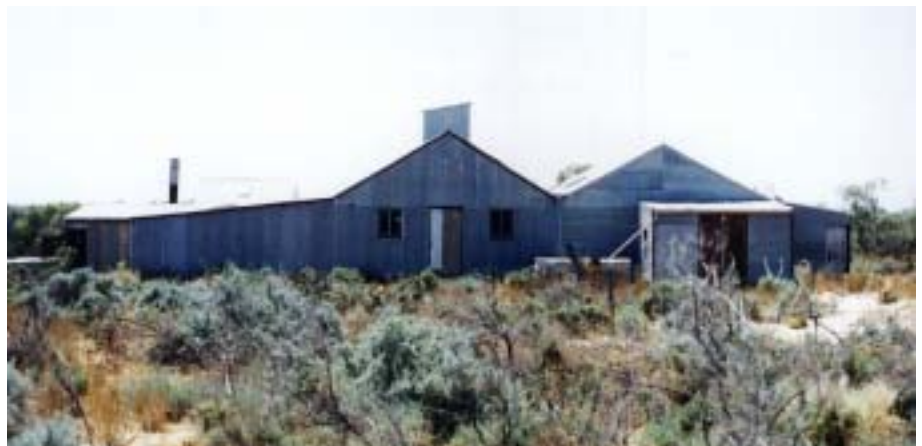
To the **west elevation** the double gable reflects the earlier roof form and that of the demolished western building. It is likely that this end of the building was extensively remodelled in the 1920s as well as conserved in the 1970s. Bruce Bray noted that *'... much of the western end of the building was reconstructed, but there were never doors on this end of the building. There is new walling at the dust flocker end'*. To the west of the shed was a drying rack [indicated in the Cox drawings] which

Figure 42
West elevation.
BN 2001 photograph

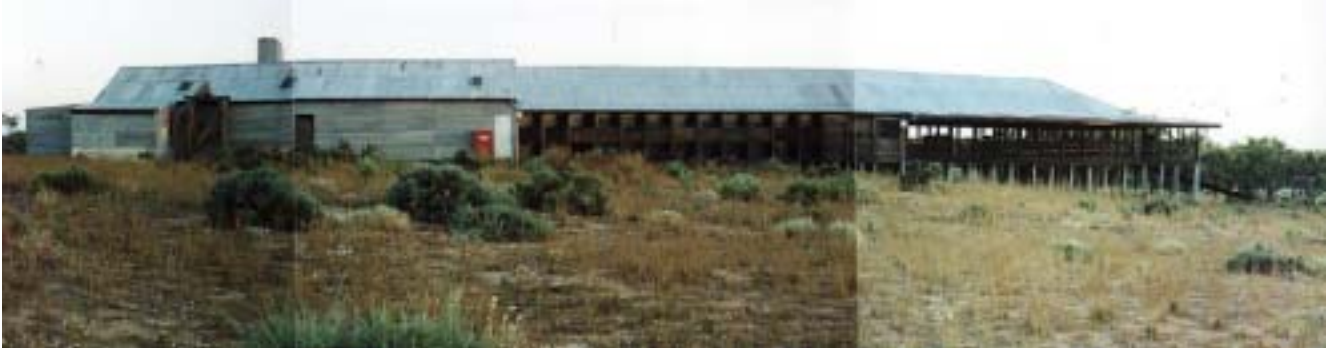
The 1920s sweating pens abut the 1870s blade wall of the **south elevation**. The corrugated iron wall to the western end of the south elevation is assumed to be part of the 1920s reconstruction and houses the dust flocker. Note the separate engine room and elevated drive gear that powered the flocker, indicating it post dated steam power. This section of the building was extensively conserved following acquisition by the NPWS in 1967.

Figure 43
 Composite photograph of the south elevation, Kinchega Woolshed, PF 2001 photograph

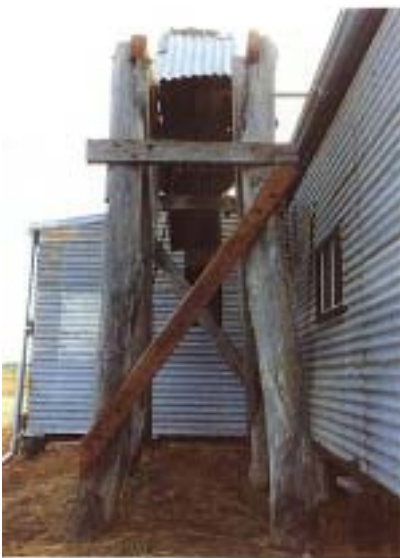
Figure 44
 Dust flocker drive gear, restored in HPRP 1993. PG photograph 2001

The dust flocker is a 'Spenshaw Wooldusting Machine' which was made by Simes & Martin of Port Adelaide. The design of the dust flocker was patented on 12 December 1929 so it was presumably installed during the early 1930s. In good condition.

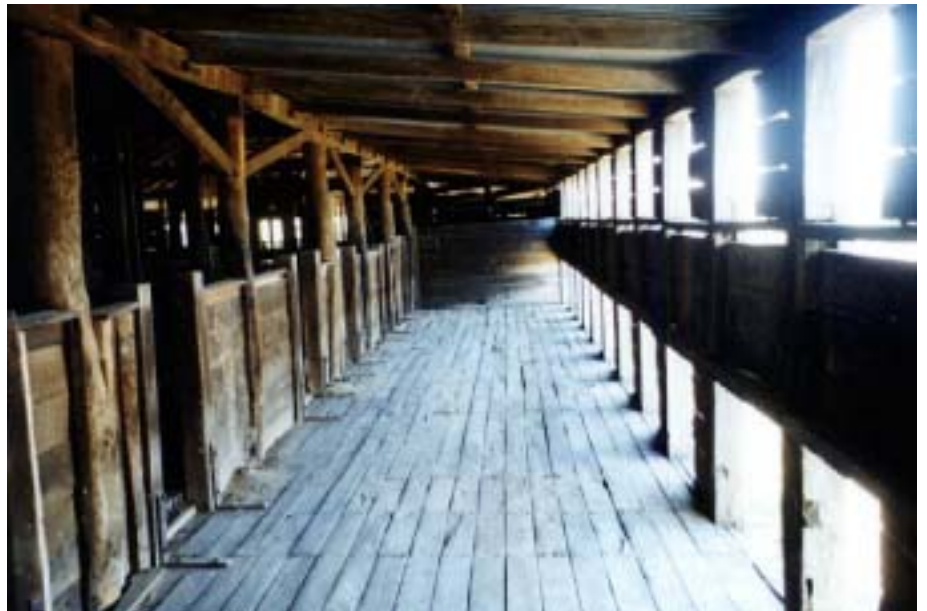
Blade shearing was done adjacent to the catching pens [2 per door] on both sides of the shed and, in the early days, at both ends of the shed, i.e. 16 per board on four **blade boards** [the western boards being removed in the 1920s]. Swing gates were not needed, as the sheep were fearful of coming out, however loose panels could be slotted in. A rattle, or 'Tin Dog', was made from an old tobacco tin and wire and was rattled to shift the sheep. If sheep were cut, Stockholm Tar was applied with a round brush. The tar was kept in an old tin, hung on a nail and applied with a round brush, an example of which was in the storeroom in 1992. Spilt tar is readily evident on the posts and floor, and a signature dated 1886 is cut into a post. The blade shearing board had hessian bags over the chutes and possibly the windows. The white discs on external walls [evident in photos] were for writing counting pen numbers, i.e. the number of sheep shorn per man.

Figure 45
 The blade board [south side]. Rebates and bolt holes on the upper face of the posts accommodated the beam that supported the first phases of overhead gear. It is likely that hessian bags would have hung over the windows. PG 2001 photograph

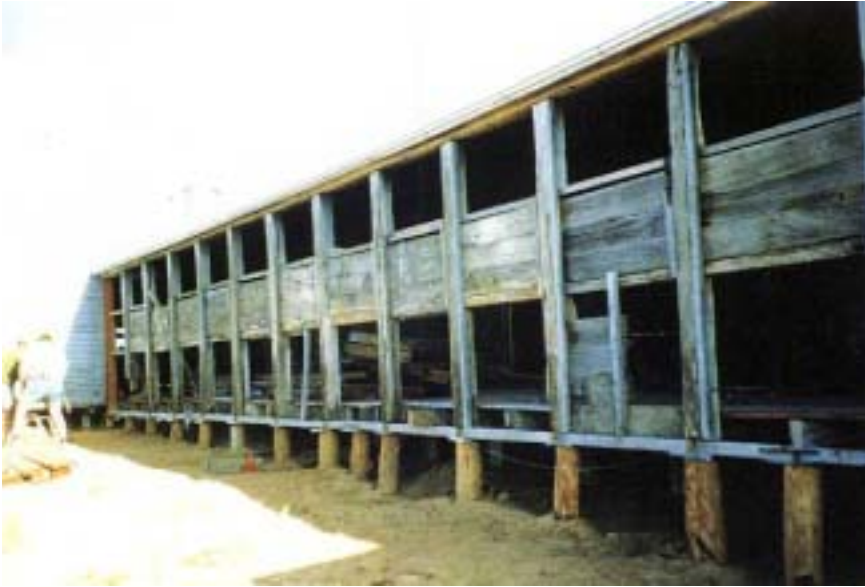
Figures 46 & 47
Blade wall exterior prior to reconstruction during Heritage Places Restoration Program [left]; and following reconstruction [right].
PG 1993 photographs

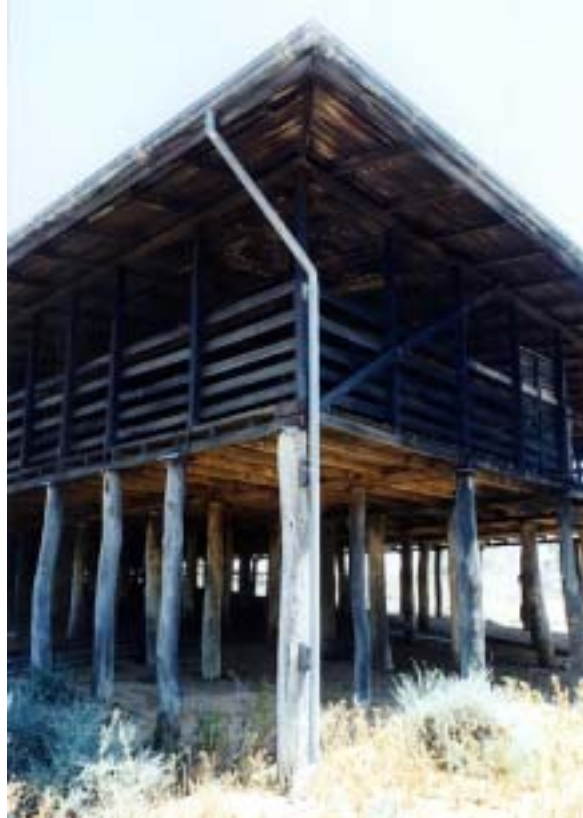
The **elevated sweating pens**, built in the 1920s, are a distinctive feature of Kinchega woolshed. They are unusual for their lightweight timber stud construction, unlike the heavy timbers of the earlier section. The roof lining boards were initially covered with malthoid [a tar impregnated felt sheet] that was later covered in corrugated iron. This section of roof was removed, re-rolled and replaced in the 1970s, which explains the occasional appearance of previously painted sheets.

Figure 49
The sweating pens
BN 2001 photograph

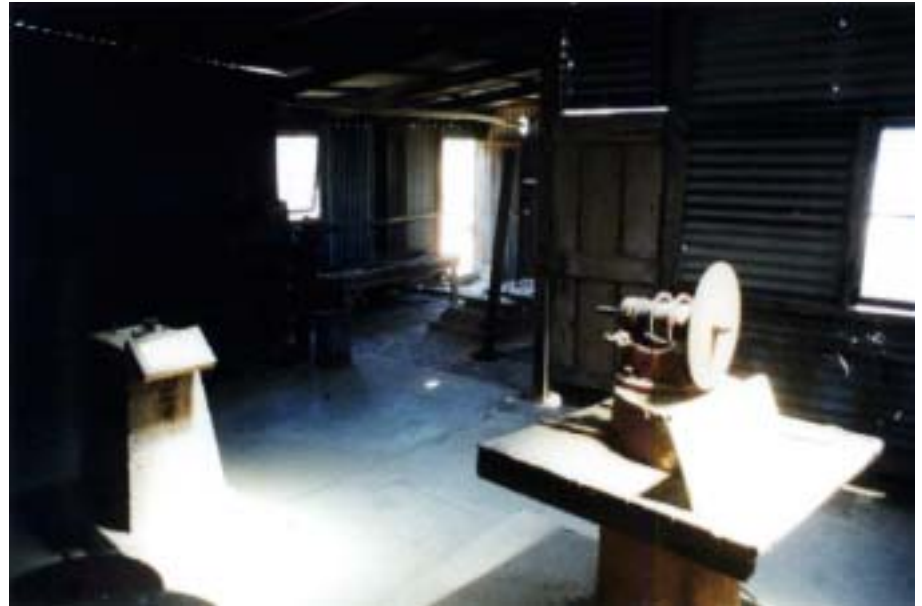
shearing adjacent to the pens not the chutes, as is apparent from rebates checked into the posts closest the pens. This gear was driven by a steam engine with the boiler outside the engine room mounted on brick piers. The boiler, which is still present on site, originally came from a railway engine. The steam was delivered by pipe from the boiler, through the wall, and to the engine which drove a belt that operated the closer of two overhead shafts [i.e. for the northern board]. A second belt then drove the far shaft located over the southern board. This second belt was supported mid-span by a lazy wheel fixed to the post; the bolt-holes are still evident.

Figure 50
 Engine room. Note the engine mounting block in the rear skillion.
 Expert's equipment, including sharpening gear, is in the foreground.
PG 2001 photograph

The woolshed **steam engine** was replaced by a 'Columbus' Kerosene unit mounted on the same spot inside the engine room. The steam boilers were left in place outside and at some stage the copper was cut out of the first boiler. The third engine ran on diesel and was also mounted where the previous two had stood. Finally an electric motor was installed beneath the drive shaft [the pulley on the shaft was removed by Bray in the 1970s]. The electric motor and pulley from the overhead gear were removed and probably went to Mt Wood [Sturt National Park, near Tibooburra].

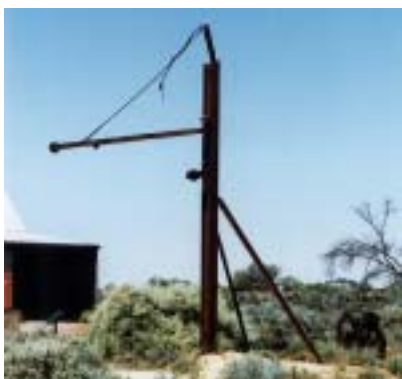
Figure 51
 Crab winch and boom for loading
 bales of wool.
PG 2001 photograph

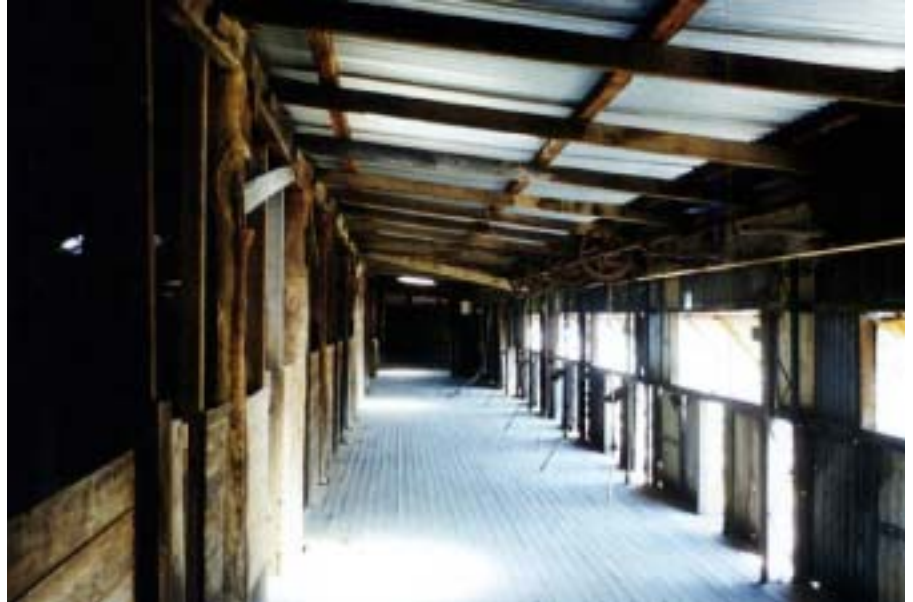
Figure 53

Reconstruction of roof over north board. Note mortises in the original plate. The wall was moved outwards in the 1950s to accommodate the vertical steel trusses and overhead gear.

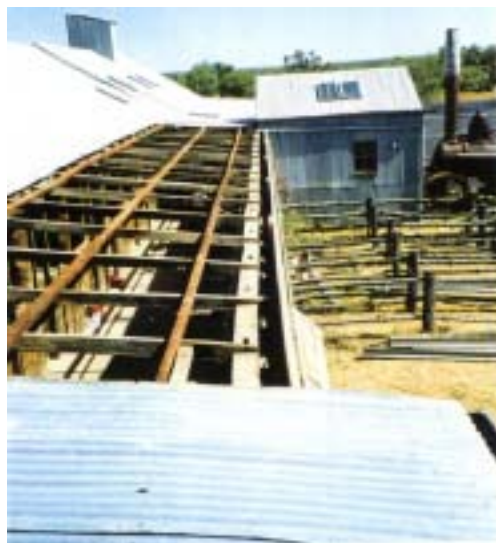
Figure 54

North wall of north board. Pens reconstructed as part of the HPRP in 1993. In this photo of 1993, the shutters have yet to be restored.

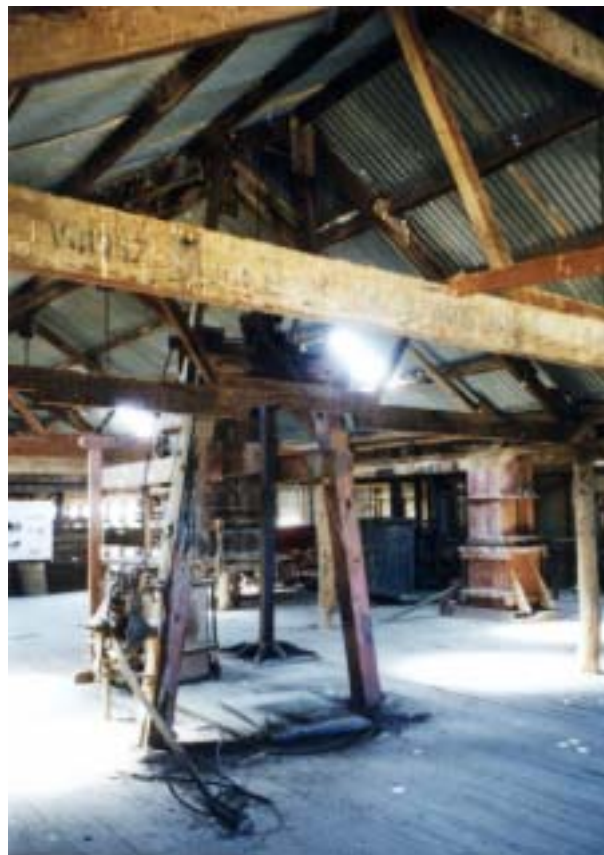
Figure 55

though it was removed to Bindara Station and replaced with a Koerstz. The third press was a Ferrier lever woolpress, manufactured by Humble & Sons, Geelong. The early presses were very labour intensive and were discarded for the more efficient later types. When the Ferrier wheel press was dismantled for the trip to Bindara corresponding parts were numbered in Roman numerals which, following retrieval and re erection in the 1980s, can still be seen. The overhead component was also retrieved from Bindara.

Interior of press area showing the Ferrier wheel type wool press in place. A Koerstz press is in the background. Note the use of Oregon trusses in this area, along with grooved purlins. This is the timber that was recycled from use as formwork in construction of the Menindee Bridge and dates this part of the structure to the 1920s and explains why towers in early and present photographs don't correlate. The bush poles may be part of the original structure.

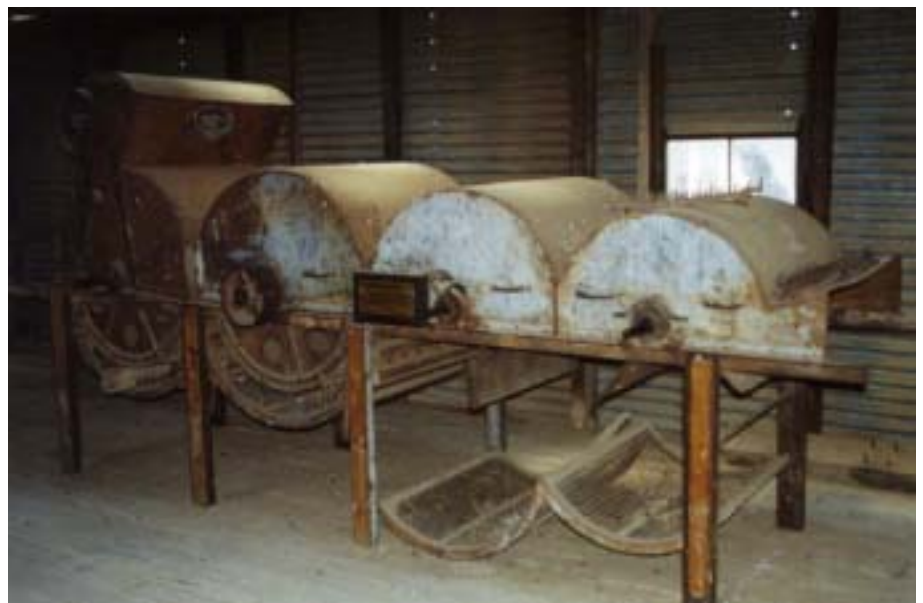
Figure 56
 Dust flocker.
 BN 2001 photograph

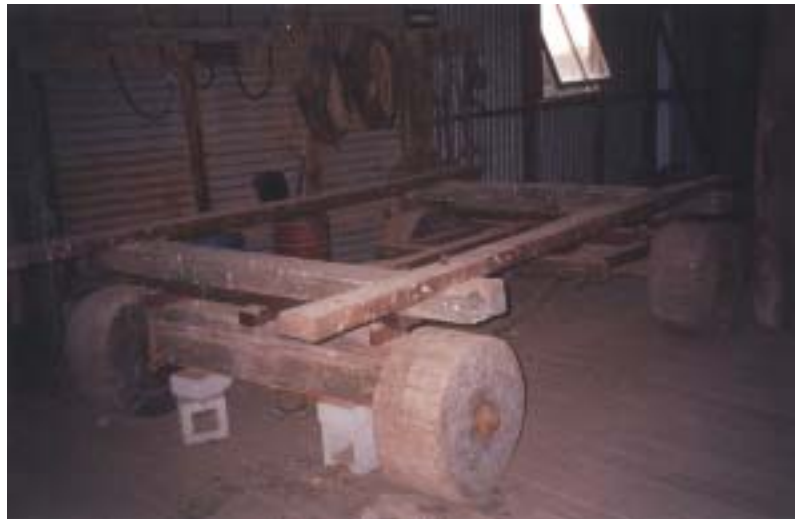
Red gum construction, used to cart red gum logs from the river area to a breaking down saw to convert the logs to fuel to fire the steam engine. Dimensions: tray 390 by 214cms; shafts [2 sets] 287 by 93 cms. The cart tray has a central Y-shaped chassis, with a heavy cross cut timber rectangular surround. Hand forged metal bracing reinforces the whole. The two axles are set within timber blocks and are connected to four solid red gum timber wheels. The jinker is located at the western end of the Kincheha woolshed and is in a good condition, although the wheels show evidence of cracking.

Figure 57
Timber jinker.
PF 2002 photograph

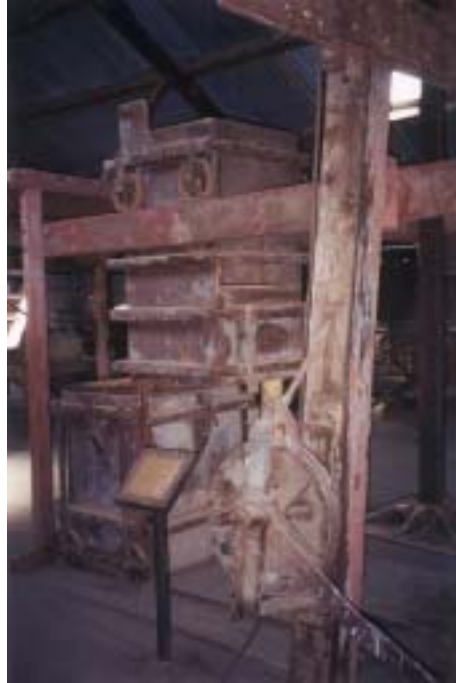
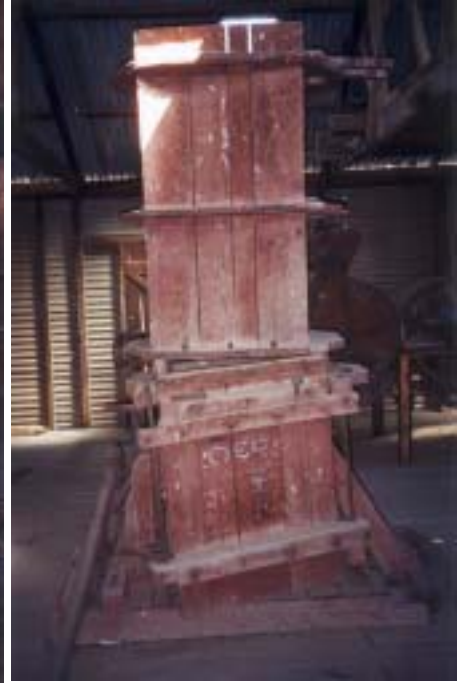
One of a total of three wool presses, all of which are located in the central body of the woolshed. Comprising two faded dark red painted vertical timber boxes, with white decorative scroll work. The upper box swivels to be above the lower and with hand pressure on the timber lever at the side compresses the fleece into a bale. All metal parts are hand forged. The press appears sound, but the timbers, particularly the straight grain Baltic Pine, are in a very dry condition.

Baltic Pine, twin timber and metal reinforced press boxes each 142 cm high. Each side of the box comprises of a single plank of timber 69 by 110 cms, the interior surface worn to satin smoothness, the outer, dark red painted with white stencilled to one side 'D. Ferrier Patent _74'. Roman numerals are etched into timber sections to aid in the reassembling of the press on return to Kincheha from Bindara station. Above the boxes a six metre high triangular gantry frame supports two wheels which by steel cables raise and lower the metal and lower the metal pressing plate onto the baled wool below. The whole sits bolted to two stabilising heavy timber floor joists. The roof line of the shed has been altered to accommodate the mechanism. Apart from cracking to a corner of the lower box, and the general dry and dusty condition of the timbers, the press appears to be in good condition.

Ferrier wheel type [left] and Koerstz [right] woolpresses. The Ferrier is believed to have been the original press. After it was removed to Bindara Station the Koerstz occupied its location in the centre of the wool room.

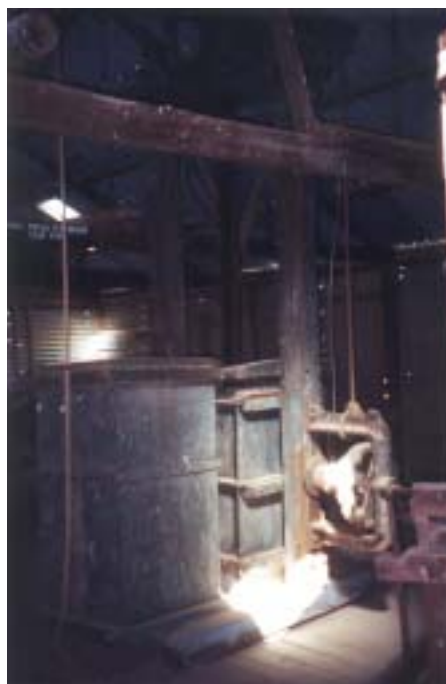
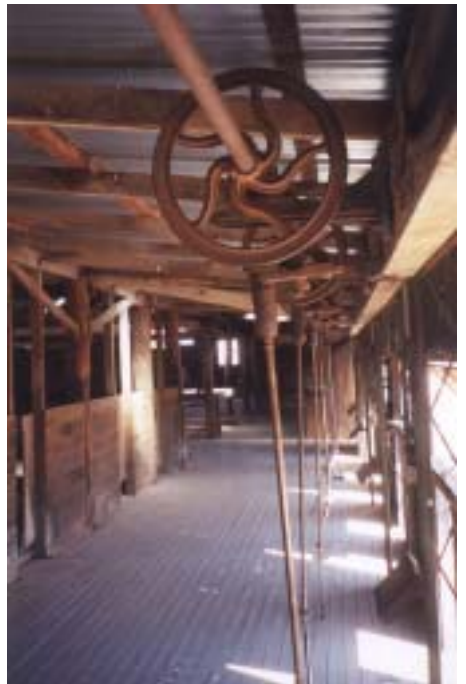
Figures 60 & 61

Press comprises two dark green painted Baltic pine vertical timbers, each 38 cm wide and 145 cm high. Painted by hand on one side is 'Ferrier Flip Type 2225, Ferriers Lever Wool Press'. On the opposite side, also in mustard coloured paint, is 'Humble & Sons Pty Ltd. Makers Geelong'. The metal pressing plate is operated from a rectangular timber gantry, the steel cable raising and lowering through two metal pulleys and a wooden block winch. A gibbet arm projects from this frame .

Ferrier woolpress [left]; and shearing mechanisms [right].

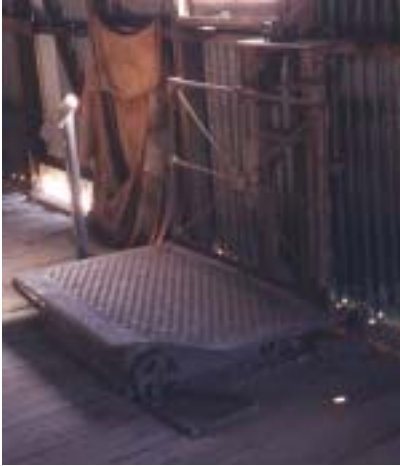
Scales manufactured by Avery of Birmingham. Cast iron low platform scales for weighing and stencilling the wool bales. The Kinchega wool bale stencils are currently stored in the NPWS office in the former shearers' quarters. The scales are located at the western end of the woolshed and apart from a snapped-off corner, which is present, is in good order.

Figure 62
Avery wool scales.
PF 2002 photograph

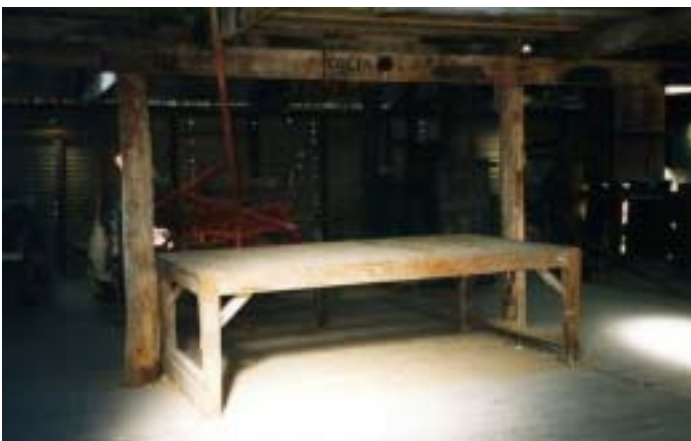
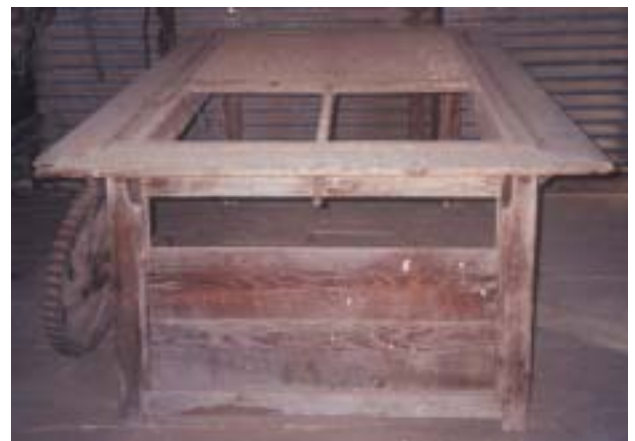
There are a total of four wool sorting tables in the shed. These tables probably date from the period circa 1900 to 1920. They are of pine timber construction, 280 cm long by 150 cm wide by 87 cm high. They have square tapered legs and mortice and tenon joints to table tops, which have reinforcing rectangular frames around the whole. Fifty two square dowels fixed on the diagonal make up the table top. The tables, situated in the central body of the shed, range from one in excellent condition, two in good condition and one in only fair condition.

Figures 63 & 64
Wool tables.
PF 2001 & 2002 photographs

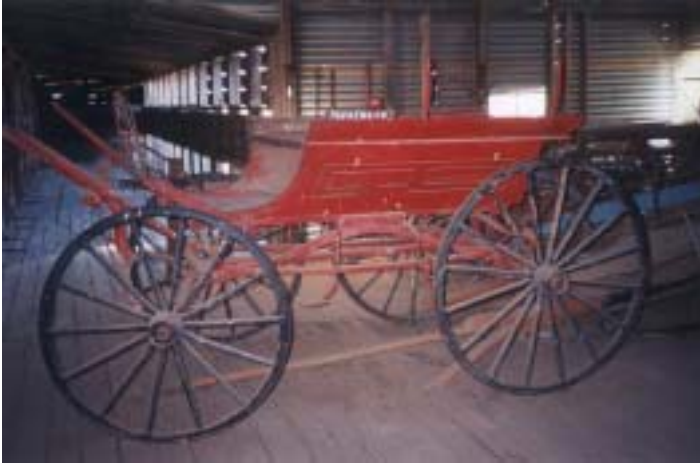
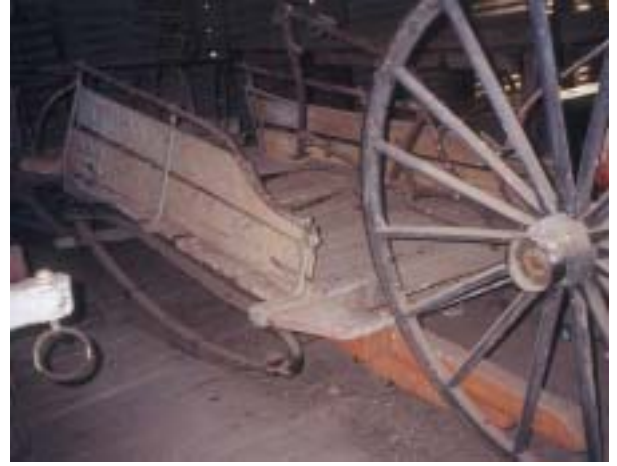
A four wheeled, red painted timber and hand forged metal vehicle, 202 cm long. It probably dates from circa 1880. There are rear and side alighting steps with a central wooden shaft. Upholstery and metal fittings to seat back is missing. Timbers excessively dry with minor cracking.

Figures 65 & 66
Passenger buggy [left] and cart
[right].
PF 2002 photographs

Twin shafted cart with flat timber tray floor, 188 cm by 124cm. Probably circa 1920. The side boards are blue, while the shafts are an orange pink colour. The cart is in poor condition: it has no wheels, a damaged floor and the right shaft is snapped.

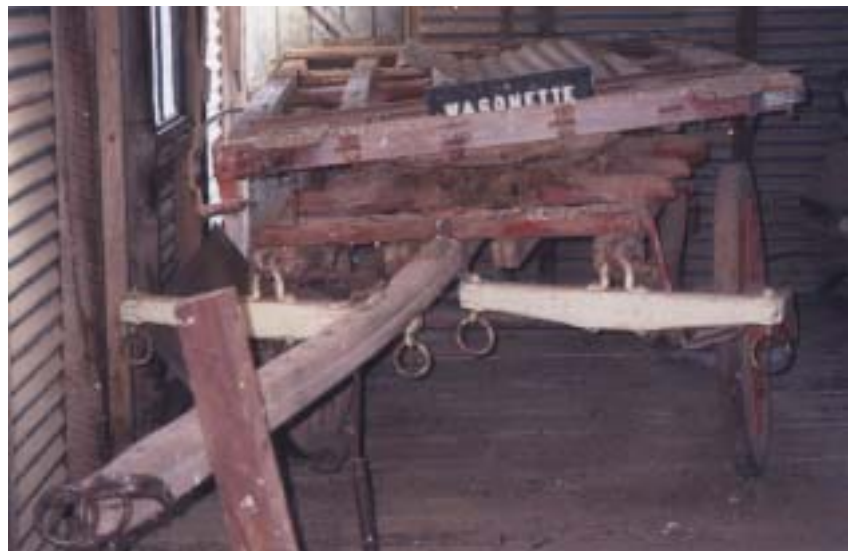
Figure 67
Wagonette.
PF 2002 photograph

WAGONETTE

A four wheeled, flat tray, central shafted timber dray or wagon, 333 cm by 160 cm with wheels of 92 cm diameter. Probably circa 1900. The remains of red paintwork are evident on the chassis and spokes. The wheel surrounds are painted duck egg blue. No evidence of a seat remains, query previous use as a bullock wagon. In dry and worn condition.

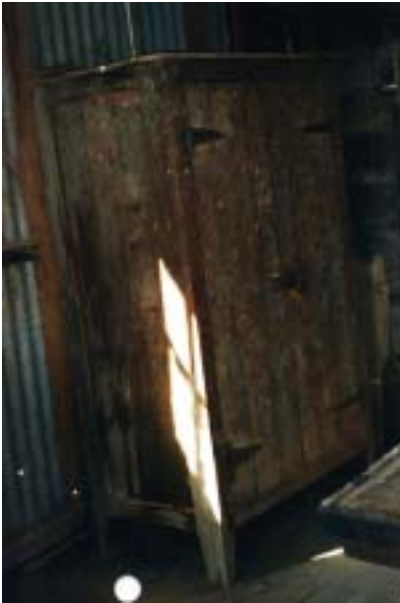
Figure 68
Cupboard in the expert's room of the woolshed.
AF 2001 photograph

CEDAR STORE CUPBOARD

A large cedar cupboard, 159 cm high by 104 cm wide, with double doors, dark stained vertical tongue and grooved timbers. There are four hand forged metal hinges and a [padlocked] hasp and staple locking mechanism. An evocative, valuable and vulnerable item of late 19th century bush carpentry.

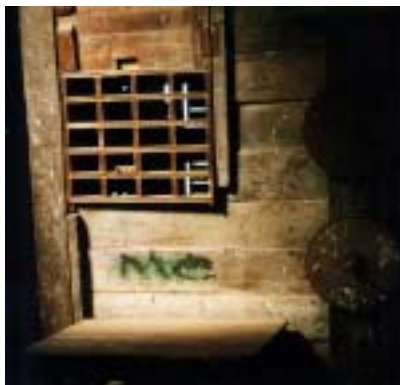
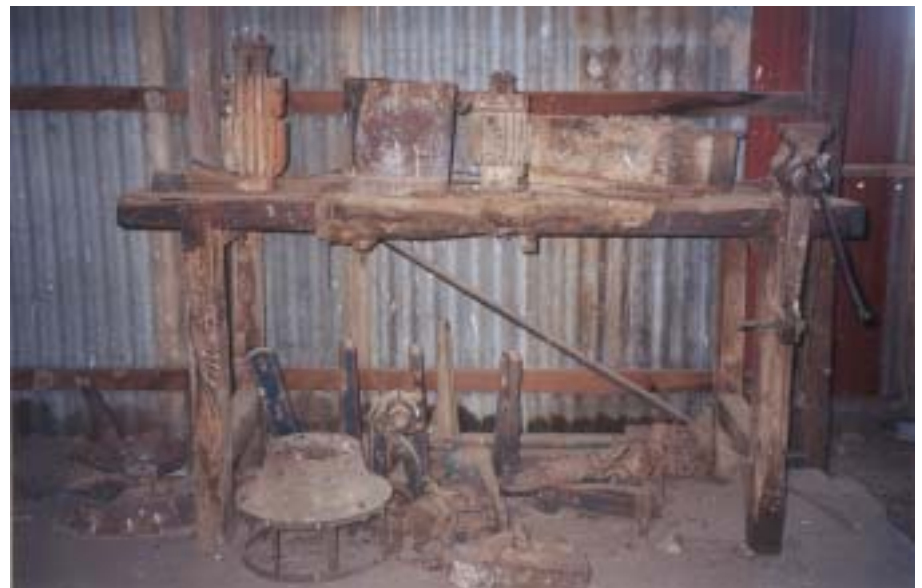
Figures 69 & 70
Pigeon holes for shearers' combs, with the pine table below [left]; and table with tools [right].
PF 2002 photographs

Red gum table 183 cm long by 62 cm wide. Heavy square legged and stretchered with steel bolt reinforcements at joints. On it is an assortment of rusted and oil-stained tools, a vise in working order is attached at one end. Possibly circa 1890.
