**FORMER KINCHEGA STATION SITES • KINCHEGA NATIONAL PARK
CONSERVATION MANAGEMENT & CULTURAL TOURISM PLAN
VOLUME 1 • THE PLAN**

PREPARED FOR THE
NSW NATIONAL PARKS & WILDLIFE SERVICE
BY:
PETER FREEMAN PTY LTD
CONSERVATION ARCHITECTS & PLANNERS
CONSULTANT TEAM

FINAL
SEPTEMBER 2002

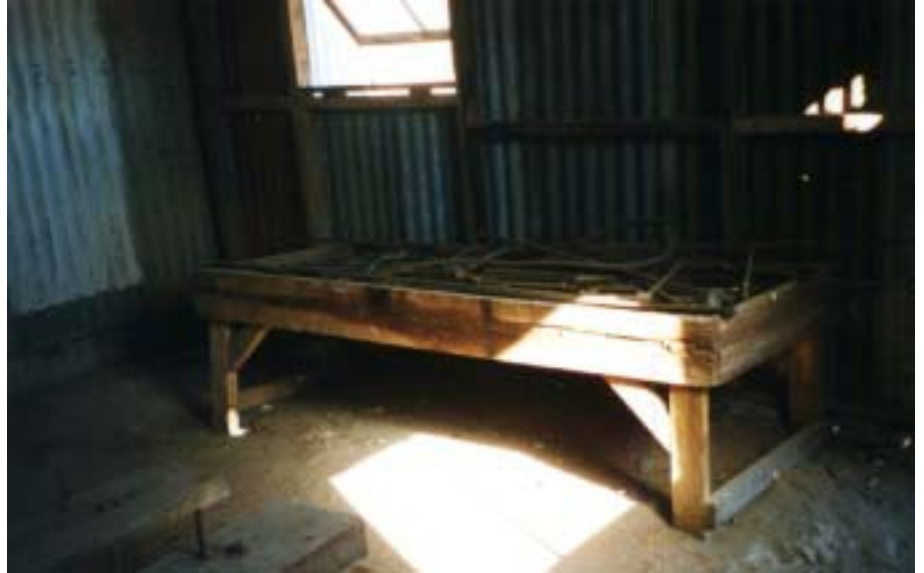
Figure 71
'Bed' in Engine Room with tools
on it.
AF 2001 photograph

BUSH BED

Pine 'bed', of simple and sturdy construction, 197 cm long by 90 cm wide by 58 cm high. Stretcher legged with corner bracing. Cross boarding timbers as bed base. Hand forged nails throughout. Various tools are stored on the bed.

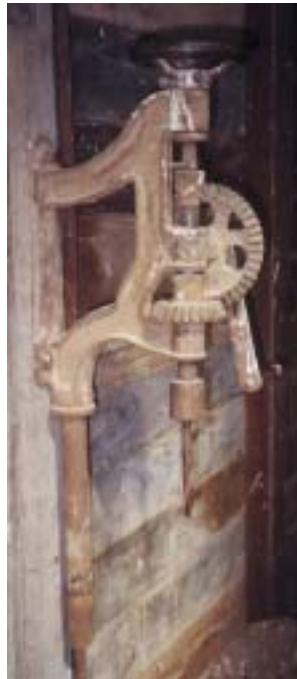
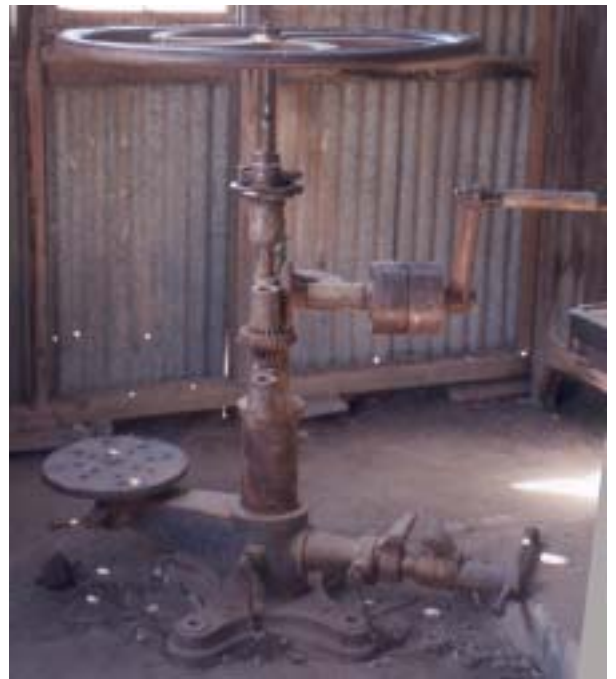
Figures 72 & 73
Wall mounted drill [left]; and drill
press [right].
PF 2002 photographs

DRILL PRESS

Large, floor mounted, cast iron, ratchet driven, with horizontal operating wheel to top. Extra parts missing, but in working order. Introduced by Bruce Bray from nearby 'Avon' as part of 1970s reconstruction.

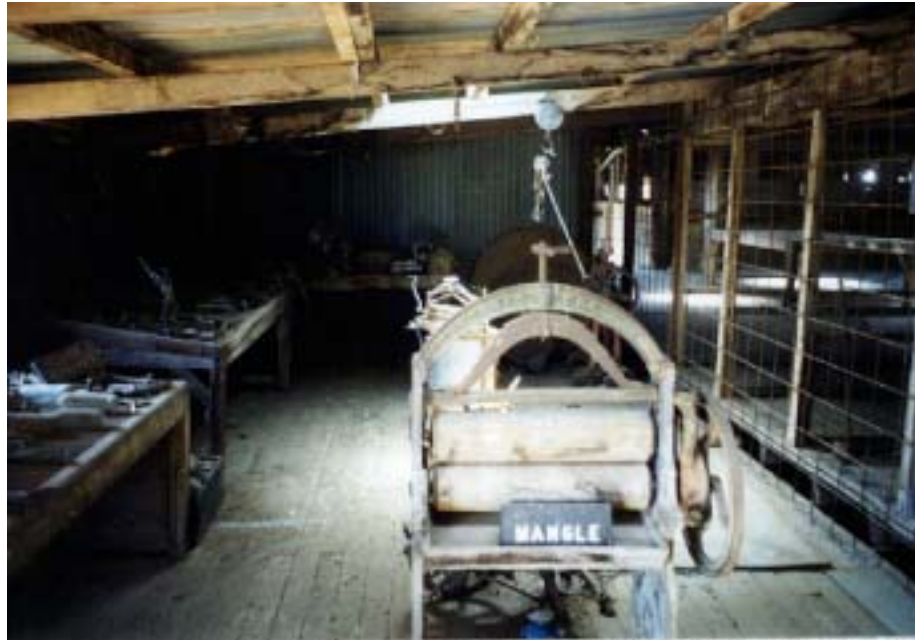
Figure 74
Artefact display within secured area
in Woolshed. Not all the artefacts
relate to Kinchega.
PG 2001 photograph

This 'secured' area is located at the left of the main woolshed entrance. The condition of all items is dry, dusty and distressed, both as a result of a long working life and their storage location. All items range from the late 19th to early 20th century.

There are three wool sorting tables in this area, similar to those previously described, and one which appears to be of earlier construction and is only about 1 m wide. Arranged on the latter table is a collection of kitchen paraphernalia including a metal bucket, large metal kettle, large cream enamel teapot, glass and metal based hurricane lamp, 10 gallon cast iron oval pot, a set of scales, 2 pint home made tin jug and a four blade metal electric fan. On the adjoining tables are a large quantity of items including coloured drinking bottles and a deteriorated collection of both large and small horse collars and other items of harness.

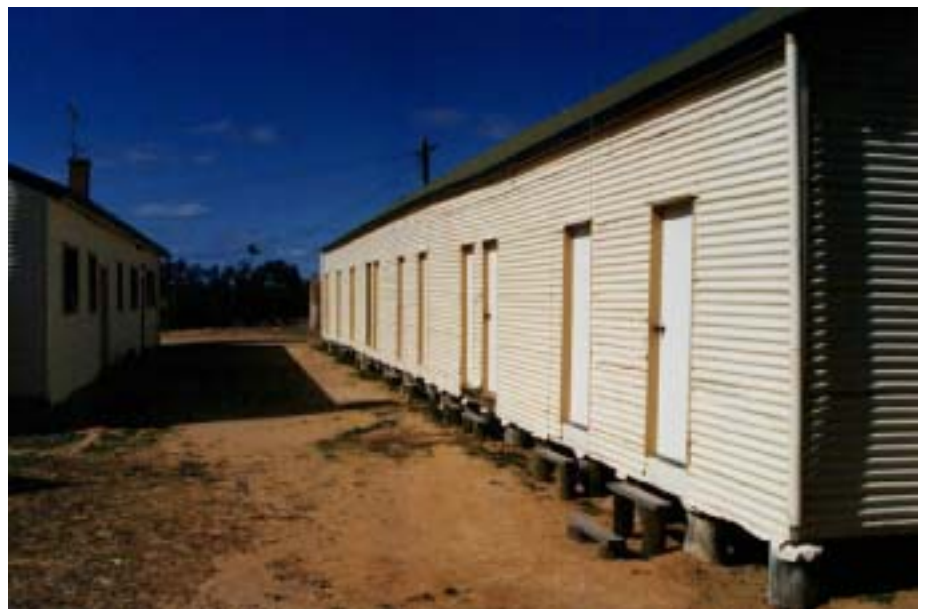
Figure 76
 Shearers' quarters prior to the
 addition of a verandah in 1994. The
 cookhouse is at left. Note the original
 steps.
PG 1993 photograph

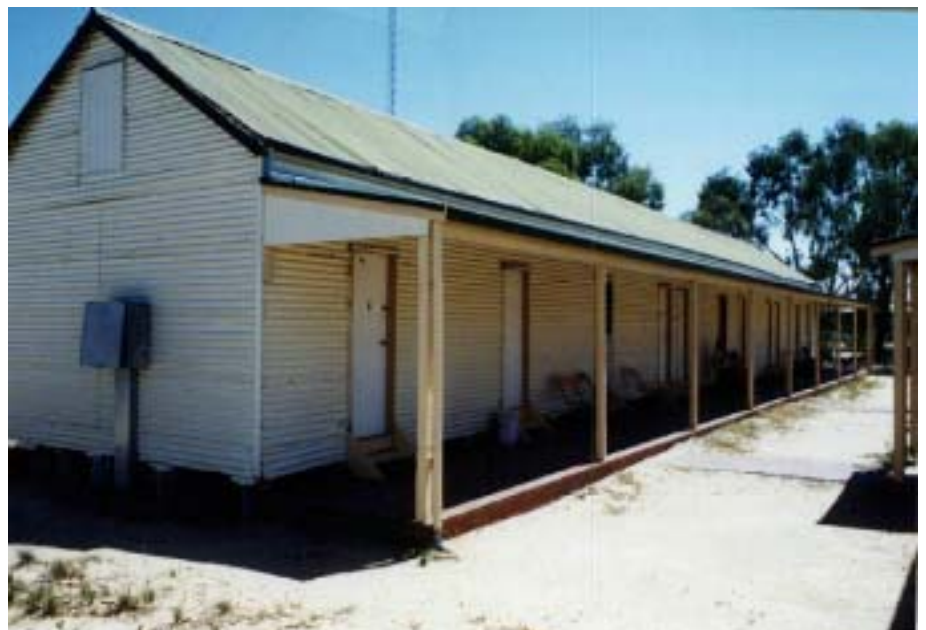
Figure 78
Shearers' quarters.
PG 2001 photograph

The nine rooms which remain in their original configuration are numbered 1 to 9; another two rooms, opposite the main door to the cookhouse [unnumbered], have been combined and fitted out to provide ranger kitchen/dining/living area. The building retains a number of its original ledged and braced timber doors [Rooms 1 to 5 and the two doors to staff room]; doors to rooms 6 to 9 have been replaced with hollow core doors. All rooms open to the north side. There is a modern aluminium screen door to the staff room.

The window openings and timber surrounds appear to be mostly original. It is presumed that the original windows comprised one fixed pane with a two pane sash beside. Some of these sashes have now been replaced with aluminium sash windows; other windows have had the whole window area replaced with sliding aluminium windows. Flywire screens to windows range from poor to fair condition. There are two vents in the wall above each window.

All the interiors have been resheeted with plasterboard and painted. Electricity and evaporative cooling have also been installed. Varnished particleboard has been placed over the original floorboards however the floorboards appear to be in reasonable condition. Window blinds are generally in poor condition. Accommodation rooms generally contain a bed and cupboard, none of which is

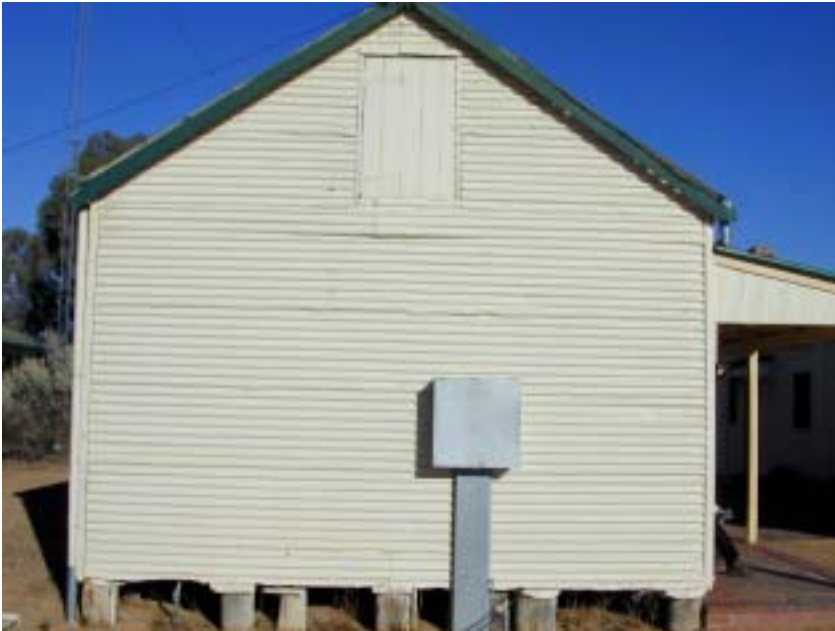
Figures 81 & 82
Shearers' quarters, detail of the north elevation [left]; and rear or south elevation [right].
PF 2002 photographs

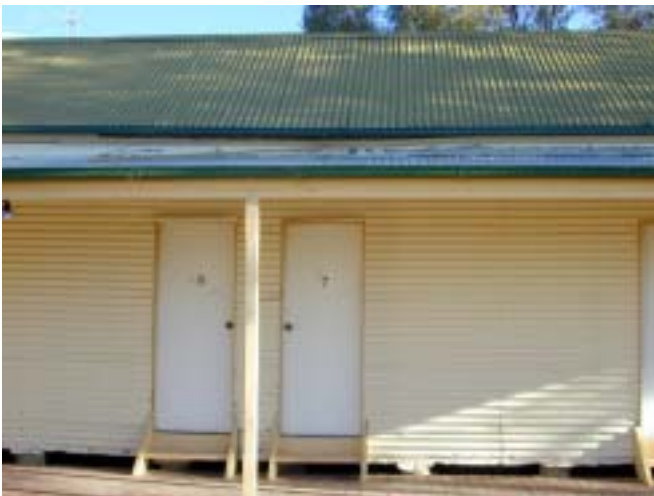
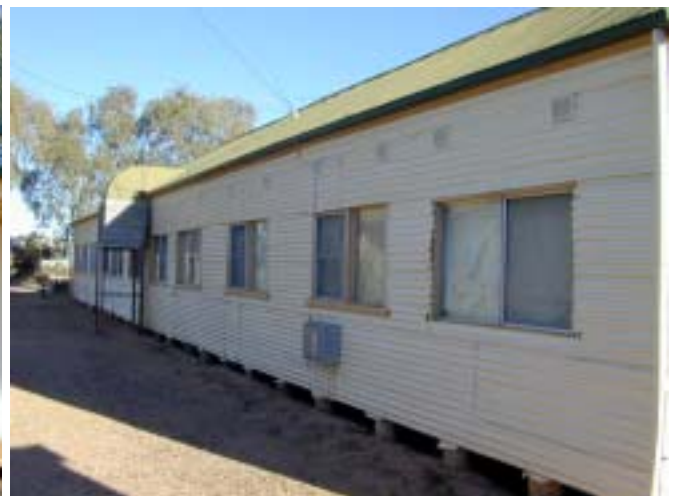
original. In 1994 a verandah, sympathetic in style to the original building, was added to the north side to make the quarters more comfortable in both hot and wet weather. The verandah is paved with bricks on a concrete slab. The original timber steps [visible in 1993 photograph above] were replaced with a new timber step in a different style as part of the verandah works.

The building is generally in good condition and retains a moderate level of integrity.

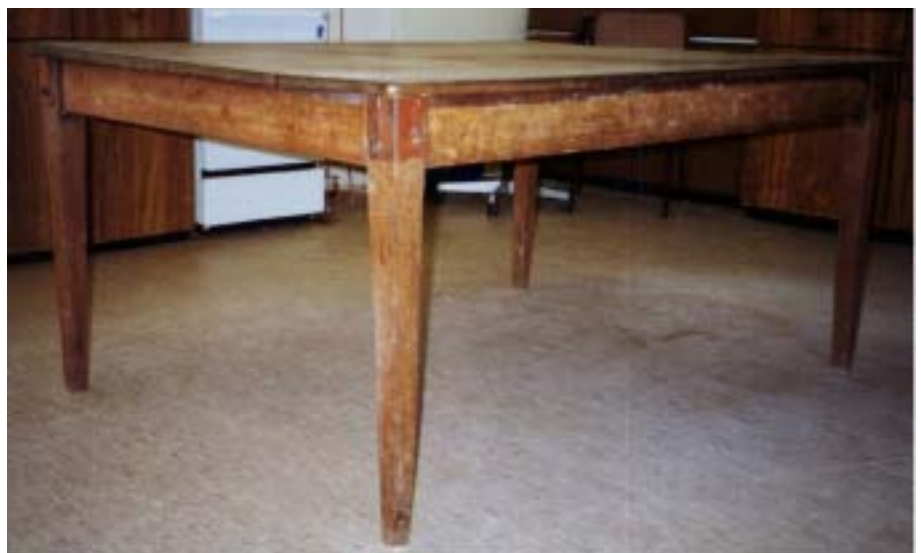
Figure 83
 Table in the NPWS staff kitchen/
 lounge area.
 PF 2002 photograph

There is a silky oak timber table to the staff room which may relate to the earlier use of the shearers' quarters. The table measures 110 cm by 161 cm. It has delicately tapered legs and has been reinforced with metal brackets at the corners.

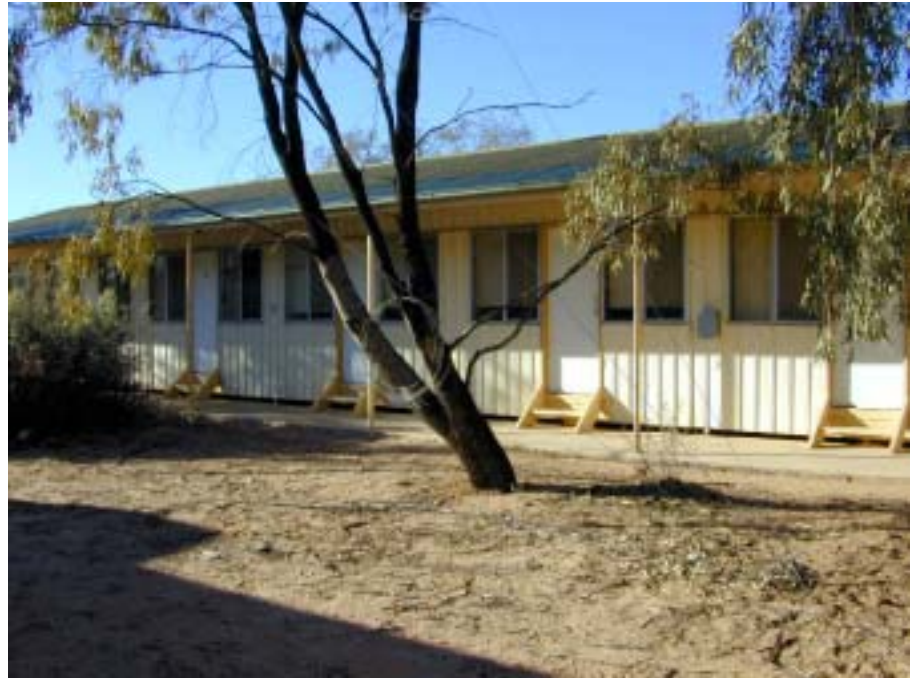
Figure 86
The c1950s shearers' quarters, north
elevation.
PF 2002 photograph

The building has a steel pipe and timber frame and is clad with vertically laid metal decking. The exterior walls have been painted mid green in the past however they are now cream. The corrugated iron roof and gutters have been painted green, the verandah roof is green Colorbond and the doors are painted white. There is netting to the tops of the walls to keep birds out of the roof space. The floor is constructed of steel trusses [the same as those used to extend the northern board of the woolshed] with timber joists and 80 mm wide floorboards.

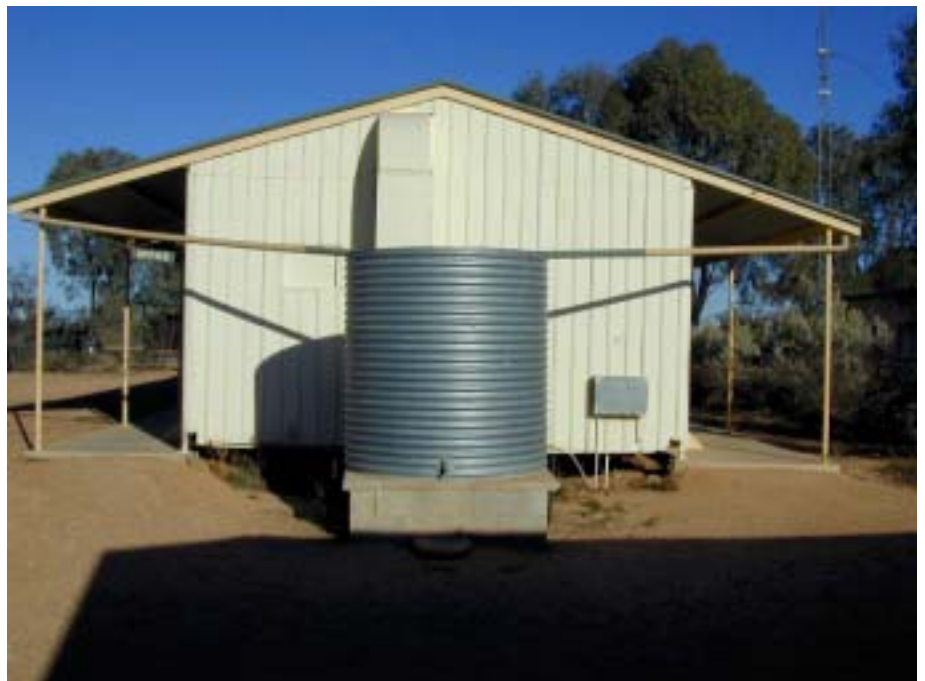
Figure 87
The c1950s shearers' quarters, east
elevation.
PF 2002 photograph

The building is generally in good condition and retains a moderate to high level of integrity.

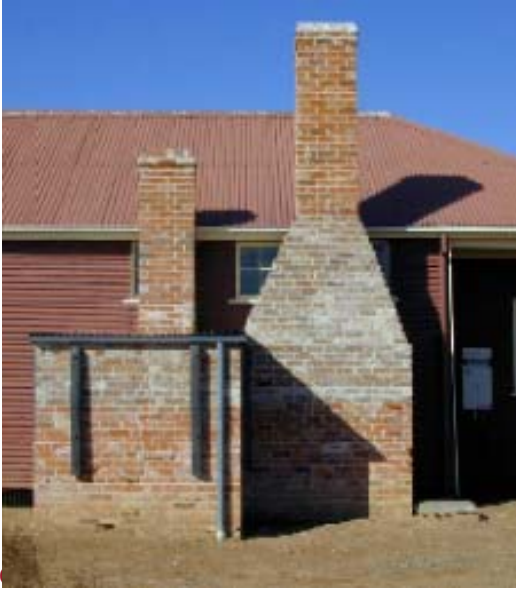
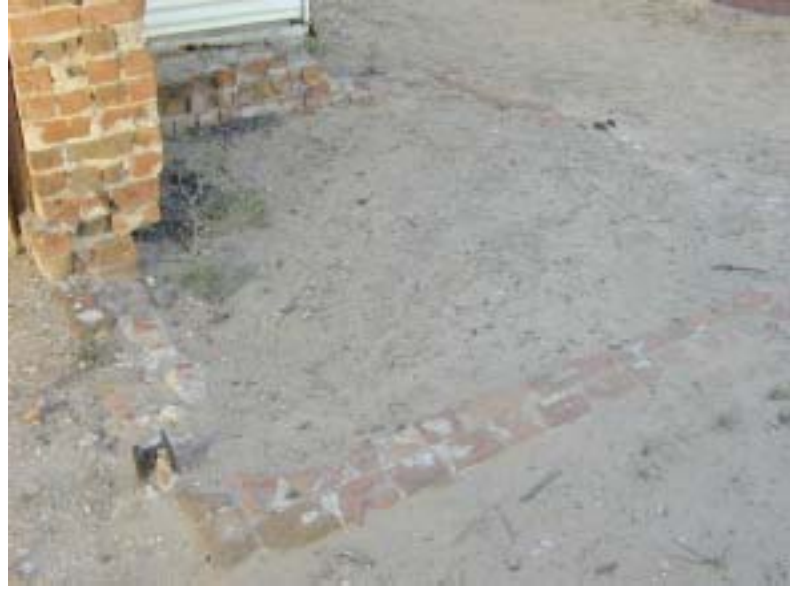
Figures 90 & 91
Willandra shearers' quarters,
baker's oven [left]; and the footings of
the Kinchega bread oven [right].
PF 2001 & 2002 photographs

The gable roof is clad with green Colorbond. Eaves are lined with strips of masonite. At the north-west [external] corner the footings and cut off steel support posts of a baker's oven can be seen. A similar extant baker's oven can be seen at Willandra Station.

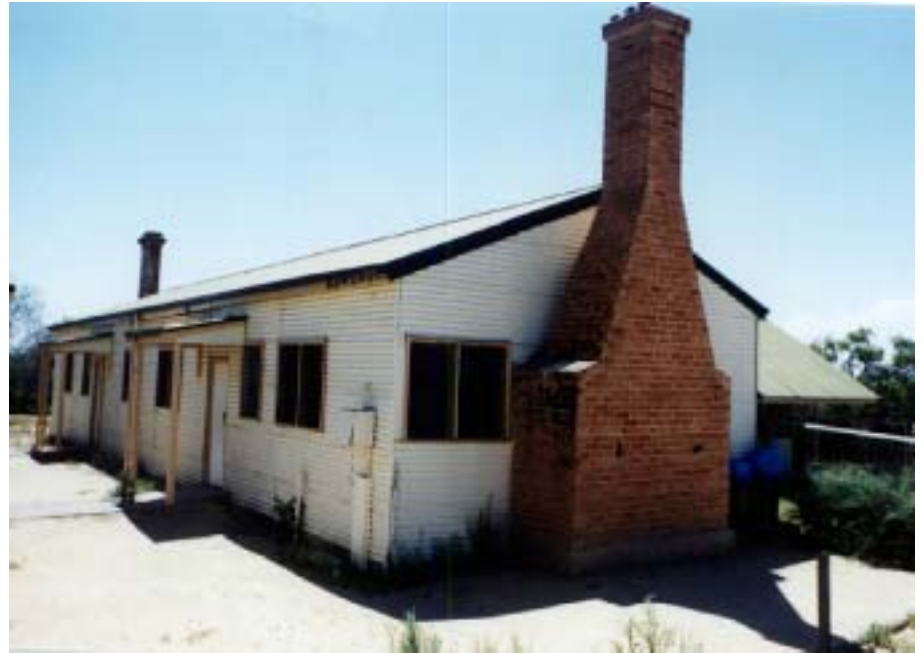
Figure 92
The Cookhouse from the east.
PG 2001 photograph

The windows are steel louvres, nine louvres high, in pairs or single sets. Not all the windows appear to be operable. Fixed flyscreens are in various states of repair. The windows generally require maintenance and repainting. The floor throughout comprises a concrete slab with linoleum covering and in the lounge area a carpet square. The walls and ceiling are clad with plasterboard, with quad to the joins rather than cornices. The extent of the fireplace opening to the lounge [former kitchen] is concealed behind the plasterboard wall and a metal baffle. The kitchen has a reasonably modern fitout, including a gas upright stove, gas cooktop, double stainless steel sink and extensive built-in benches with cupboards below.

The cookhouse is in fair to good condition. The building retains a moderate level of integrity.

Awnings were added over doorways in 1994 and cracks in the concrete floor slab repaired along with chimney repointing in 1998.

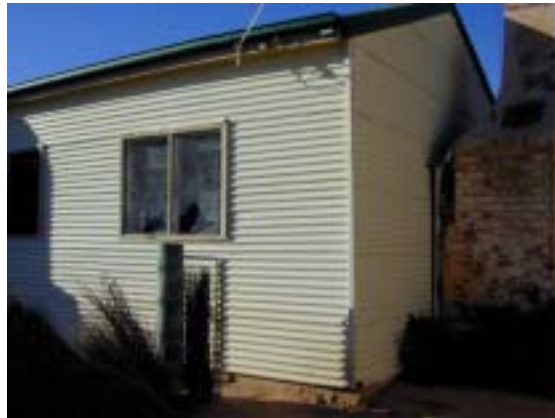
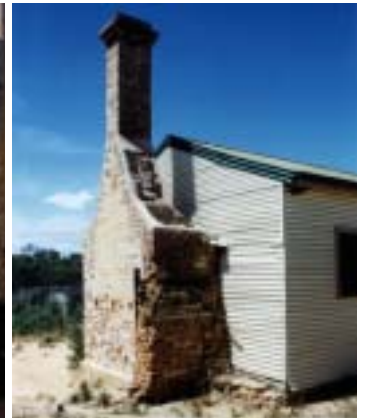
Figures 93 & 94
The western chimney to the
Cookhouse. This chimney is believed
to pre-date the existing building.
PF 2002 & PG 2001 photographs

The date of construction of the **cookhouse** is not known however Cox dates the western fireplace as circa 1880 and the eastern one of a later design. According to Peter Beven the cookhouse burnt down c1930s and was rebuilt.³ The eastern fireplace was probably built then and presumably the stove was inserted at the same time. Prior to this, the western fireplace with its adjacent bread oven was probably the location of the kitchen. The fireplace retains an iron bar for suspending cooking pots over the fire. The building was in poor condition when taken over by NPWS in 1967. The Cox report recommended adaptation as a museum however the building was adapted c1985 in a utilitarian fashion to continue its historic function of providing cooking and dining facilities for itinerant visitors.

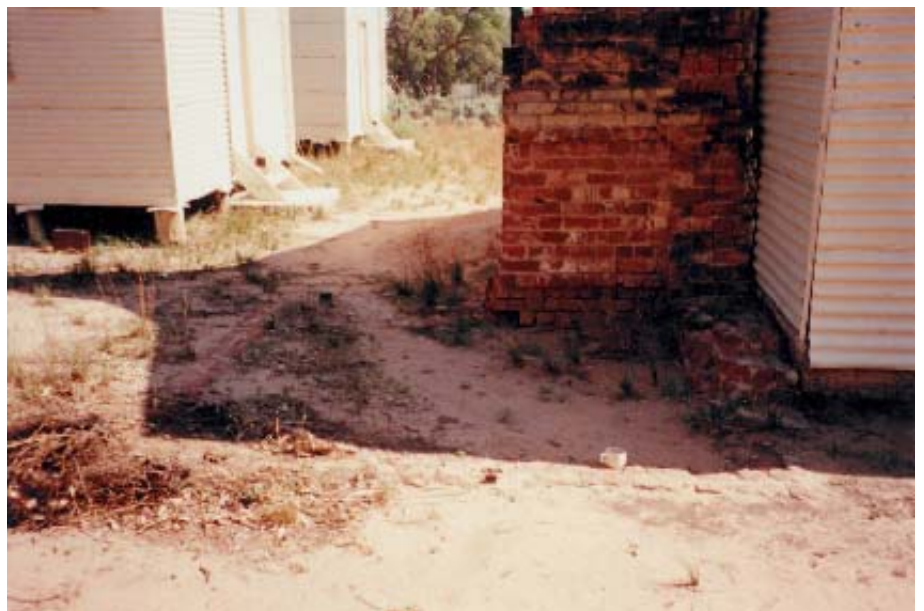
Figure 95
Brick foundations can be seen
adjacent to the existing chimney in
the Cookhouse building. This was
the former bread oven site.
SMT 2001 photograph

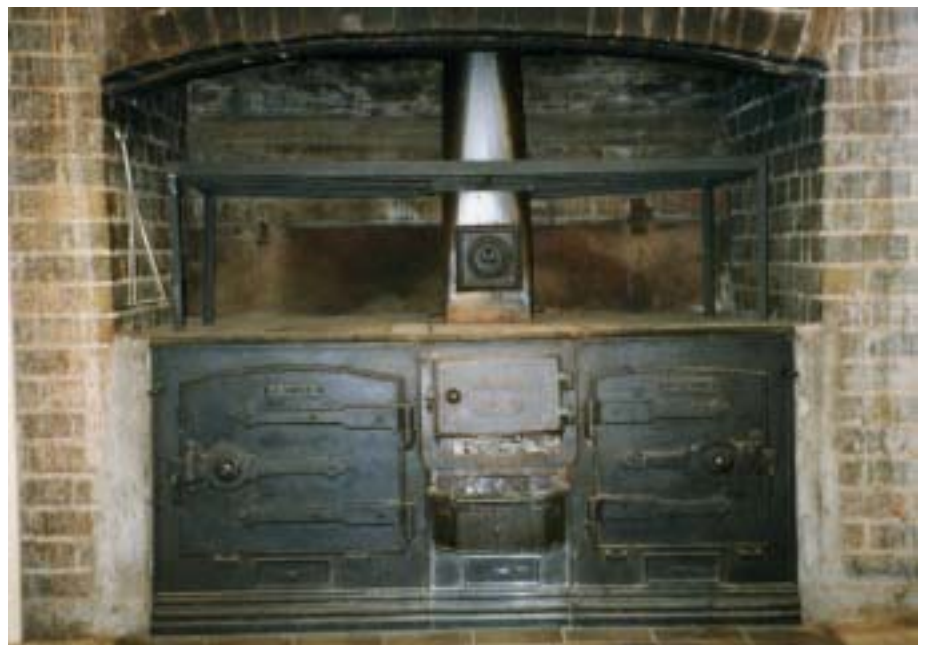
Figure 98
 Cast iron stove in the kitchen area of the cookhouse. Note how the Metters door is too short for the firebox.
 PF 2001 photograph

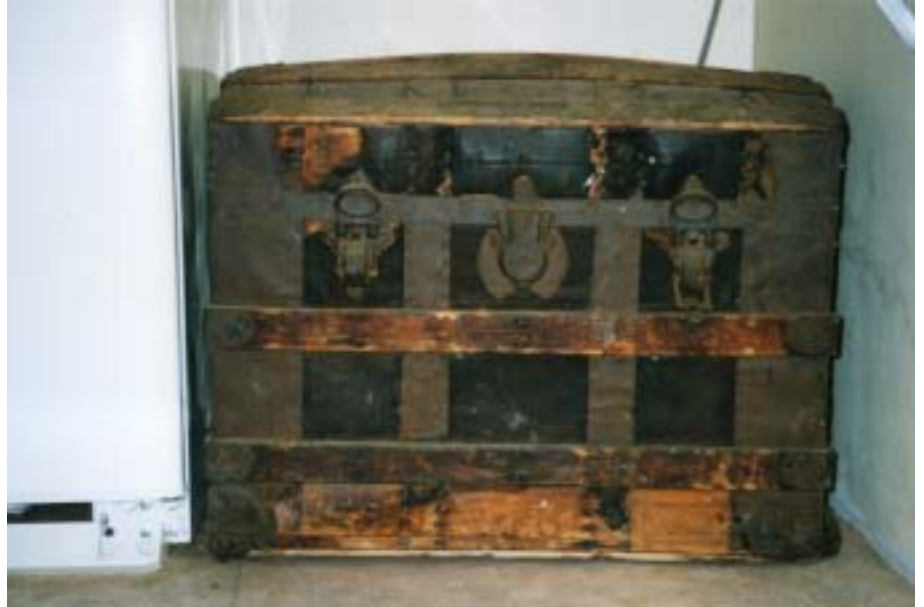
Figure 99
Chest in kitchen pantry of cookhouse.
This chest is apparently not related to
the historical use of the place.
PF 2001 photograph

Timber with metal reinforcing, curved top, remnant wallpaper lining, black [japanned] paint surface, two metal hinges and three metal fasteners. According to NPWS Ranger Lisa Menke, this trunk is supposed to have been purchased by a NPWS staff member, Dave Bearup, from an antique store in Broken Hill to be used as a table by a Greencorp crew who were working at Kinchege.⁴

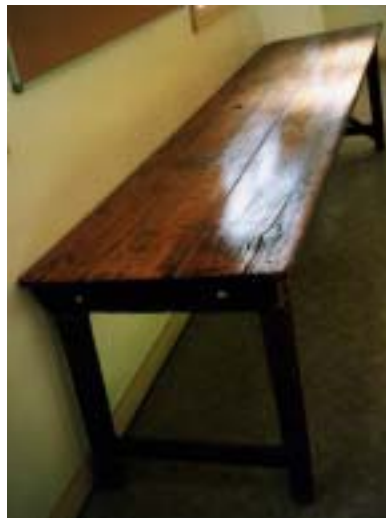
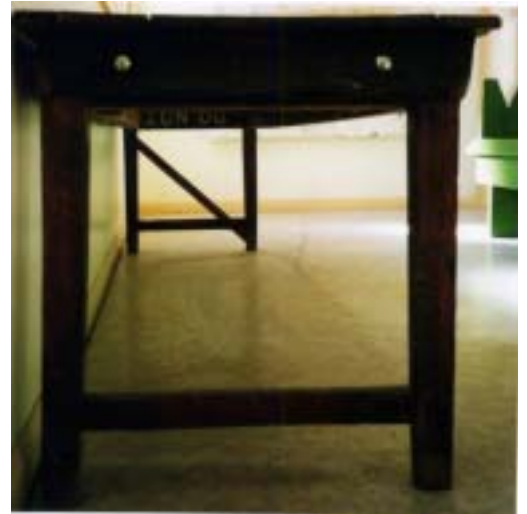
Figures 100 & 101
Table 1 in dining area of cookhouse.
Note the reinforcing under the table
using old signs. The words 'Do Not'
are just visible in the photograph at
right.
PF 2001 photographs

A laquered red gum table 3.33 m long and 72 cms wide. This table is one of two tables in the cookhouse and is the earlier, more primitive example. Stretcher legged form with slightly tapered legs. Showing water immersion line. The top comprises three planks, two of which are approximately 30 cm wide. Drawer to one end with battered brass knobs. Repair to drawer space at undersurface with recycled 'DO

NOT' sign. Condition generally good however a small corner piece has cracked off, probably from being lifted incorrectly.

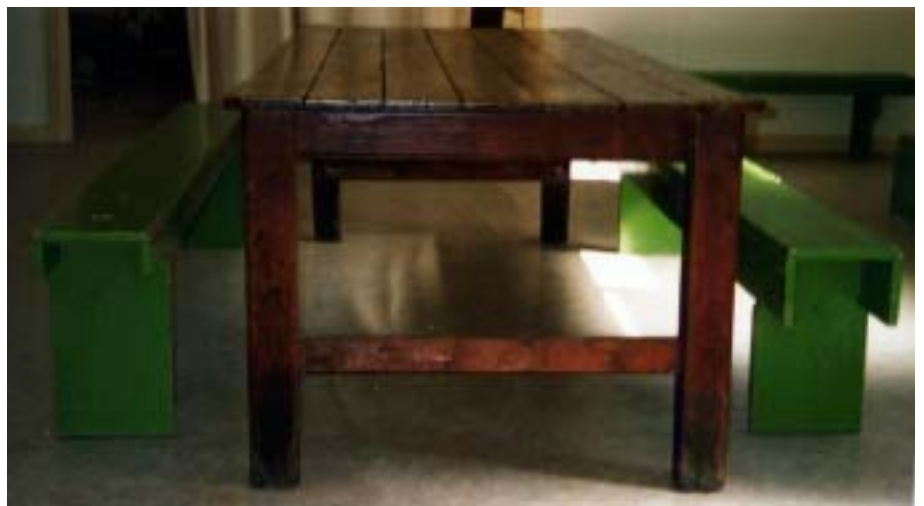
Figure 102
Table 2 and benches in cookhouse.
PF 2001 photograph

Square form stretcher legged lacquered red gum table 2.9 m long and 1.01 m wide. The top comprises seven planks. Cedar legs are secured by modern steel screws. Table top secured with hand forged nails. Good condition.

Five green-painted wooden benches approximately 3.6 m long. All benches have metal bracing connecting the legs to the seat. One has painted masonite on top of the seat. Generally in good condition.

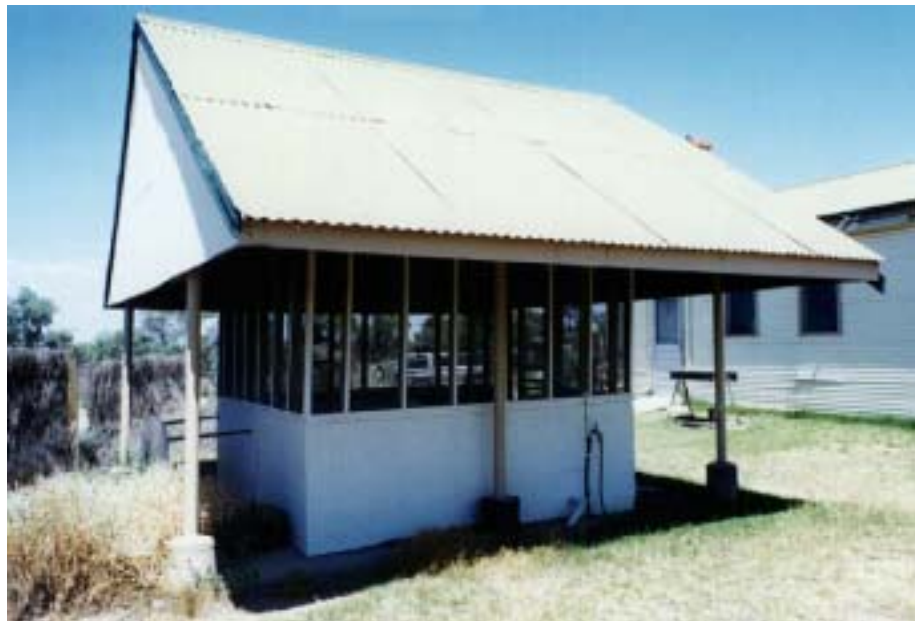
Figure 105
The meathouse.
PF 2001 photograph

The floor comprises a concrete slab and there is a narrow concrete apron around the perimeter of the building. A severe crack to the rear [north] masonry wall and outer slab allows access by small animals and insects. There are also cracks to the perimeter slab. The timber structure appears to be sound however there are holes in the flywire and there are bird droppings on top of the flywire section. A timber framed flyscreen door is out of plumb and unable to latch properly.

The building is in fair condition and retains a high level of integrity.

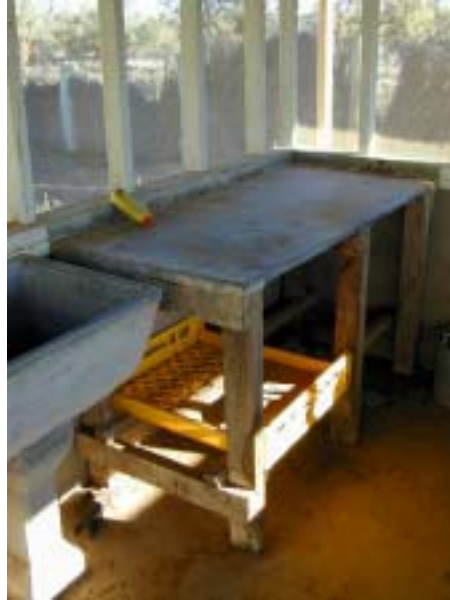
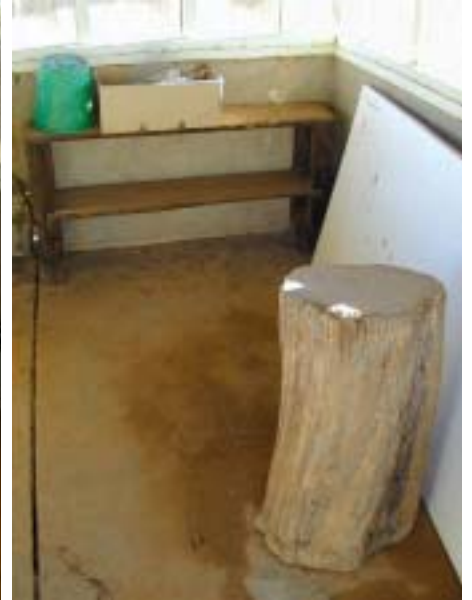
Figures 106 & 107

Inside the meathouse there is a large metal ring suspended from the ceiling [110 cm diameter], a chopping block [age unknown], a large built-in bench covered with metal sheet and a double concrete laundry trough with water connected. Electricity is also connected. The meathouse is painted to cream to match the other buildings. Cracks to the front of the building have been repaired in the past.

Interior of the meathouse showing the trough and built-in bench [left]; and the chopping block [right].
PF 2002 photographs

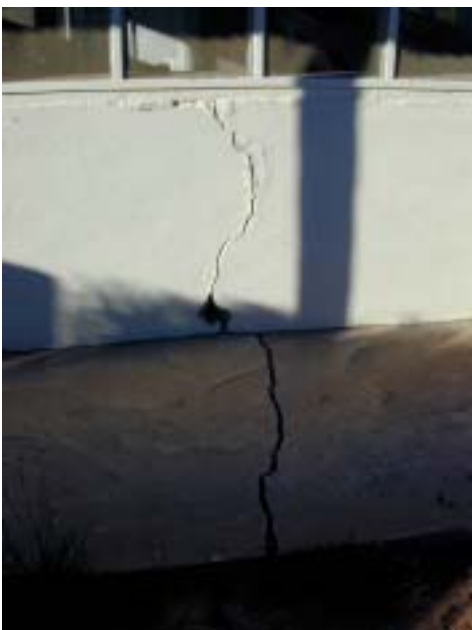
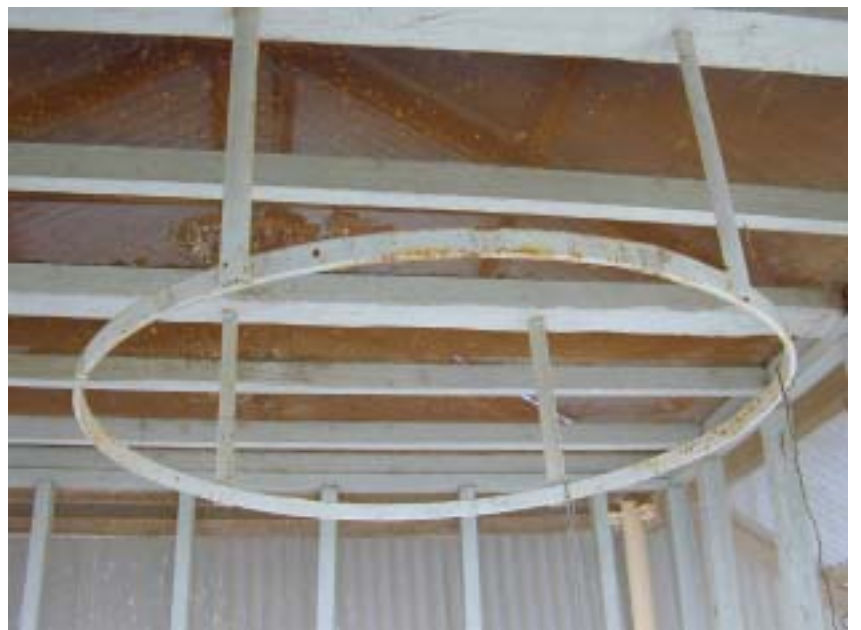
Crack to the rear [north] wall of the meathouse [left]; and the metal ring from which carcasses would be hung [right].
PF 2002 photographs

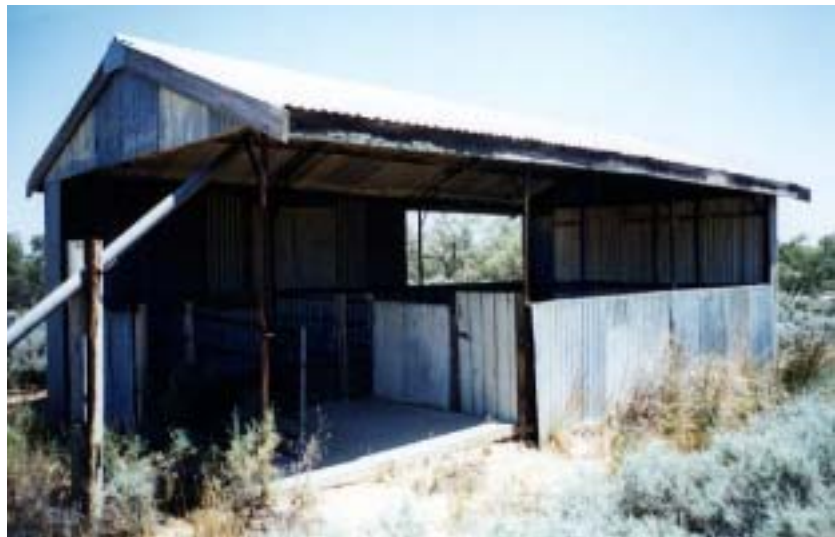
Figure 112
Killing shed.
PG 2001 photograph

The killing shed is constructed of steel pipe in four sections, with timber horizontal members between. Some of the timber horizontal members have rotted. The building is clad with vertically laid corrugated iron, some of which has been recycled. The floor is part earth, part decayed timber and part concrete. A pivot pole for suspending the carcass is adjacent.

The building is in fair condition. It is difficult to ascertain the integrity of the building as the extent of modification is not readily apparent, however, it appears to exhibit a moderate to high level of integrity.

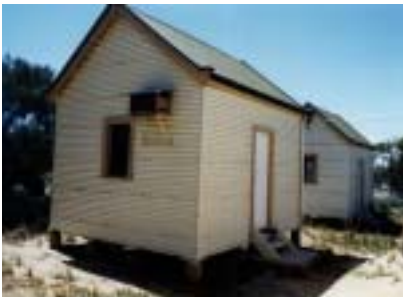
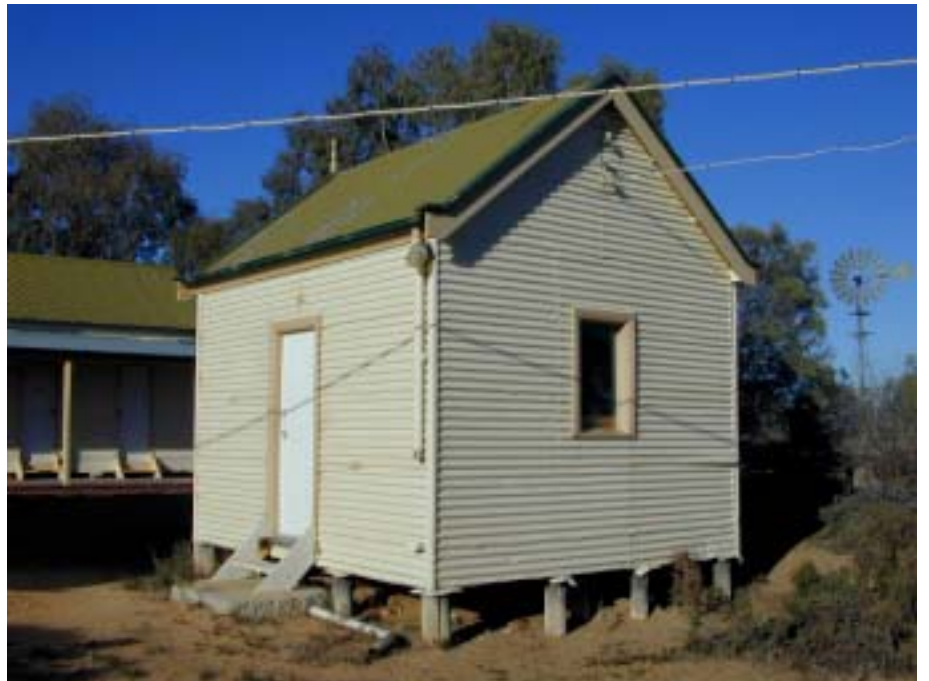
Figures 118 & 119
Expert's quarters south east view
[left]; and north-east view [right].
PG 2001 & PF 2002 photographs

The building has a timber frame on round timber stumps with metal ant caps and is clad with corrugated iron laid horizontally. The door is a ledged and braced with vertical boards and there is a timber step on a small concrete slab. The pitched gable roof is clad with corrugated iron and features timber finials to either end [one currently missing], and decorative barge battens. To either end wall there are metal framed louvre windows.

The building is generally in good condition and retains a moderate level of integrity.

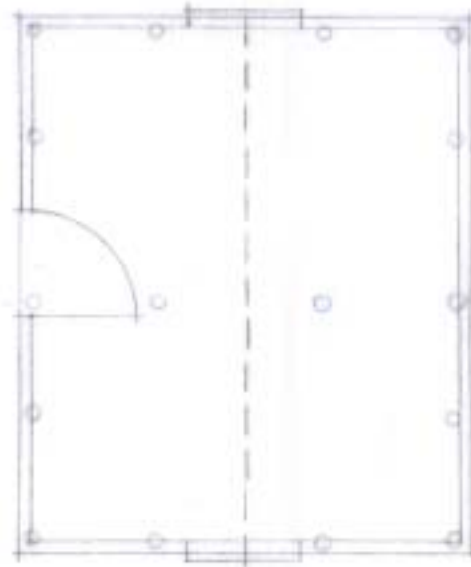
Figure 123

Floor plan of the classer's quarters.
PF sketch plan 2002

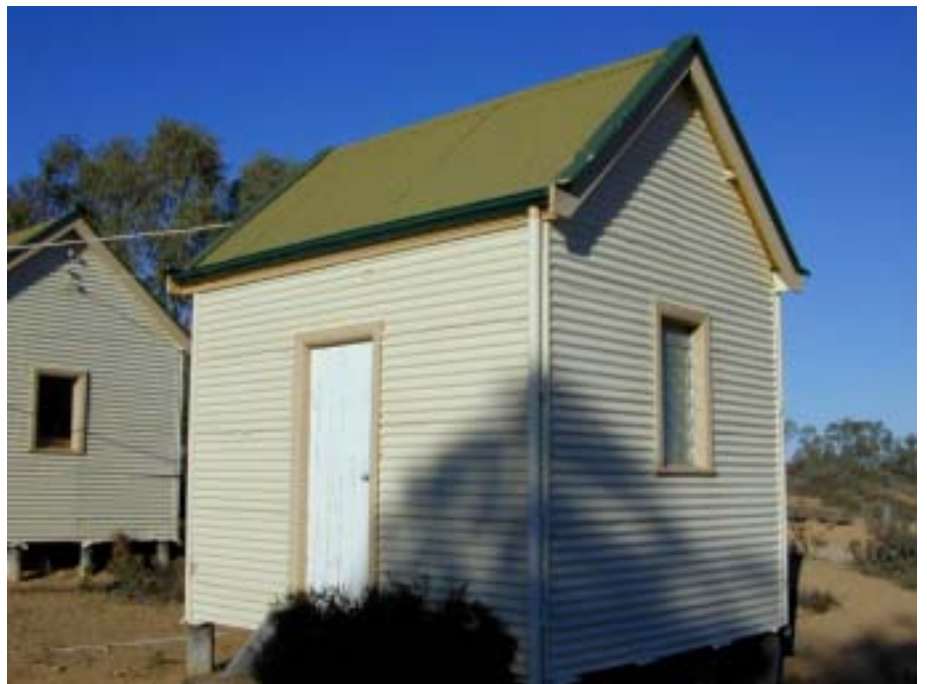
Figure 124

In 1970 the external walls and roof of the Classer's Quarters were corrugated iron in fair condition, ceilings and doors were missing, as were the finials. The building has been restored to match others in the precinct [without its finials].

The building is generally in good condition and retains a moderate level of integrity.

Classer's quarters, north-east view.
PF 2002 photograph

Refer conservation policies for Kinchega Station Woolshed &
 Shearers' Quarters Group generally, page 63 above.

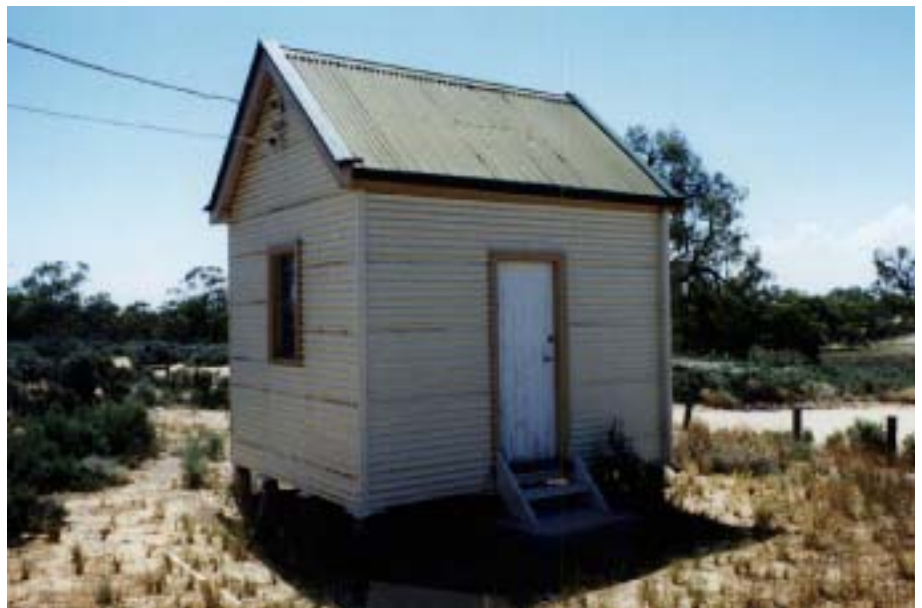
Figure 125
 Classers' quarters south-east view.
 PG 2001 photograph

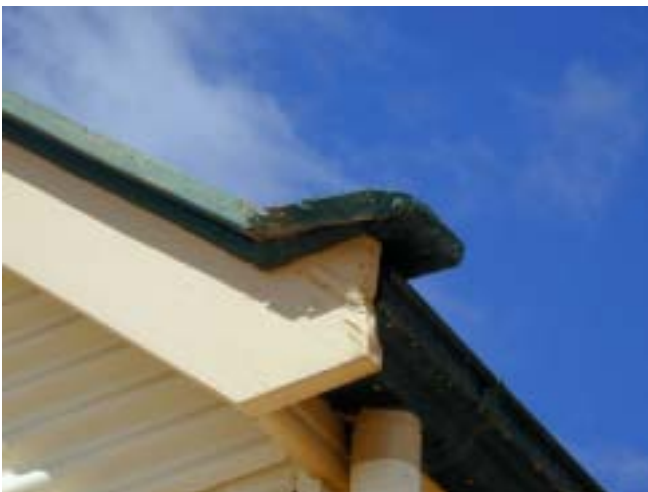
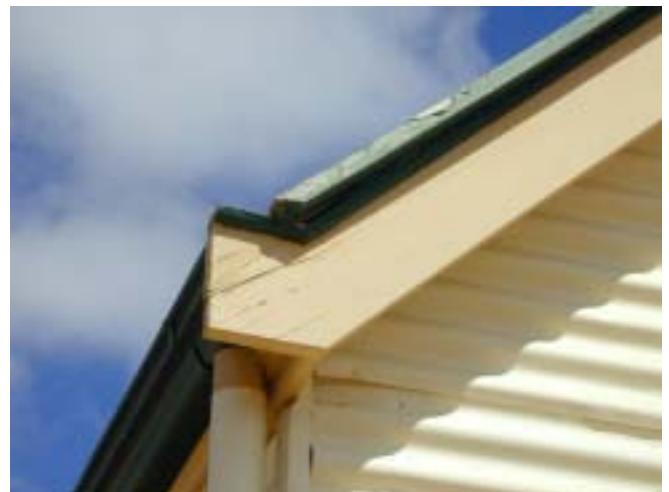
Figures 126 & 127
 Classer's quarters, gable details.
 PF 2002 photographs

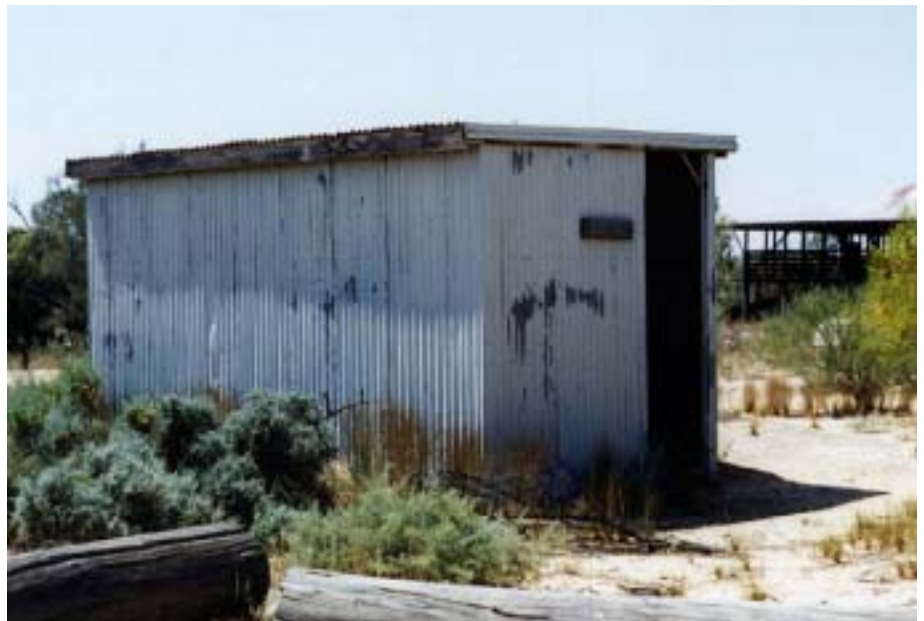
The date of construction of the **Pit Toilets** is unknown however given their steel frame they are possibly c1950s. The 1970 Cox report recommended demolition of this building. The building is located on a rubbish dump which is likely to pre-date the building and has archaeological potential.

The building is generally in good condition and retains a moderate level of integrity.

Figure 130
 The 'long drop' toilet block.
PG 2001 photograph

Refer conservation policies for Kinchega Station Woolshed & Shearers' Quarters Group generally, page 68 above.

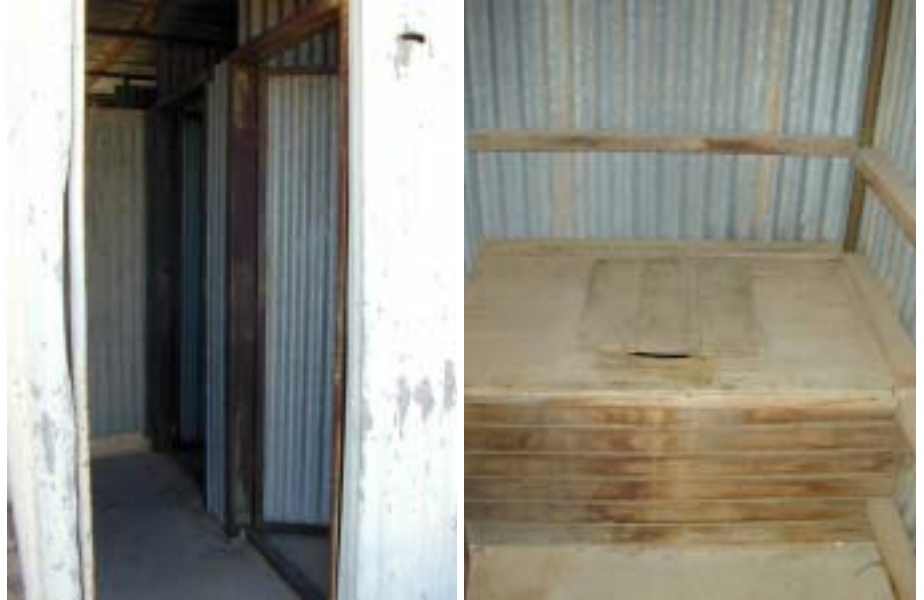
Figure 131 & 132
The 'long drop' toilet block, interior.
PF 2002 photographs

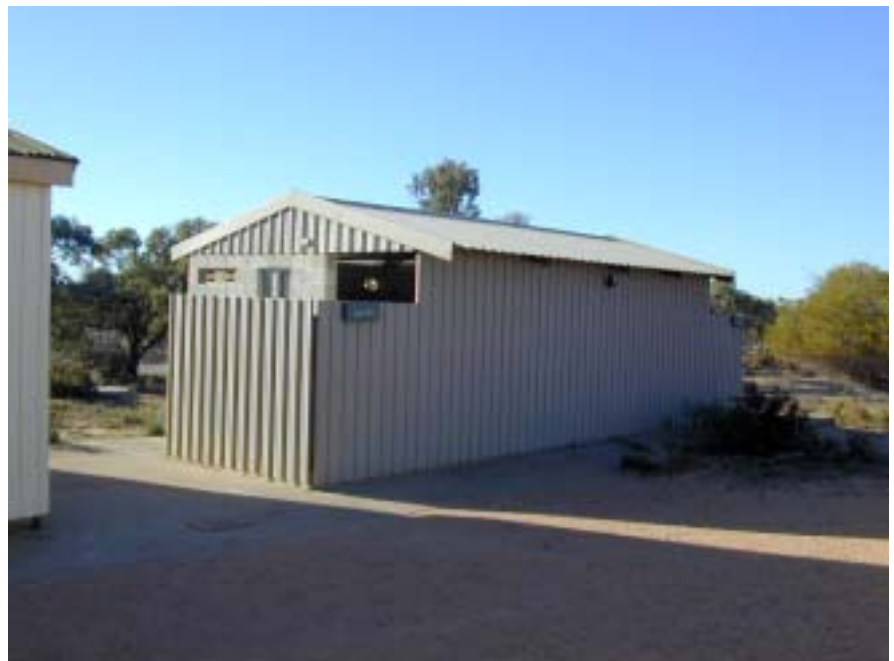
A toilet block constructed of concrete blocks with a low pitched gable roof clad with grey metal decking. The toilets are divided into Male and Female: there are two pans, a urinal and handbasin in the male section; and three pans and a handbasin in the female section. The floors are tiled and the walls painted internally.

Figure 134
 The modern toilet block from the north-west.
PF 2002 photograph

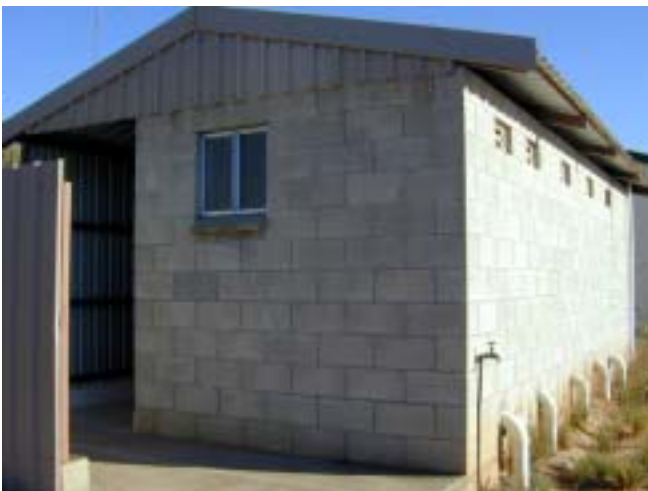
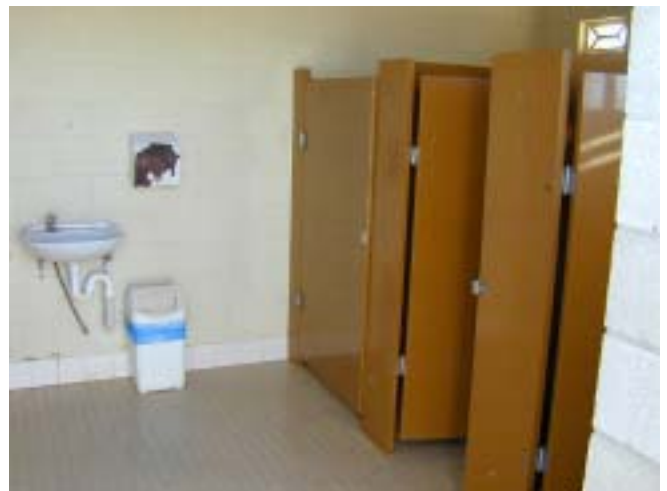
Figures 136 & 137
The modern toilet block from the
south-east [left]; and interior view.
PF 2002 photographs

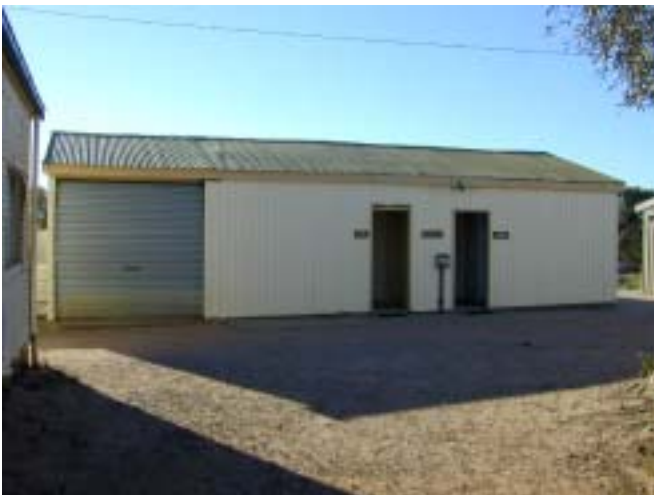
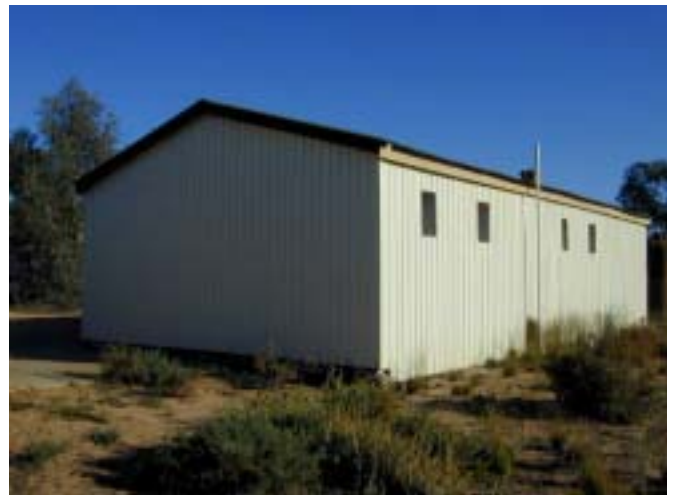
Figures 140 & 141
The shower block from the west [left];
and from the south-east [right].
PF 2002 photographs
