**FORMER KINCHEGA STATION SITES • KINCHEGA NATIONAL PARK
CONSERVATION MANAGEMENT & CULTURAL TOURISM PLAN
VOLUME 1 • THE PLAN**

PREPARED FOR THE
NSW NATIONAL PARKS & WILDLIFE SERVICE
BY:
PETER FREEMAN PTY LTD
CONSERVATION ARCHITECTS & PLANNERS
CONSULTANT TEAM

FINAL
SEPTEMBER 2002

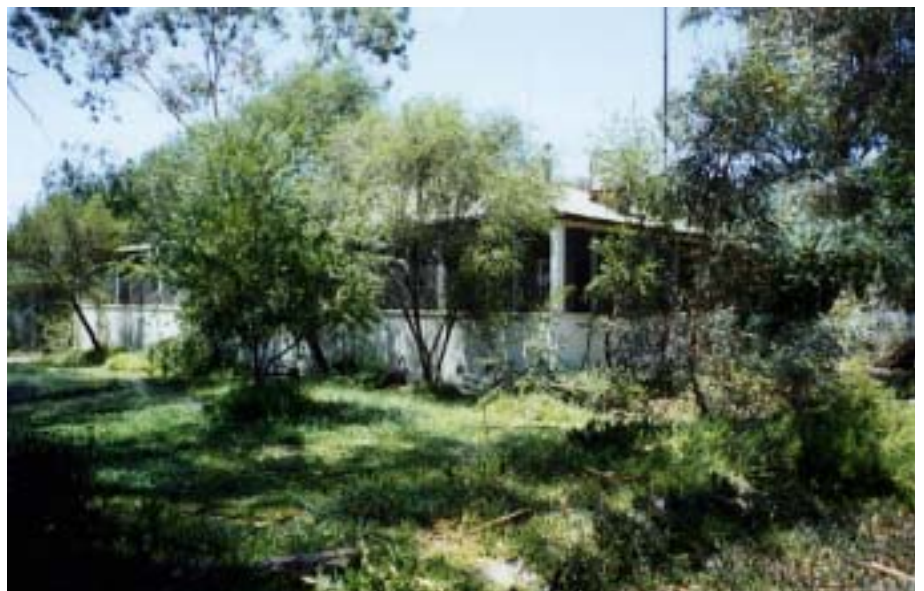
PLACE/ITEM NAME	Kincheга Manager's Residence & Outbuildings
REGISTERS	NPWS HPR : Not registered NPWS ASR : Not registered
LOCATION	The north bank of Emu Creek and north of the Woolshed group.
HISTORICAL BACKGROUND	This building was built c1950 when the Kincheга Homestead [No. 2] was no longer functional.
DESCRIPTION	<p>This mid twentieth century building is typical of many rural homesteads constructed in the western region. Strategically located near the woolshed, it was enclosed with a colorbond fence in the 1990s and landscaped with native plants and bushes.</p> <p>Adjacent and to the rear of the Manager's Residence are several metal sheds and workshops housing NPWS equipment. An area within this works compound has been set aside for the storage of Aboriginal artefacts accumulated over the thirty-five years of NPWS management. Beyond these outbuildings is a functional earth airstrip.</p>
CONDITION	The building is in fair to good condition and appears to retain a moderate level of integrity [not able to be inspected].

Figure 142
New manager's house.
PG 2001 photograph

There are no specific policy recommendations relating to the Former Manager's Residence.

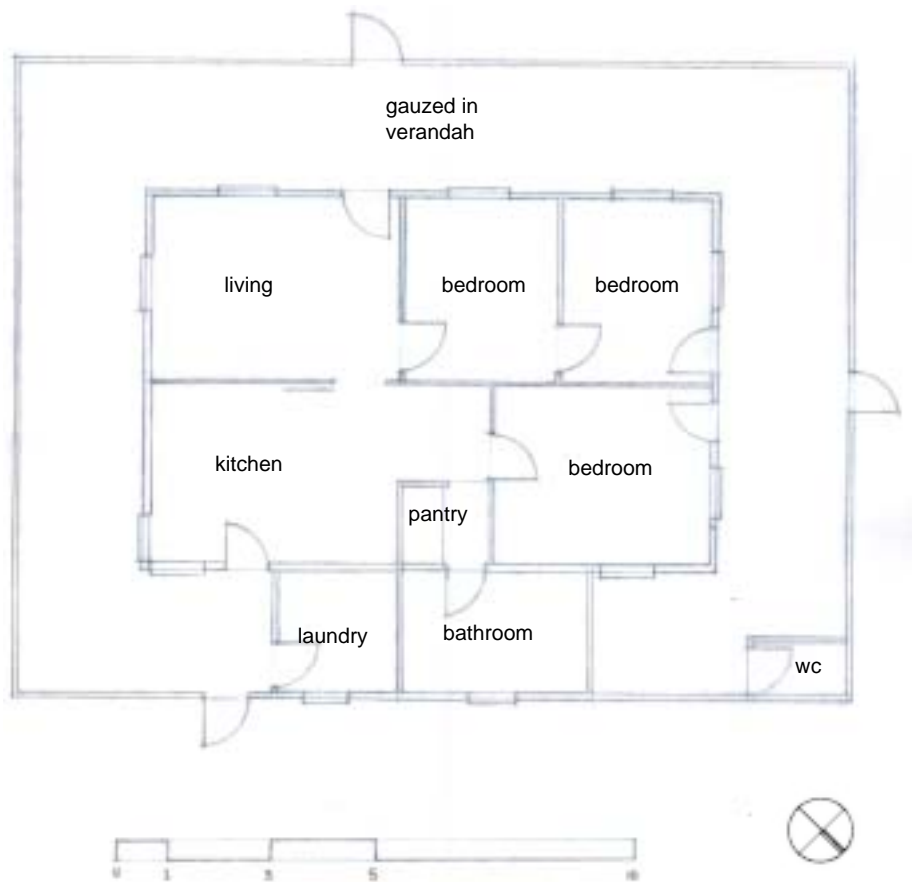
Figure 143
 Floor plan of the former Manager's
 Residence.
 NPWS 1981 plan

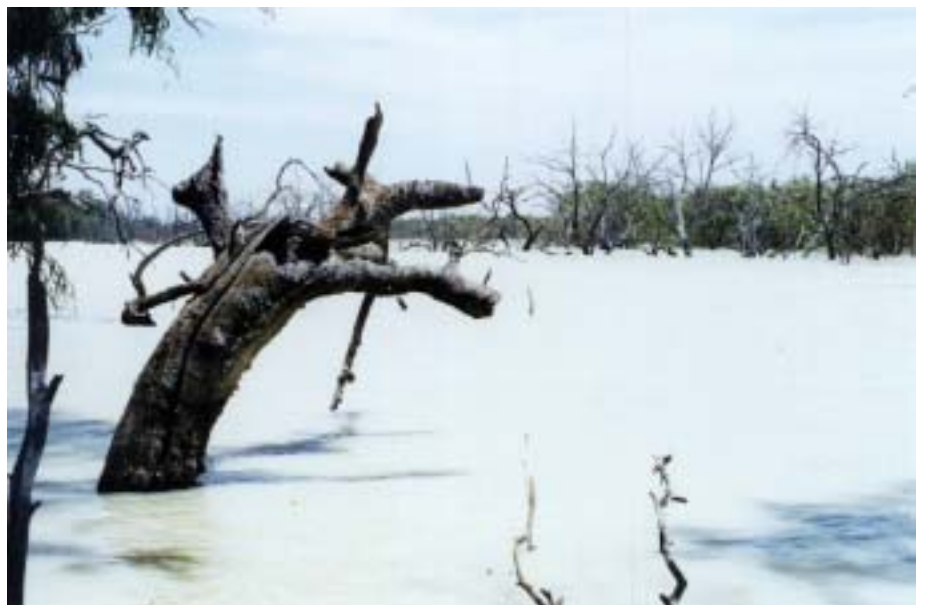
The stockyards are usually all or partly submerged, however as a result of dry conditions during 2002 the yards have been fully exposed. The yards are sheepyards which are very similar in configuration to the Kincheega Woolshed yards. There are four large holding pens arranged in a square. In the central portion of these there are smaller pens for working the sheep, drafting, drenching etc. The outer yards comprise slender sapling uprights with closely spaced holes drilled through them to accommodate strands of wire. The inner, working section of the yards comprise more sturdy upright logs with pairs of holes through which wire was threaded, presumably to secure horizontal saplings.

Figure 5
The site of the submerged stockyards in 2001.
PF 2001 photograph

The sheeppads are in remarkably good condition considering that they have been inundated for many years. The site retains a moderate level of integrity, the layout of the yards is still highly visible. No conservation works are proposed for this site which is usually inundated.

Interpret the former Stockyards, and their connections with the woolshed and the Kinchega Station generally. Interpretation should be in association with the proposed Morton Boolka walk. There may be scope for interpretation of the Stockyards and Telegraph Line in the context of the further development of the Morton Boolka Picnic Area. Generally speaking, priority should be given to the interpretation of things which are accessible, or at least visible to visitors. In this case, those would be the landforms that made this the easiest crossing of Cawndilla Creek, prior to the present Lakes Regulation System. The broad consequences of the introduction of that system on the movement of stock and the subsequent reconfiguration of Kinchega Station are, perhaps, the main stories here, as is the Stockyards question, i.e. 'Where are they now?'. These themes would be the basis for the Stockyards signs.

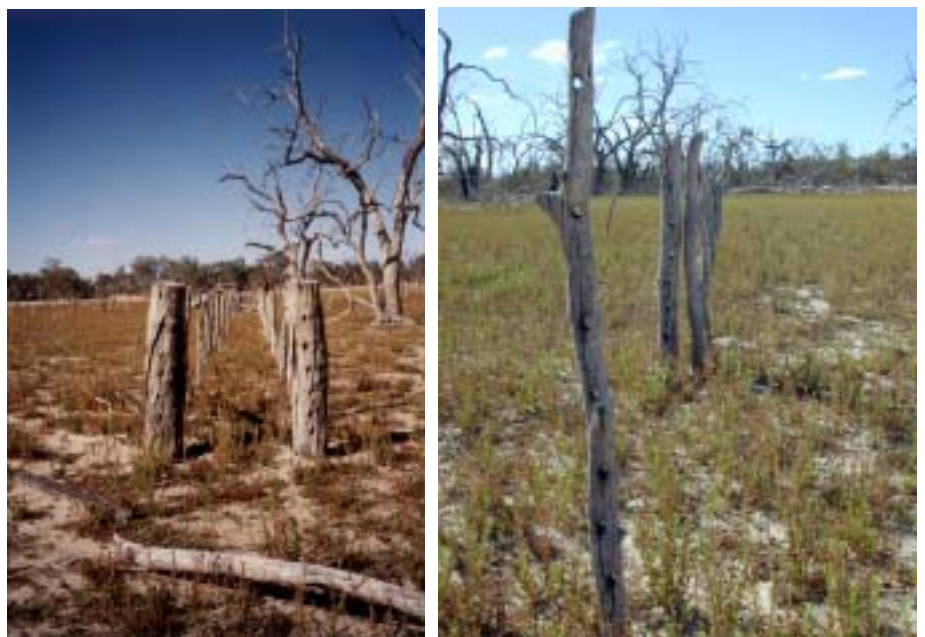
Figures 6 & 7
Race, Kinchega sheeppads [left]; and
detail of posts which make up the
four outer yards.
PF 2002 photographs

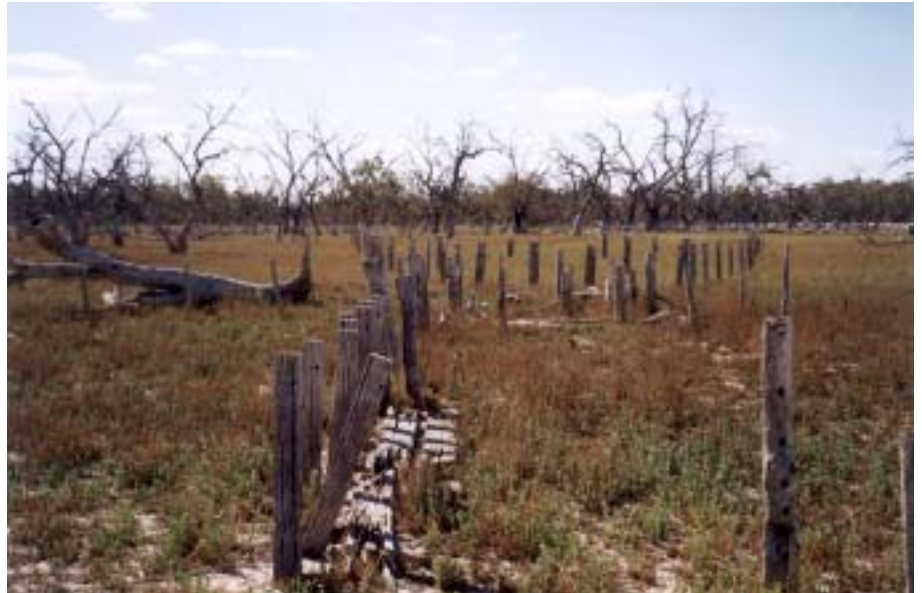
Figure 8
Kinchega sheepyards, looking north
from the centre of the yards.
PF 2002 photograph

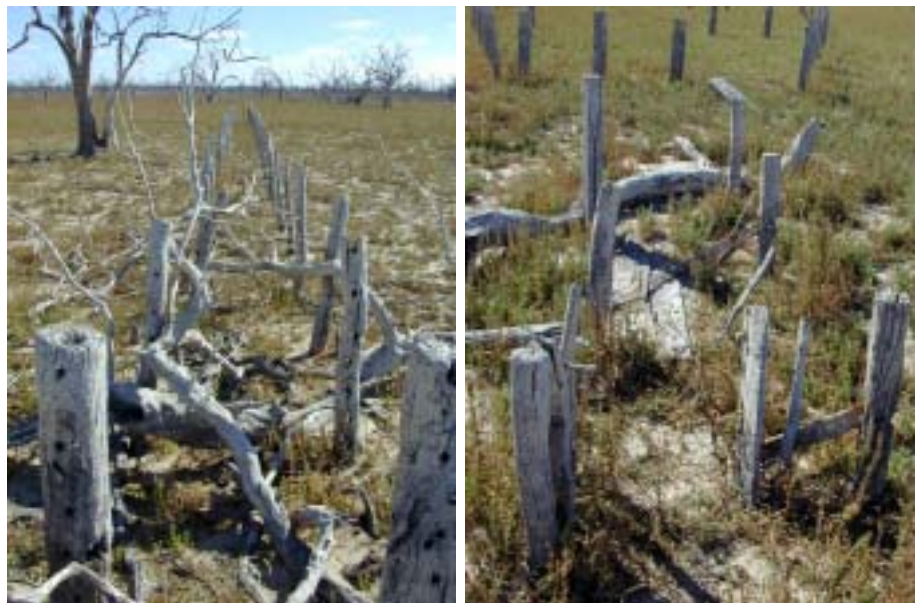
Figures 9 & 10
Kinchega sheepyards, details.
PF 2002 photographs

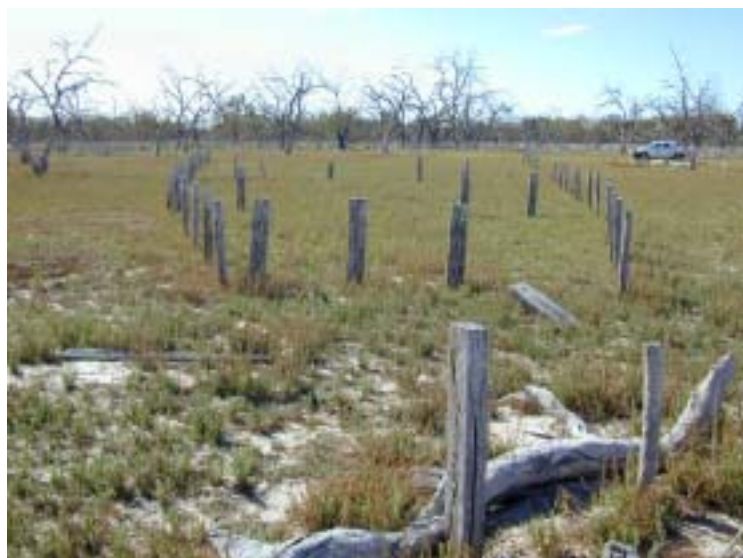
Figure 11
Kinchega sheepyards, looking north
from the centre of the yards towards
a central 'funnel'.
PF 2002 photograph

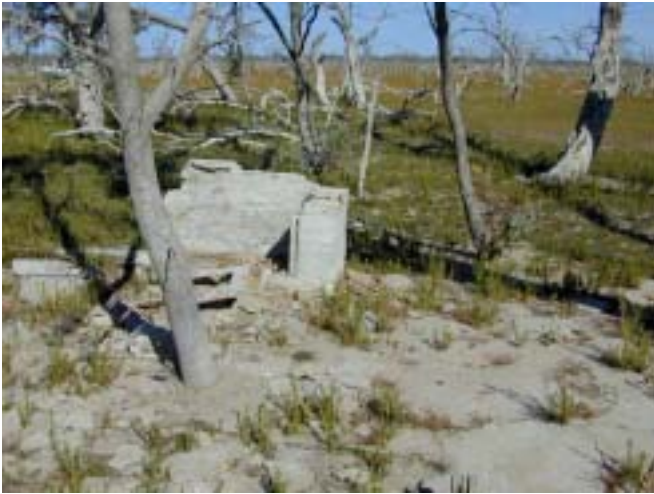
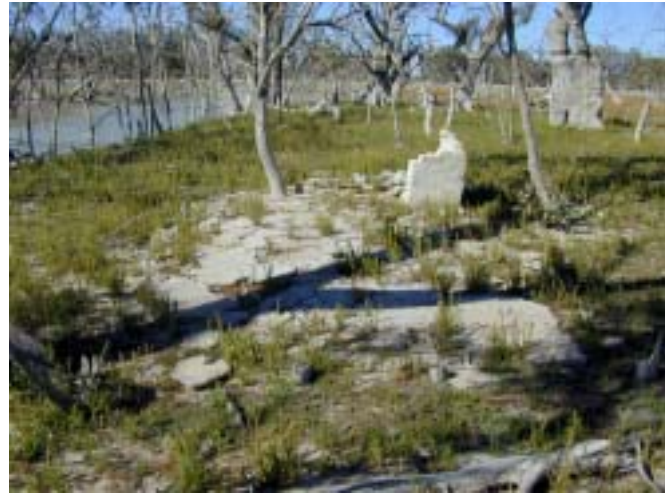
To the north of the sheepyards, on the banks of Cawdilla Creek, there is a hut site which comprises the remains of a concrete slab floor and fireplace, pieces of cast iron stove, bottles and brick scatters. Nearby [to the west] there are the uprights of what was once probably an associated shed. A short distance away to the east, there is a evidence

Figures 12 & 13
Hearth at hut site to the north of the
sheepyards, on the bank of
Cawndilla Creek.
PF 2002 photographs

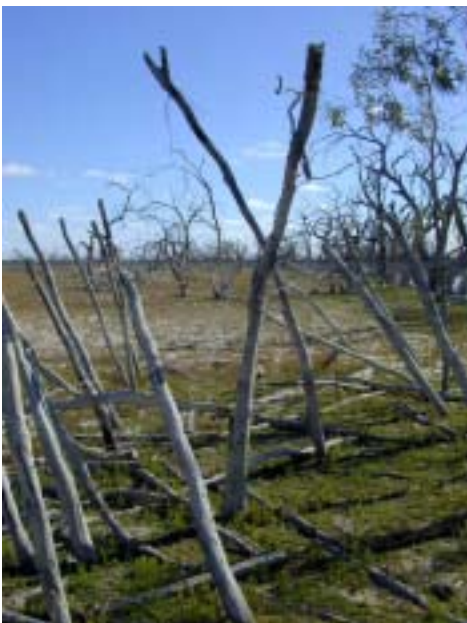
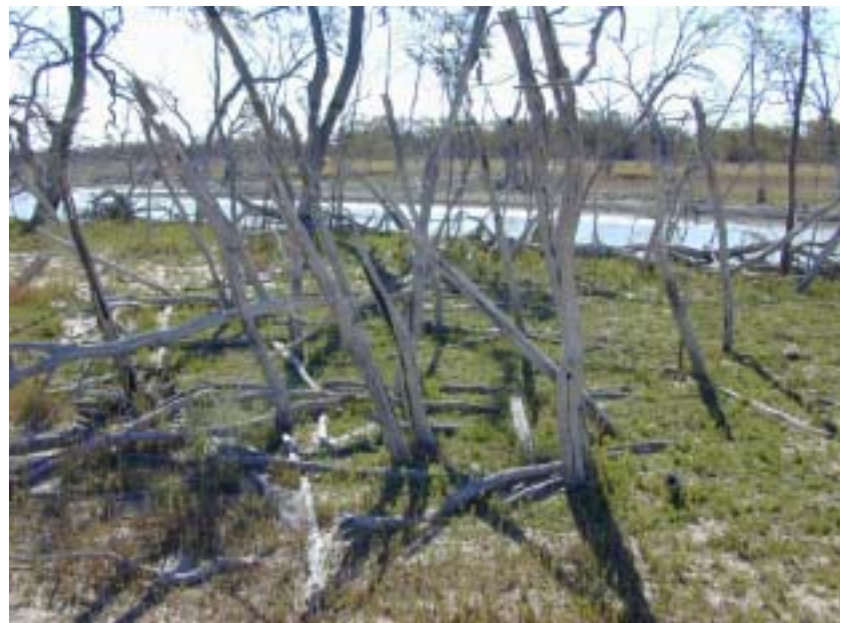
Figures 15 & 16
The remains of a former shed, west of
the hut site.
PF 2002 photographs

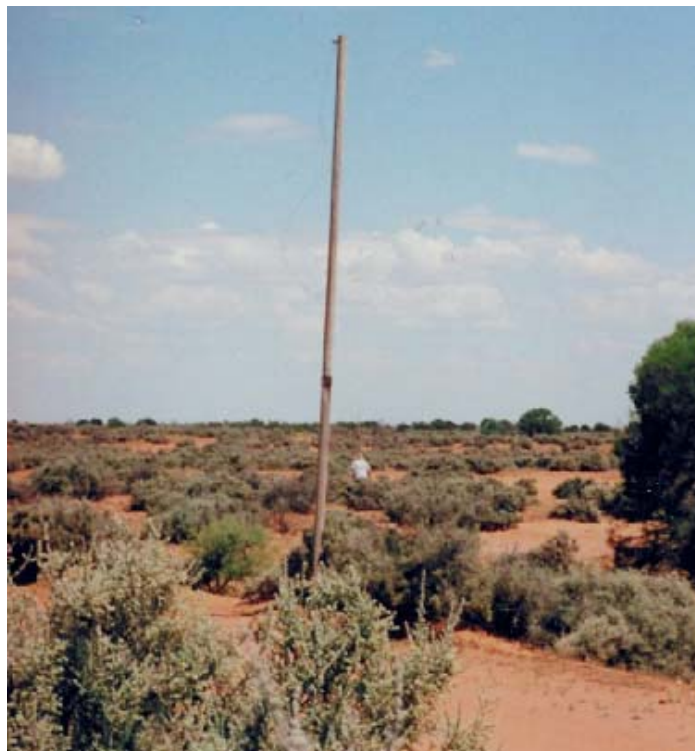
The telegraph line is of low integrity and the remnant posts are in poor condition with most poles fallen or non existent. Little of the wire and insulators remain.

Figure 17
Telegraph pole of galvanised pipe
SMT 2001 photograph

Several of the poles closest to the road should be conserved and interpreted to prevent damage through ignorance. The route does not appear on maps and so should be recorded. No further conservation action should be undertaken on the bulk of the line.

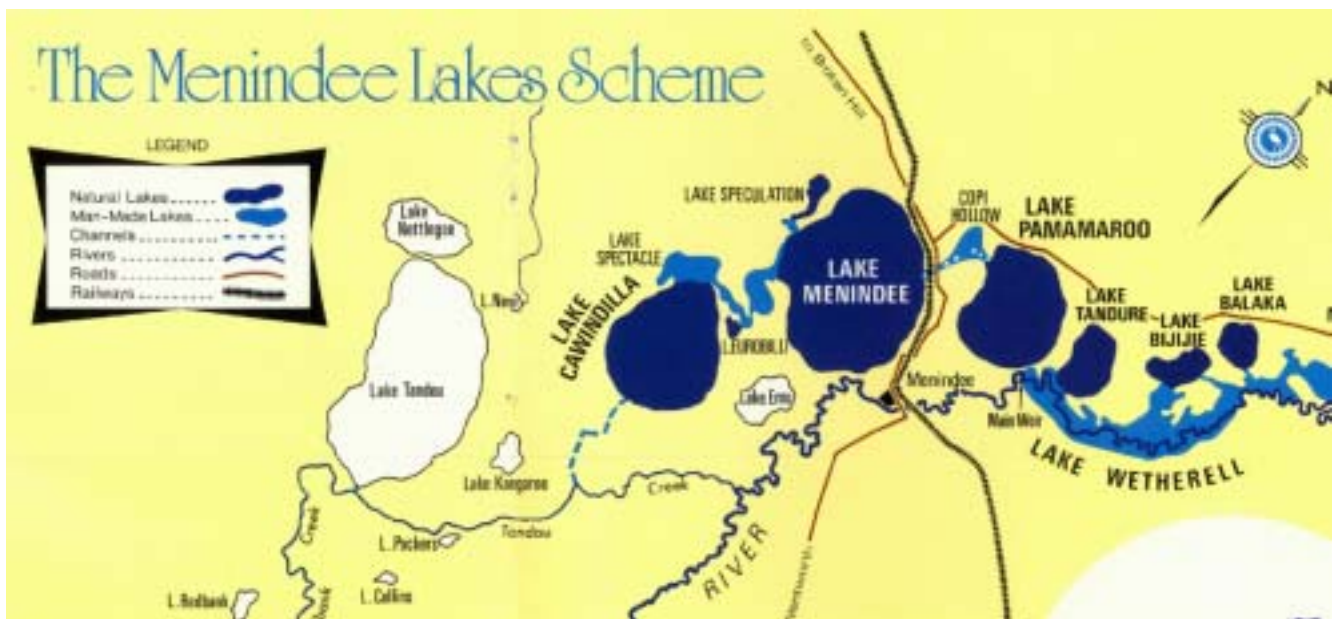
Figure 18
 The Menindee Lakes Scheme from a Water Resources Commission booklet. ND but 1960s
DLWC Menindee
 SMT 2001 photograph

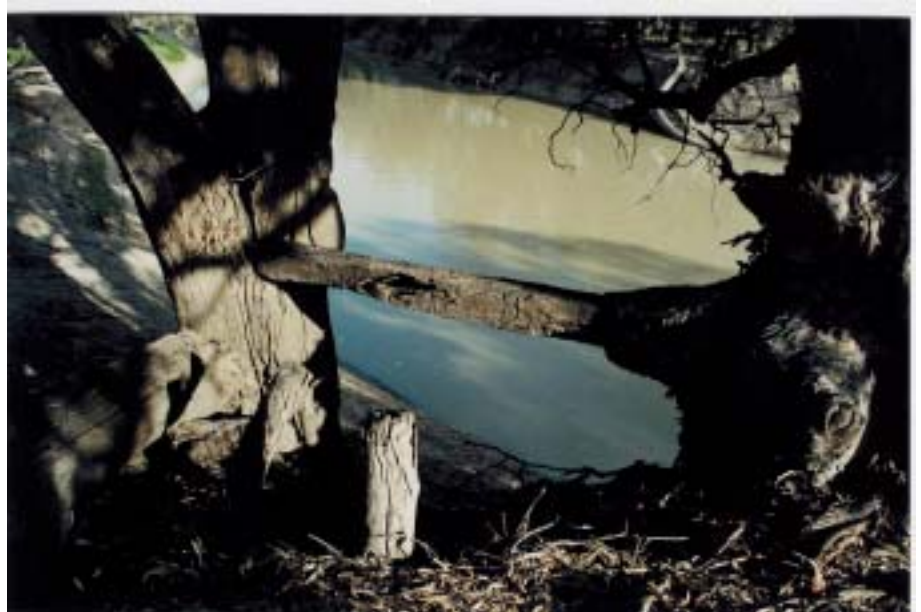
Figure 4
 The wharf [?] location on the river
 SMT 2001 photograph

It is recommended that an archaeological investigation be undertaken for the wharf area and related sites, with the objective of assessing its natural Aboriginal and historic values.

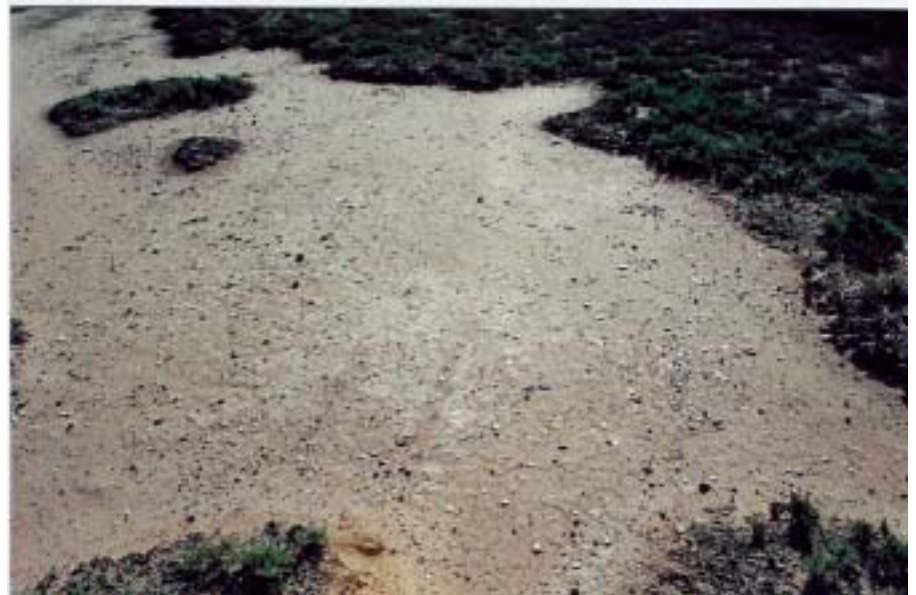
Figure 5

Adjacent to the wharf are mounded archaeological deposits with both Aboriginal pre and post contact artefacts and European debris.
SMT 2001 photograph

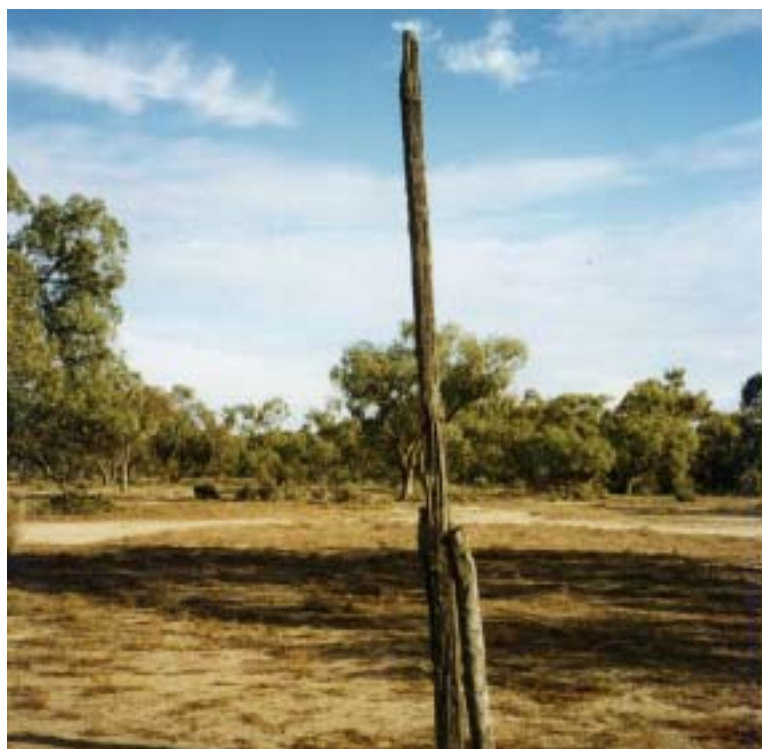
Figure 6

Telegraph pole, Kinchege Wharf group.
AF 2001 photograph

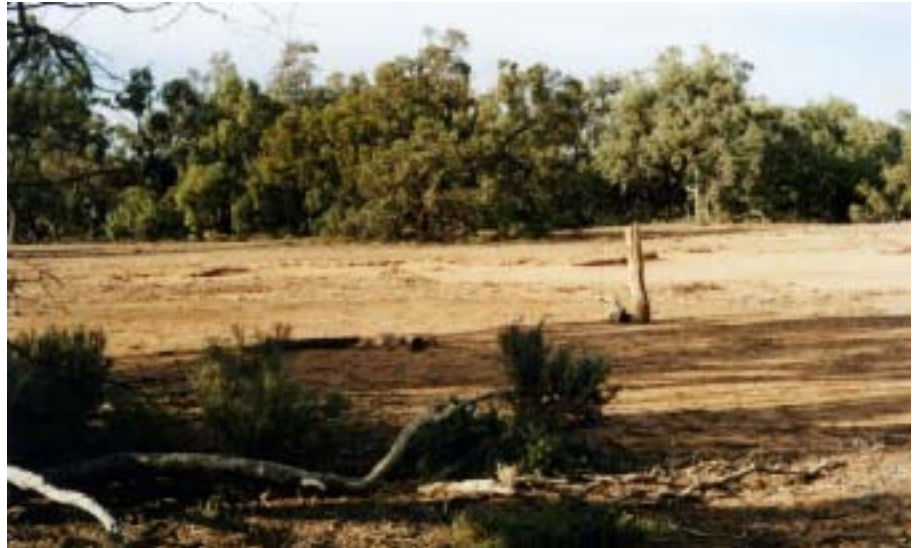
Figure 7
Former gate post, Kincheha wharf
group
AF 2001 photograph

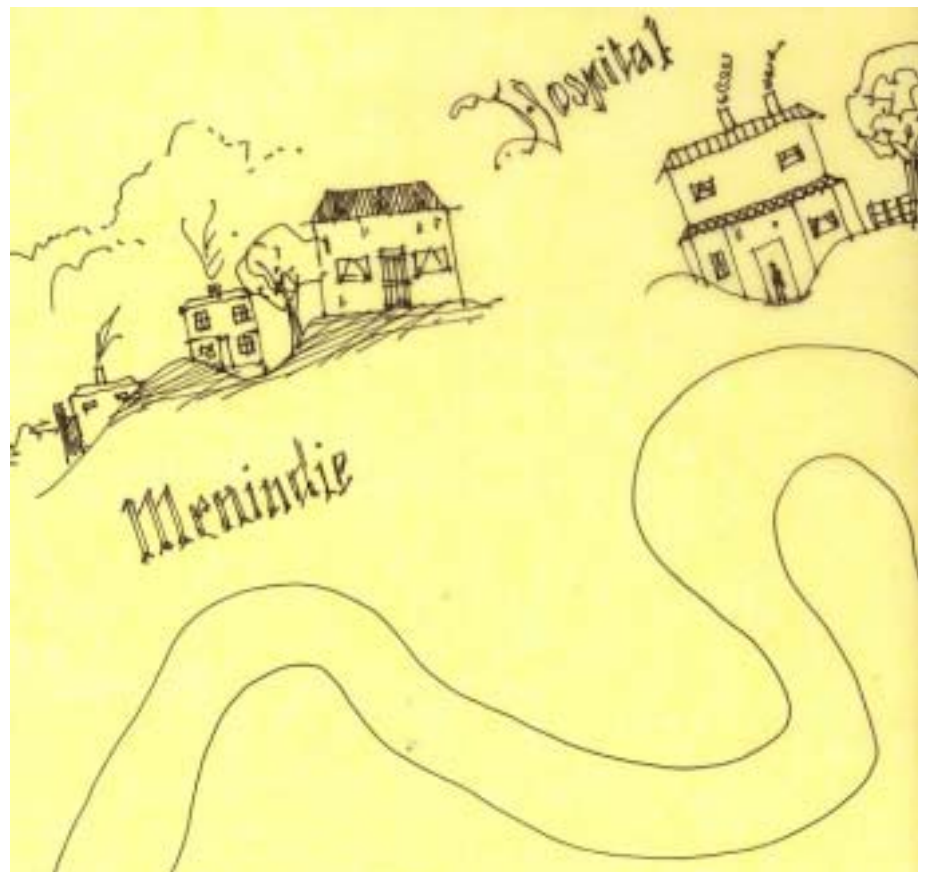
Figure 2
The township of Menindee as shown
on the Darling River navigation chart
c1875.
SLNSW Mitchell Library: PF
overdrawing

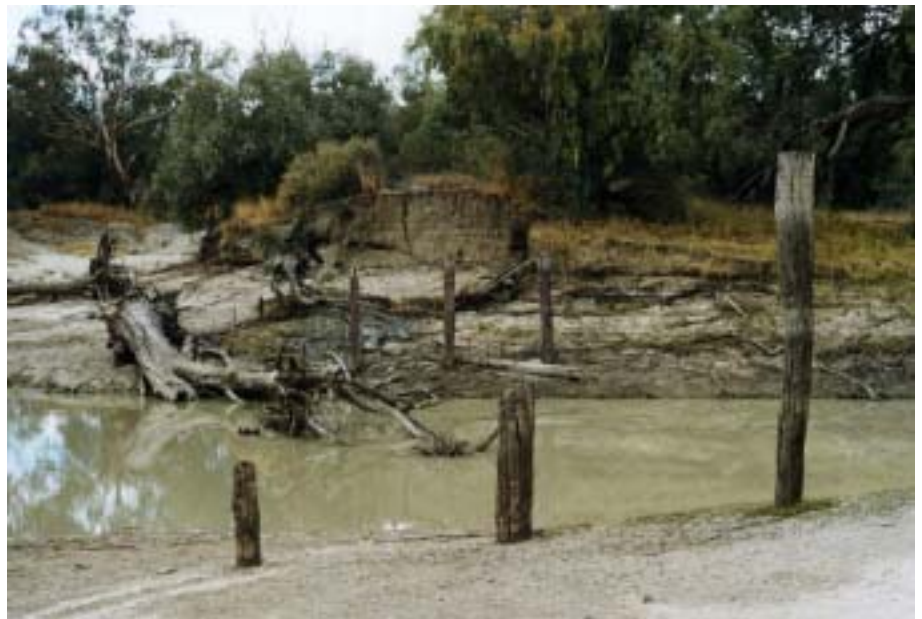
Figure 3
The bridge posts.
PF 2001 photograph

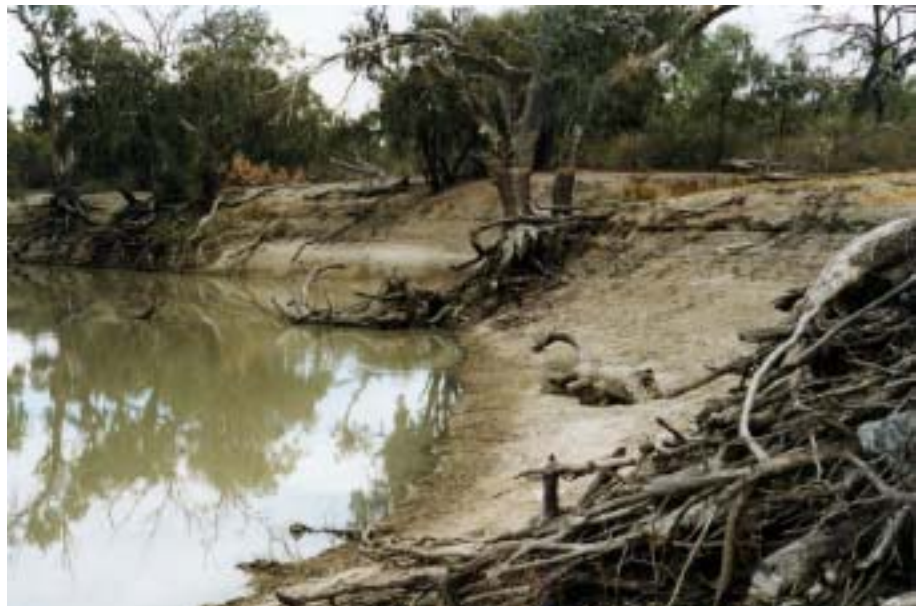
Figure 4
The western bank of the river
adjacent the bridge.
PF 2001 photograph

The riverbanks are currently eroding at this point due to high outflows from the Regulator. NPWS should pursue this matter with DLWC.

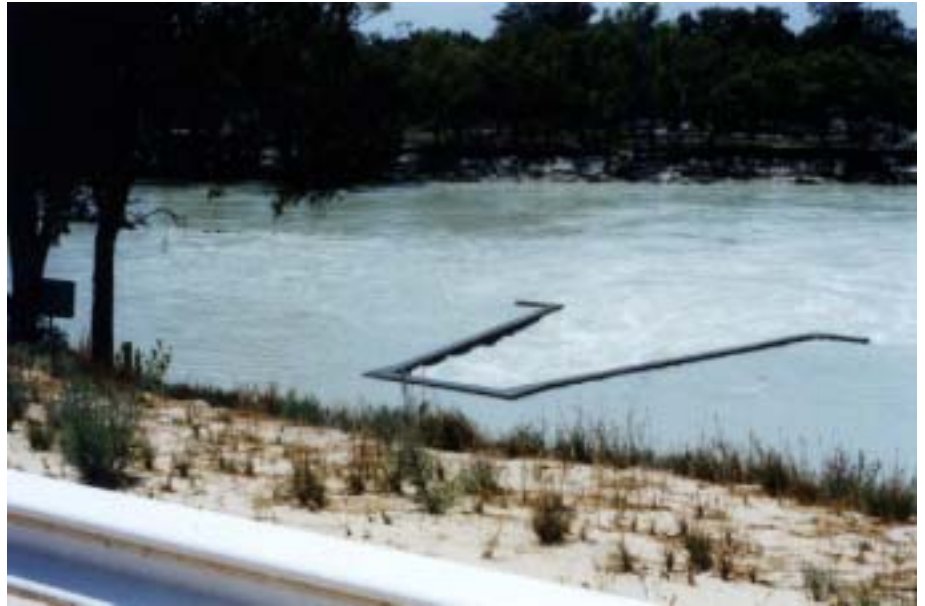
Figure 5
The Regulator at high river levels.
PG 2001 photograph

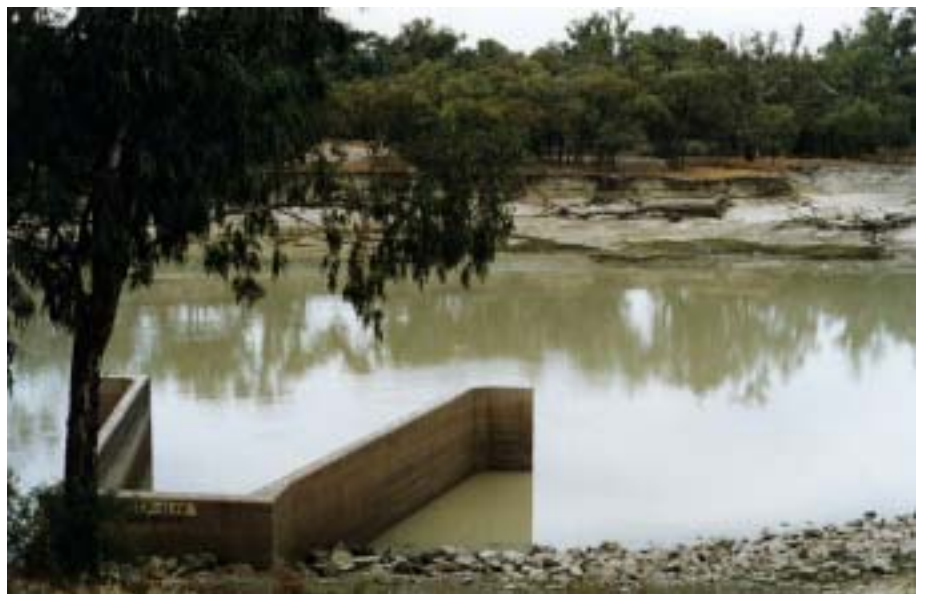
Figure 6
The river at low river levels.
PF 2001 photograph
