## Beachwatch

# State of the beaches 2022–23

Central Coast Region

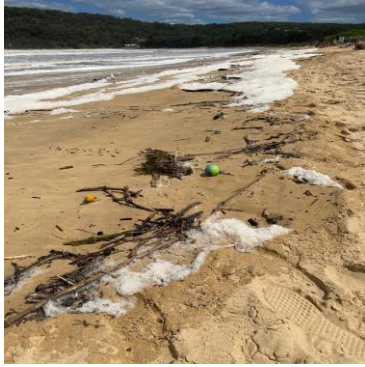
Flood debris washed up on Umina Beach in March 2022

While microbial levels returned to normal at many swimming sites, there was still a large amount of debris or other hazards, such as murky water, which posed a risk to recreational activities.

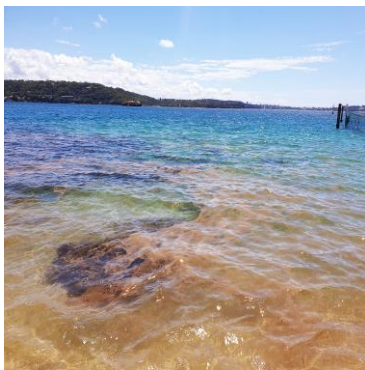
Marine algal bloom present in the water

The appearance of **marine algae** is sometimes mistaken for **sewage contamination** or **oil slicks**, due to a strong odour and red or brown discolouration in the water caused by the blooms.

As a precaution, direct contact with algae should be avoided as it can cause skin and eye irritations. The marine algal blooms dissipated with changes in tide and wind conditions.

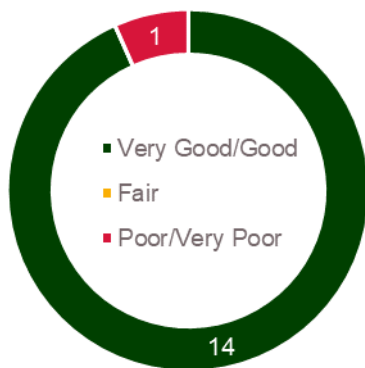
Beach Suitability Grades for Central Coast ocean beaches

North Entrance Beach was graded as Very Good in 2022–2023, consistent with the previous year. Water quality at this site was suitable for swimming almost all of the time.

Terrigal Beach was graded as Poor in 2022–2023, consistent with the previous year. Despite the Poor grade, water quality at this site was mostly suitable for swimming in dry weather conditions, with 90% of samples within the safe swimming limit when no rain had fallen in the previous 24 hours.

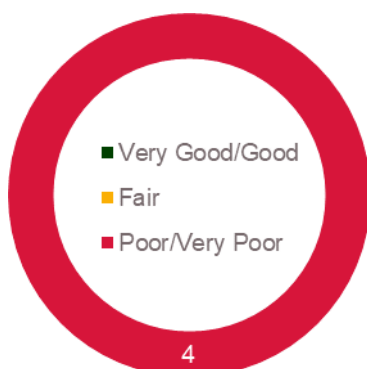
**Beach Suitability Grades for Central Coast estuarine beaches**

Microbial water quality at Davistown Baths, Pretty Beach Baths and Woy Woy Baths was often elevated during dry weather conditions. At these sites, the bacterial levels continued to increase significantly in response to increasing rainfall, with bacterial levels regularly exceeding the safe swimming limit after light to moderate rain. Despite the Poor grades, Woy Woy Baths and Davistown Baths have shown trends of improved microbial assessments in recent years with management actions improving water quality at these sites.

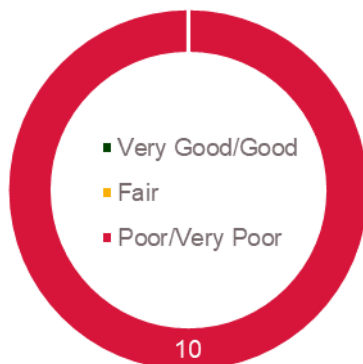
**Beach Suitability Grades for Central Coast lake/lagoon swimming sites**

The impact of rainfall-related pollution is more apparent at these sites with low levels of flushing and slower dilution to disperse pollution inputs. Swimming should be avoided during and for at least 3 days after rainfall.

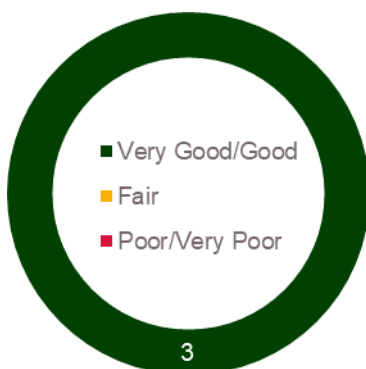
**Beach Suitability Grades for Central Coast ocean baths**

The Entrance Ocean Baths and Pearl Beach Rockpool were frequently suitable for swimming during dry weather conditions, with 100% and 93% of dry weather samples within the safe swimming limit, respectively. Elevated enterococci were recorded following heavy rain.

The Entrance Ocean Baths are cleaned regularly year round by council, while Cabbage Tree Bay Rockpool and Pearl Beach Rockpool are flushed irregularly and are dependent on the natural exchange of ocean water over the rocks and pool walls. It is recommended that swimming be avoided during and for up to one day after rainfall, or if there are signs of pollution such as discoloured water or floating debris.

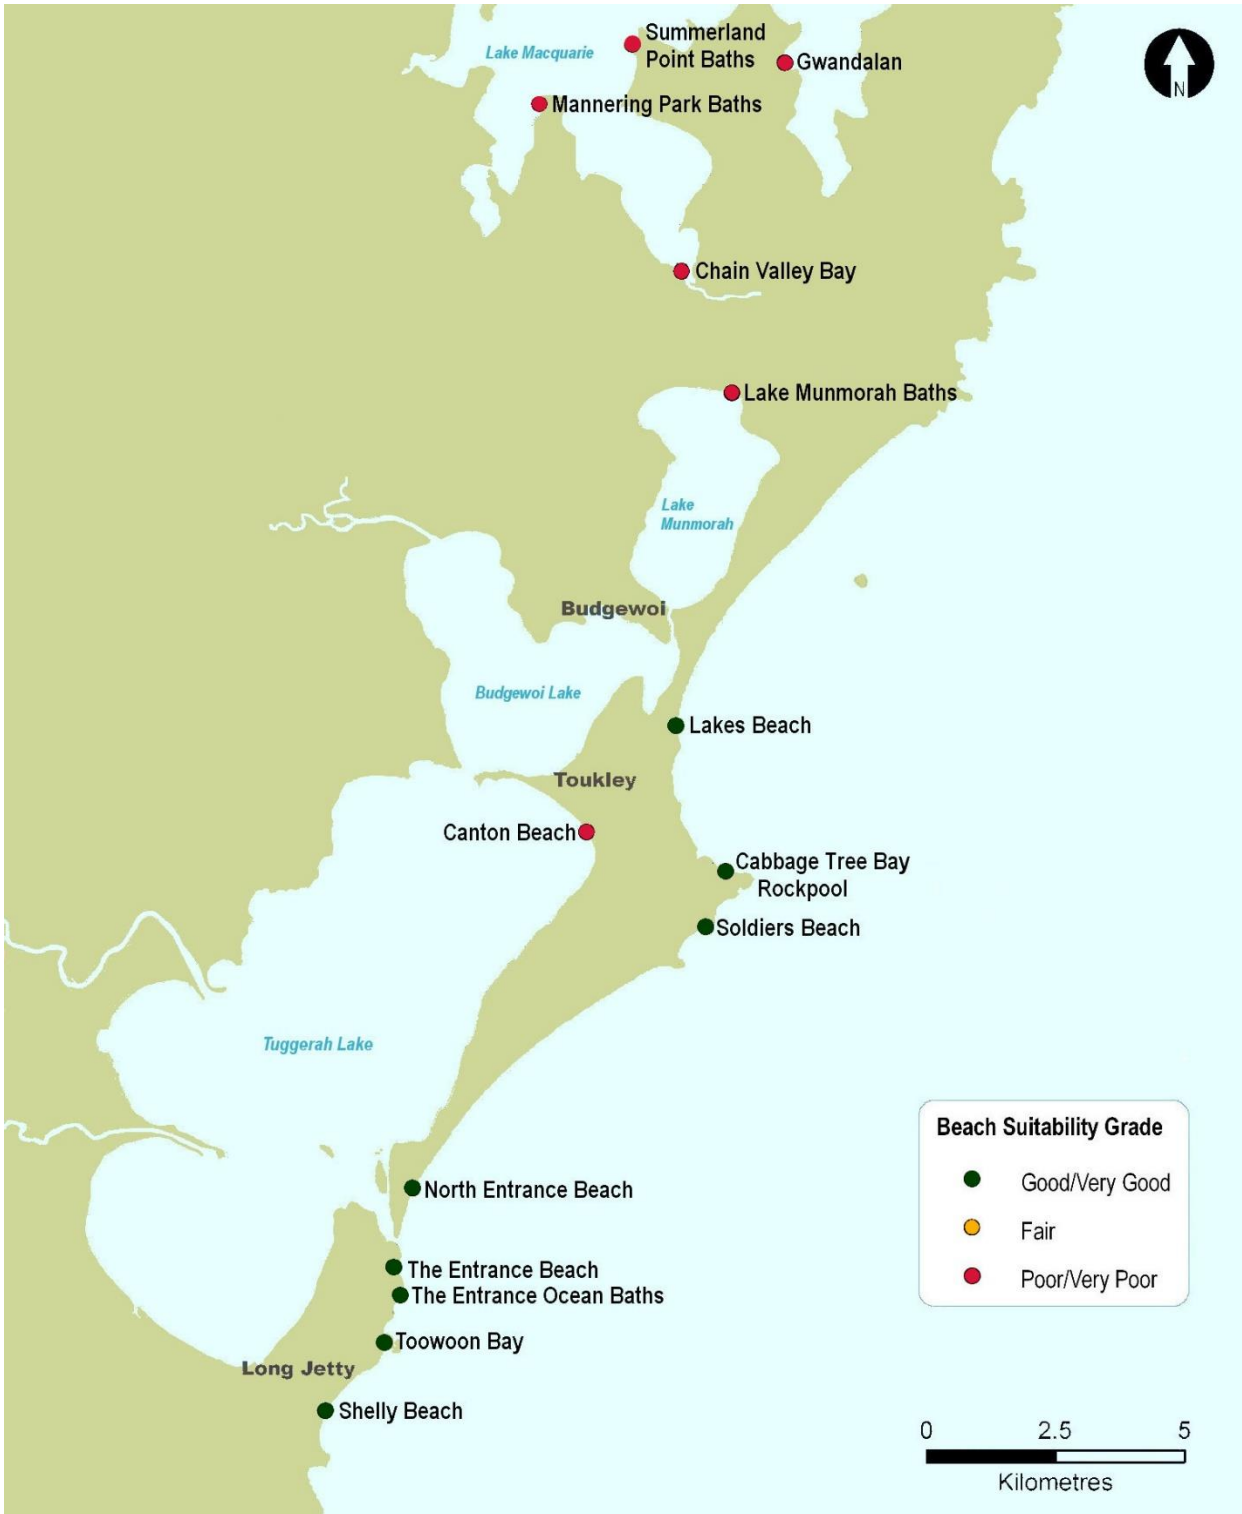
Sampling sites and Beach Suitability Grades in Central Coast Council (northern)

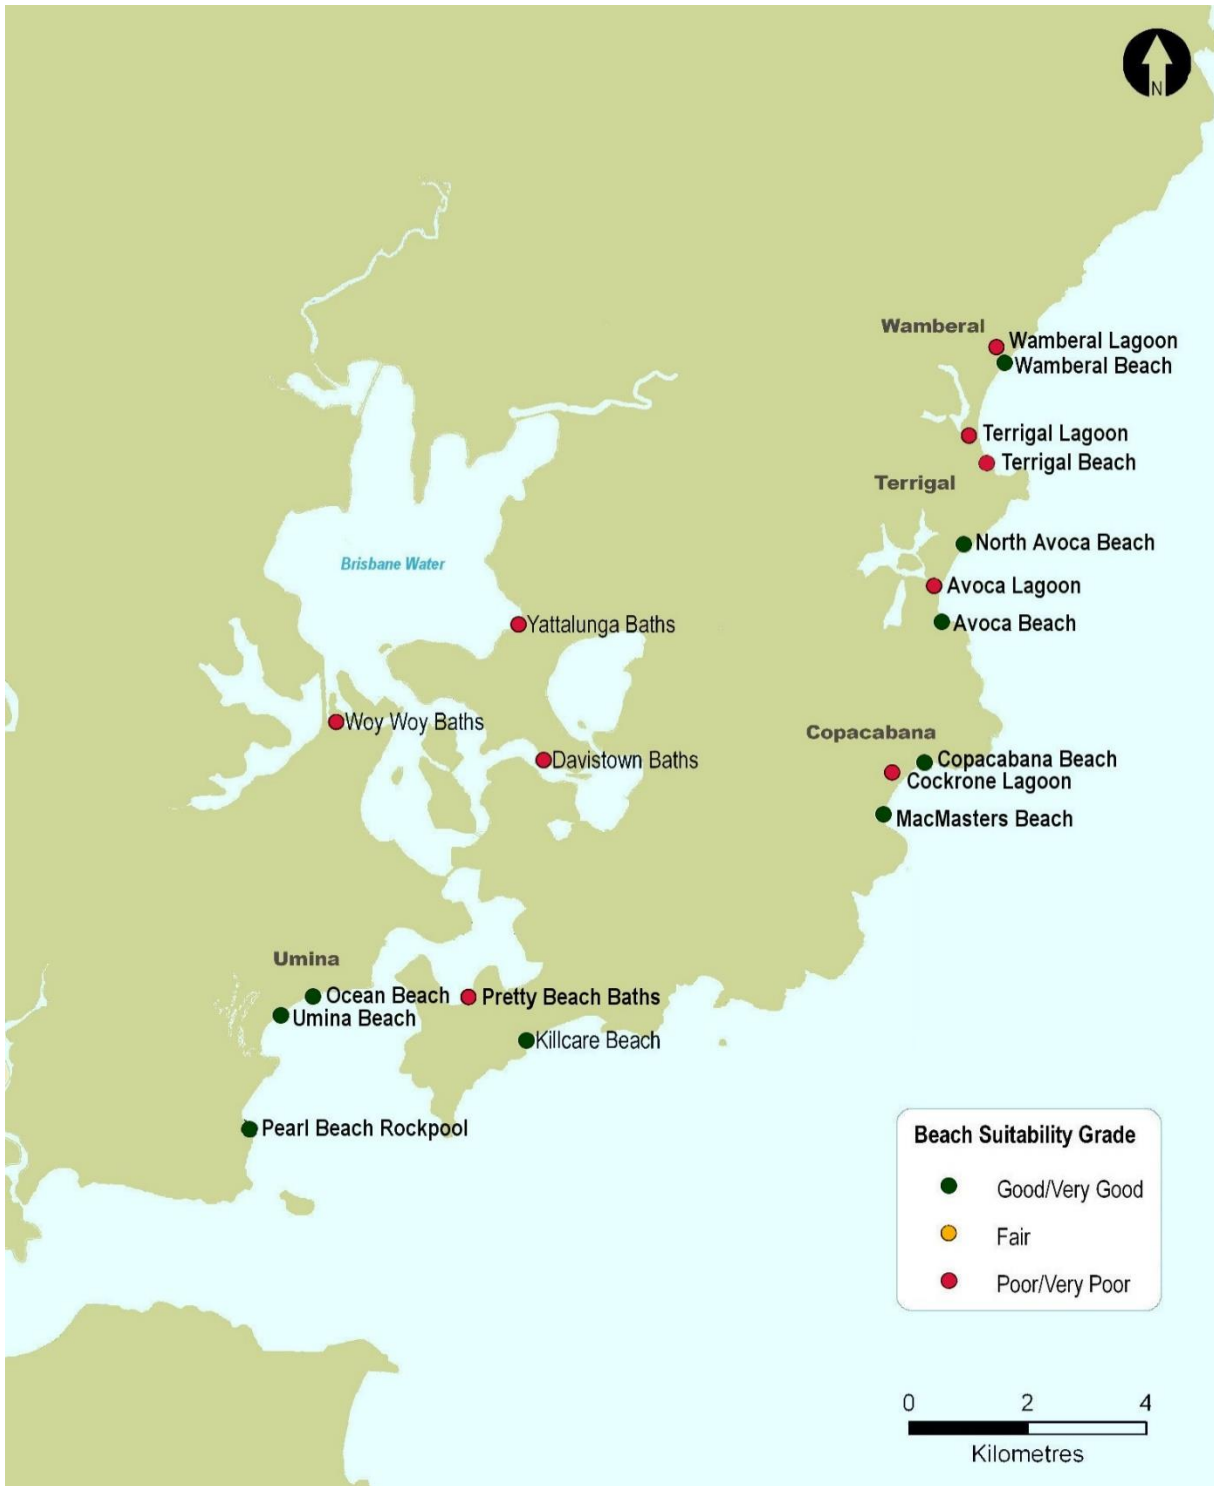
Sampling sites and Beach Suitability Grades in Central Coast Council (southern)

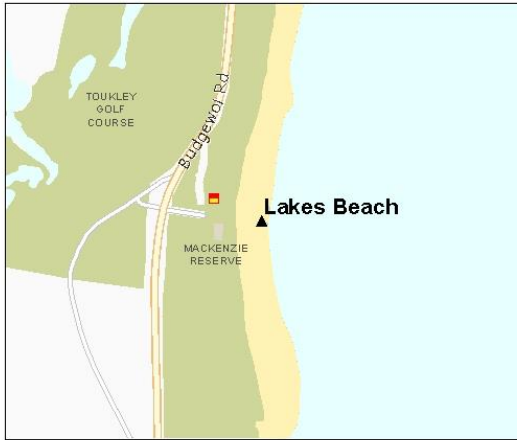
# Lakes Beach

Lakes Beach is at the southern end of an 8 km stretch of beach. The beach is patrolled during summer.

The Beach Suitability Grade of Good indicates microbial water quality is considered suitable for swimming most of the time but may be susceptible to pollution after rain, with several potential sources of minor faecal contamination.

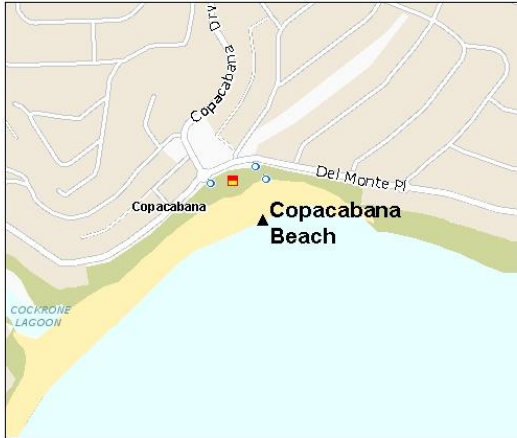
# Copacabana Beach

See 'How to read this report' for key to map.

Copacabana Beach is at the northern end of a 1 km stretch of beach and is patrolled during the summer swimming season.

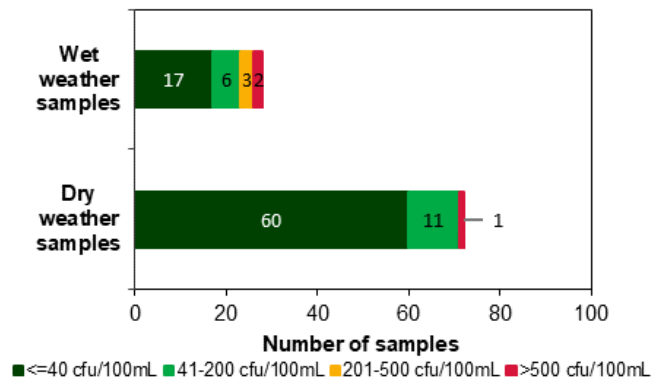
### Wet and dry weather water quality chart

201 and 500 cfu/100 mL and greater than 500 cfu/100 mL. These categories reflect the Microbial Assessment Category thresholds and are coloured on the graph as dark green, light green, amber and red respectively.

It is expected that swimming sites with lower levels of flushing will show some elevated bacterial results in dry weather samples (no rainfall in the previous 24 hours) due to the longer time needed to recover from a rainfall event. At some estuarine and lake/lagoon swimming locations the impacts of stormwater pollution on beach water quality may be detected up to 3 days after rainfall.

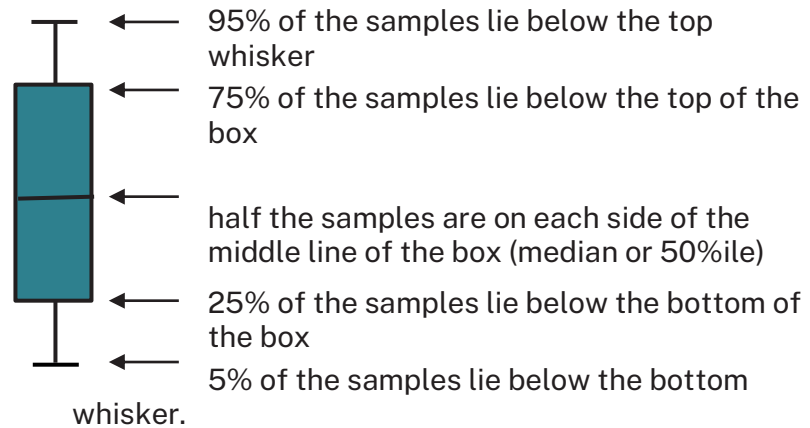
Each part of the box plot represents a significant percentile value of the sample population:
