## Beachwatch

# State of the beaches 2022–23

Hunter Region

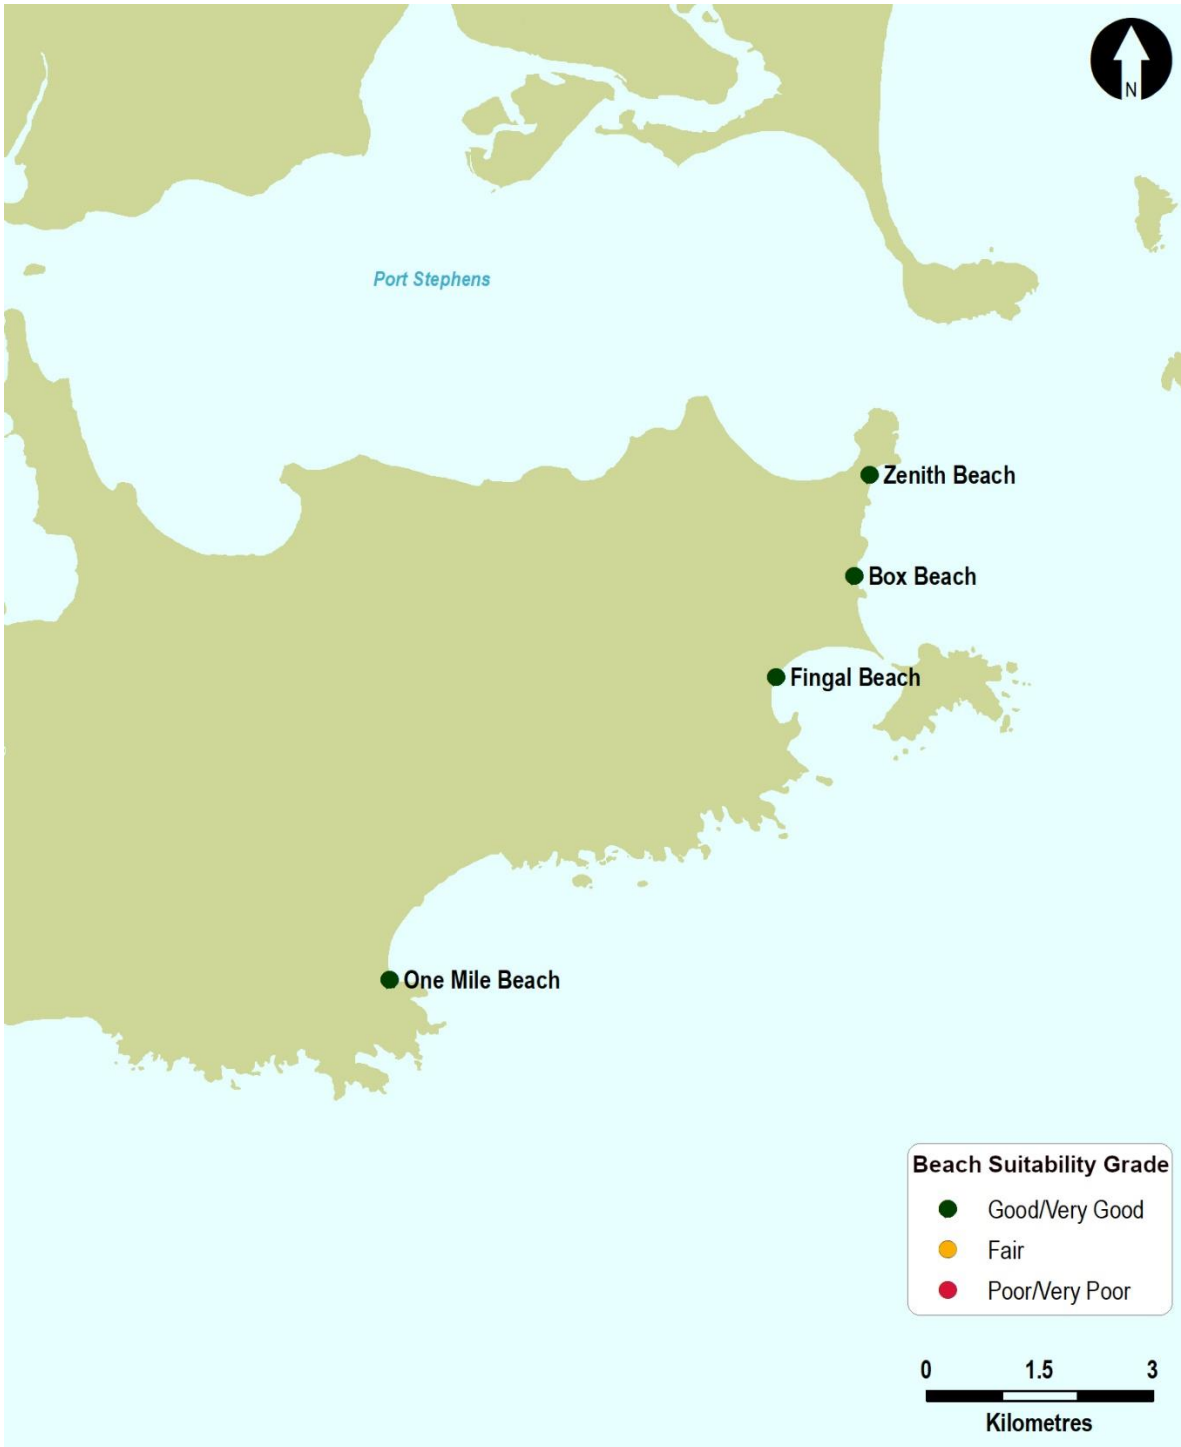
**Sampling sites and Beach Suitability Grades in Port Stephens Council**

All 4 ocean beaches were graded as Very Good in 2022–2023: Zenith Beach, Box Beach, Fingal Beach and One Mile Beach. Water quality at these sites has continued to be of a high standard and was suitable for swimming almost all of the time.

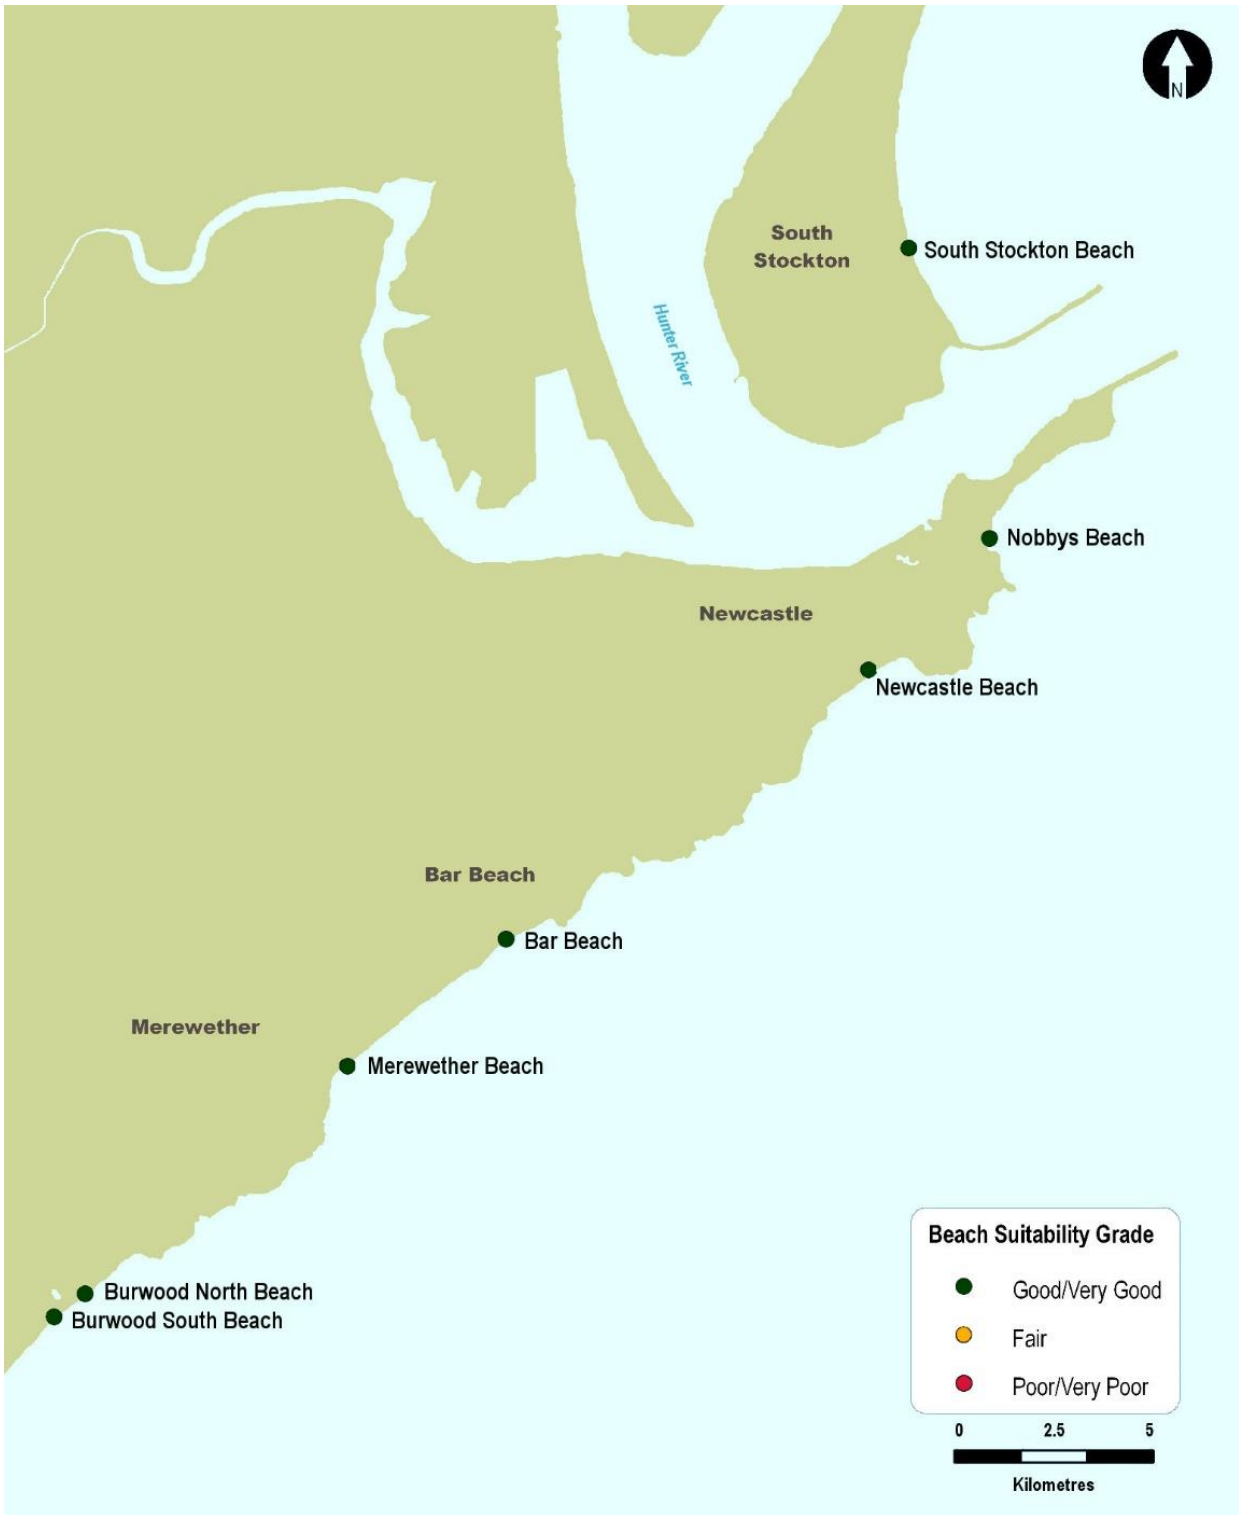
Sampling sites and Beach Suitability Grades in City of Newcastle Council

All 7 ocean beaches were graded as Very Good in 2022–2023: Stockton Beach, Nobbys Beach, Newcastle Beach, Bar Beach, Merewether Beach, Burwood North Beach and Burwood South Beach. Stockton Beach improved to Very Good from Good in the previous year. Water quality at these sites was suitable for swimming almost all of the time and has been of a high standard for many years.

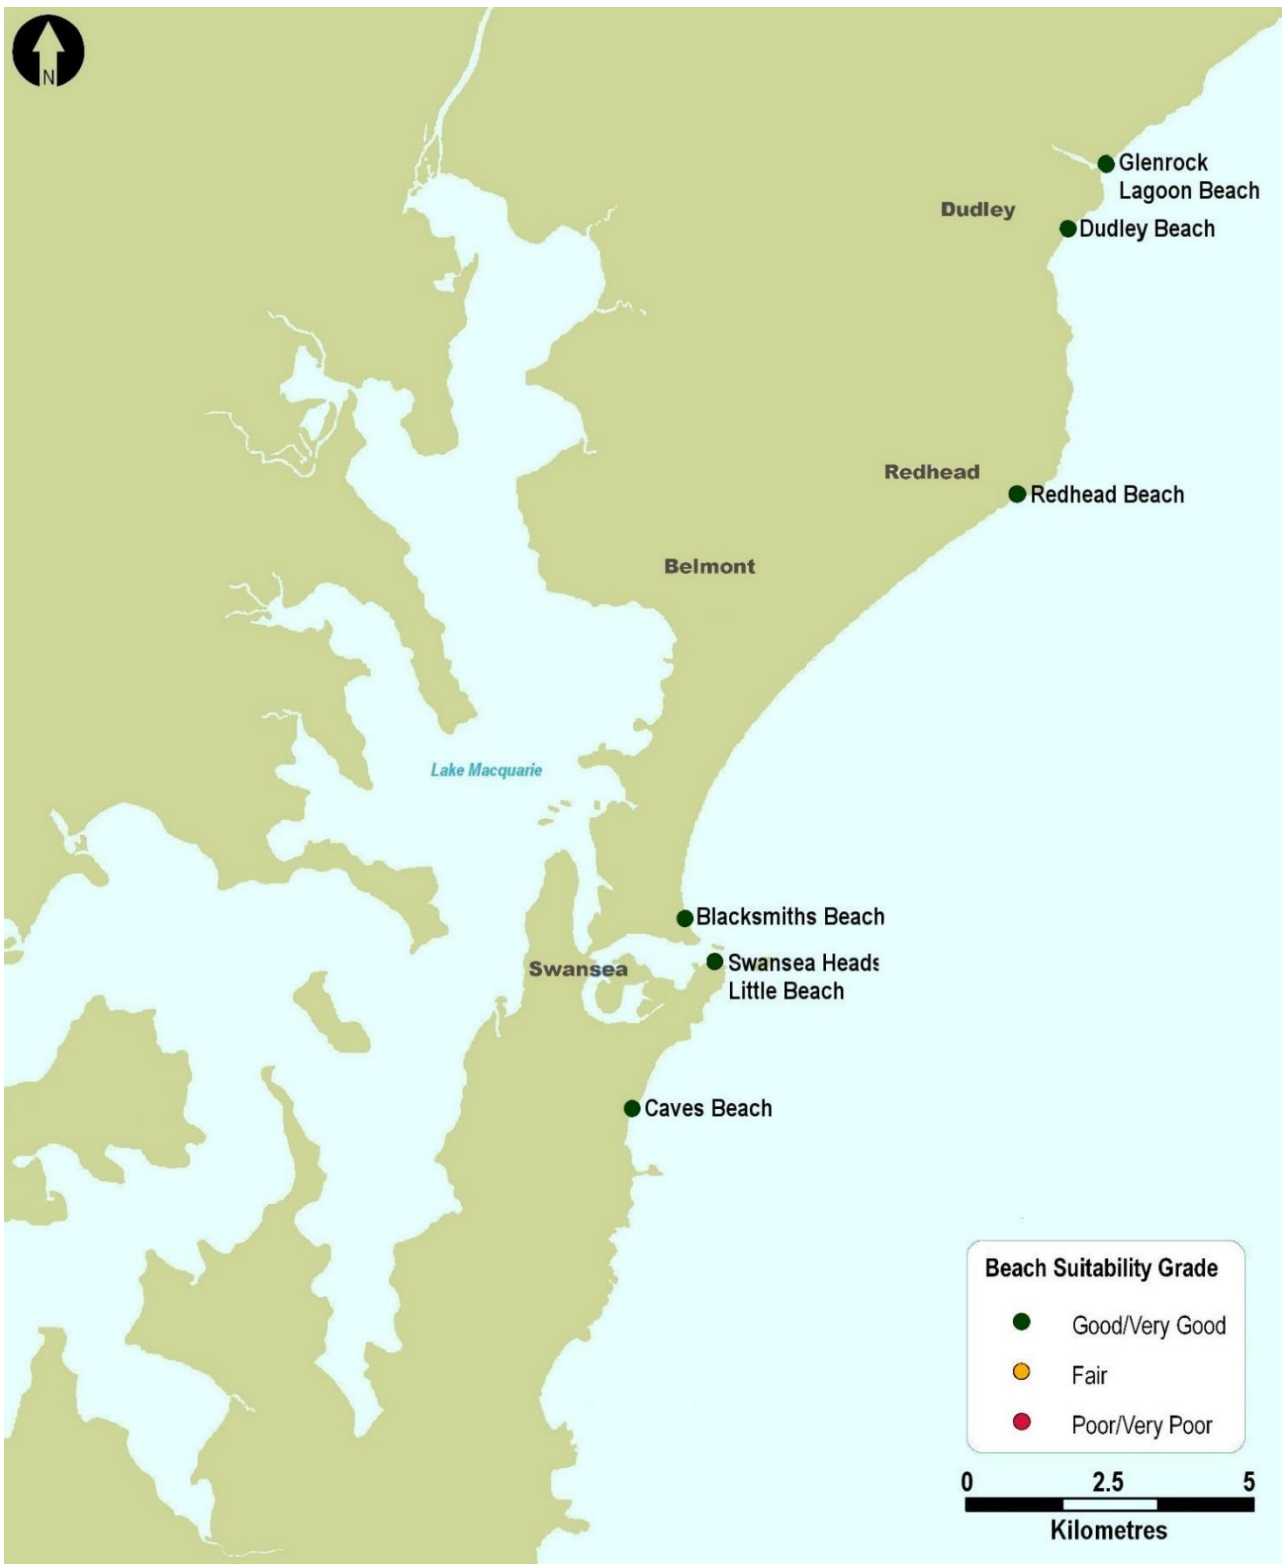
Sampling sites and Beach Suitability Grades in Lake Macquarie City Council

Five of the 6 ocean beaches were graded as Very Good in 2022–2023: Glenrock Lagoon Beach, Dudley Beach, Redhead Beach, Blacksmiths Beach and Caves Beach. The water quality at these beaches is suitable for swimming almost all of the time.

Swansea Heads Little Beach continued to be graded Good in 2022–2023, consistent with the previous year. While the water quality was suitable for swimming during dry weather conditions, with 100% of dry weather samples within the safe swimming limit, elevated levels often exceeded the safe swimming limit following light rainfall.

Microbial water quality has generally been more elevated at Swansea Heads Little Beach in comparison to nearby beaches for the last 5 years. This beach is located at the entrance to Lake Macquarie in a 100 m long bay bordered by a rock platform and breakwall, which may reduce flushing and dilution of contaminants compared to other nearby open ocean beaches.

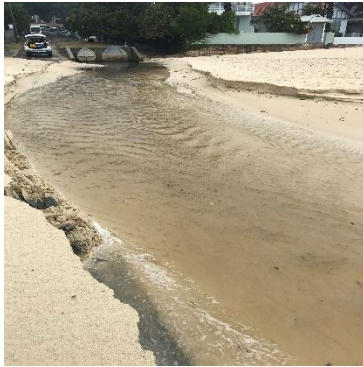
Stormwater drain flow  
Photo: Beachwatch/DPE

Stormwater in urban areas often contains sewage from leakages, overflows or sewer chokes when the sewerage system fails.
