## Beachwatch

# State of the beaches 2022–23

Statewide summary and how to read this report

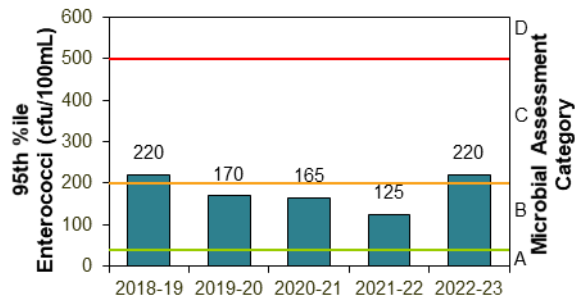
On each beach page, the MACs for the last 5 years are displayed on a simple bar chart. The MAC for the current year is based on enterococci data collected during the assessment period. The bars are labelled with the 95th

percentile value for each year and the thresholds dividing the A, B, C and D categories are marked in green, amber and red for reference.

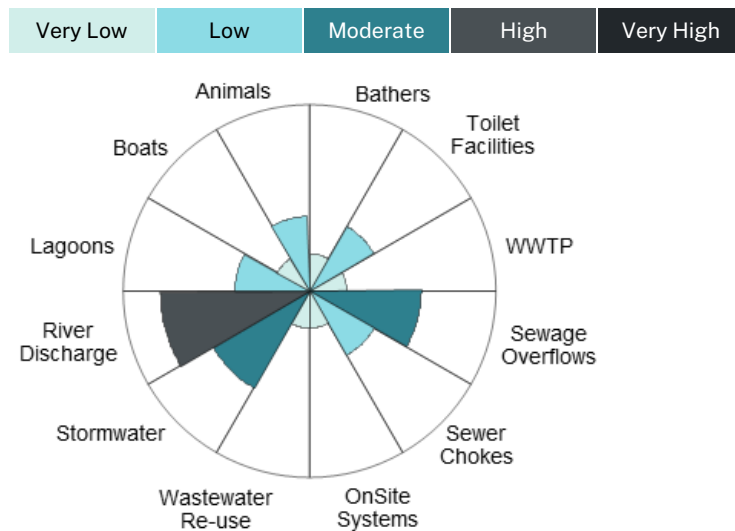
### Sanitary Inspection Category (SIC) chart

The results of the sanitary inspection for each swimming location are presented in a radar pie chart. The chart shows the likelihood that each identified pollution source will contribute to faecal contamination at a swimming site, as indicated by the size and colour of the segment, ranging from very low (lightest colour) to very high (darkest colour) as shown below. The sum of these contributions is the overall likelihood, or Sanitary Inspection Category.

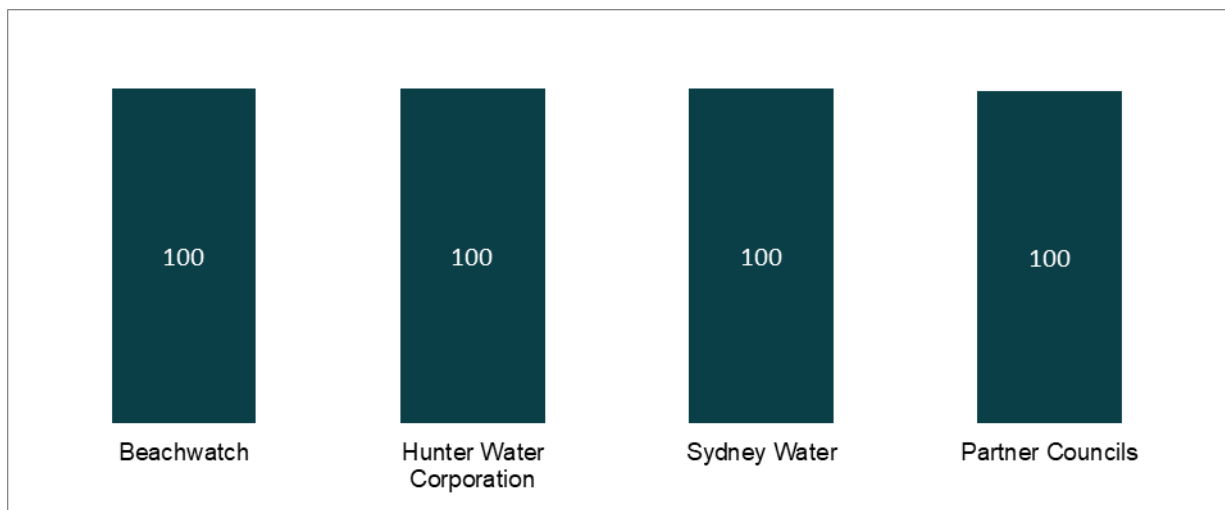
Figure 1 Percentage compliance with Beachwatch sampling protocols in 2022–2023

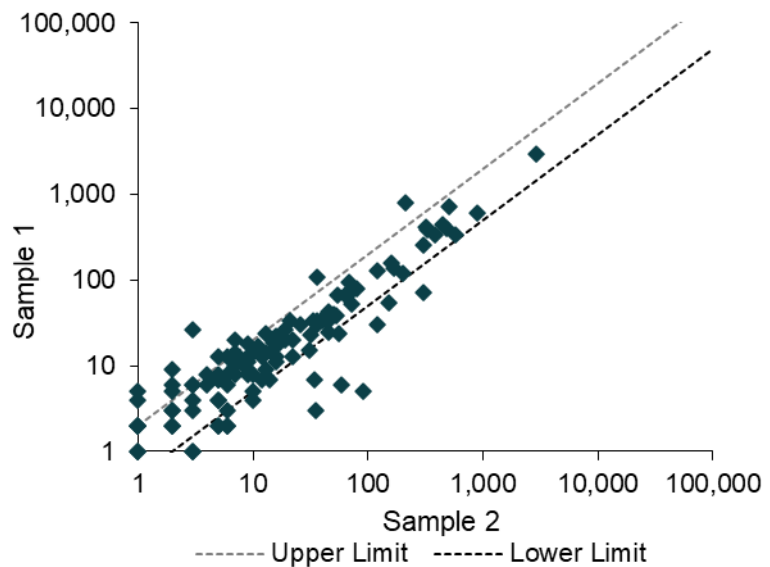
**Figure 2** Distribution of duplicate enterococci (cfu/100 mL) results for the contracted laboratory, May 2022 to April 2023

To assess the reliability of laboratory data, Beachwatch sends duplicate water samples to our contracted microbiological laboratory, which is accredited by the National Association of Testing Authorities (NATA). Duplicate samples are collected from the same site at the same time and the laboratory is unaware that the samples are collected from a single location. The results are expected to be similar.

Due to the inherent variability of bacterial levels in environmental samples, duplicate results that are within 0.3 log-units of each other (equivalent to a halving or doubling of density on a linear scale) are considered to be acceptable. Most duplicate samples were within the acceptable limits; however, some enterococci results were outside this range, with most of these at very low bacterial densities that were below the safe swimming limit.

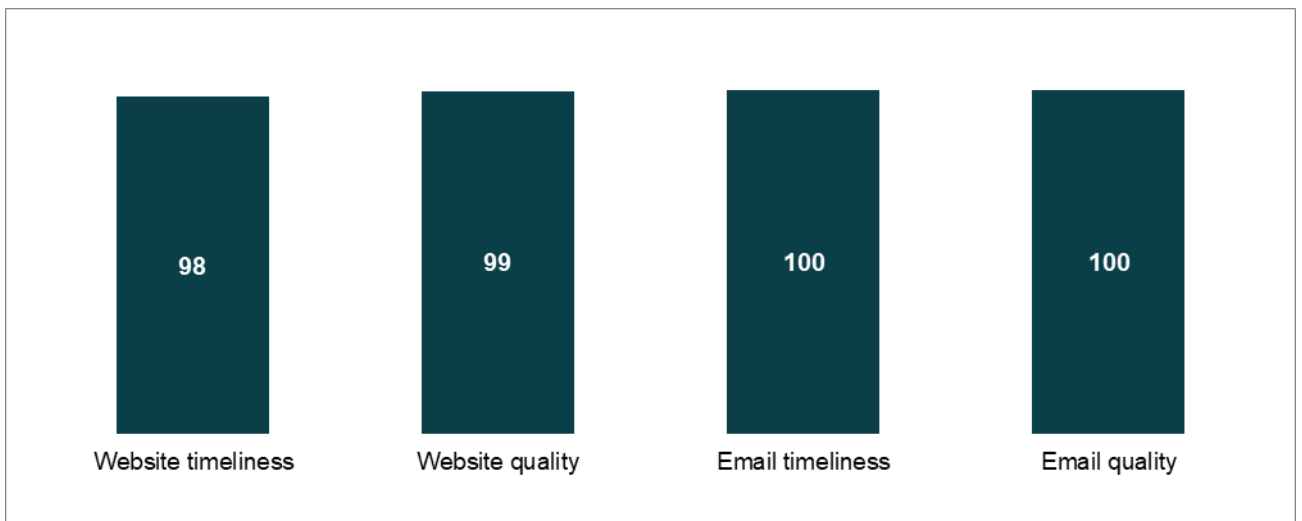
**Figure 3** Percentage compliance with beach pollution forecast reporting protocols in 2022–2023

In 2022–2023 an overall compliance of 99% was achieved with the beach pollution forecast reporting protocols for quality and timeliness. The breakdown of compliance performance for forecast reports on the Beachwatch website and by email is shown in Figure 3.
