**Beachwatch**

# State of the beaches 2021–22

Illawarra Region

Department of Planning and Environment

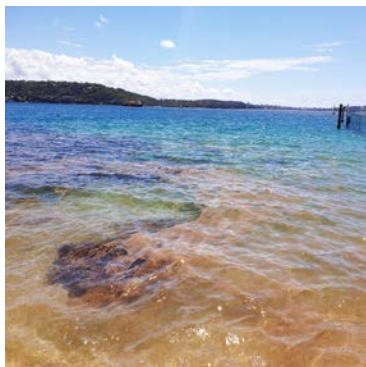
Marine algal bloom present in the water

The appearance of **marine algae** is sometimes mistaken for **sewage contamination** or **oil slicks**, due to a strong odour and red or brown discolouration in the water caused by the blooms.

As a precaution, direct contact with algae should be avoided as it can cause skin and eye irritations. The marine algal blooms dissipated with changes in tide and wind conditions.

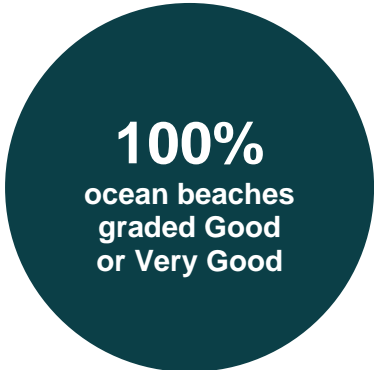
### Percentage of sites graded as Very Good or Good

2019– 2020	2020– 2021	2021– 2022	Trend
Ocean beaches (13 sites)	100%	100%	<b>100%</b>	—

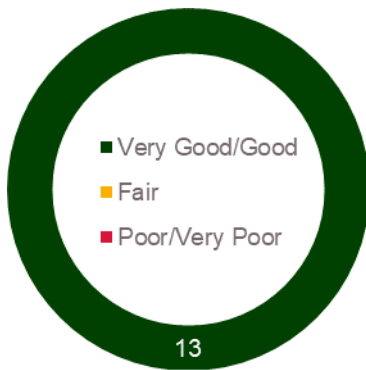
Beach Suitability Grades for Wollongong City Council ocean beaches

Coledale Beach, Thirroul Beach, Bulli Beach, Bellambi Beach, Corrimal Beach, North Wollongong Beach and Port Kembla Beach were graded as Good. Water quality at these sites was frequently suitable for swimming during dry weather conditions. Bacterial levels generally increased with increasing rainfall, regularly exceeding the safe swimming limit after heavy rainfall. Many of these sites have several, or more significant, potential sources of pollution such as stormwater or upstream sources discharged from creeks or lagoons. Discharges from storm sewage treatment plants (SSTPs) at Bellambi and Port Kembla may also affect the water quality at nearby beaches Bellambi, Corrimal and Port Kembla following heavy rainfall.

It is recommended that swimming be avoided at these beaches during and for up to one day following rainfall, or if there are signs of pollution such as discoloured water, flowing drains or floating debris.

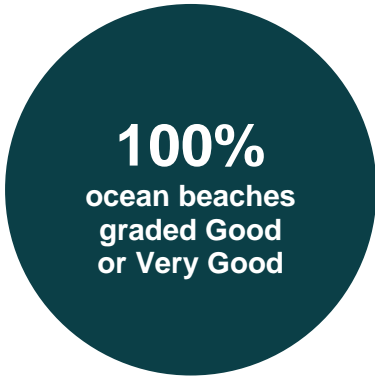
All 3 swimming sites were graded as Very Good or Good in 2021–2022. This is an excellent result and consistent with previous years.

### Percentage of sites graded as Very Good or Good

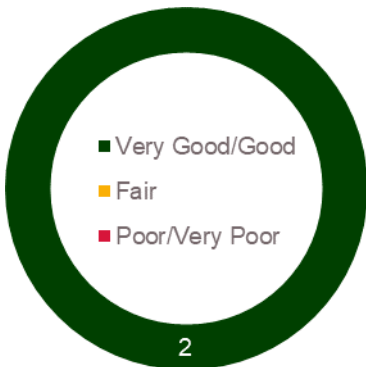
Beach Suitability Grades for Shellharbour City Council ocean beaches

Shellharbour Beach continued to be graded as Very Good in 2021–2022, consistent with previous years. This site had excellent water quality and was suitable for swimming almost all of the time.

Warilla Beach was downgraded to Good from Very Good in 2021–2022. While microbial water quality was suitable for swimming 100% of the time during dry weather conditions, elevated enterococci levels were regularly recorded following heavy rain.

It is recommended that swimming be avoided at ocean beaches during and for up to one day following rainfall, or if there are signs of pollution such as discoloured water, flowing drains or floating debris.

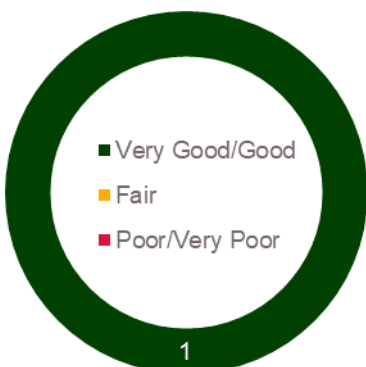
Beach Suitability Grades for Shellharbour City Council lake/lagoon swimming sites

Entrance Lagoon Beach continued to be graded as Good in 2021–2022, as in previous years. Water quality at this site was mostly suitable for swimming during dry weather conditions, with 83% of dry weather samples within the safe swimming limit when there had been no rain in the previous 24 hours. Enterococci levels increased with increasing rainfall and were often recorded after light rain. The swimming site is located within the entrance of Lake Illawarra and has lower levels of flushing. Due to this, the site can retain pollution inputs and take longer to recover from the impacts of stormwater. Water quality at this site may be impacted by contaminants discharged from Lake Illawarra, and stormwater during and following rainfall.

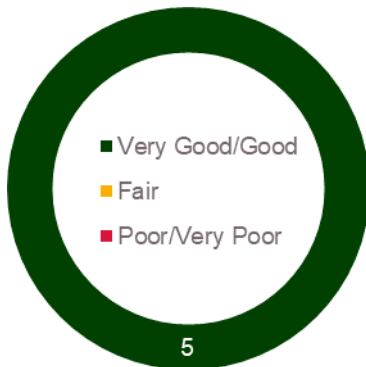
Werri Beach was upgraded to Very Good from Good in the previous year. This site had excellent water quality and was suitable for swimming almost all of the time.

Boyd's Jones Beach, Bombo Beach, Surf Beach Kiama and Seven Mile Beach were graded as Good in 2021–2022. Bombo Beach and Seven Mile Beach (Gerroa) downgraded from Very Good to Good due to a decline in microbial water quality. While these beaches were mostly suitable for swimming during dry weather conditions, elevated enterococci levels were occasionally recorded following light rain, and more often after moderate to heavy rainfall.

Beach Suitability Grades for Kiama Municipal Council ocean beaches

It is recommended to avoid swimming during and for at least one day following rainfall or if there are signs of stormwater pollution such as discoloured water and floating debris.

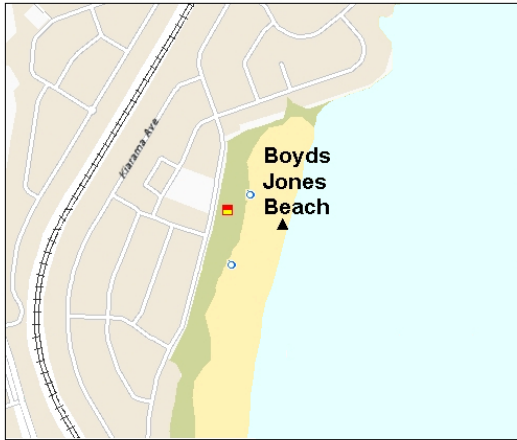
# Boyd's Jones Beach

Boyd's Jones Beach is 1 km long, east facing and backed by dunes. Lifeguards patrol the beach from October to April.

The Beach Suitability Grade of Good indicates microbial water quality is considered suitable for swimming most of the time but may be susceptible to pollution after rain, with several potential sources of faecal contamination.

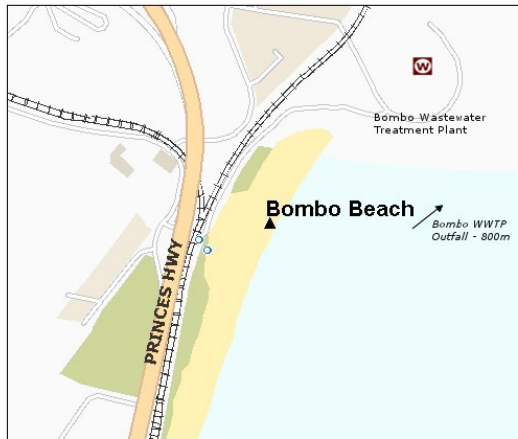
# Bombo Beach

Bombo Beach is backed by a narrow reserve, railway and freeway. Lifeguards patrol the beach over the summer school holidays.

The Beach Suitability Grade of Good indicates microbial water quality is considered suitable for swimming most of the time but may be susceptible to pollution after rain, with several potential sources of faecal contamination.

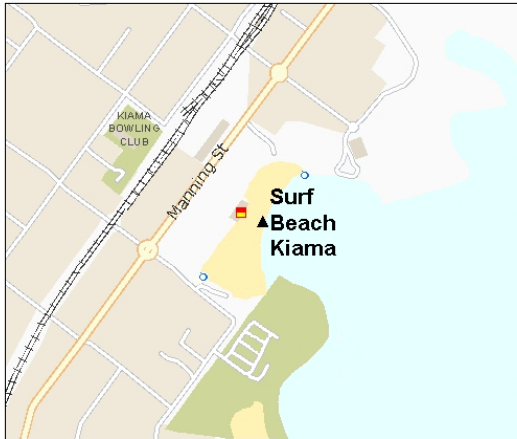
# Surf Beach Kiama

Surf Beach in Kiama is 250 m long and backed by a park and surf club. Lifeguards patrol the beach from September to April.

The Beach Suitability Grade of Good indicates microbial water quality is considered suitable for swimming most of the time but may be susceptible to pollution after rain, with several potential sources of faecal contamination including stormwater.

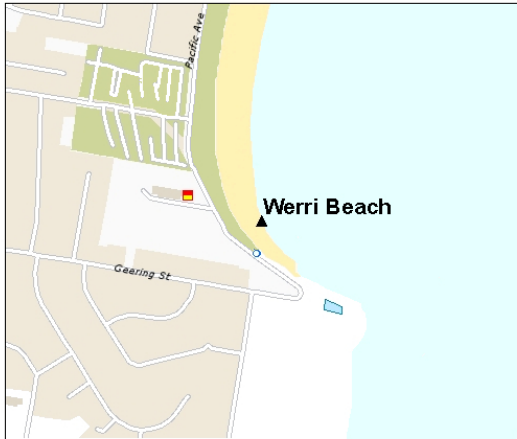
# Werri Beach

Werri Beach is 1.7 km long with an ocean pool on the southern rock platform. It is patrolled over the summer school holidays.

The Beach Suitability Grade of Very Good indicates microbial water quality is considered suitable for swimming almost all of the time, with few potential sources of significant faecal contamination.

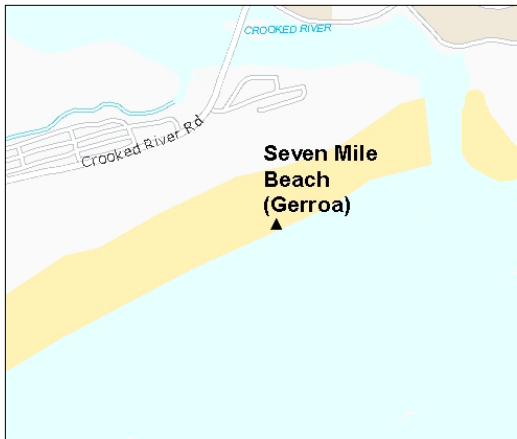
# Seven Mile Beach (Gerroa)

Seven Mile Beach at Gerroa is at the northern end of a long open beach. Lifeguards patrol during the summer school holidays.

The Beach Suitability Grade of Good indicates microbial water quality is considered suitable for swimming most of the time but may be susceptible to pollution after rain, with several potential sources of faecal contamination.

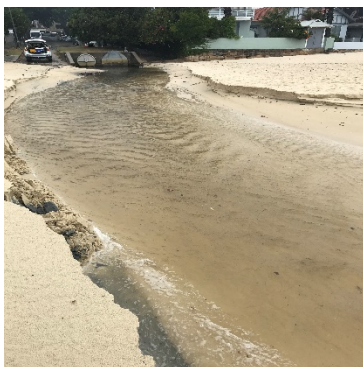
Stormwater drain flow  
Photo: Beachwatch/DPE

Stormwater in urban areas often contains sewage from leakages, overflows or sewer chokes when the sewerage system fails.

Sewage overflows can occur in wet weather when the network has exceeded capacity due to rainwater entering the system. The mix of sewage and rainwater discharges from designated overflow points and drains to waterways, usually via the stormwater system. Overflows from the sewerage system can also occur in dry weather due to mechanical failure or power outage.
