State of the beaches 2018-2019

Central Coast region

Beachwatch

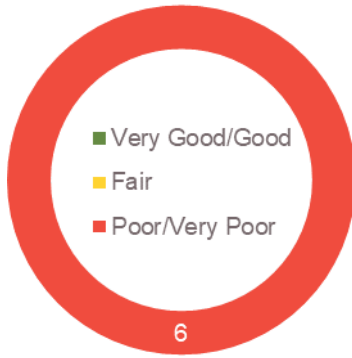
Beach Suitability Grades for Central Coast lake/lagoon swimming sites

All six lake swimming sites were graded as Poor: Gwandalan, Summerland Point Baths, Chain Valley Bay, Mannering Park Baths, Lake Munmorah Baths and Canton Beach. Summerland Point Baths was downgraded from Good in 2017–2018.

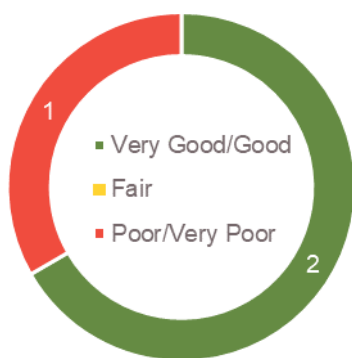
Beach Suitability Grades for Central Coast ocean baths

Two of the three ocean baths continued to be graded as Good in 2018–2019: The Entrance Ocean Baths and Pearl Beach Rockpool. Water quality at The Entrance Ocean Baths was generally suitable for swimming during dry and wet weather conditions. Pearl Beach Rockpool was mostly suitable for swimming after little or no rain, with elevated levels of enterococci mostly recorded following heavy rainfall.

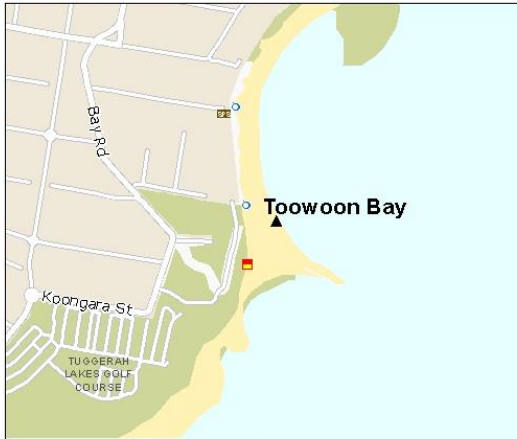
See 'How to read this report' for key to map.

Toowoan Bay is a relatively calm ocean beach protected by headlands and a tombola. The beach is patrolled during summer.

The Beach Suitability Grade of Poor indicates microbial water quality is susceptible to faecal pollution, particularly after rainfall and occasionally during dry weather conditions, with several potential sources of faecal contamination including stormwater.

Toowoona Bay was graded as Poor in 2018–2019, downgraded from Good in the previous year. A Poor grade indicates the site is more susceptible to pollution and not always suitable for swimming. While water quality at Toowoona Bay was mostly suitable for swimming in dry weather conditions, elevated enterococci levels were occasionally recorded after little or no rain. Microbial water quality at this site has declined in recent years, with slightly elevated bacterial results occurring more frequently since 2017.

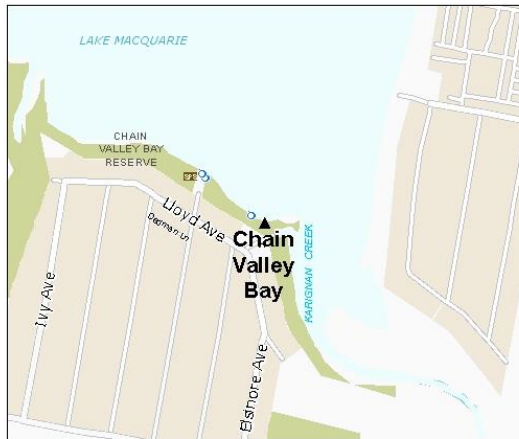
Chain Valley Bay is an enclosed swimming area located at the southern end of Lake Macquarie.

The Beach Suitability Grade of Poor indicates microbial water quality is susceptible to faecal pollution, particularly after rainfall and occasionally during dry weather conditions from several potential sources of faecal contamination including Lake Macquarie and stormwater.

Water quality at Gwandalan, Summerland Point Baths, Chain Valley Bay and Lake Munmorah Baths was mostly suitable for swimming during dry weather conditions, with between 72 and 85% of samples within the safe swimming limit when no rain had fallen in the previous 24 hours; however, elevated enterococci levels were recorded after light rainfall and sometimes in no rain. Water quality at Mannering Park Baths and Canton Beach was often elevated during dry and wet weather conditions, with enterococci levels increasing with increasing rainfall.

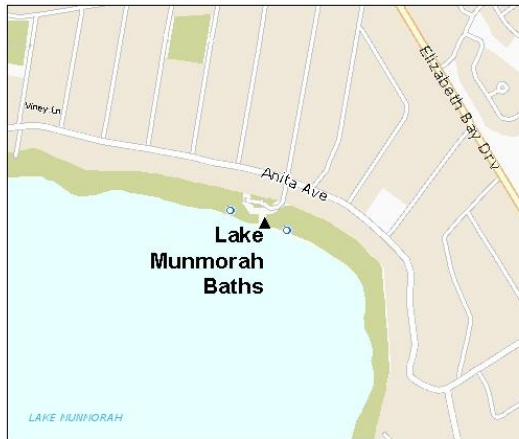
Lake Munmorah Baths is an enclosed swimming area in the north of Lake Munmorah.

The Beach Suitability Grade of Poor indicates microbial water quality is susceptible to faecal pollution, particularly after rainfall and occasionally during dry weather conditions, with several potential sources of faecal contamination including Lake Munmorah and stormwater.

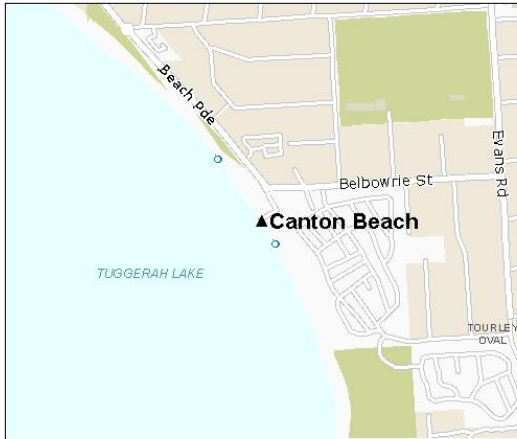
Canton Beach is within Tuggerah Lake and is backed by a narrow reserve and picnic area.

The Beach Suitability Grade of Poor indicates microbial water quality is susceptible to faecal pollution, particularly after rainfall and occasionally during dry weather conditions, with several potential sources of faecal contamination including Tuggerah Lake and stormwater.

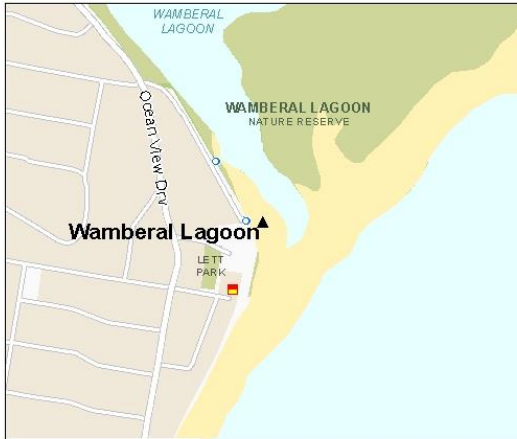
Wamberal Lagoon is intermittently open to the ocean toward the southern end of Wamberal Beach.

The Beach Suitability Grade of Poor indicates microbial water quality is susceptible to faecal pollution, particularly after rainfall and occasionally during dry weather conditions, with several potential sources of faecal contamination including Wamberal Lagoon.

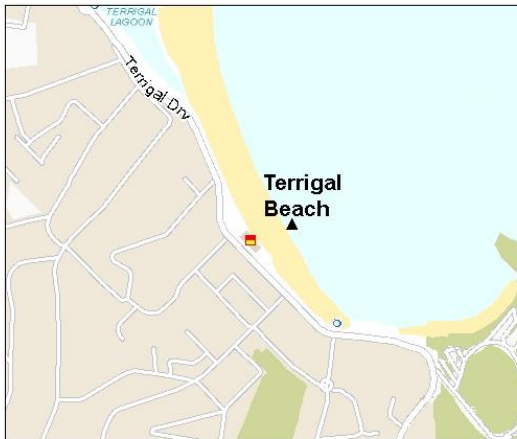
Terrigal Beach is a very popular north-east facing beach and is patrolled during the warmer months.

The Beach Suitability Grade of Good indicates microbial water quality is considered suitable for swimming most of the time but may be susceptible to pollution after rain, with potential sources of faecal contamination including discharge from Terrigal Lagoon.

Terrigal Beach improved to Good from a Poor grade in 2017–2018, reflecting a slightly higher proportion of water samples collected during dry weather conditions compared to the previous year. Microbial water quality at Terrigal Beach is mostly suitable for swimming in dry weather conditions, with 89% of samples within the safe swimming limit when no rain had fallen in the previous 24 hours. While water quality at the beach has shown some improvement over the past few years, it remains close to the threshold between Good and Poor. Terrigal Beach can be impacted by several potential pollution sources, including stormwater and contaminants discharged in outflow from nearby Terrigal Lagoon.

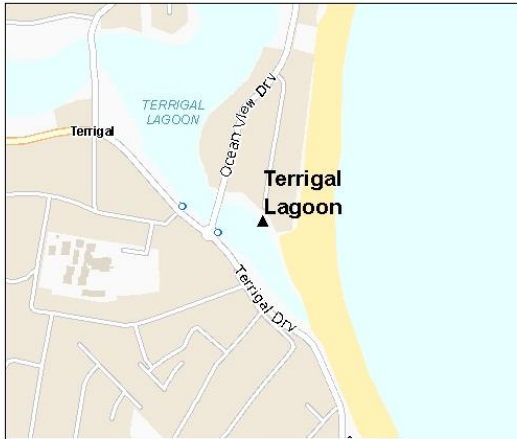
Terrigal Lagoon is intermittently open to the ocean to the north of Terrigal Beach.

The Beach Suitability Grade of Poor indicates microbial water quality is susceptible to faecal pollution, particularly after rainfall and occasionally during dry weather conditions, with several potential sources of faecal contamination including sewage overflows and from within Terrigal Lagoon.

The four lagoons were graded Poor, the same result as previous years: Wamberal Lagoon, Terrigal Lagoon, Avoca Lagoon and Cockrone Lagoon. Water quality was often unsuitable for swimming during dry weather conditions and swimming should be avoided if there are any signs of pollution such as discoloured water, odours or floating debris. Bacterial levels increased significantly with increasing rainfall.

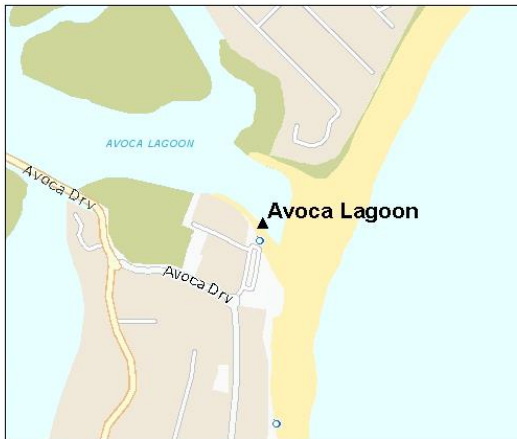
Avoca Lagoon is intermittently open to the ocean and located to the north of Avoca Beach.

The Beach Suitability Grade of Poor indicates microbial water quality is susceptible to faecal pollution, particularly after rainfall and often during dry weather conditions, with several potential sources of faecal contamination including sewage overflows and from within Avoca Lagoon.

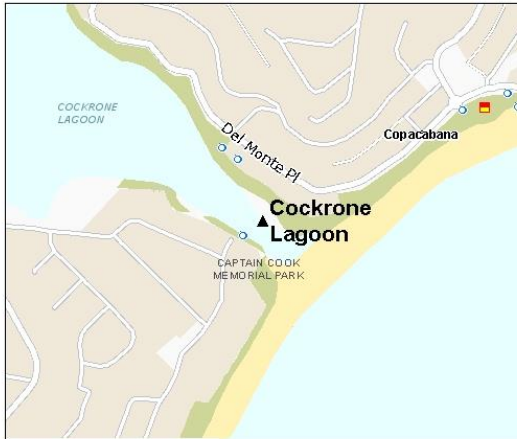
Cockrone Lagoon is intermittently open to the ocean and is located between Copacabana and MacMasters beaches.

The Beach Suitability Grade of Poor indicates microbial water quality is susceptible to faecal pollution, particularly after rainfall and occasionally during dry weather conditions, with several potential sources of faecal contamination including Cockrone Lagoon.

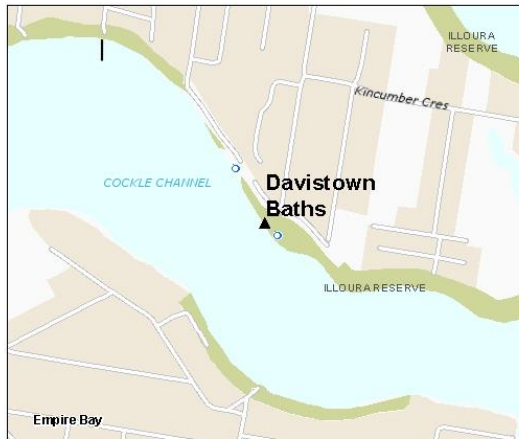
The Davistown Baths are a netted swimming enclosure in the channel between Brisbane Water and the Kincumber Broadwater.

The Beach Suitability Grade of Poor indicates microbial water quality is susceptible to faecal pollution, particularly after rainfall and occasionally during dry weather conditions, with several potential sources of faecal contamination including Brisbane Water and stormwater.

Microbial water quality at Davistown Baths and Woy Woy Baths was often elevated during dry and wet weather conditions. At these sites, the bacterial levels continued to increase significantly in response to increasing rainfall.

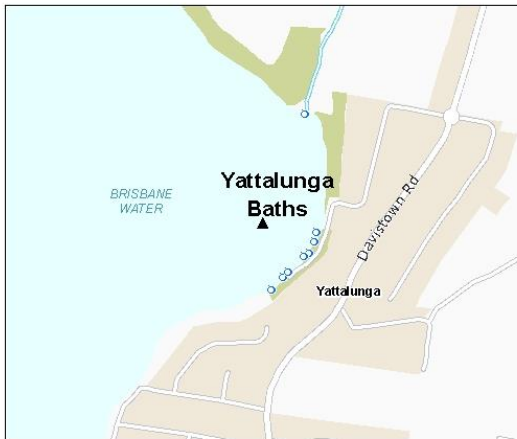
Yattalunga Baths is a netted swimming enclosure located in the upper reaches of Brisbane Water.

The Beach Suitability Grade of Poor indicates microbial water quality is susceptible to faecal pollution, particularly after rainfall and occasionally during dry weather conditions, with several potential sources of faecal contamination including Brisbane Water and stormwater.

Enterococci levels in wet and dry weather conditions are presented for each swimming location as a bar graph. All data collected during the assessment period is included in the analysis. Dry weather is defined as no rainfall recorded in the previous 24 hours. Each bar is colour coded to show the number of enterococci results up to 40cfu/100mL, between 41 and 200cfu/100mL, between 201 and 500cfu/100mL and greater than 500cfu/100mL. These categories reflect the Microbial Assessment Category thresholds and are coloured on the graph as dark green, light green, amber and red respectively.

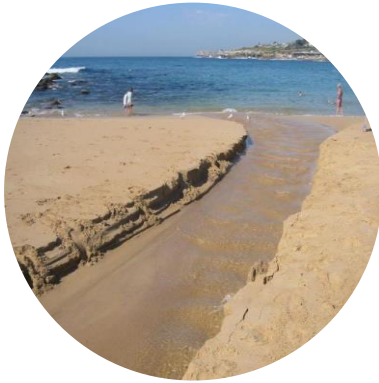
Stormwater at Coogee Beach
Photo: Beachwatch/EES, DPIE

Stormwater in urban areas often contains sewage from leakages, overflows or sewer chokes when the sewerage system fails.
