State of the beaches 2018-2019

North Coast region

Beachwatch

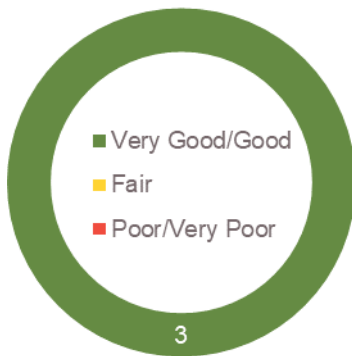
Beach Suitability Grades for Ballina Shire Council ocean beaches

Seven Mile Beach and Lighthouse Beach continued to be graded Very Good, as in previous years. These beaches had excellent water quality and were suitable for swimming almost all of the time.

Shelly Beach was graded as Good. Water quality at this site was of a high standard and suitable for swimming most of the time. While water quality at Shelly Beach has shown improvement over the past five years, there are several potential sources of faecal contamination nearby.

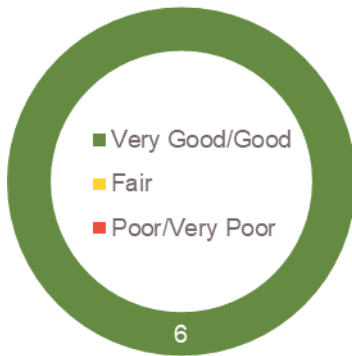
Beach Suitability Grades for Ballina Shire Council estuarine beaches

All six estuarine swimming locations were graded as Good in 2018–2019: Shaws Bay North, Shaws Bay East, Shaws Bay East Arm, Shaws Bay East Beach, Shaws Bay West and The Serpentine. Water quality at these sites was mostly suitable for swimming in dry weather, with 90% or greater of dry weather samples within the safe swimming limit. Elevated enterococci levels were occasionally recorded following light rainfall and more often after heavy rainfall. Water quality at these sites can be impacted by upstream sources and can take longer to recover due to lower levels of flushing.

It is recommended that swimming should be avoided during and for up to three days following rainfall at estuarine swimming sites, or if there are signs of pollution such as discoloured water or floating debris.

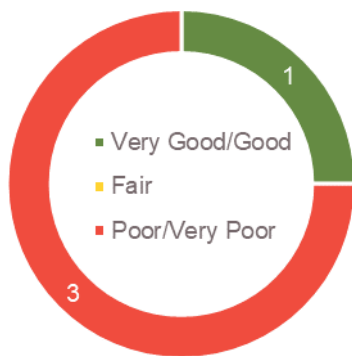
Beach Suitability Grades for Ballina Shire Council lake/lagoon swimming sites

Lake Ainsworth South was graded as Good in 2018–2019. Water quality at this swimming location was often suitable for swimming during dry weather, with 95% of dry weather samples within in the safe swimming limit.

Elevated bacteria levels were recorded at these lake swimming sites during dry and wet weather conditions. Despite the poor grades, between 69% and 81% of dry

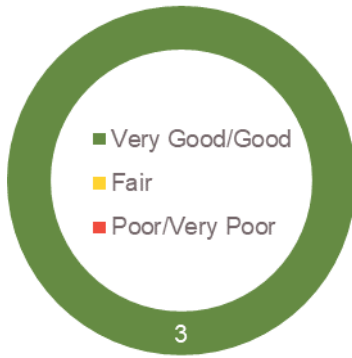
Beach Suitability Grades for Richmond Valley Council ocean beaches

All three ocean beaches were graded as Very Good: Airforce Beach, Main Beach and Shark Bay. Water quality at these beaches has been consistently excellent for many years and is suitable for swimming almost all of the time.

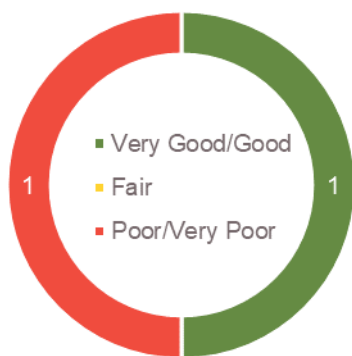
Beach Suitability Grades for Richmond Valley Council estuarine beaches

Elm Street Bridge North in the Evans River was graded as Good. This is a similar result to the previous two years. Water quality was frequently suitable for swimming during dry weather conditions with 93% of samples within the safe swimming limit. Elevated enterococci levels were mostly recorded following rainfall.

Evans River, located downstream of Elm Street Bridge North, was graded as Poor in 2018–2019, the same as the previous year. Water quality at this site was mostly suitable for swimming during dry weather conditions, with 68% of samples within the safe swimming limit. Elevated enterococci levels were occasionally recorded in dry weather, and often during and following rainfall. High bacteria counts have mostly been recorded during and following moderate to heavy rainfall in the previous days. Discharge from a nearby large stormwater drain is also likely to impact water quality at this site when flowing.

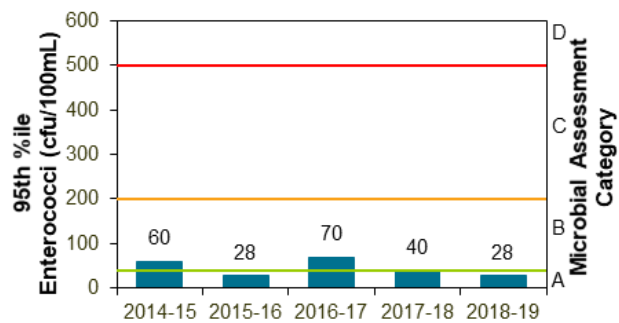
On each beach page, the MACs for the last five years are displayed on a simple bar chart. The MAC for the current year is based on enterococci data collected during the assessment period. The bars are labelled with the 95th percentile value for each year and the thresholds dividing the A, B, C and D categories are marked in green, amber and red for reference.

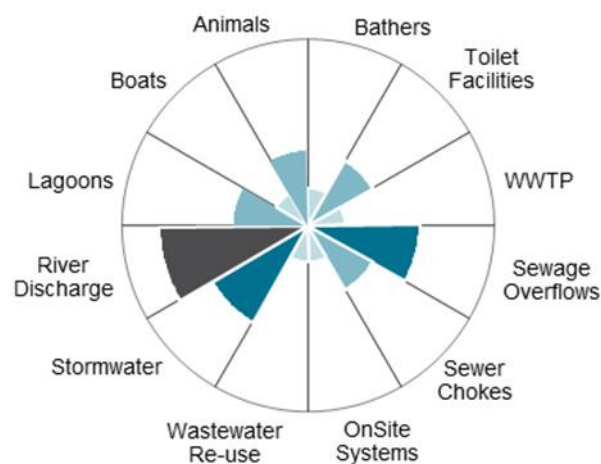
Sanitary Inspection Category (SIC) chart

The results of the sanitary inspection for each swimming location are presented in a radar pie chart. The chart shows the likelihood that each identified pollution source will contribute to faecal contamination at a swimming site, as indicated by the size and colour of the segment, ranging from very low (lightest colour) to very high (darkest colour) as shown below. The sum of these contributions is the overall likelihood, or Sanitary Inspection Category.

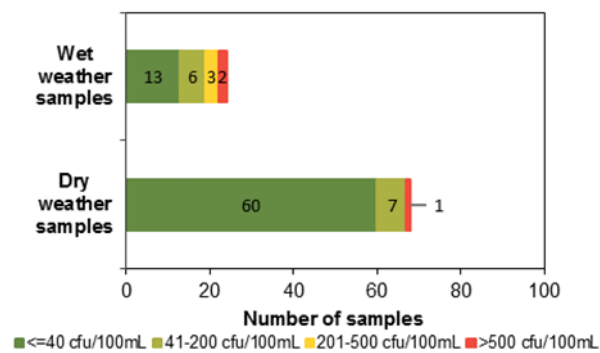
Wet and dry weather water quality chart

Enterococci levels in wet and dry weather conditions are presented for each swimming location as a bar graph. All data collected during the assessment period is included in the analysis. Dry weather is defined as no rainfall recorded in the previous 24 hours. Each bar is colour coded to show the number of enterococci results up to 40cfu/100mL, between 41 and 200cfu/100mL, between 201 and 500cfu/100mL and greater than 500cfu/100mL. These categories reflect the Microbial Assessment Category thresholds and are coloured on the graph as dark green, light green, amber and red respectively.

It is expected that swimming sites with lower levels of flushing show some elevated bacterial results in dry weather samples (no rainfall in the previous 24 hours) due to the longer time needed to recover from a rainfall event. At some estuarine and lake/lagoon swimming locations the impacts of stormwater pollution on beach water quality may be detected up to three days after rainfall.

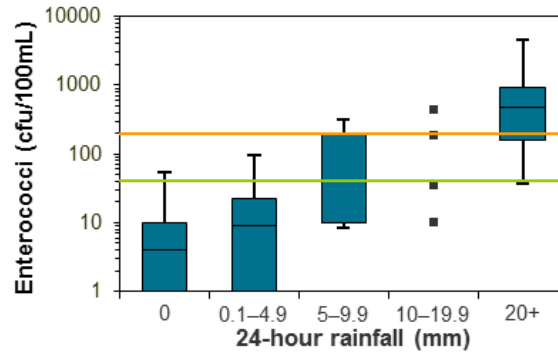
Water quality in response to rainfall

Trends in enterococci levels in response to rainfall are shown using a box plot. For reference, enterococci levels of 40cfu/100mL and 200cfu/100mL are indicated with a green and orange line, respectively. The 40cfu/100mL level is referred to as the 'safe swimming limit'. The enterococci data were obtained from the last five years of monitoring. Rainfall data were obtained from rain gauges situated close to the sample site and are 24-hour totals to 9am on the day of sampling. If there are fewer than five enterococci data points in a rainfall category, individual data points are presented instead of a box plot. At sites where many results are below the detection limit (1cfu/100mL), only the upper portion of the box plots will be visible.
