Beachwatch

State of the beaches 2023–24

South Coast region

Department of Climate Change,
Energy, the Environment and Water

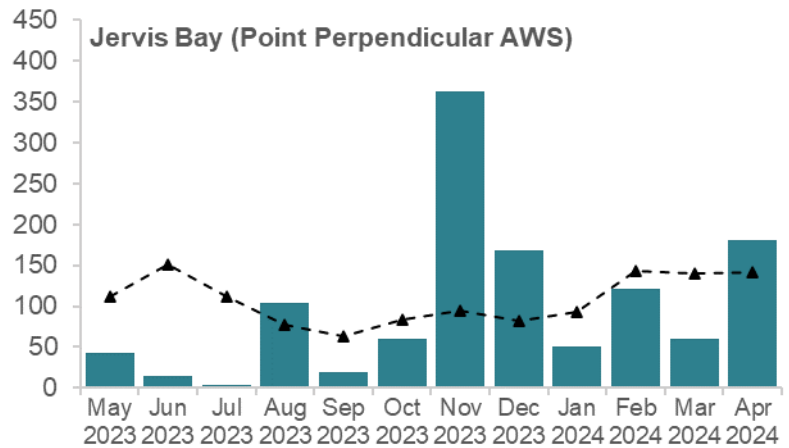
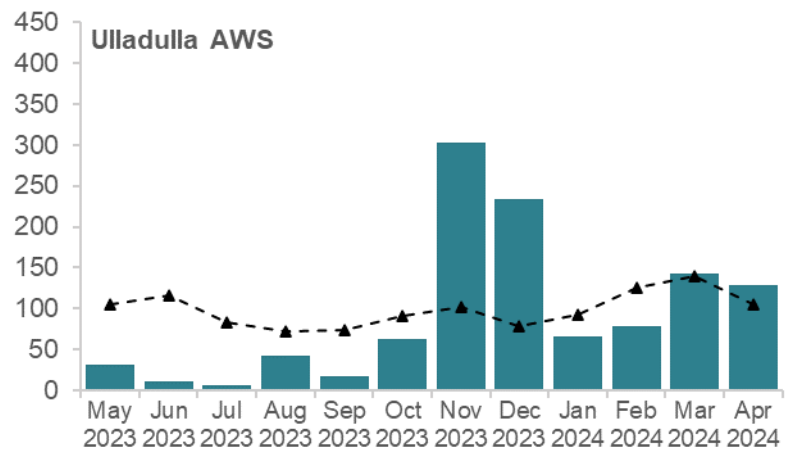
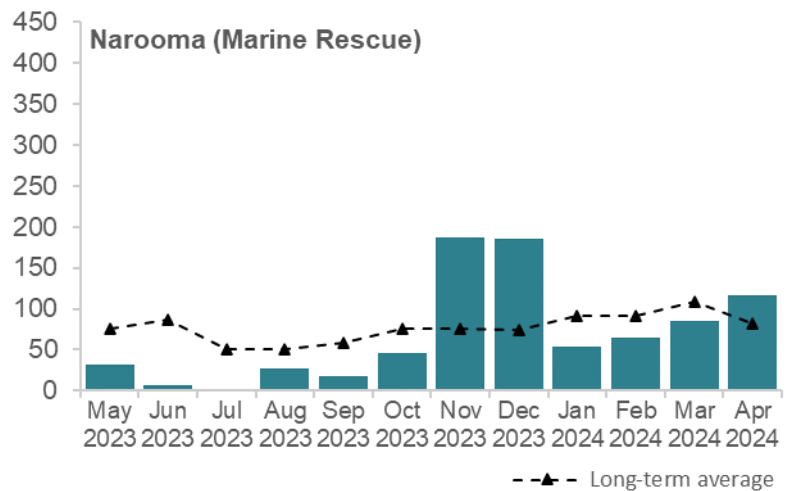
South Coast region rainfall

Rainfall on the South Coast was average to below average for the 2023–2024 reporting year, except for some isolated wet months. Well above average rainfall was recorded in November and December 2023 and April 2024 across the region.

November and December 2023 were notably wet on the South Coast. Jervis Bay and Ulladulla both recorded their highest November daily rainfall and record highest November and December total rainfall. Similarly, Narooma recorded its highest November total rainfall in 23 years.

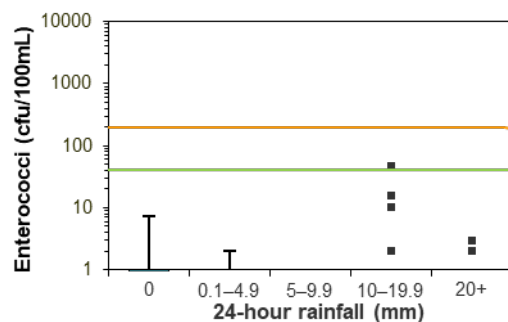
Water quality in response to rainfall

Enterococci levels had little response to rainfall and generally remained below the safe swimming limit across all rainfall categories.

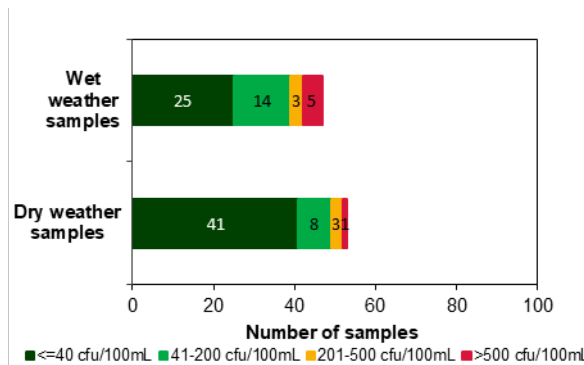
Dry and wet weather water quality

Surf Beach was graded as Poor in 2023–2024, consistent with the previous years. Elevated bacterial levels were often recorded during dry weather conditions and increased with increasing rainfall. Despite this, 77% of dry weather samples were within the safe swimming limit.

catchments draining to Surf Beach Creek and Surf Beach. Following this, council engaged a consultant to undertake a water quality investigation that included statistical analysis, hydrodynamic modelling, investigative sampling and DNA marker analysis. The investigation identified multiple potential sources of contamination including domestic canine faeces entering waterways, discharge from Batemans Bay Sewage Treatment Plant (STP) during overflow events, STP outfall contamination via tidal patterns and failure or leakage of onsite sewer management systems (OSSM) upstream of Surf Beach. Council will action the recommendations to improve water quality, including a responsible dog waste disposal education program and an audit of all OSSMs in the catchment to reduce any potential contamination from these sources. Council also completed the Surf Beach STP upgrades in December 2023.

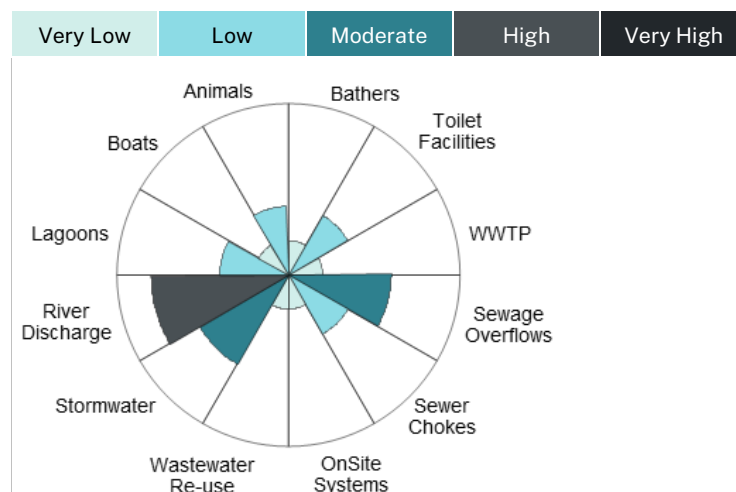
Sanitary Inspection Category (SIC) chart

The results of the sanitary inspection for each swimming location are presented in a radar pie chart. The chart shows the likelihood that each identified pollution source will contribute to faecal contamination at a swimming site, as indicated by the size and colour of the segment, ranging from very low (lightest colour) to very high (darkest colour) as shown below. The sum of these contributions is the overall likelihood, or Sanitary Inspection Category.

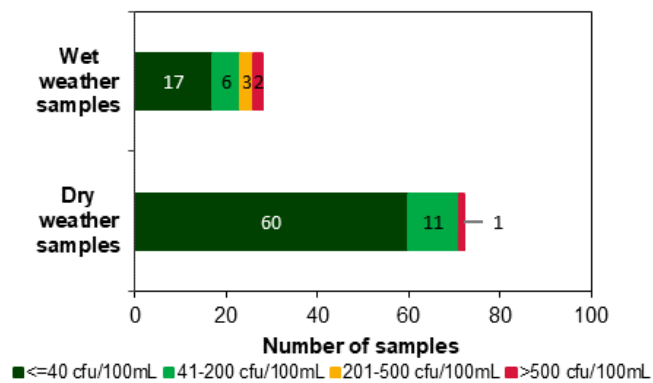
Wet and dry weather water quality chart

Enterococci levels in wet and dry weather conditions are presented for each swimming location as a bar graph. All data collected during the assessment period is included in the analysis. Dry weather is defined as no rainfall recorded in the previous 24 hours. Each bar is colour coded to show the number of enterococci results up to 40 cfu/100 mL, between 41 and 200 cfu/100 mL, between 201 and 500 cfu/100 mL and greater than 500 cfu/100 mL. These categories reflect the Microbial Assessment Category thresholds and are coloured on the graph as dark green, light green, amber and red respectively.

It is expected that swimming sites with lower levels of flushing will show some elevated bacterial results in dry weather samples (no rainfall in the previous 24 hours) due to the longer time needed to recover from a rainfall event. At some estuarine and lake/lagoon swimming locations the impacts of stormwater pollution on beach water quality may be detected up to 3 days after rainfall.

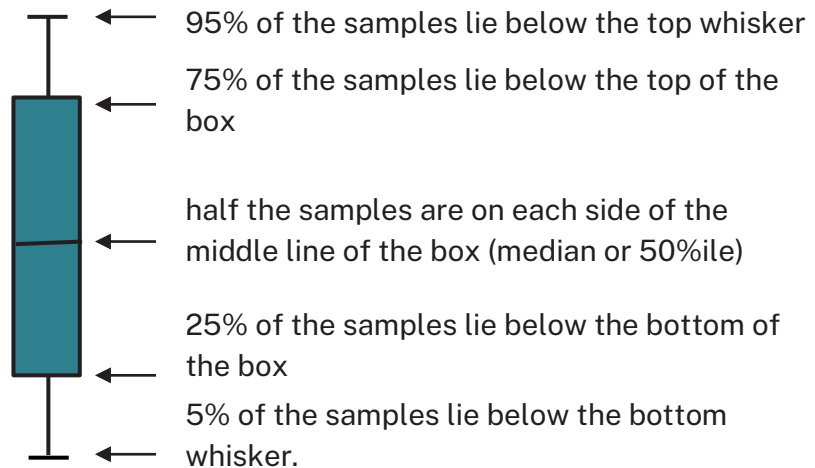
Each part of the box plot represents a significant percentile value of the sample population:
