Thirlmere Lakes Inquiry

Final Report of the Independent Committee

23 October 2012

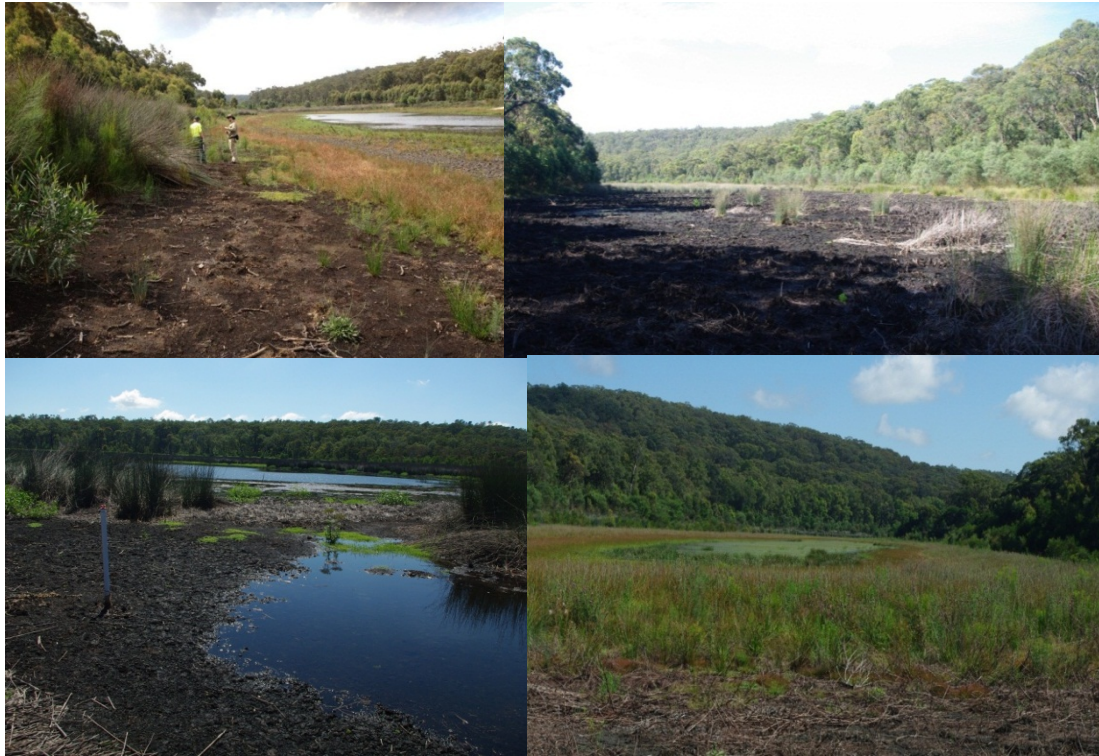
Figure 1-3. Pictures of Thirlmere Lakes, early February 2012. From top left, clockwise, Lake Couridjah, Lake Baraba, Lake Werri Berri and Lake Gandangarra.

The lakes were substantially dry during the initial period of the Committee's deliberations (November 2011). Lakes Gandangarra, Werri Berri, Couridjah and Baraba had a small amount of water; while Lake Nerrigorang was dry (Fig. 1-3). Water tables in the dry section of lake beds were within 1 m of the surface. Storms during the period of the Committee's deliberations added water to the lakes, as discussed in Section 4. The total area of the lakes, when full, is approximately 50 ha. At the time of the Committee's early visits to the lakes the water surface area was much less than 10 ha.

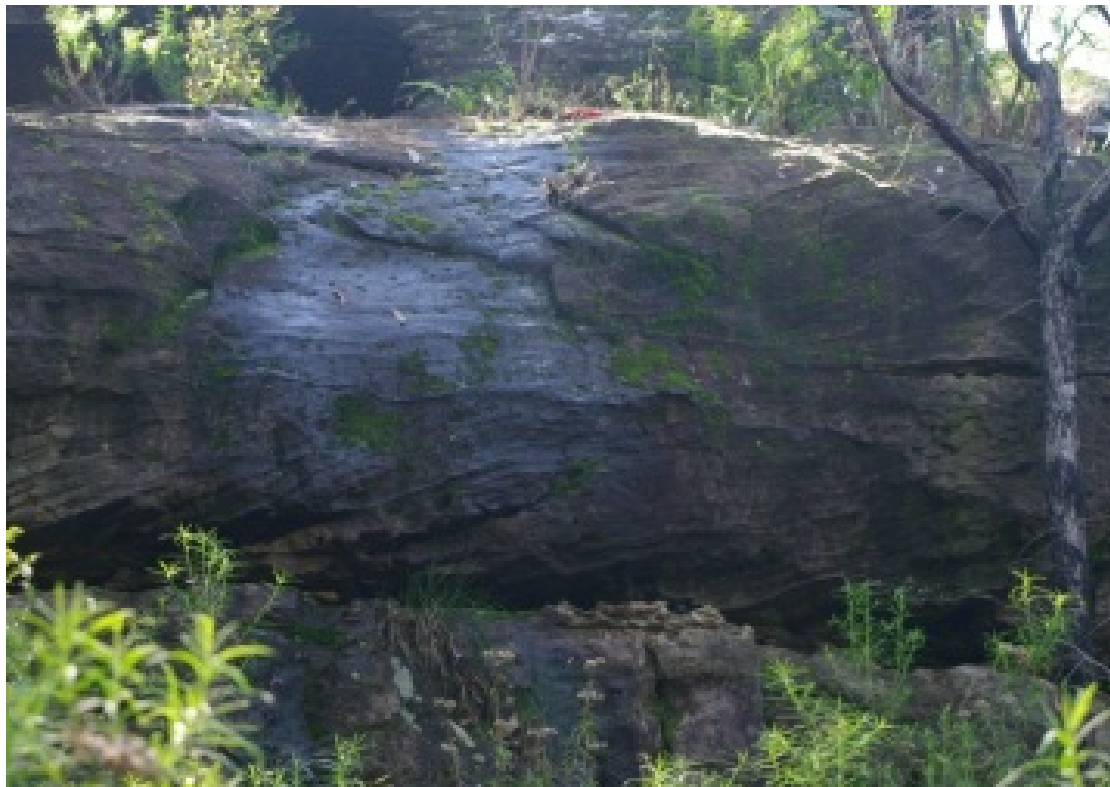
Figure 2-1. Flow emerging onto a rock face in Thirlmere Lakes Valley only to infiltrate further downslope.

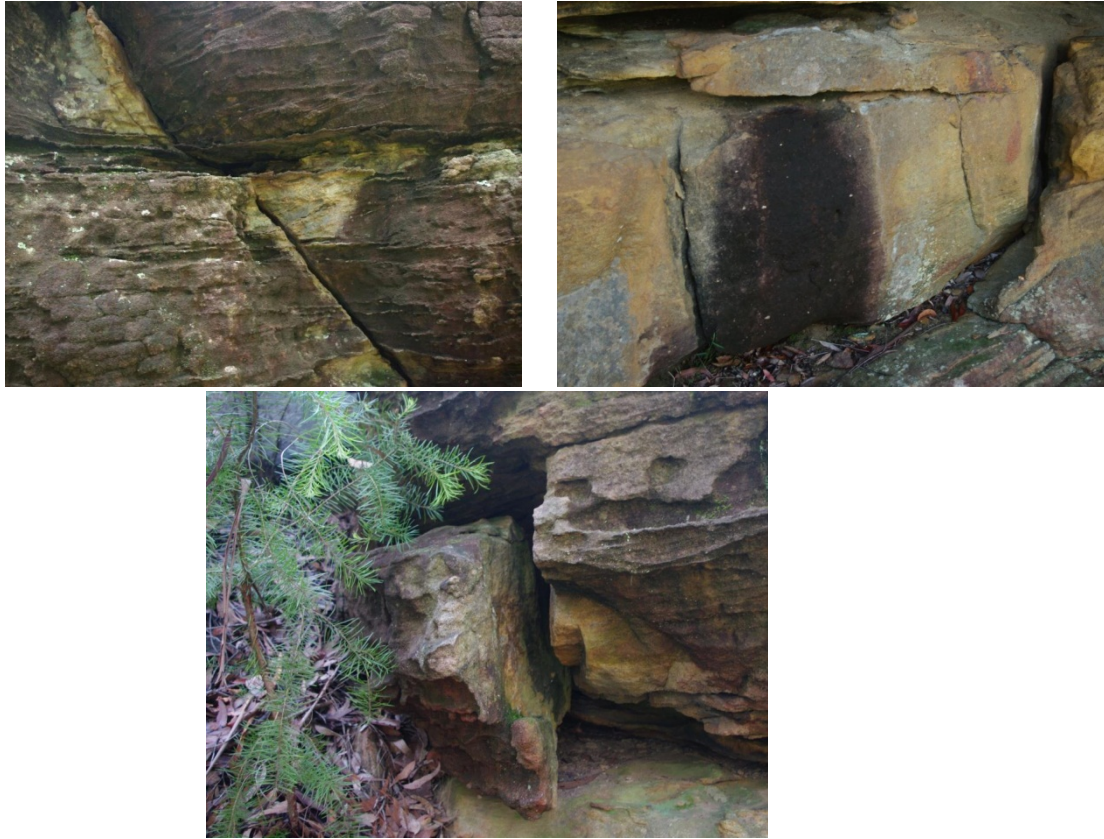
Figure 3-4. Structural elements in Thirlmere Lakes valley. Each image shows sub-horizontal bedding planes and steeply dipping joints contributing to the detachment of blocks of rock from the cliff faces.

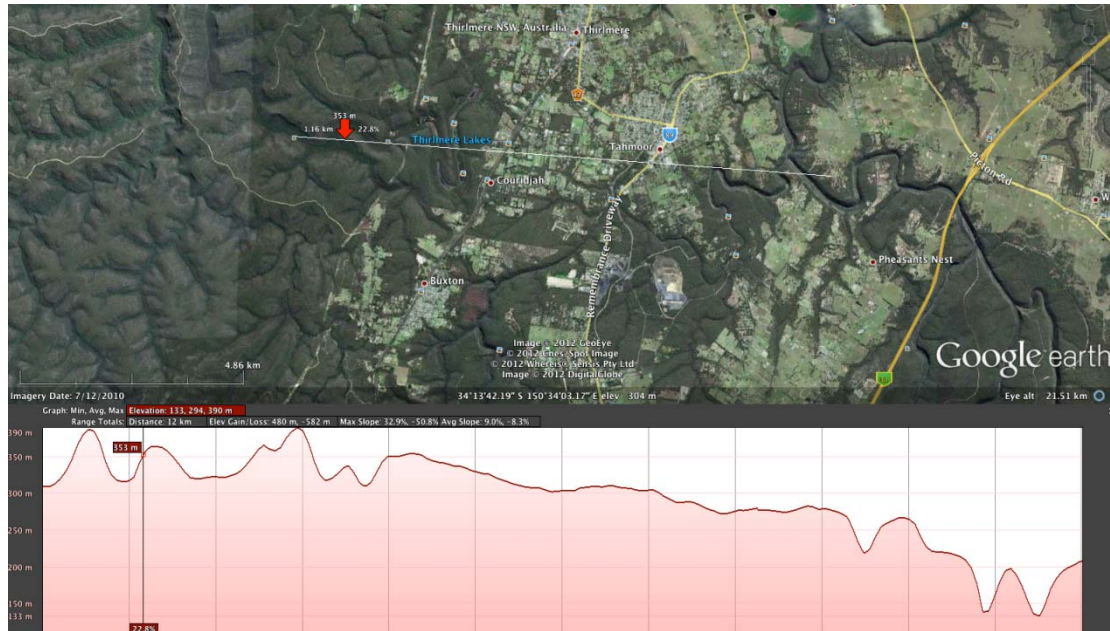
Figure 3-6. Cross section drawn from Google Earth showing Thirlmere Lakes topographically above much of the land surface to the east (copyright; Google Earth; 2012 ©Whereis@Sensis Pty Ltd; Image©2012GeoEye).

The eastward dip slope and orientation of the lineaments suggests that groundwater flow will be towards the east, particularly as the elevation of the land surface also declines towards the east (Fig. 3-6). There is no barrier to the eastward drainage of groundwater.

Thirlmere Lakes occupy a topographic high. The town of Tahmoor is lower than the bed of the lakes (see Fig. 3-6). While the topography rises west of the lakes the deeply incised streams, such as Blue Gum Creek, are lower than the bed of the lake. Any regional groundwater drainage would be away from the lakes so they are not a regional groundwater sink.

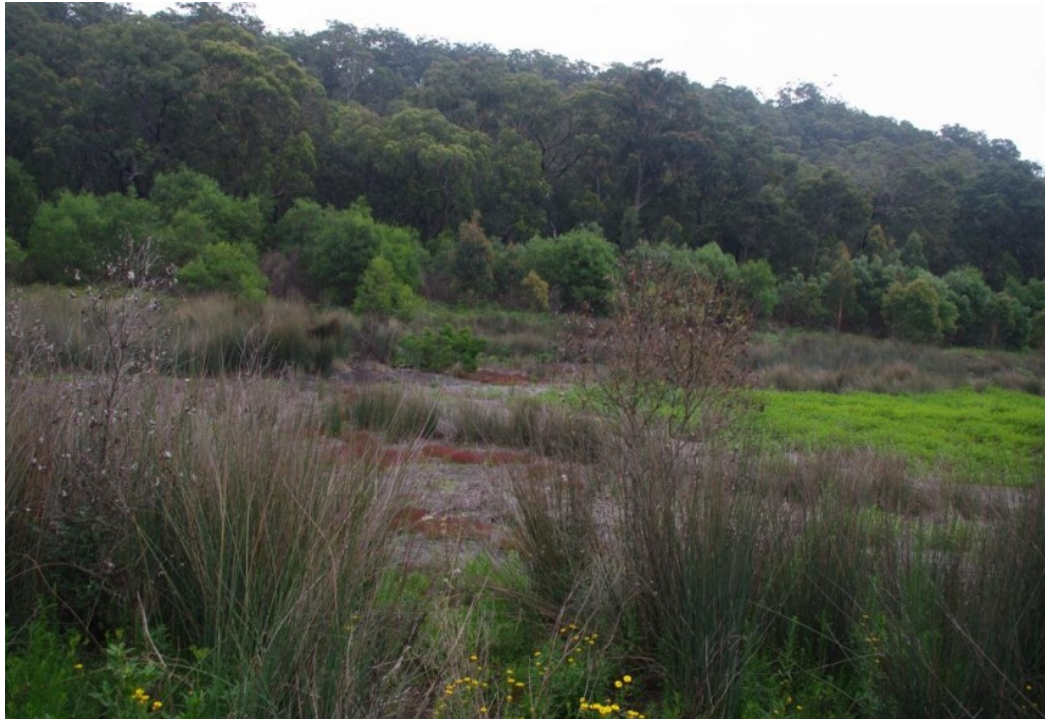
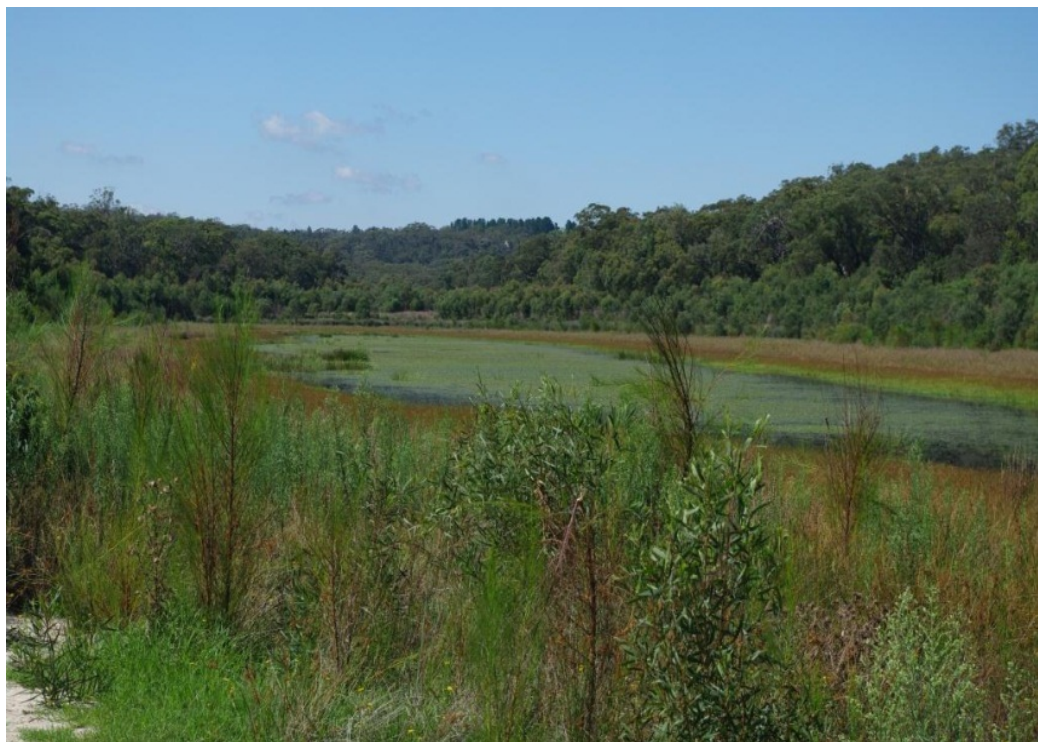
Figure 3-10. Vegetation encroachment on margins of lakes Nerrigorang (upper image) and Werri Berri (lower image) (January, 2012).

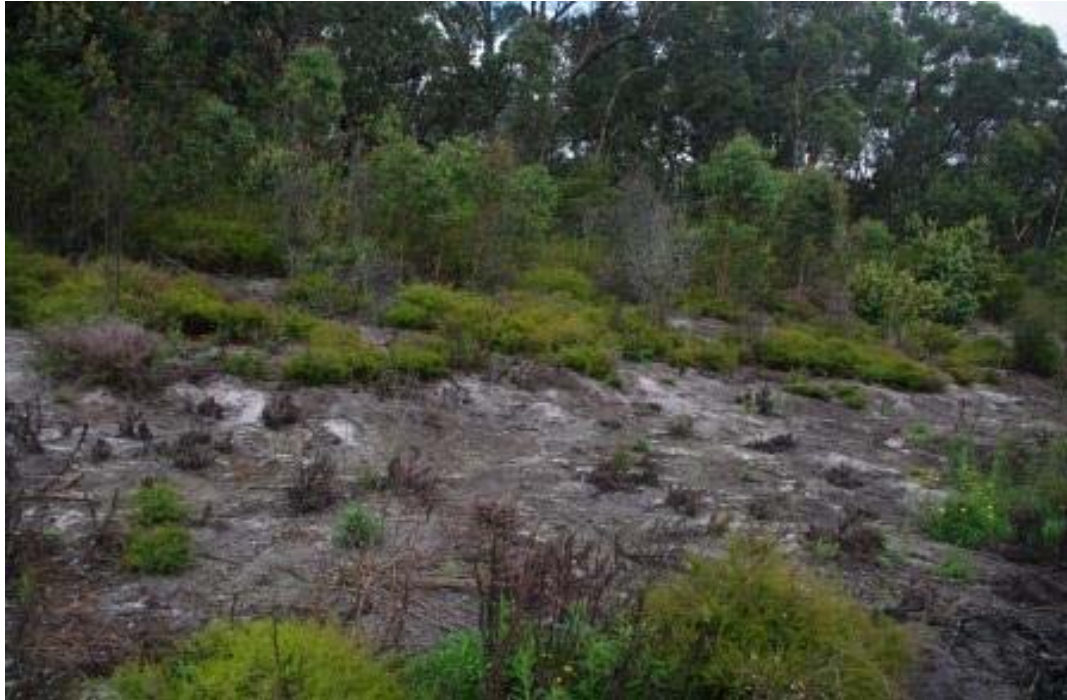
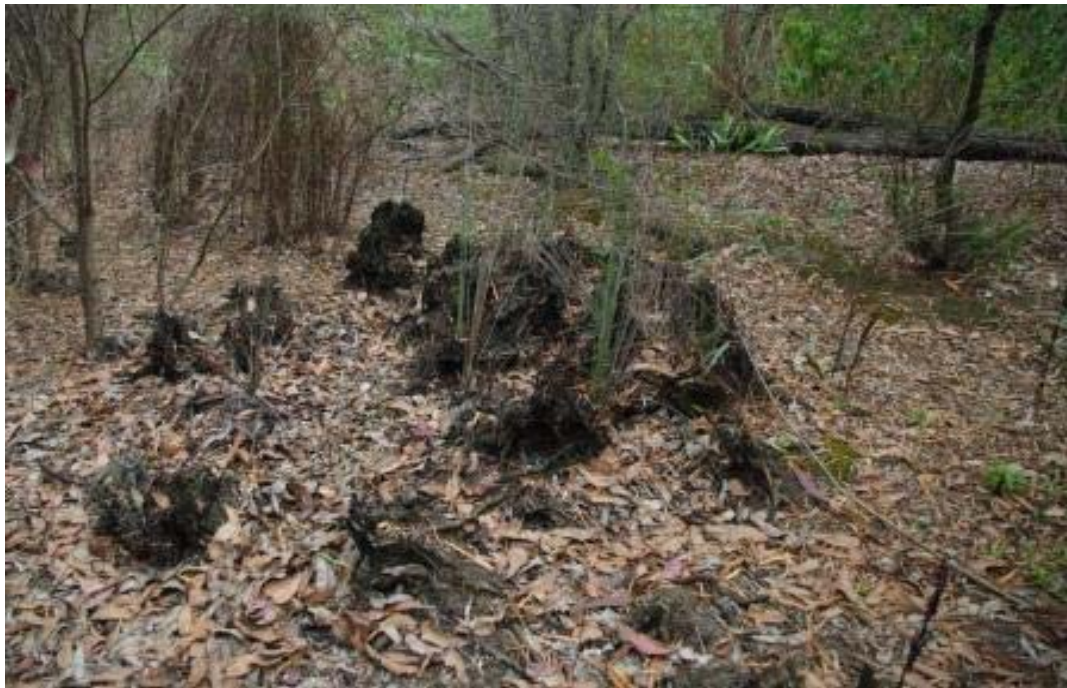
Figure 3-11. Abandoned lake shore features, Lake Nerrigorang. Nov 2011. Upper image shows a washed beach feature and lower shows relict lacustrine vegetation.

The old shorelines were clearly indicated by relict reed swamps, benching and distinct grain size differentiation across the surface suggesting some form of wave-winning.

The benches were several metres higher than the beds of the lakes and at least four sets of old lake shore features were identified for some lakes in elevations up to 7 m above the lake floors. How long it takes for these features to form is not known. It is not possible to use the evidence of previous lakes levels in this report to indicate the period of long-standing water levels or to date these higher lake levels, as the data on their ages are not available. It would be a worthwhile exercise to undertake a geomorphic survey of the abandoned lake shores, using relevant absolute and relative dating techniques.

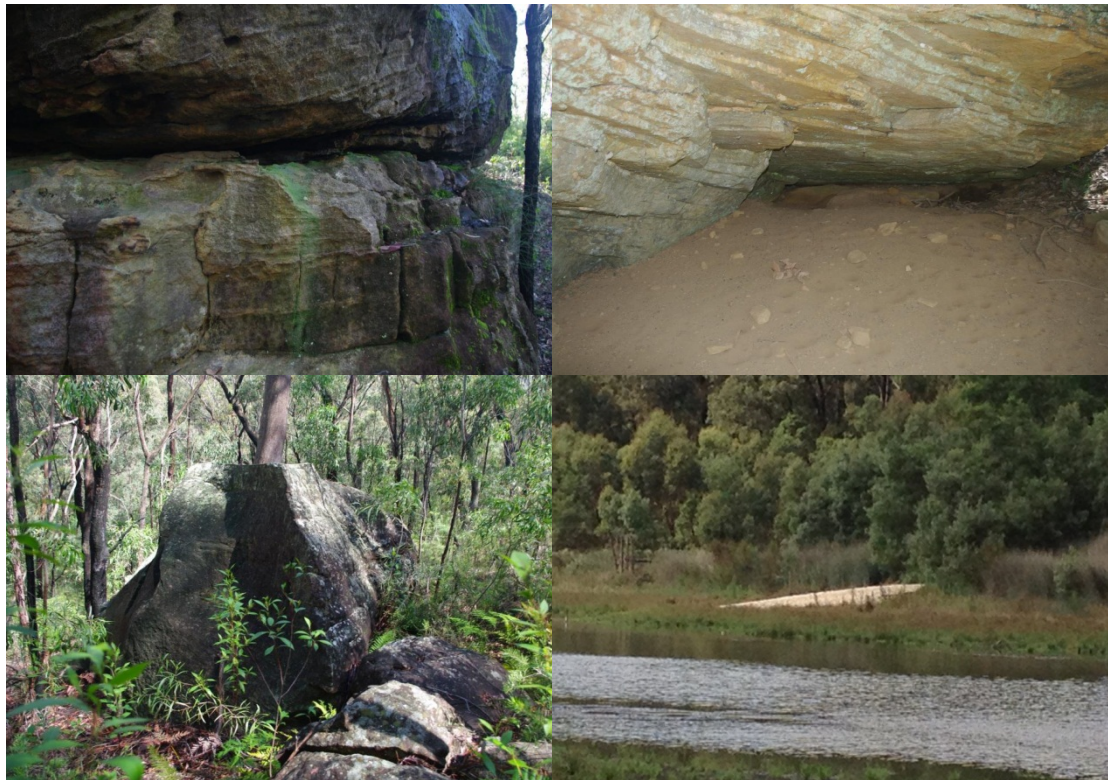
Figure 3-17. Weathering, erosion and deposition in Thirlmere Lakes Valley.

The texture of colluvial slope material fines downslope. Towards the base of the colluvial slopes brown coloured soils are evident. Ants appear to be a major factor in bioturbation of the colluvial slopes, although avian scratching of the surface is also evident. Wombat holes are abundant in the lower slopes and near the lake margins, while other animals are excavating underneath the rock ledges. Debris dams attest to some overland flow.

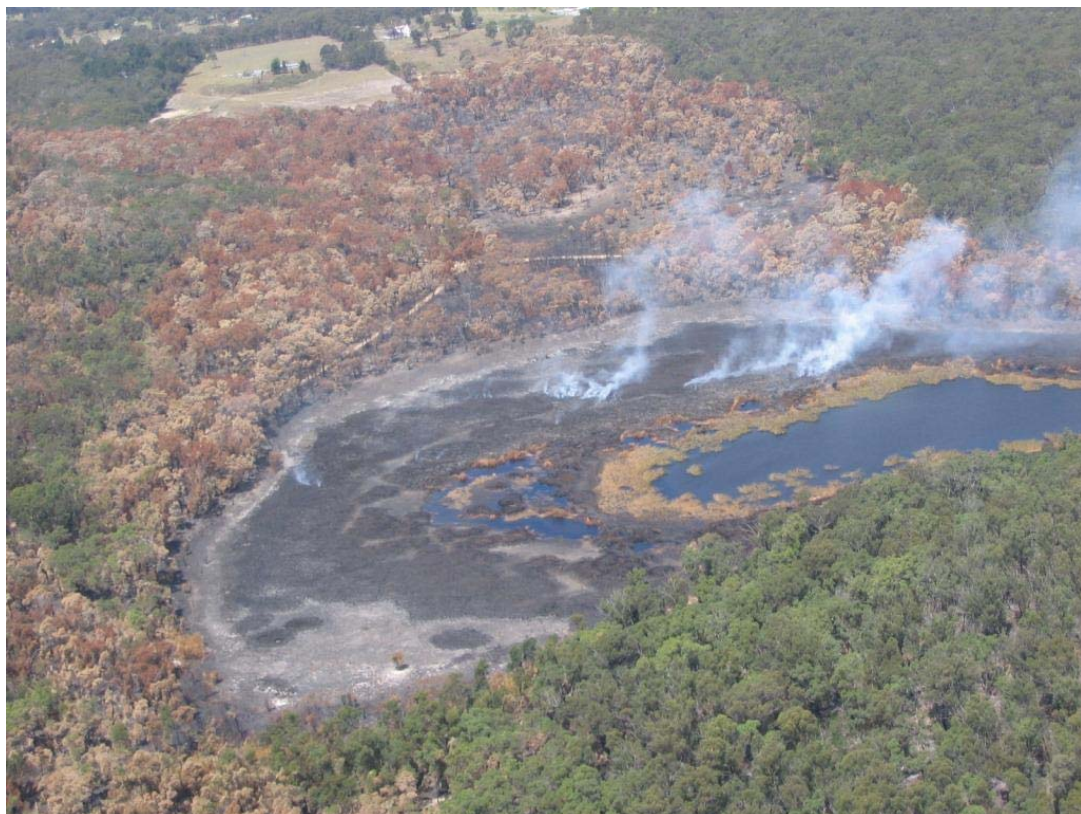
Figure 3-18. Lake Gandangarra basin alight following 2006 bushfire. View looking east from northwest of the lake.

Study of lake sediment cores from Thirlmere Lakes shows the common occurrence of fire, creating charcoal which washes into the lake sediments. Where the peat on the bed of lakes catches fire (Fig. 3-18) it is oxidised and converted to mineral ash that can be removed in the smoke column or blown or washed away. The exact role of fire in determining the sedimentology of Thirlmere Lakes is poorly known.

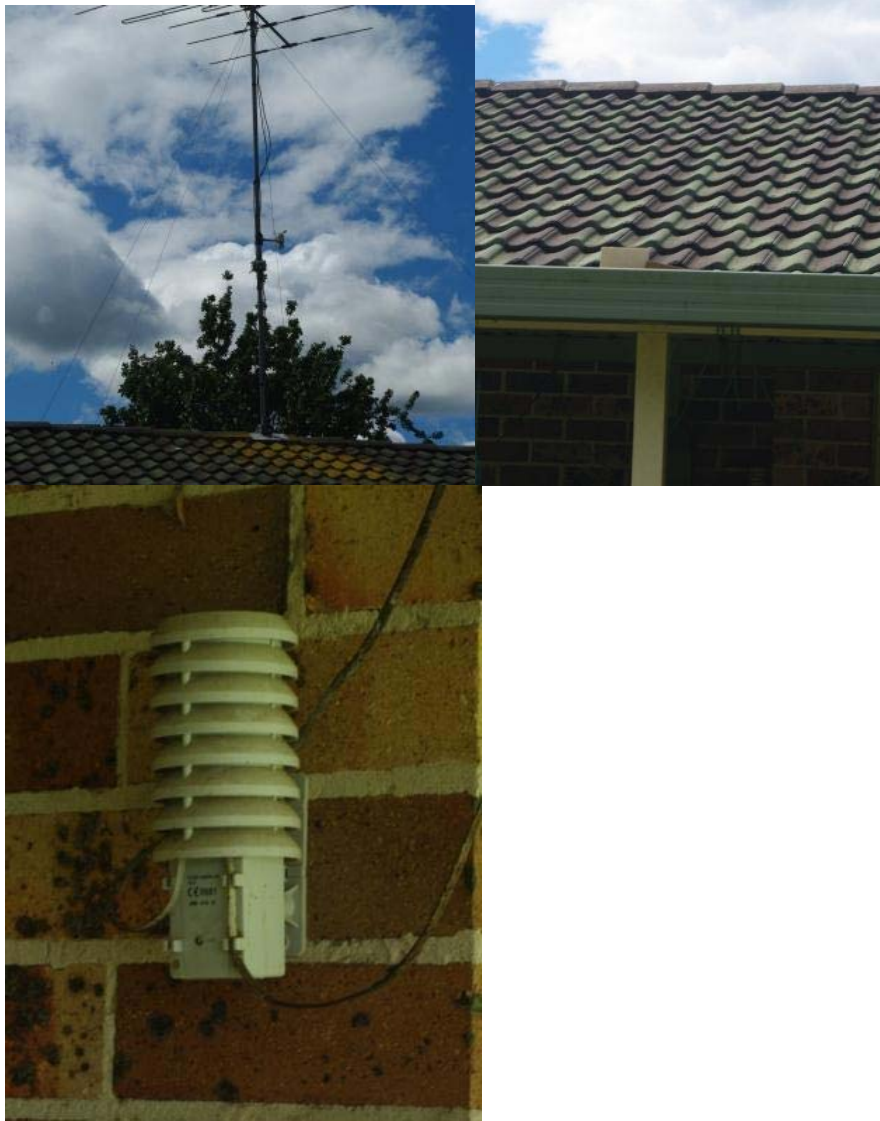
Figure 4-2. Elements of the Thirlmere Lakes Automatic Weather Station. From top left, clockwise, anemometer, tipping bucket rain gauge, and temperature and pressure probe housing.

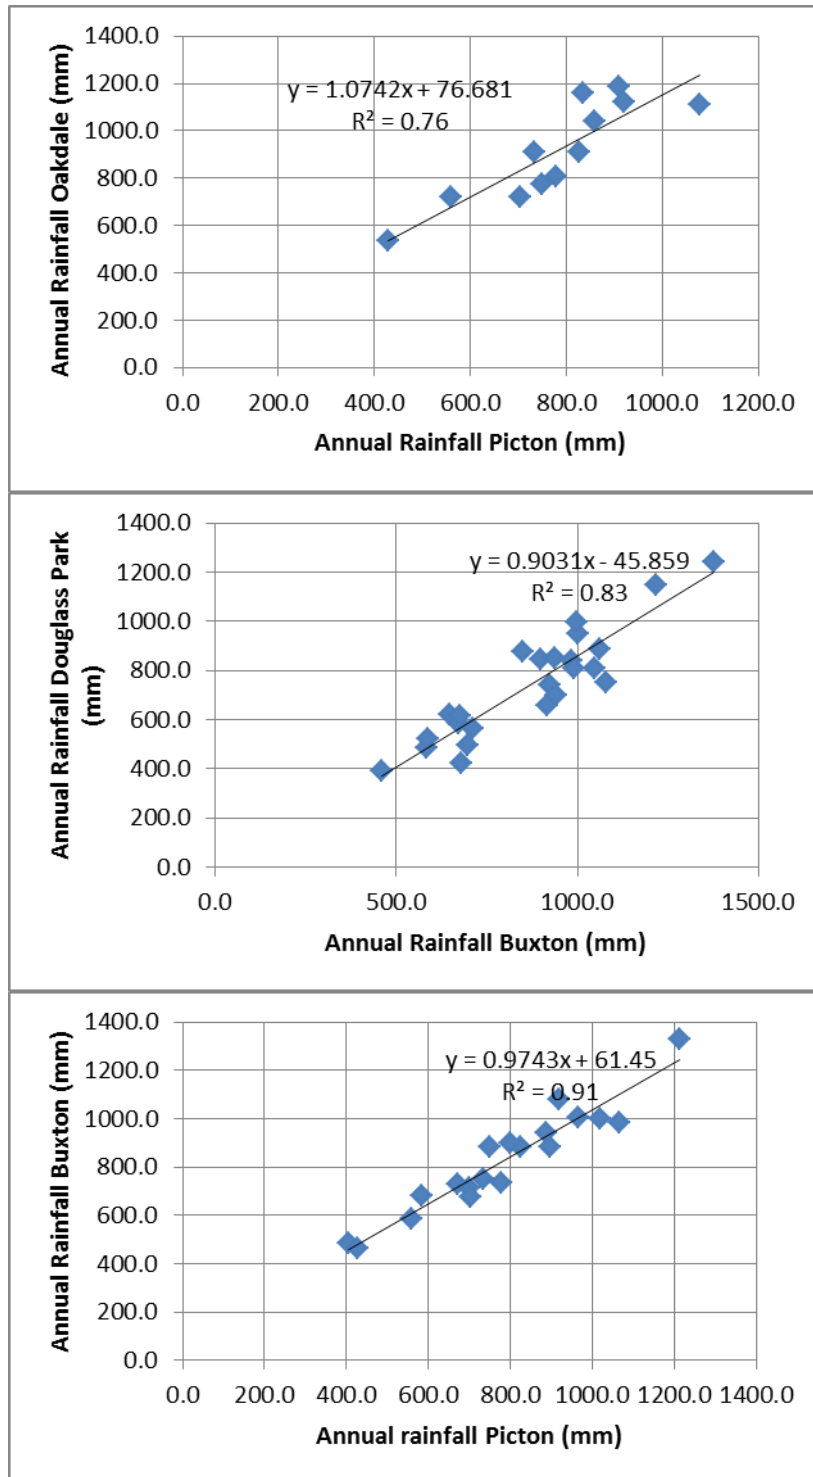
Figure 4-3. Comparison of annual rainfalls for common periods for Picton (from 1880), Buxton (from 1967), Oakdale (from 1963) and Douglas Park (from 1974).

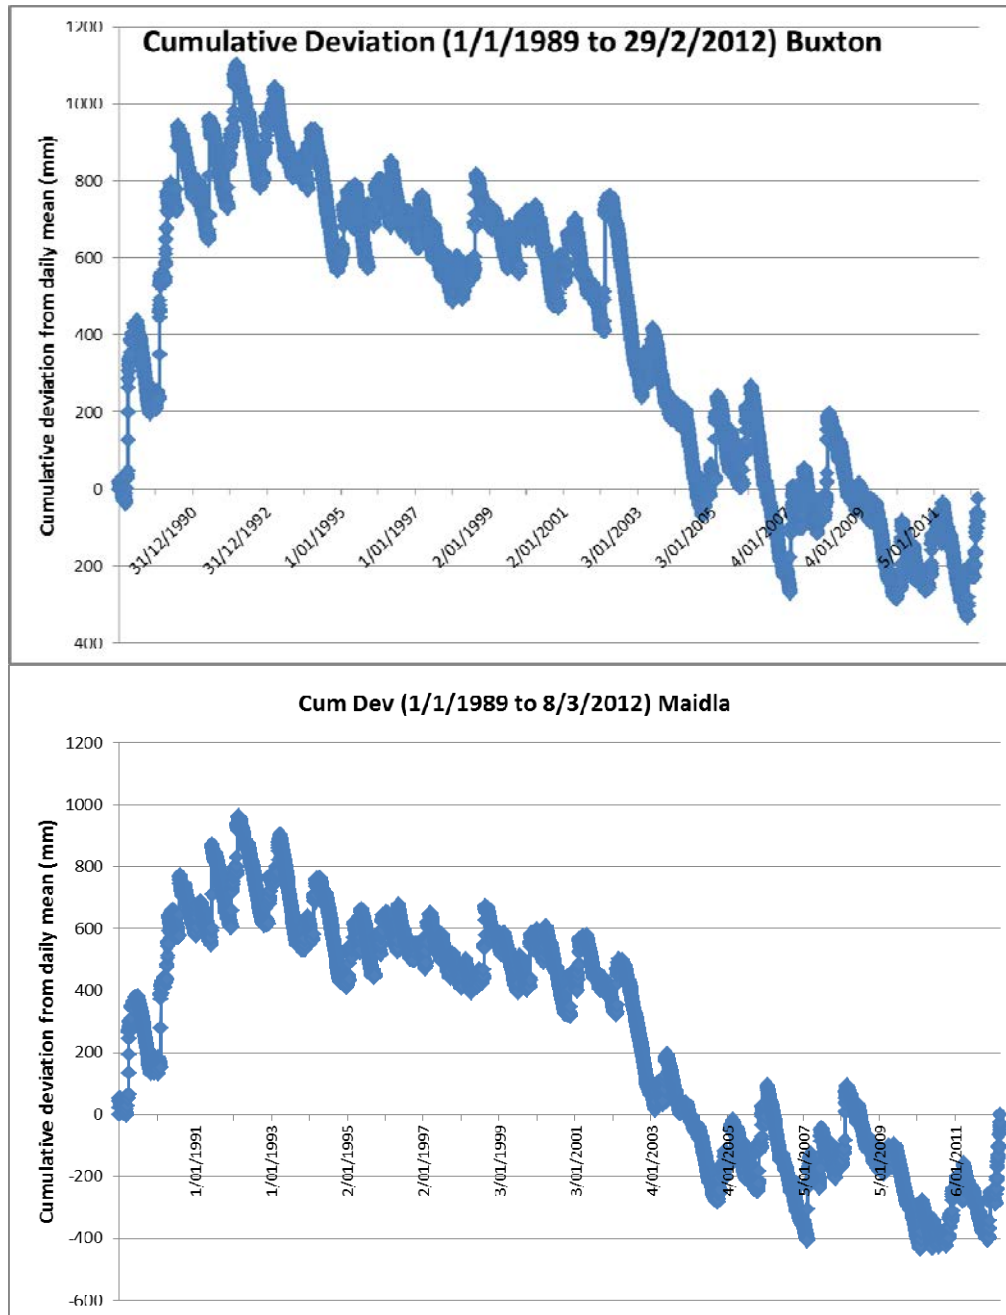
Figure 4-7. Temporal variations in rainfall for the period 1989 to 2012, Buxton and Maidla.

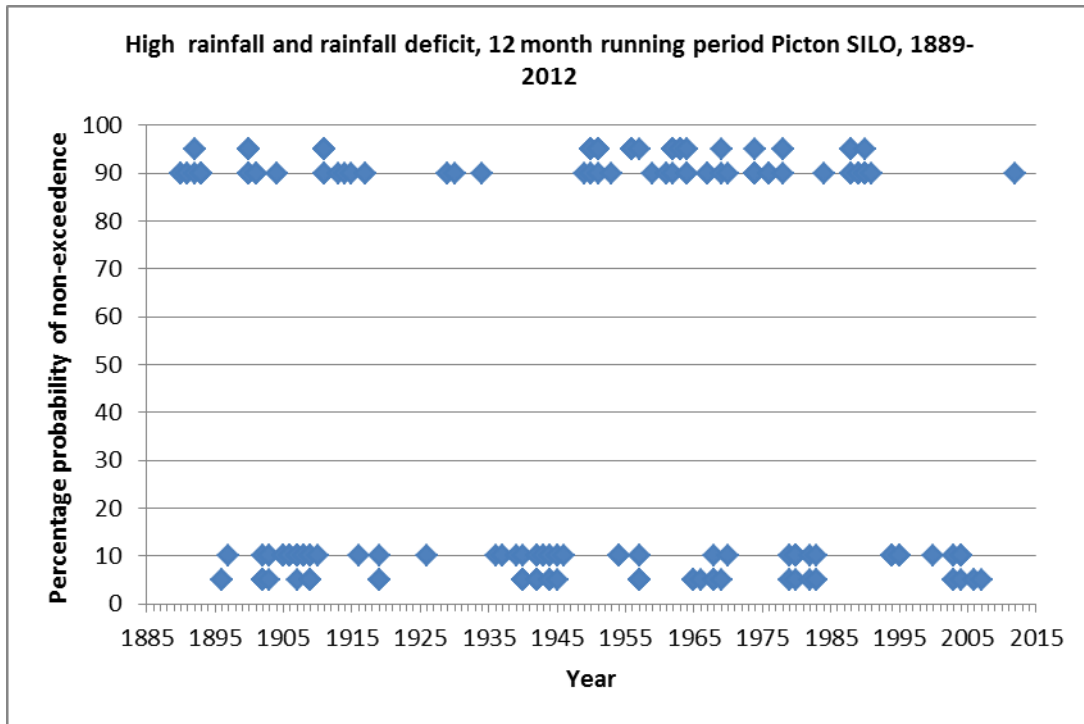
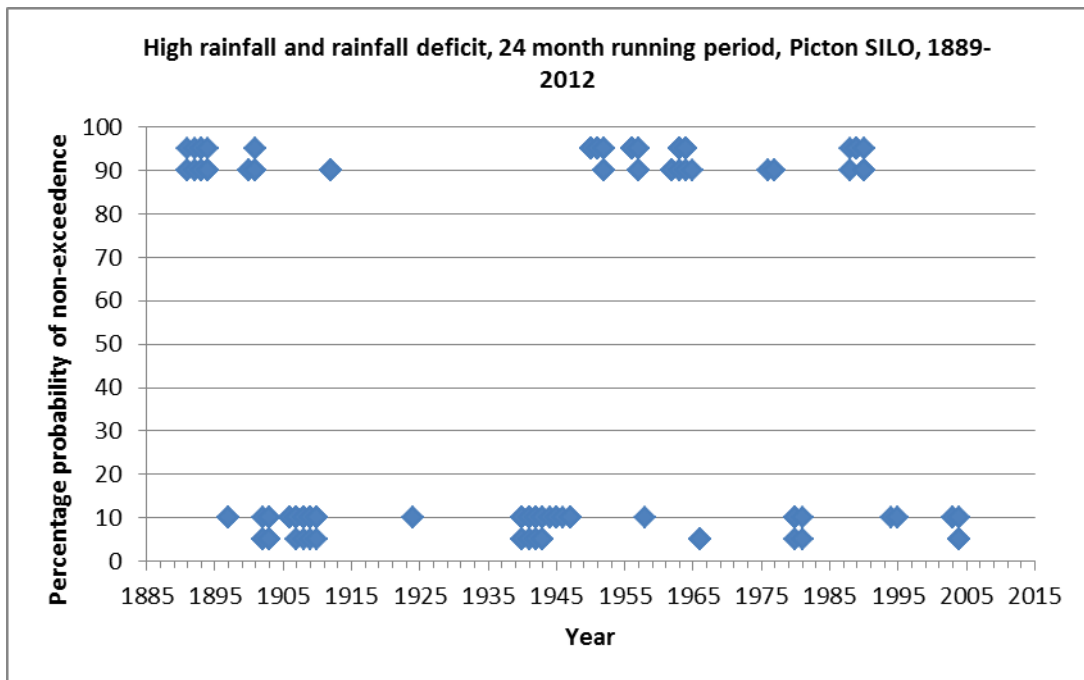
Figure 4-10. Heavy rainfall and rainfall deficiency for 12, 24 and 60 month running periods, Picton SILO monthly rainfall data, 1889-2012.

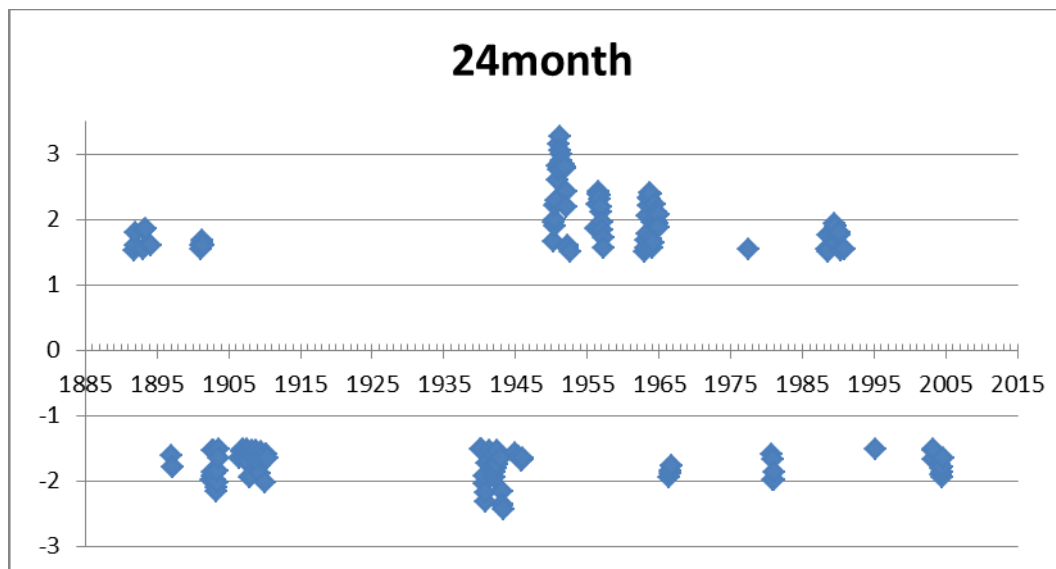
Figure 4-13. 24 month Standard Precipitation Index for Picton SILO, 1889 to 2011. Only values greater than 1.5 or less than -1.5 are shown.

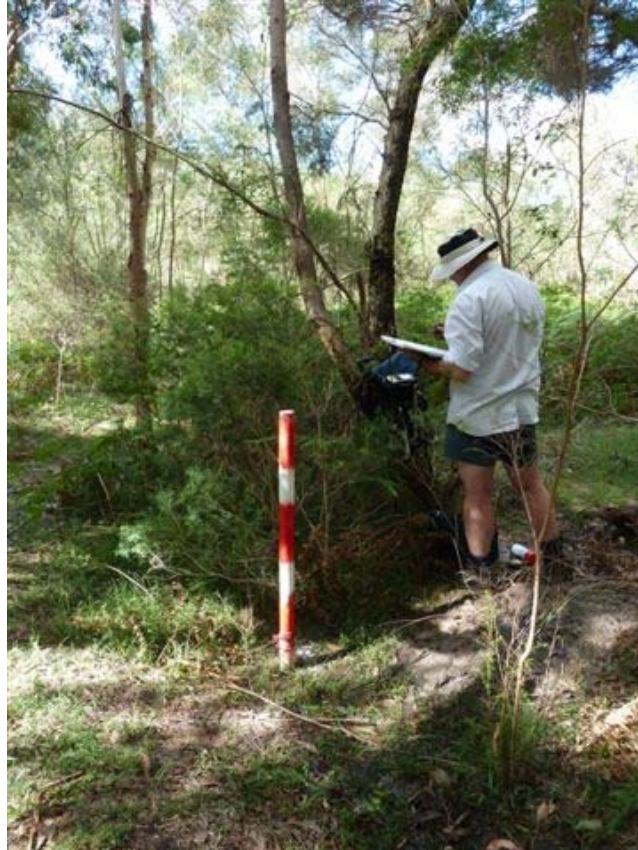
Figure 5-1. Piezometer at outlet from Lake Nerrigorang.

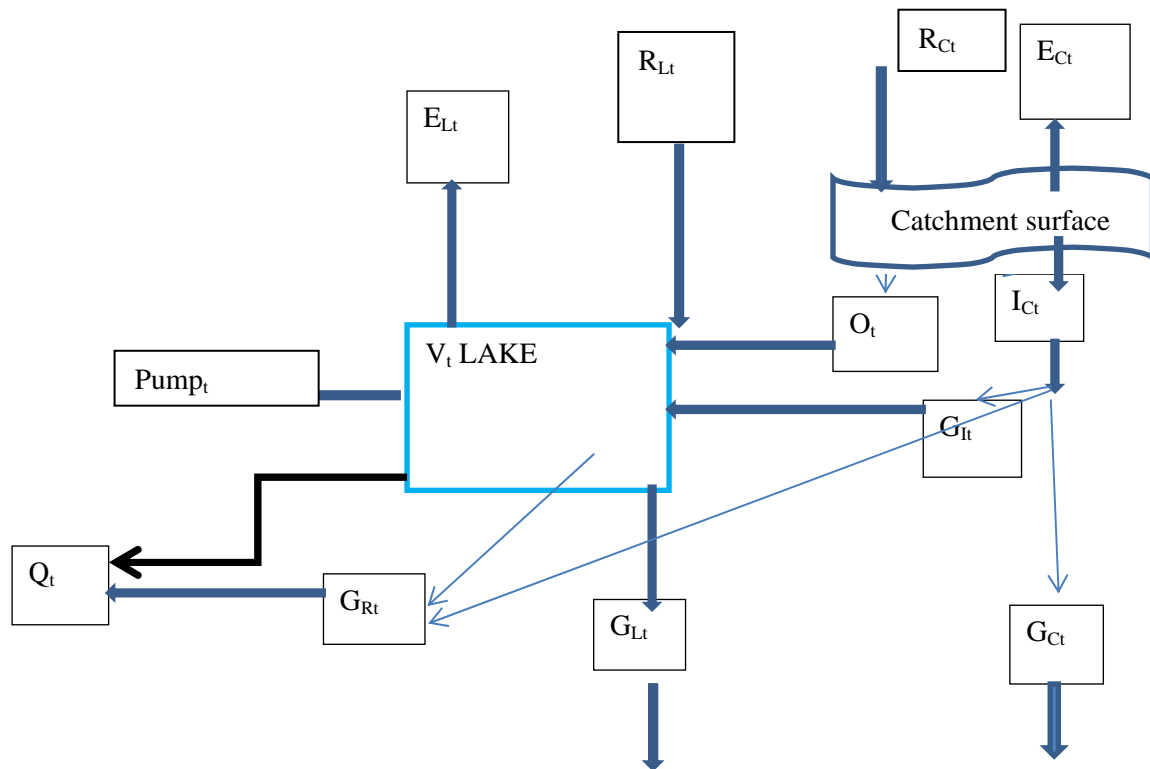
Figure 5-4. Committee’s conceptual hydrological model for Thirlmere Lakes.

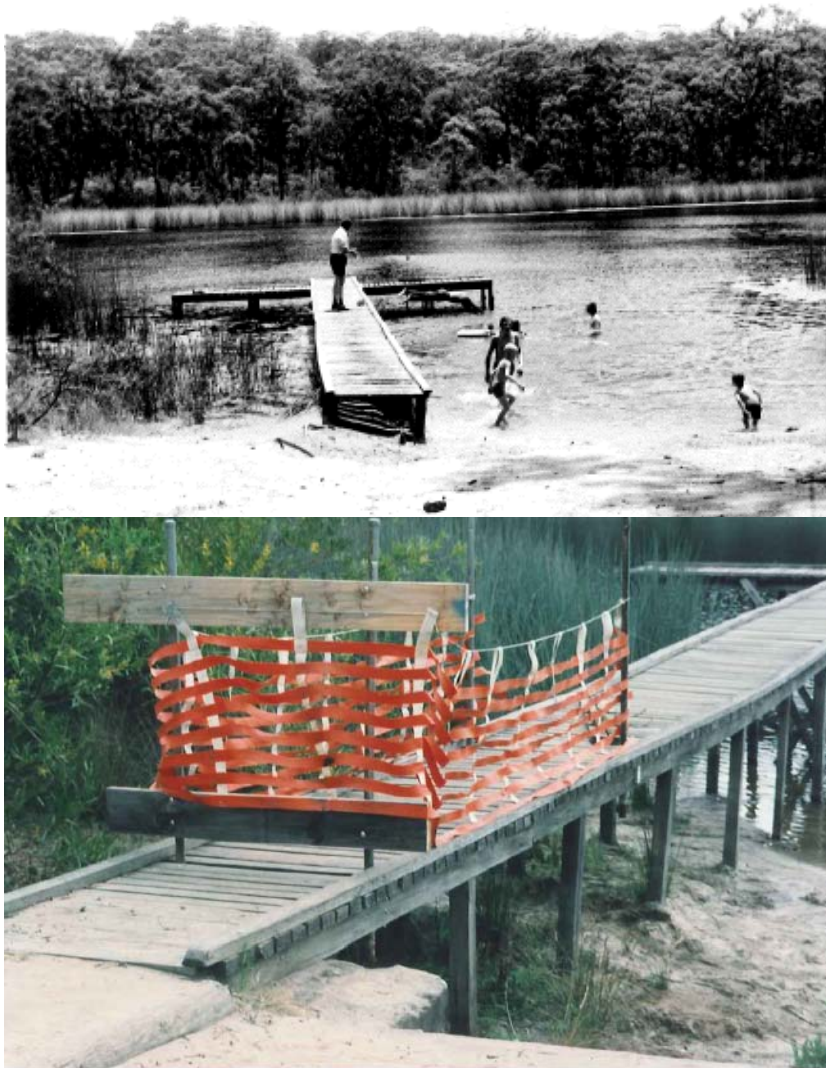
Figure 5-5. Upper photograph, taken by Vorst in May 1974 showing water level relative to jetty (source: Fanning) and lower photograph, taken late 1997 shows jetty relative to concrete wall (source: NPWS).

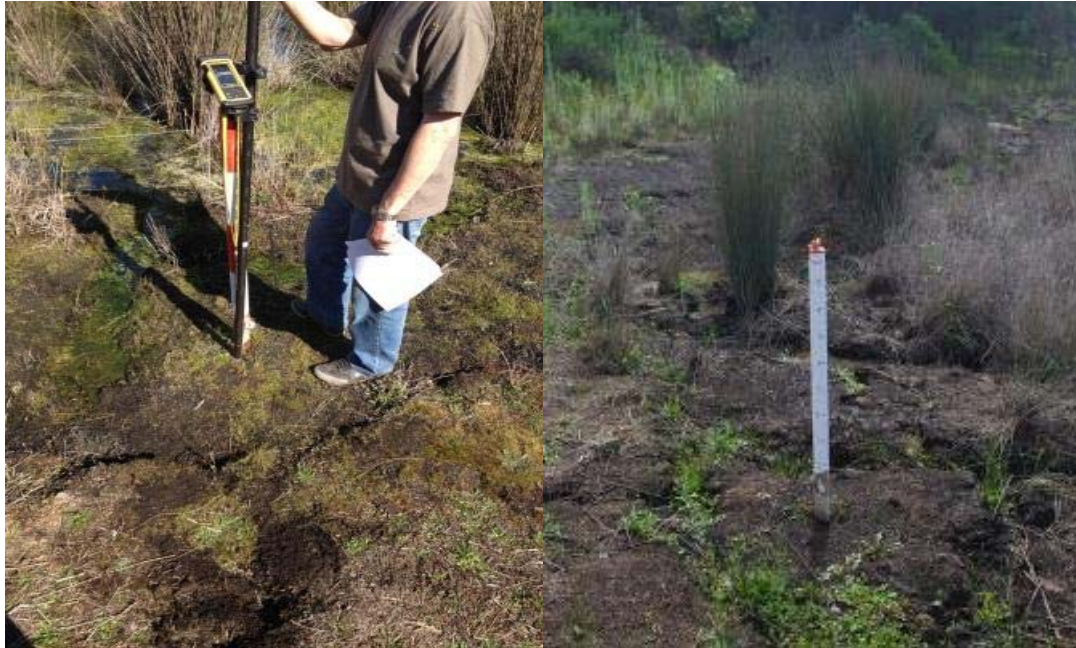
Figure 5-7. Nerrigorang Piezometer. Left is Sept 2012, right is February 2012.

Examination of the difference in water levels at the 5 piezometers in the lakes shows Gandangarra had the greatest fall of 0.15 m between June and August while all the others showed water level falls of the order of 3 to 6 cm (Table 5-3).

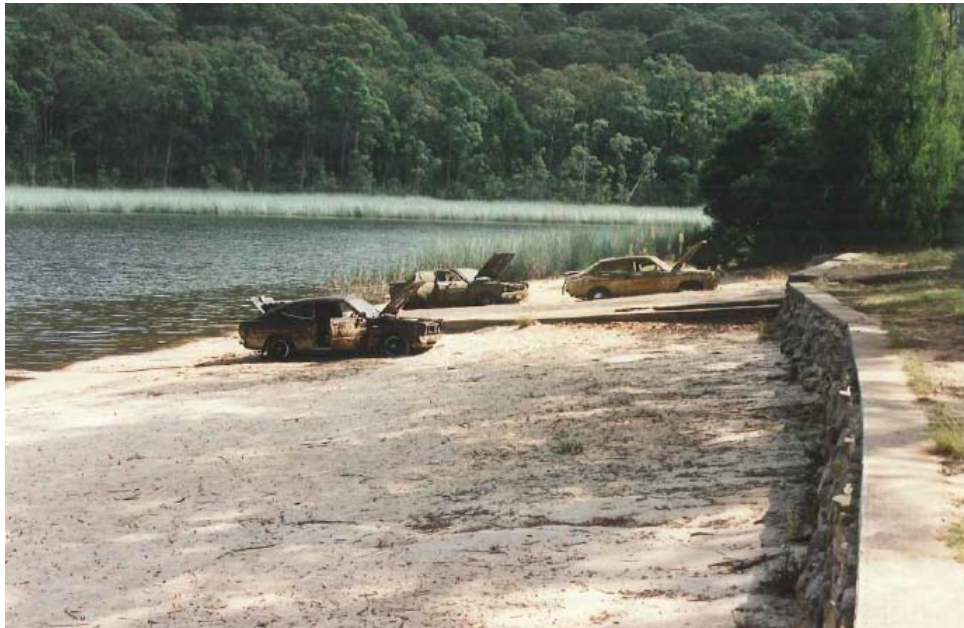
Figure 5-8. Terrestrial photograph of Lake Werri Berri and the retaining wall, late 1997 (source: NPWS).

Figure 5-8 shows Lake Werri Berri in late 1997. The top of the concrete-block wall is 307.0 mAHD. The photograph suggests that the level of the lake is approximately 2.5 m below the top of the wall, given that the cars, from chassis to roof are approximately 1.5 m high, their roofs must have been below water level (maximum is 306 mAHD), and the lake appears to be 0.5 to 1m below the cars. The cars were obviously dumped by pushing them out into a lake much higher than shown in the photograph. The estimate of relative elevations gives an elevation for the lake of 303.5 mAHD, possibly lower. Figure 5-9 shows the scene in early September 2012. A DGPS survey of the position of water level estimated from Fig 5.8 gave a height of 302.4 mAHD. Cross checking with the scene in Fig 5.10 (see below) would suggest that the DGPS survey point was wrongly positioned and has underestimated the water level elevation, and that it is probably closer to 304 mAHD.

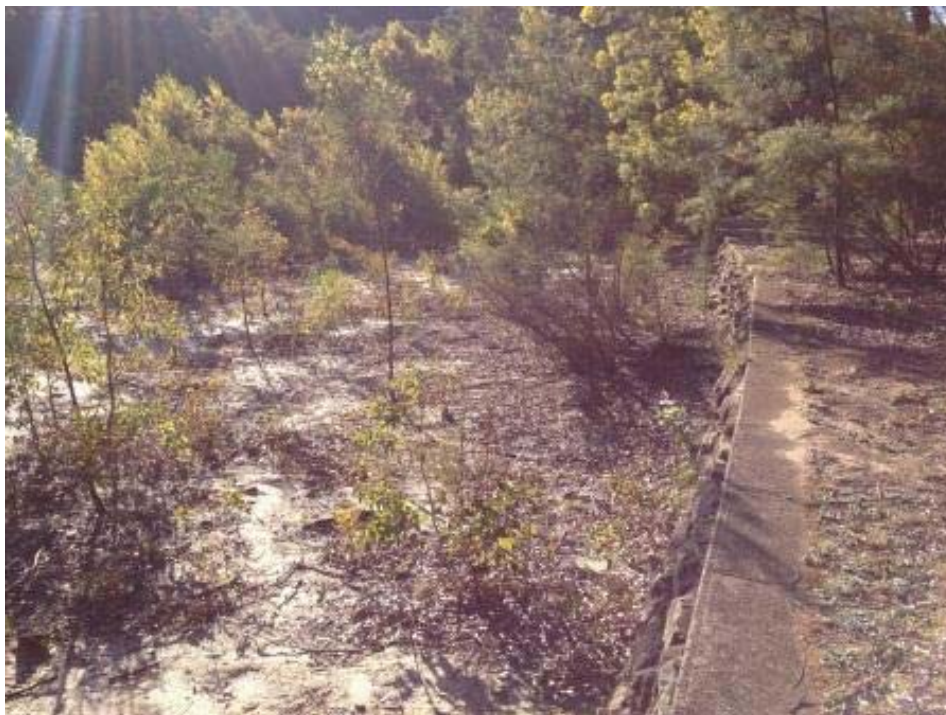
Figure 5-9. Looking towards position of boat ramp Sept 2012 (use break in wall alignment as reference point with Fig 5.8).

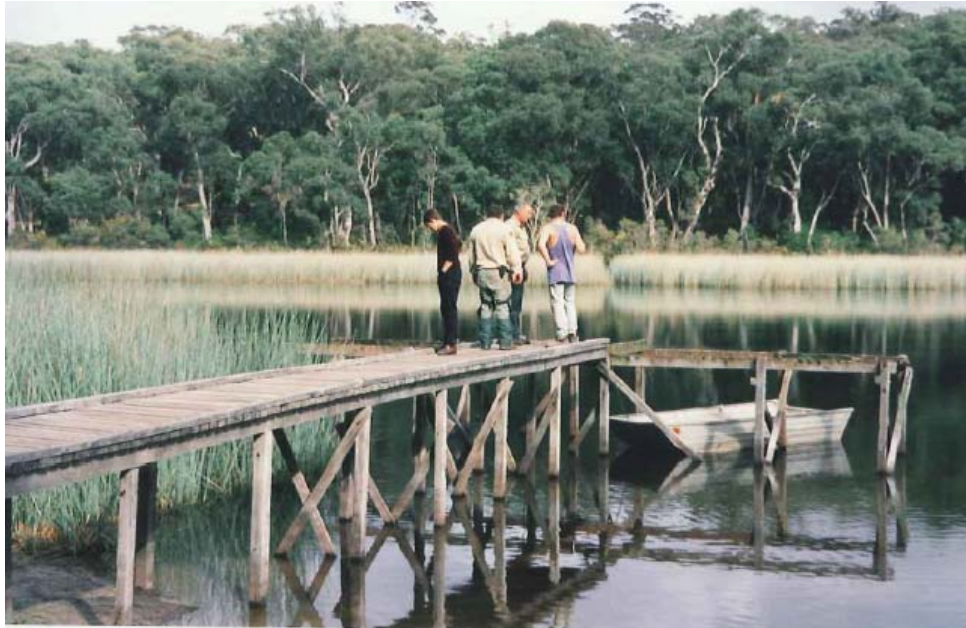
Figure 5-10. Lake Couridjah at the time of dismantlement of the jetty, late 1997 (source: NPWS).

Figure 5-10 shows the scene in late 1997 when the jetty at Lake Couridjah was being dismantled. The water level is approximately 2 to 2.5 m below the walkway of the jetty. Given that the walkway is approximately 306.5 mAHD (see previous discussion) the water level is approximately 304 mAHD, which is similar to that estimated for the scene in Figure 5-8 but much higher than the DGPS survey suggests for the scene in Fig 5-8.

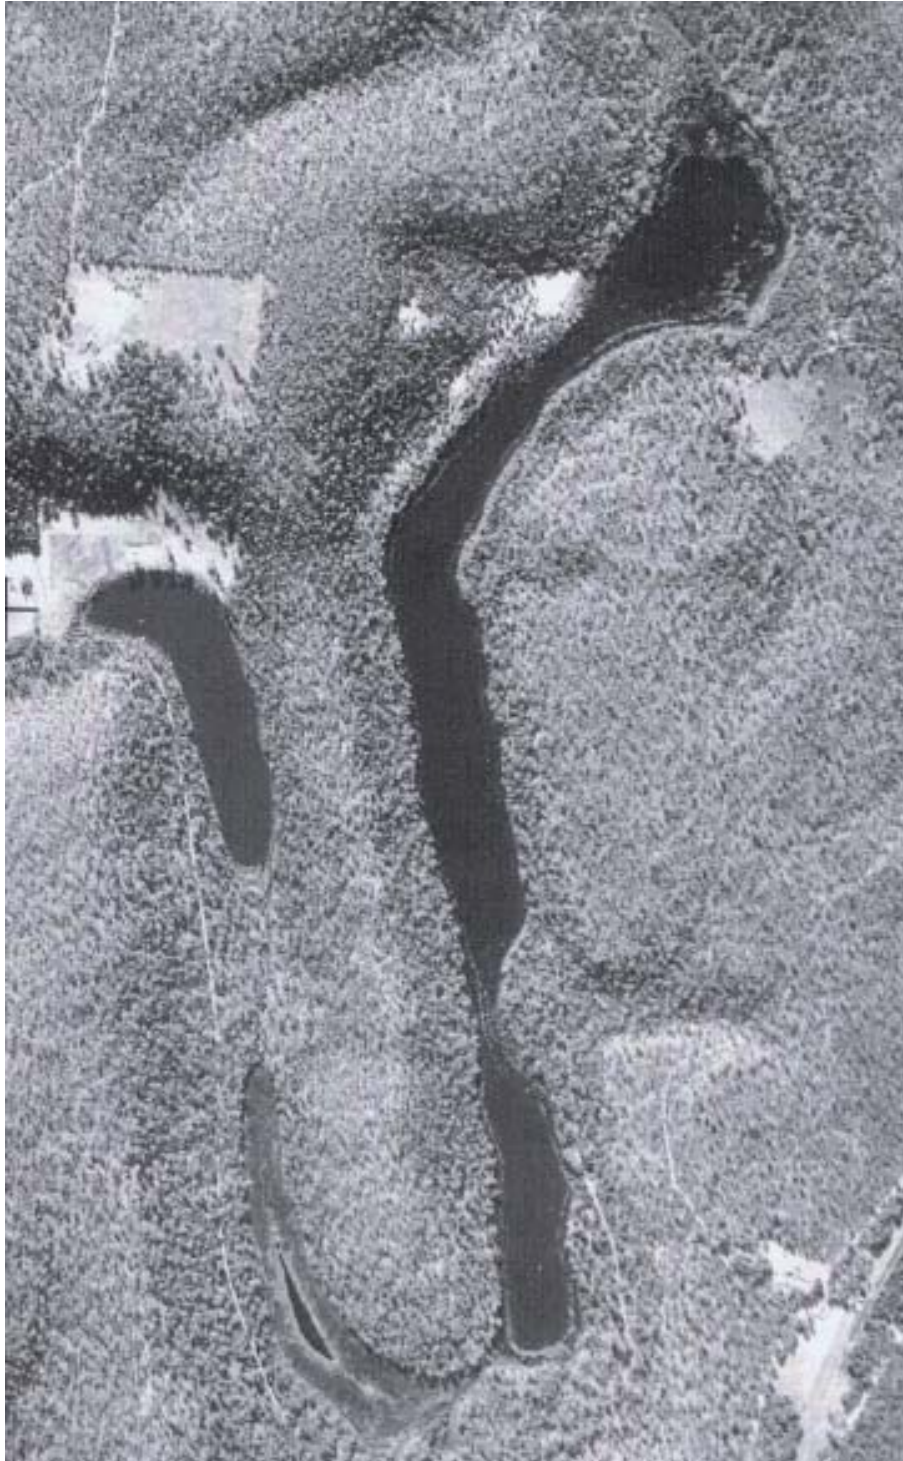
Figure 5-11. July 1955 aerial photograph (NSW Dept. Lands, NSW 581-5034, Warragamba Catchment, Run 10, 5.7.55: With permission ©NSW Dept. of Finance and Services, Land and Property Information Copyright NSW Government).

The 1955 imagery shows the lakes at their highest level, with lakes Gandangarra, Werri Berri and Couridjah connected. This high level is not repeated in any other aerial imagery available to the Committee. Lake Baraba's exposed water surface remains remarkably constant in position and size for all of the aerial photographs. Lake Nerrigorang is not connected to the upstream lakes, as shown in the aerial photographs (Figures 5-11-5-21).

1. A decline in water levels for all lakes between 1955 and 1966 (Figs 5-11 and 5-12).
2. A slight rise in water levels between 1966 and 1975 for all lakes (Figs 5-12-5-14).
3. A similar water level for all lakes between 1975 and 1988 (Figs 5-14-5-16).
4. A rise in water level for all lakes between 1988 and 1990 (Figs 5-16 and 5-17).
5. A decline in water levels between 1990 and 1994, more noticeable in lakes Werri Berri and Nerrigorang (Figs 5-17 and 5-18).
6. A fall in water level of all lakes between 1994 and 1998, with a very small channel between lakes Werri Berri and Gandangarra (Figs 5-18 and 5-19).
