Thirlmere Lakes Inquiry

Final Report of the Independent Committee

23 October 2012

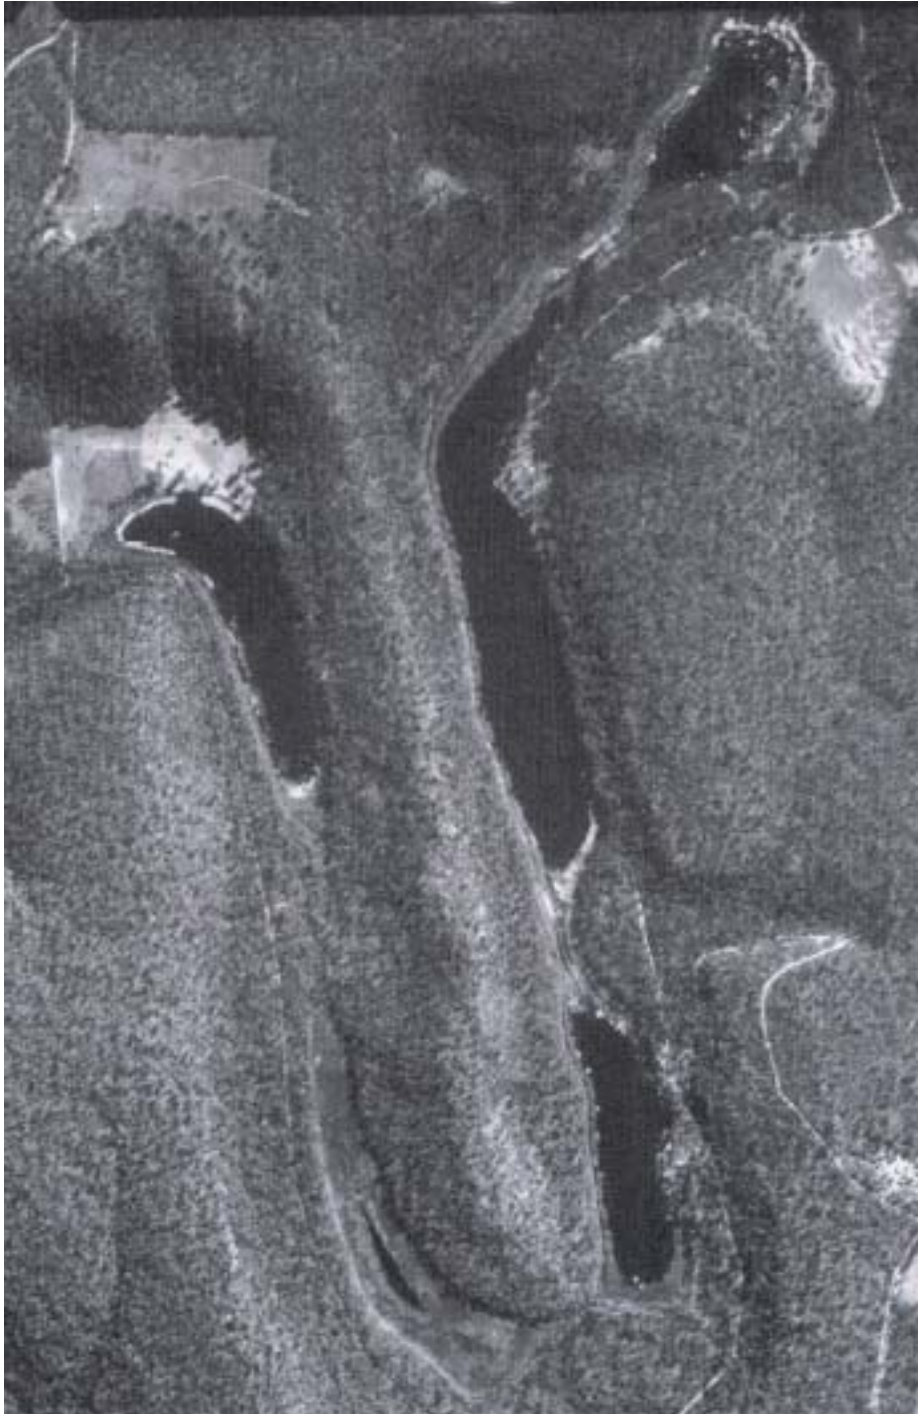
Figure 5-12. March 1966 aerial photograph (NSW Dept. of Lands NSW 1440-5019, Wollongong, Run 6C, 22.3.66: With permission ©NSW Dept. of Finance and Services, Land and Property Information Copyright NSW Government).

1. A decline in water levels for all lakes between 1955 and 1966 (Figs 5-11 and 5-12).
2. A slight rise in water levels between 1966 and 1975 for all lakes (Figs 5-12-5-14).
3. A similar water level for all lakes between 1975 and 1988 (Figs 5-14-5-16).
4. A rise in water level for all lakes between 1988 and 1990 (Figs 5-16 and 5-17).
5. A decline in water levels between 1990 and 1994, more noticeable in lakes Werri Berri and Nerrigorang (Figs 5-17 and 5-18).
6. A fall in water level of all lakes between 1994 and 1998, with a very small channel between lakes Werri Berri and Gandangarra (Figs 5-18 and 5-19).

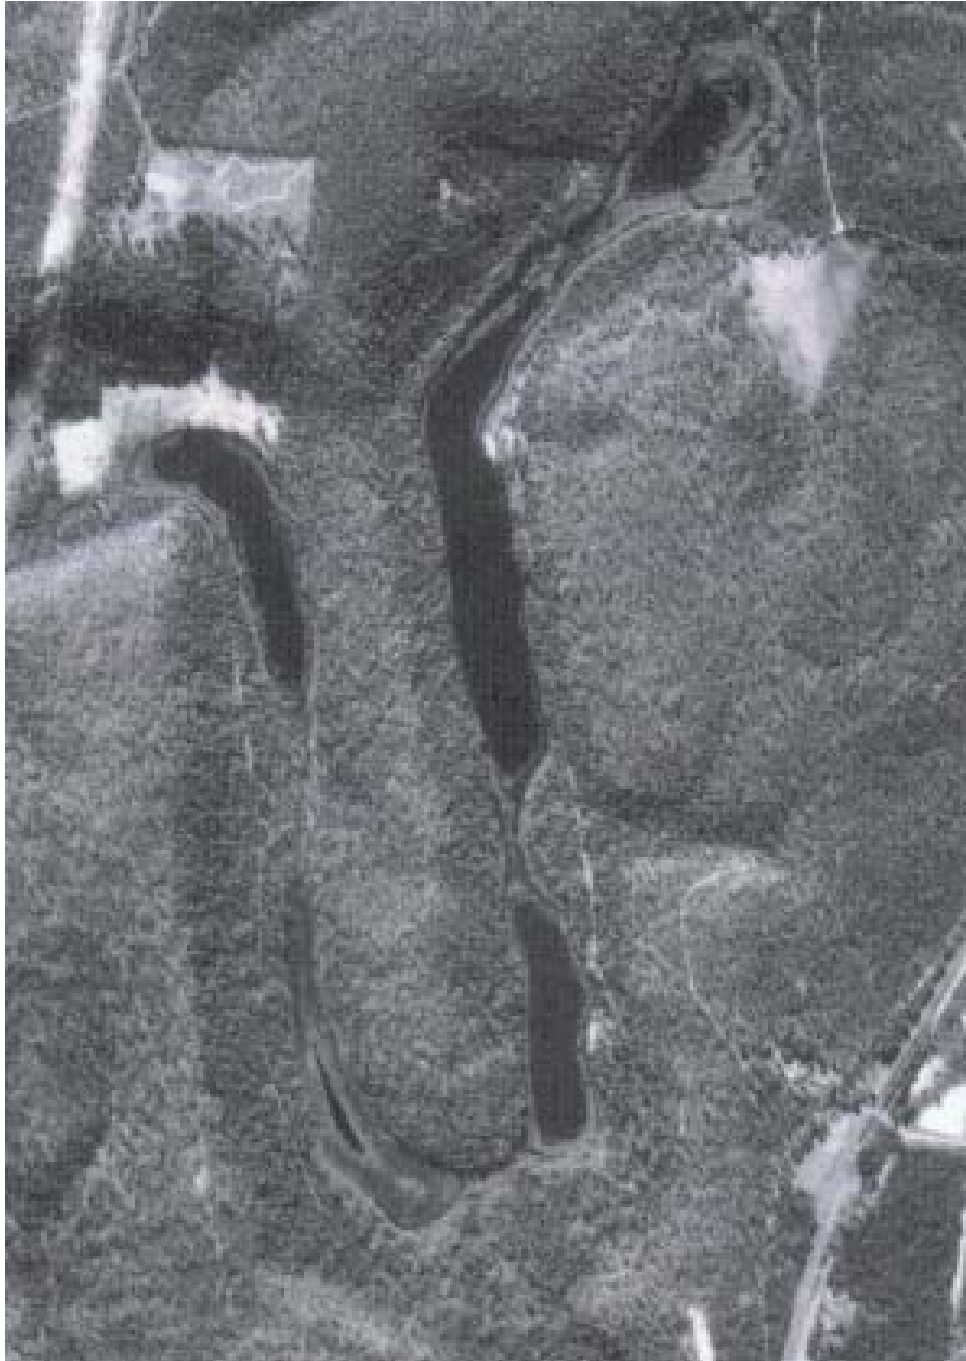
Figure 5-13. June 1969 aerial photograph (NSW Dept. of Lands, NSW 1623-1544, Wollongong, Run 4C, 29.6.69: With permission ©NSW Dept. of Finance and Services, Land and Property Information Copyright NSW Government).

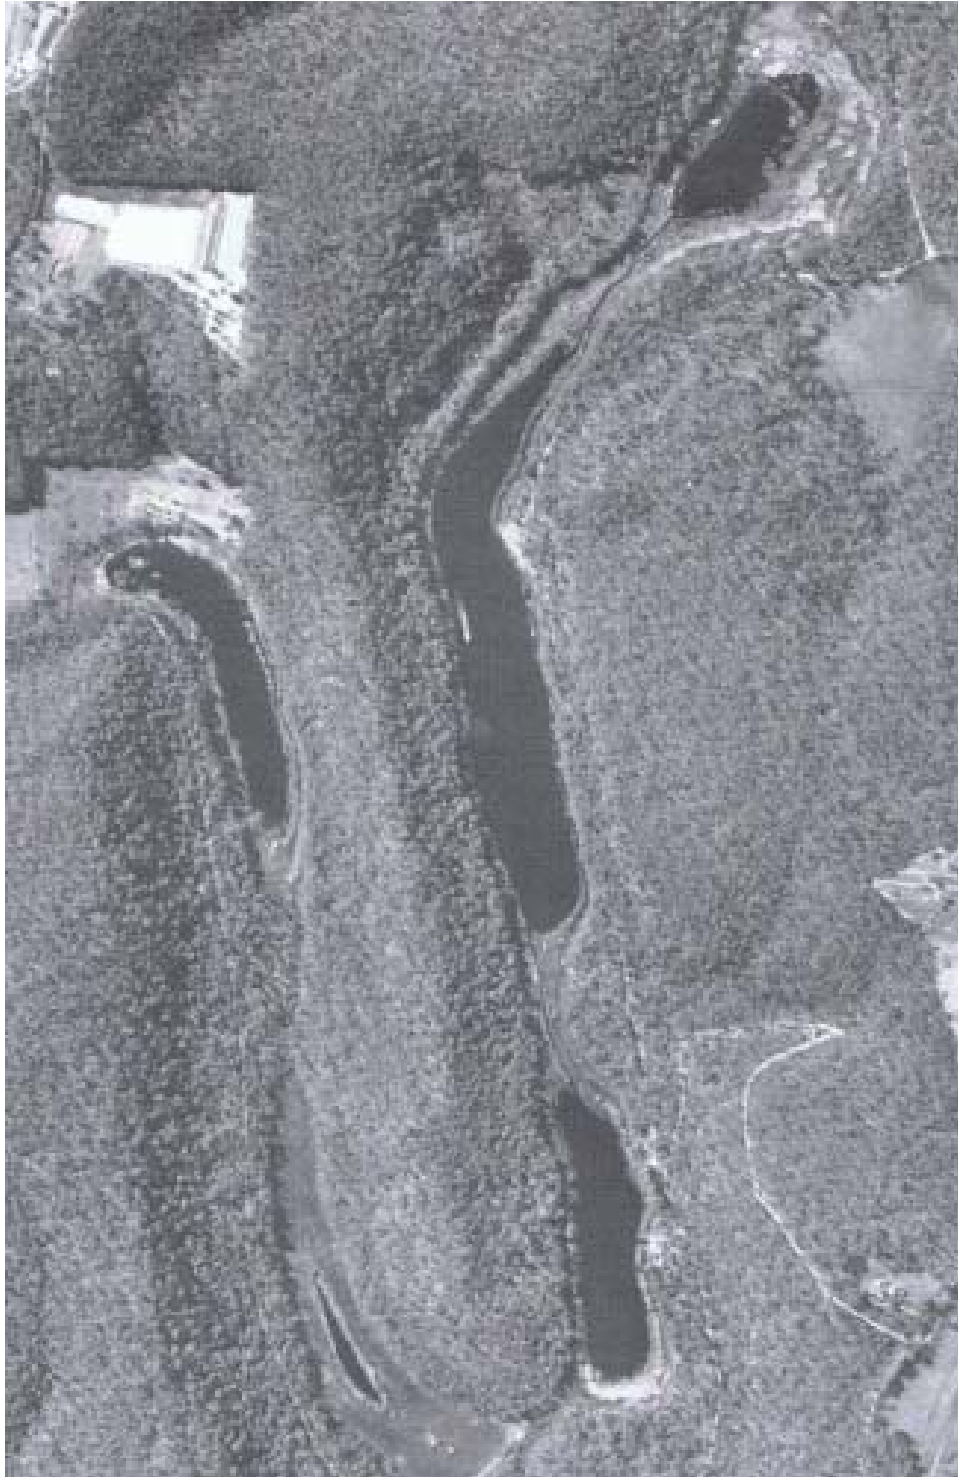
Figure 5-14. April 1975 aerial photograph (NSW Dept. of Lands, NSW 2300-61, Wollongong, Run 4, 2.4.75: With permission ©NSW Dept. of Finance and Services, Land and Property Information Copyright NSW Government).

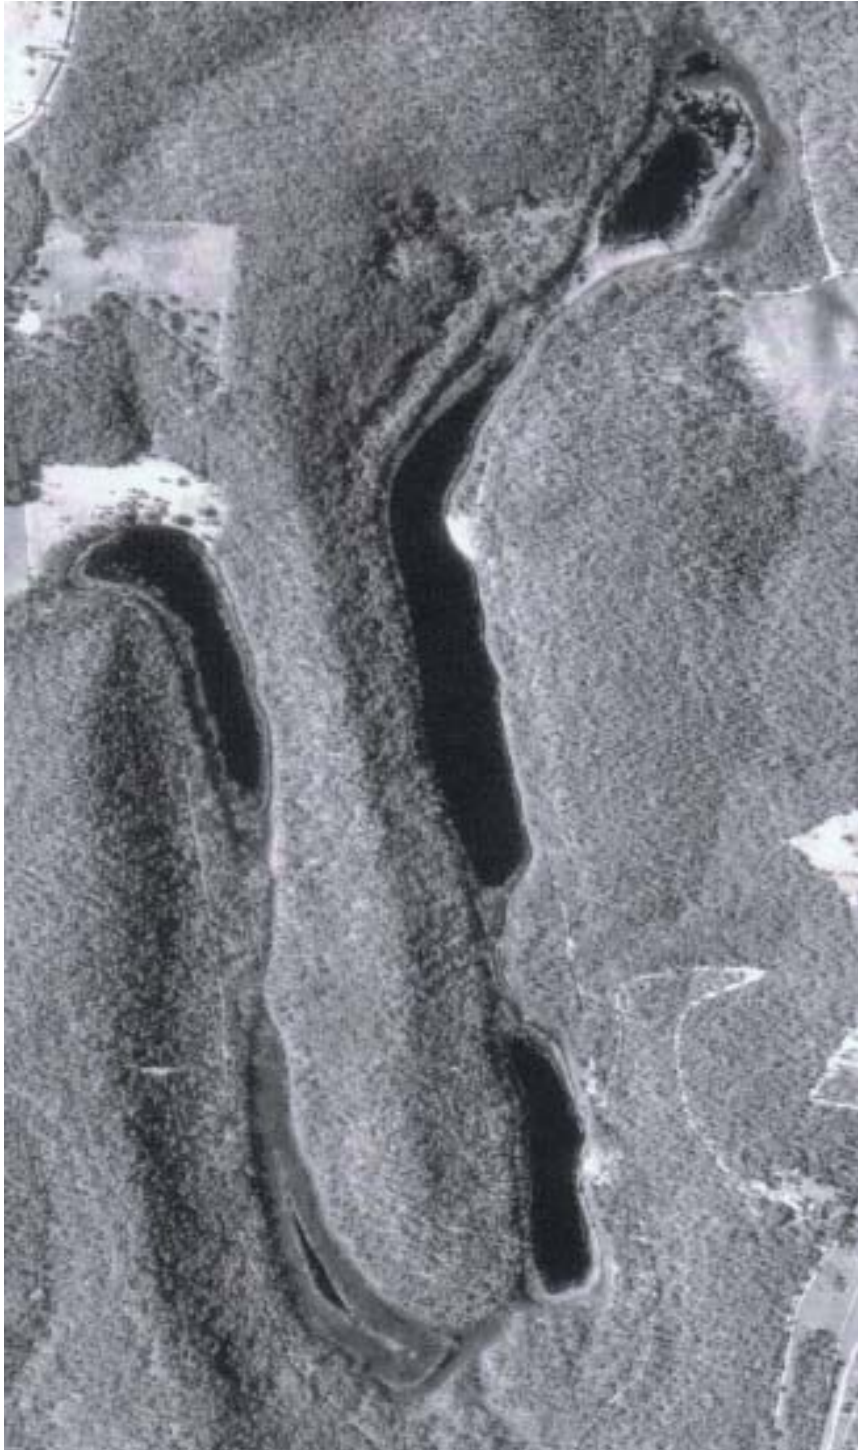
Figure 5-15. October 1983 aerial photograph (NSW Dept. of Lands, NSW 3341-230, Wollongong, Run 4, 27.10.83: With permission ©NSW Dept. of Finance and Services, Land and Property Information Copyright NSW Government).

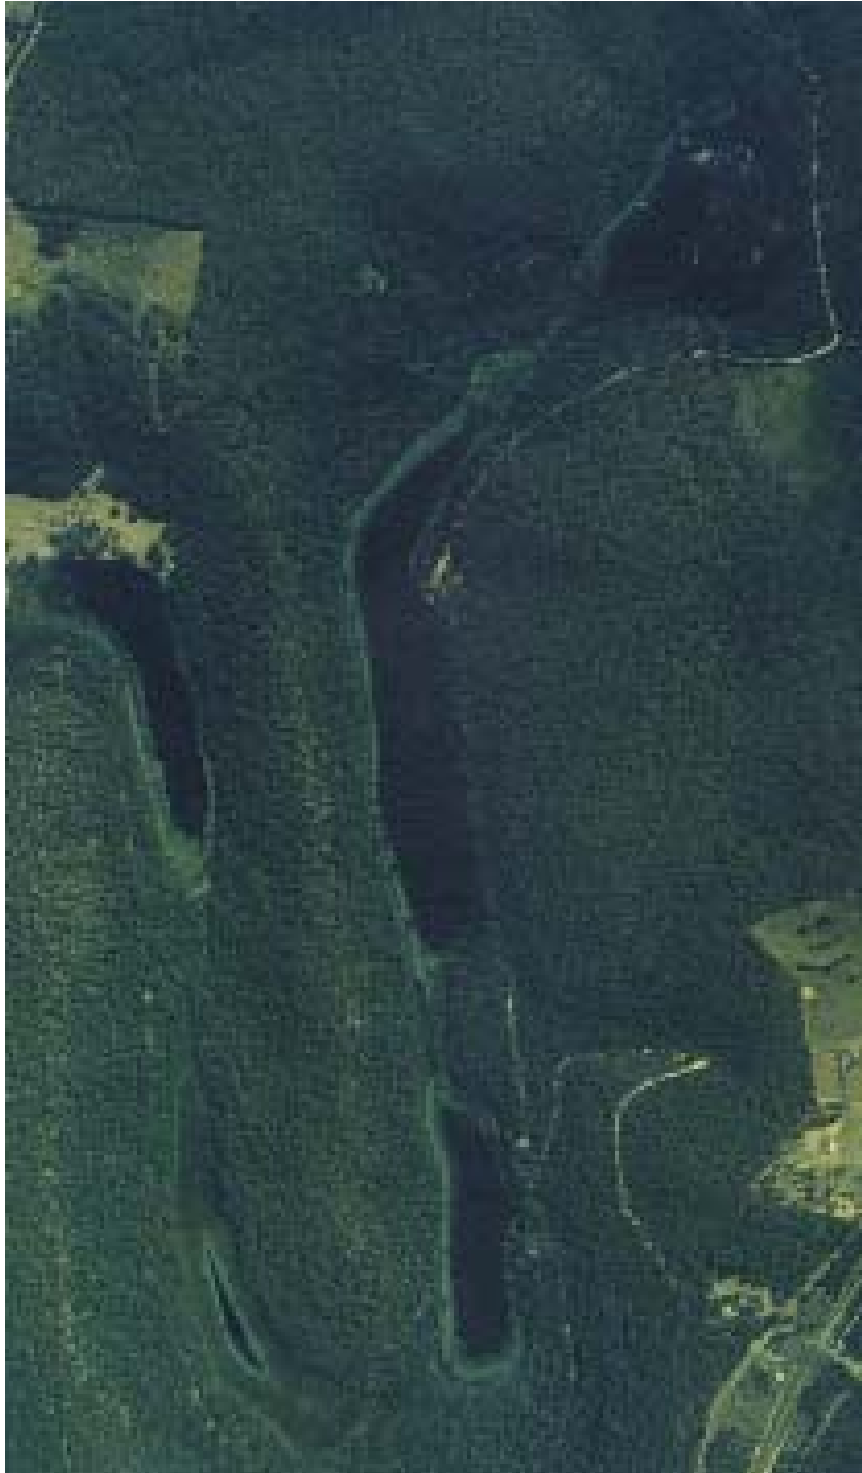
Figure 5-16. March 1988 aerial photograph (NSW Dept. of Lands, NSW 3609-42, Wollongong, Run 11W, 21.3.88: With permission ©NSW Dept. of Finance and Services, Land and Property Information Copyright NSW Government).

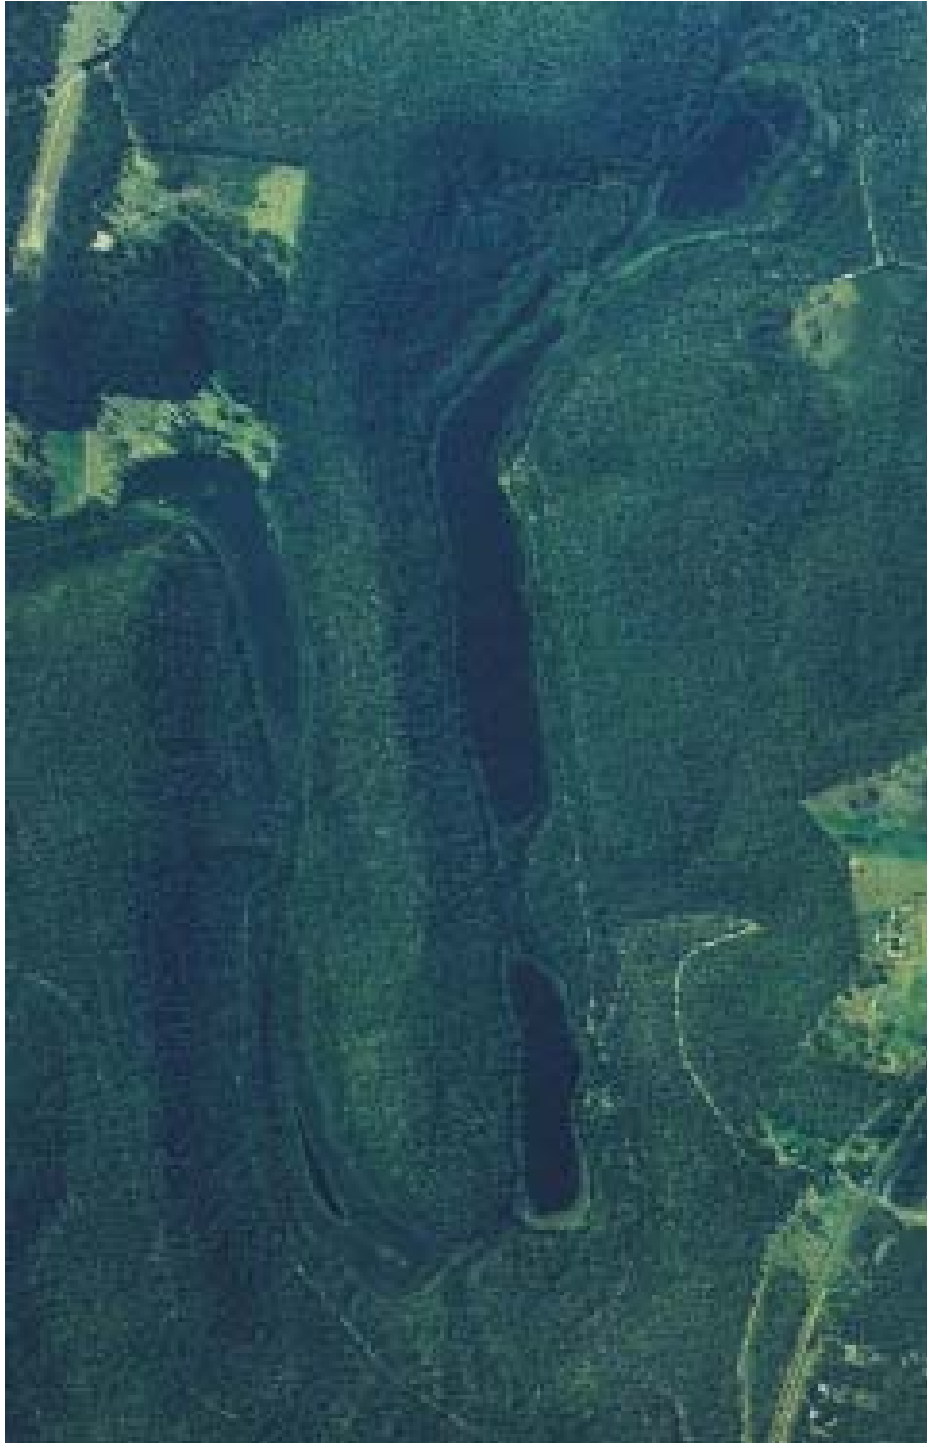
Figure 5-17. September 1990 aerial photograph (NSW Dept. of Lands, NSW 3751-213, Wollongong, Run 11, 25.9.90: With permission ©NSW Dept. of Finance and Services, Land and Property Information Copyright NSW Government).

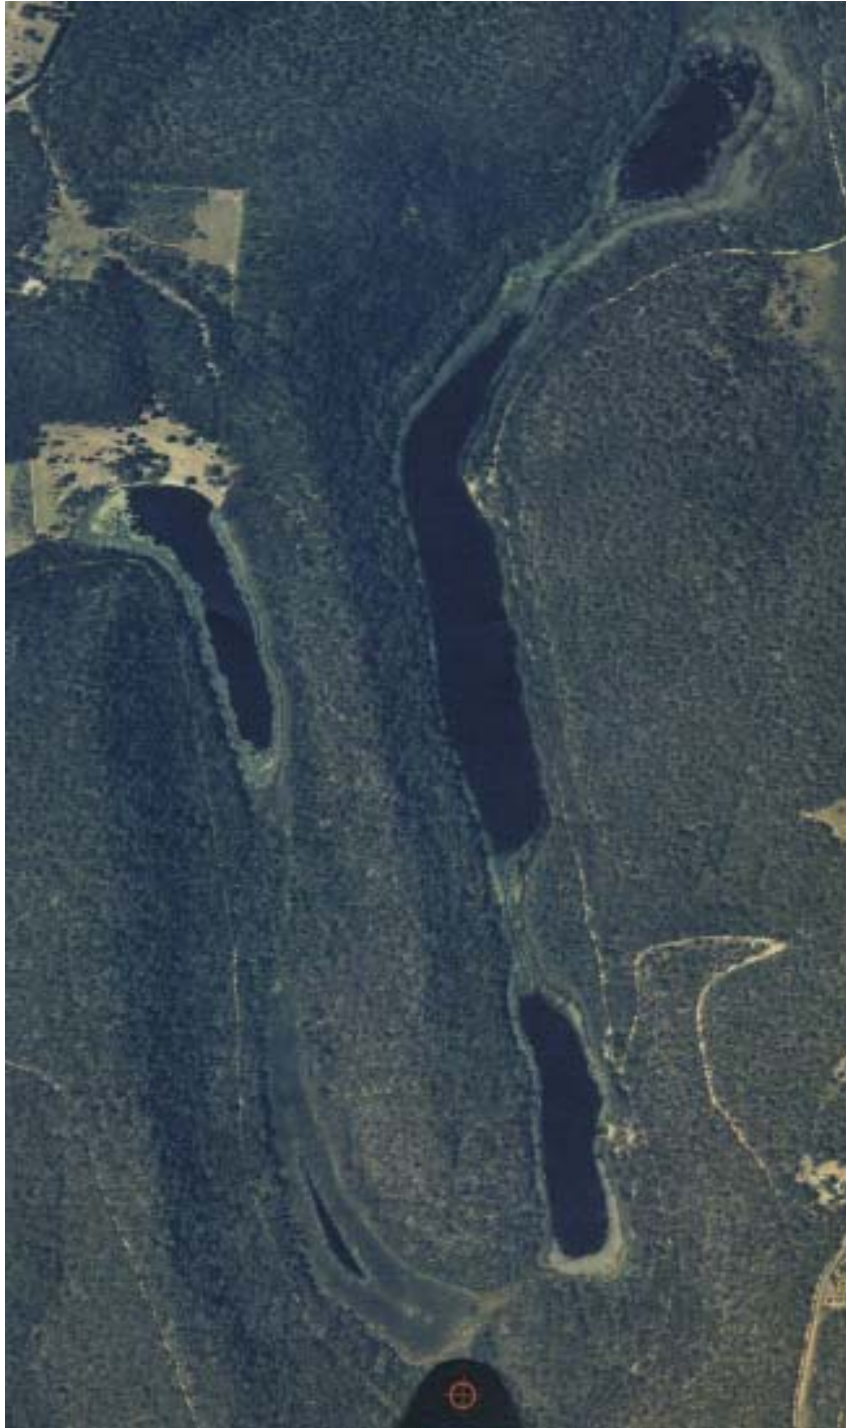
Figure 5-18. January 1994 aerial photograph (NSW Dept. of Lands, NSW 4178 163-184, Wollongong, Run 6, 4.1.94: With permission ©NSW Dept. of Finance and Services, Land and Property Information Copyright NSW Government).

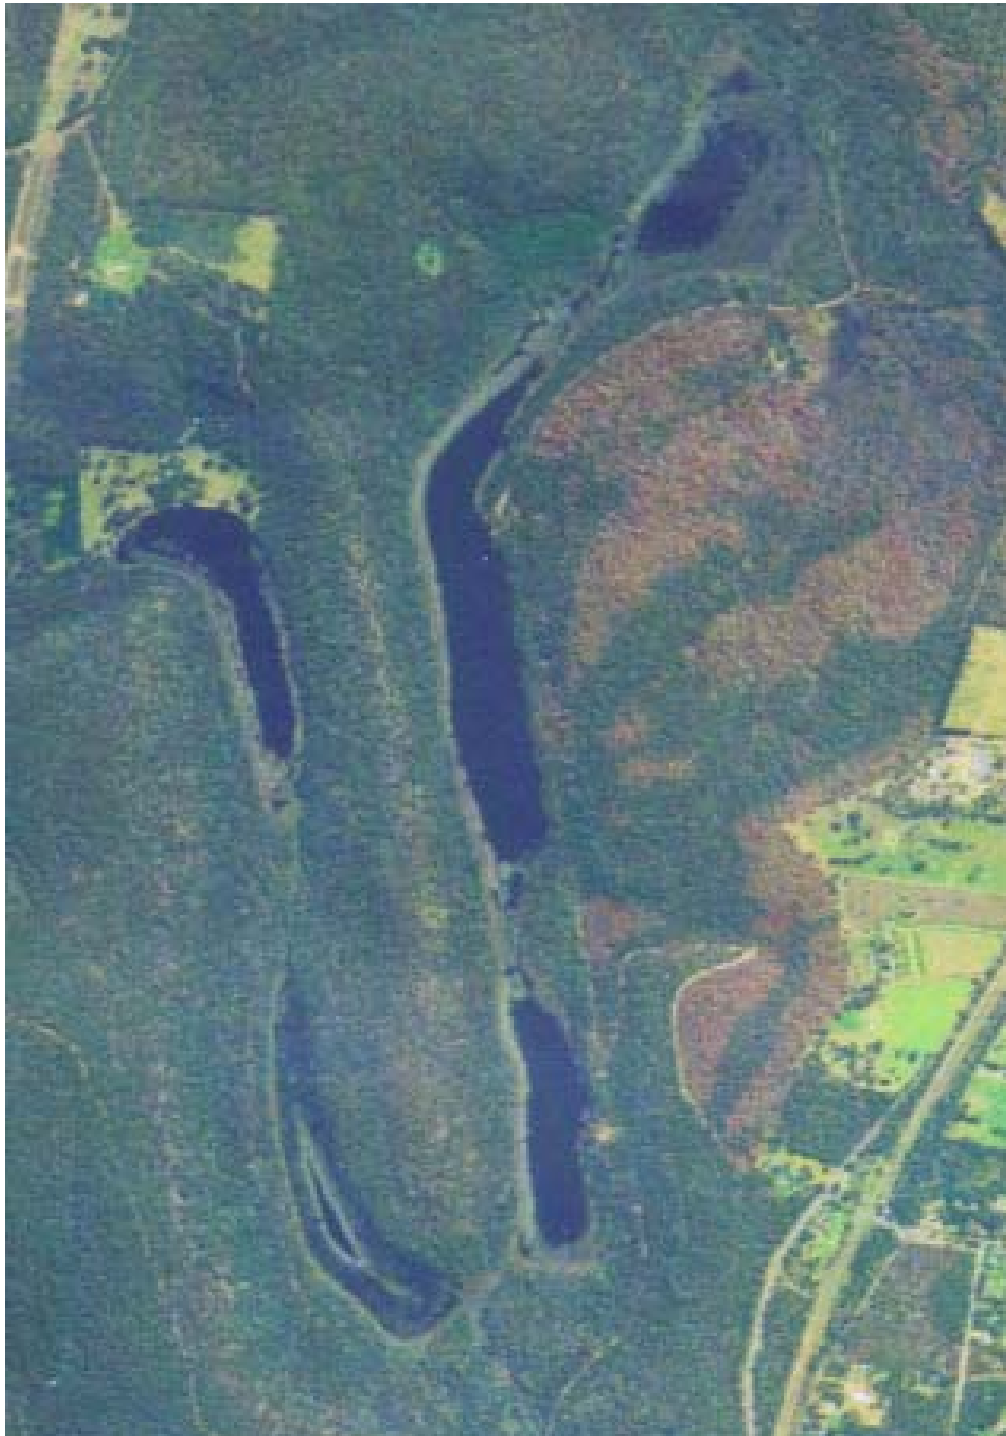
Figure 5-19. October 1998 aerial photograph (NSW Dept. of Lands, NSW 4455, Wollongong, 142-154, 14.10.98: With permission ©NSW Dept. of Finance and Services, Land and Property Information Copyright NSW Government).

7. A fall in water level of all lakes between 1998 and 2002, with lakes Werri Berri and Gandangarra disconnected and lakes Werri Berri and Nerrigorang appearing to show a more significant lowering than lakes Couridjah and Gandangarra (Figs 5-19 to 5-20).
8. A fall in water levels for all lakes between 2002 and 2005, with lakes Couridjah and Werri Berri disconnected and a greater apparent fall in levels in lakes Werri Berri and Nerrigorang (Figs 5-20 and 5-21).

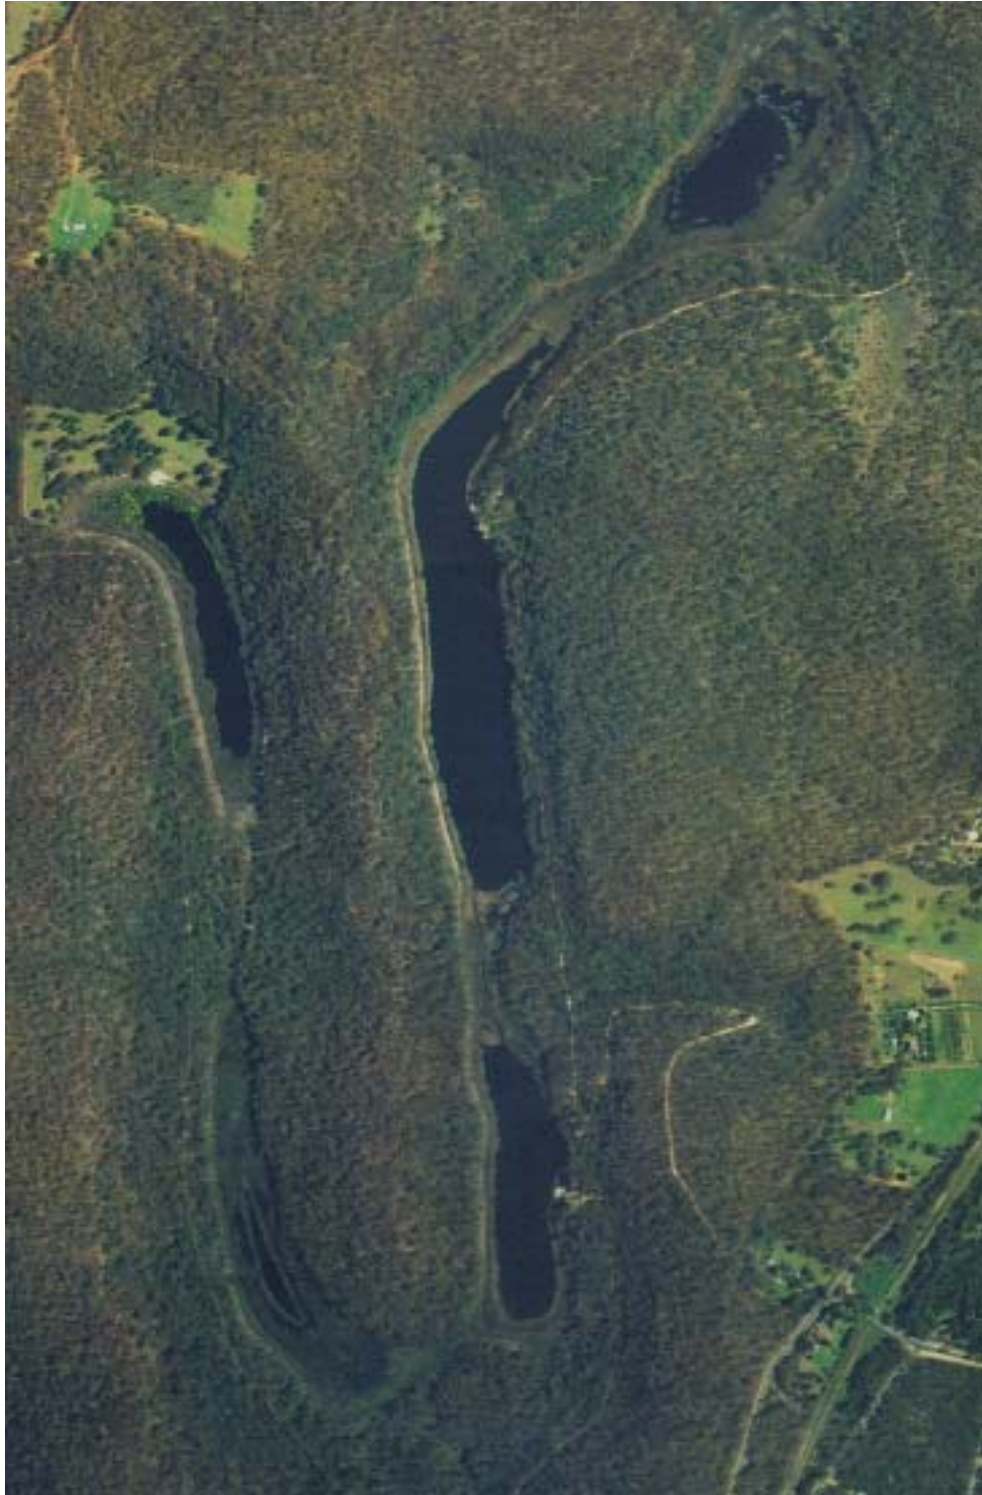
Figure 5-20. February 2002 aerial photograph (NSW Dept. of Lands, NSW 4599, Wollongong, 175-200, Run 6, 22.2.02: With permission ©NSW Dept. of Finance and Services, Land and Property Information Copyright NSW Government).

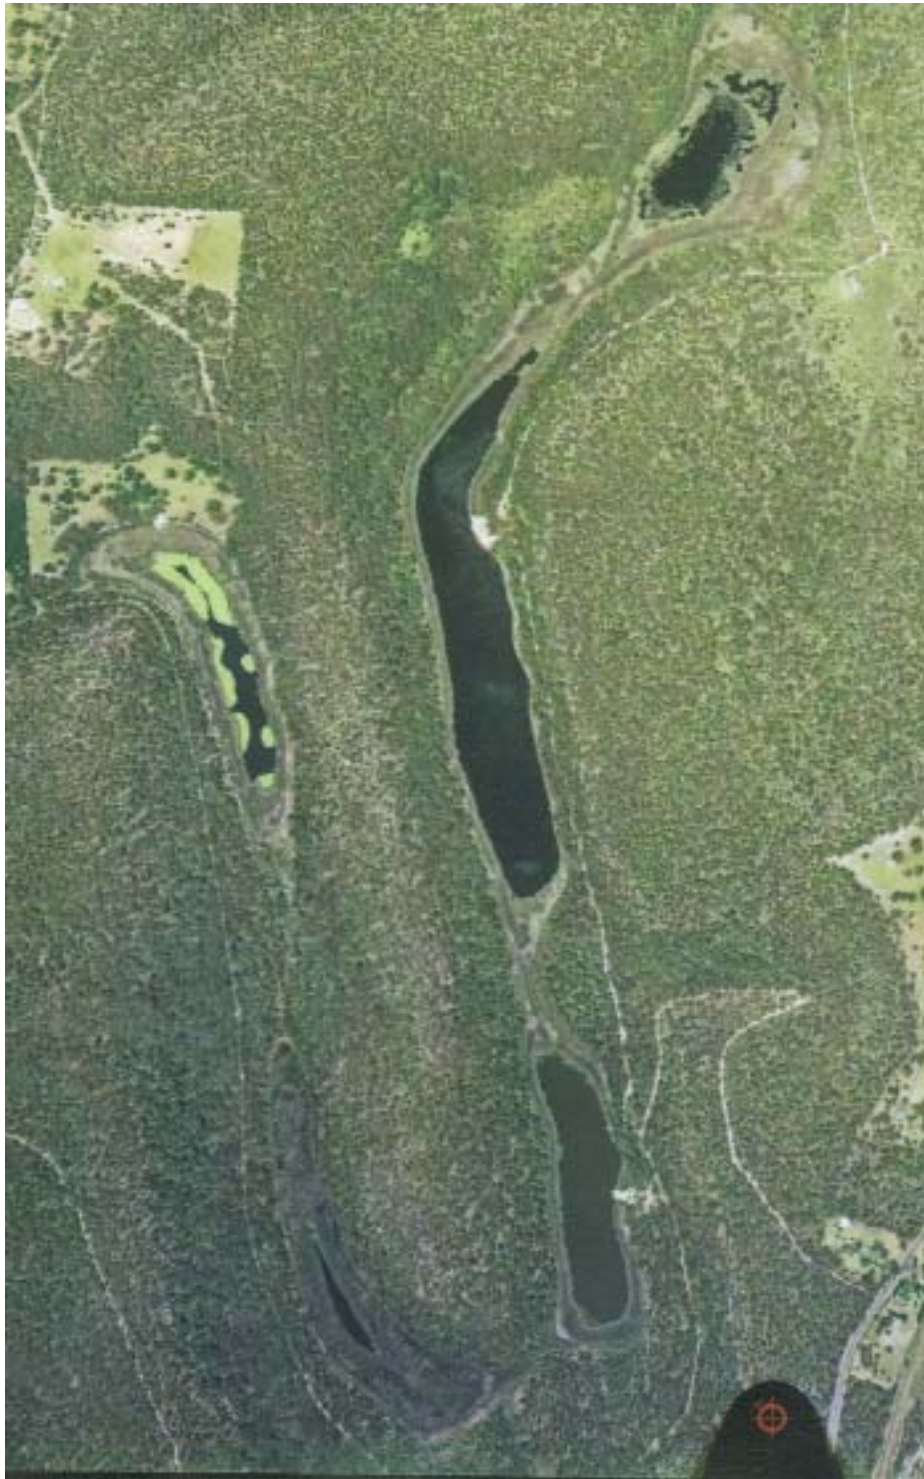
Figure 5-21. December 2005 aerial photograph (NSW Dept. of Lands, NSW 4942, Wollongong, 59-83, Run 6, 20.12.05: With permission ©NSW Dept. of Finance and Services, Land and Property Information Copyright NSW Government).

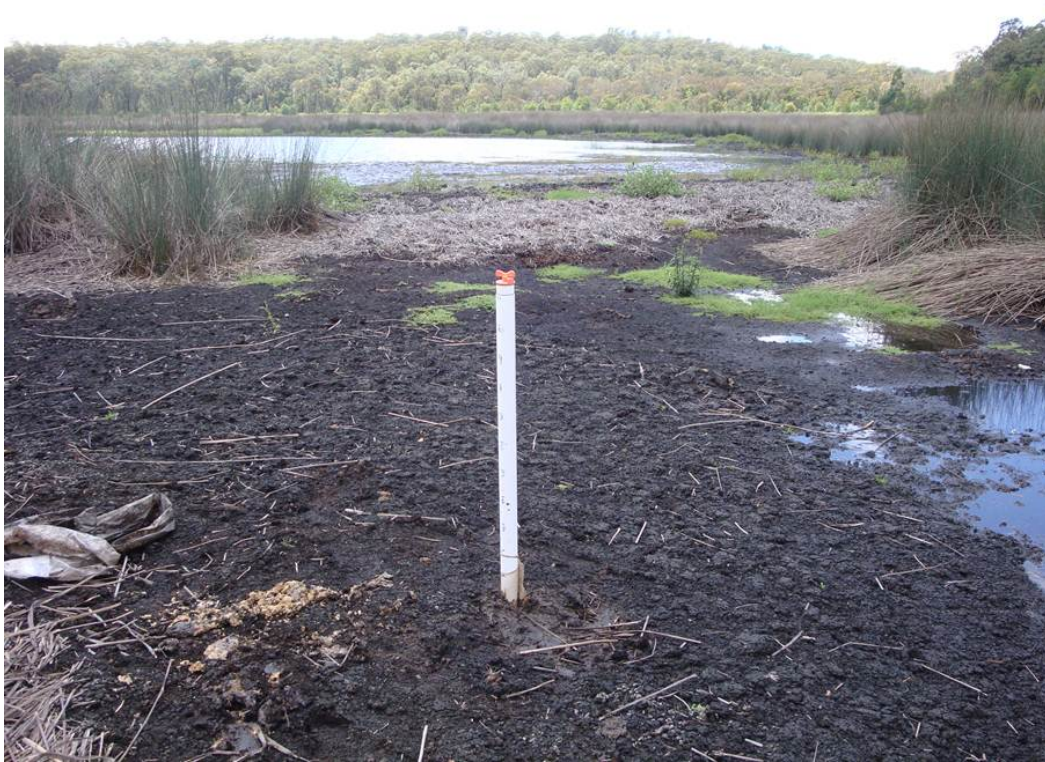
Figure 5-31. Lake Gandangarra piezometer at installation, 10 February 2012.

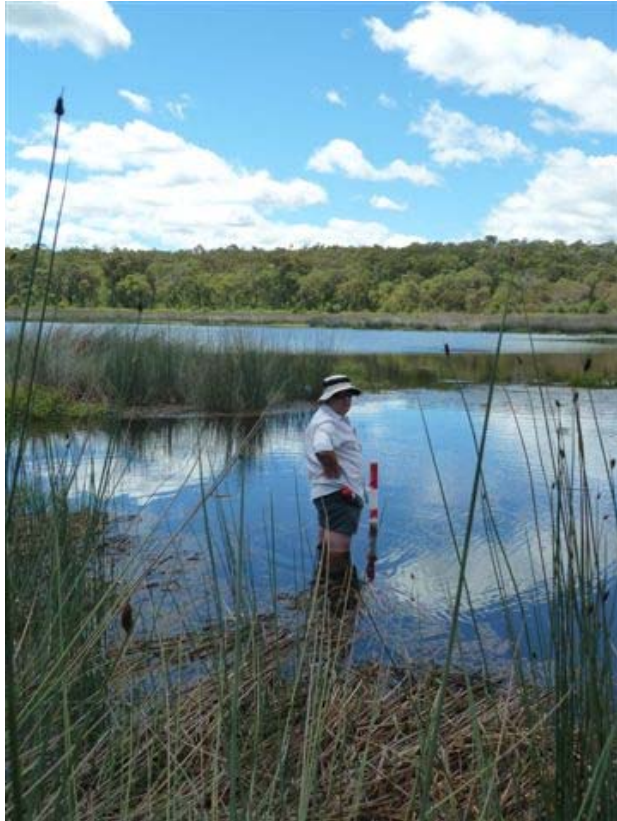
Figure 5-32. Lake Gandangarra piezometer 9th March 2012.

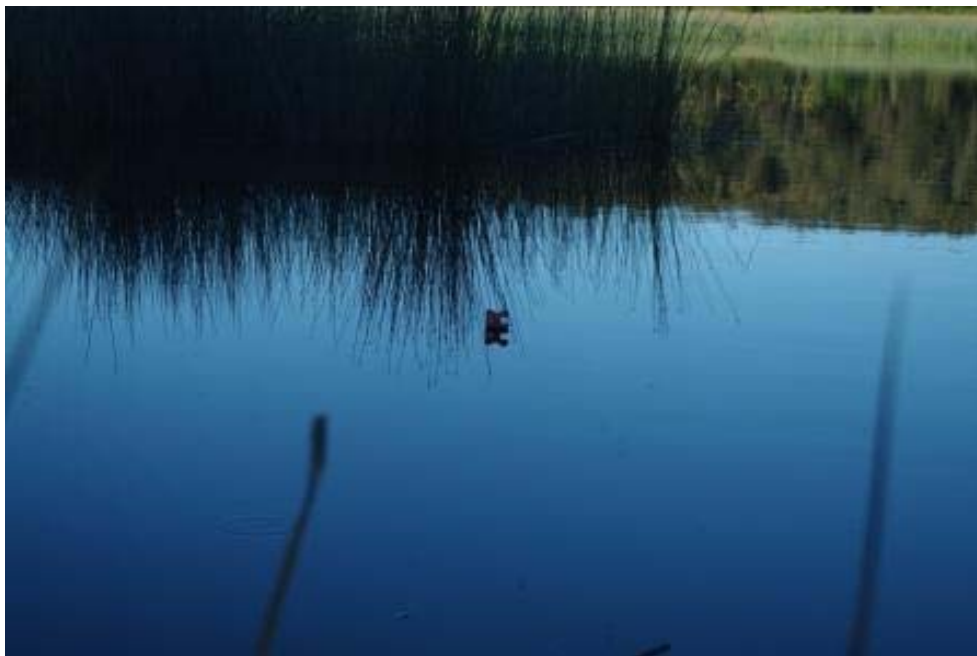
Figure 5-33. Lake Gandangarra piezometer, 3 May 2012. The cap can just be seen protruding from the water.

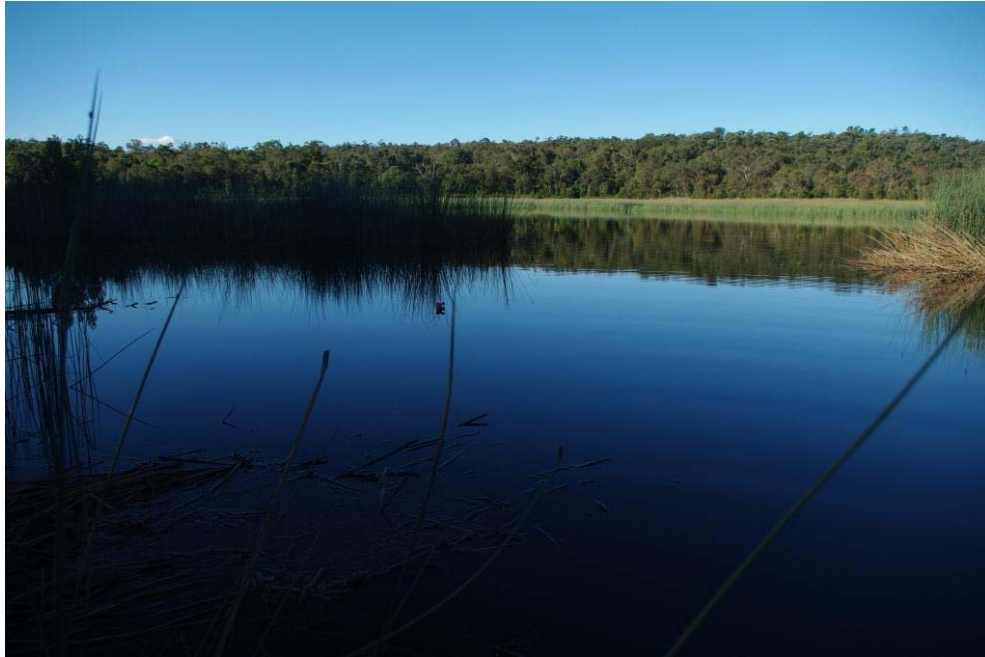
Figure 5-34. Lake Gandangarra piezometer, 3 May 2012, with similar wide angle view to Fig. 5-31.

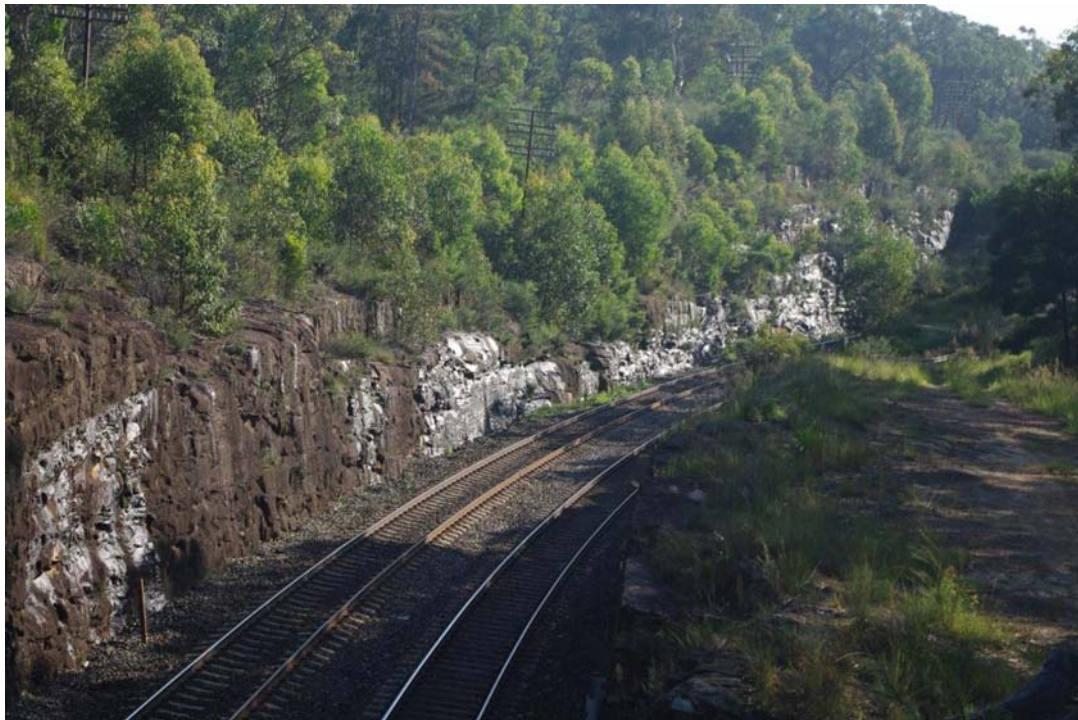
Figure 6-3. Groundwater emerging from the east-facing slope on the railway cutting at Bargo River Rd.

There are indications in the landscape of this eastward groundwater flow. The railway cutting to the north of the bridge where Bargo River Rd crosses the Main Southern Railway shows groundwater discharging from the east facing slope (Fig. 6-3). The rock is Hawkesbury Sandstone and the elevation is 270 to 275 mAHD. The discontinuity of flow from individual bedding planes and the heterogeneity of discharge points from the rock face are evident as groundwater flow from the west returns to the surface at this cutting. While the Committee acknowledges that the emergent flow is shallow groundwater, it nevertheless demonstrates an eastward flow as there is no seepage on the opposite face.

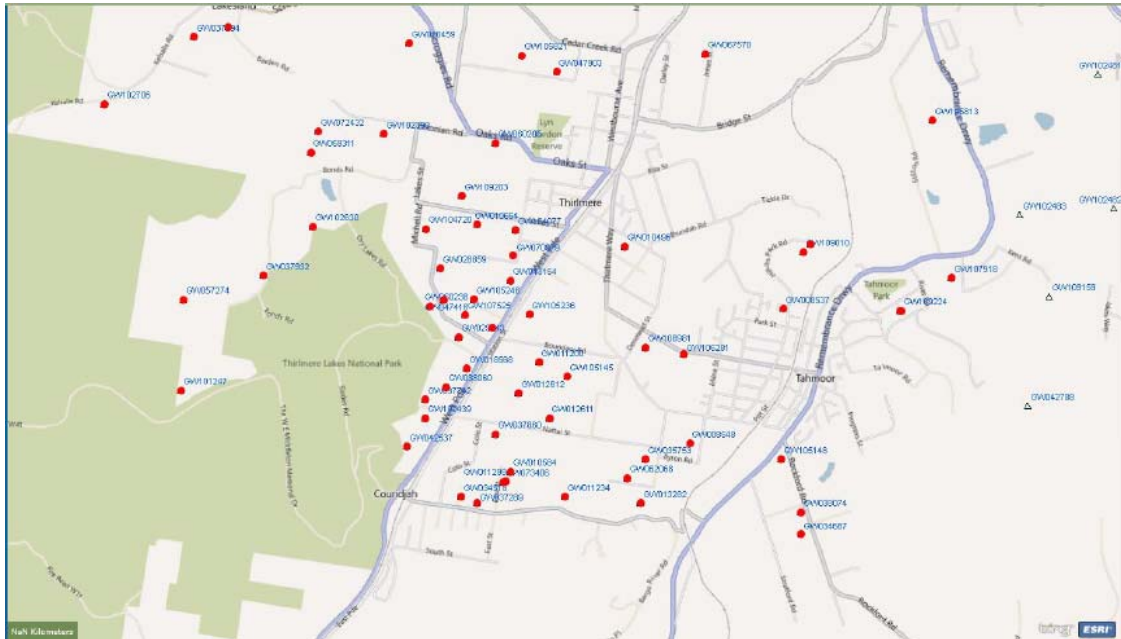
Figure 6-5. Location of bores used in this study.

A search of the NSW Office of Water database identified 65 private bores for the area between Thirlmere Lakes and Tahmoor. Summary data (bore ID, drilling date, easting, northing, hole depth, depth to water (at time of drilling), yield and lithology) are provided in Appendix 6-1 and Fig. 6-5.

The majority of bores are open hole construction with multiple water bearing zones contributing to overall bore yields. The recorded bore yields range from 0.113 L/s to 6.69 L/s, with an average of 1.12 L/s.

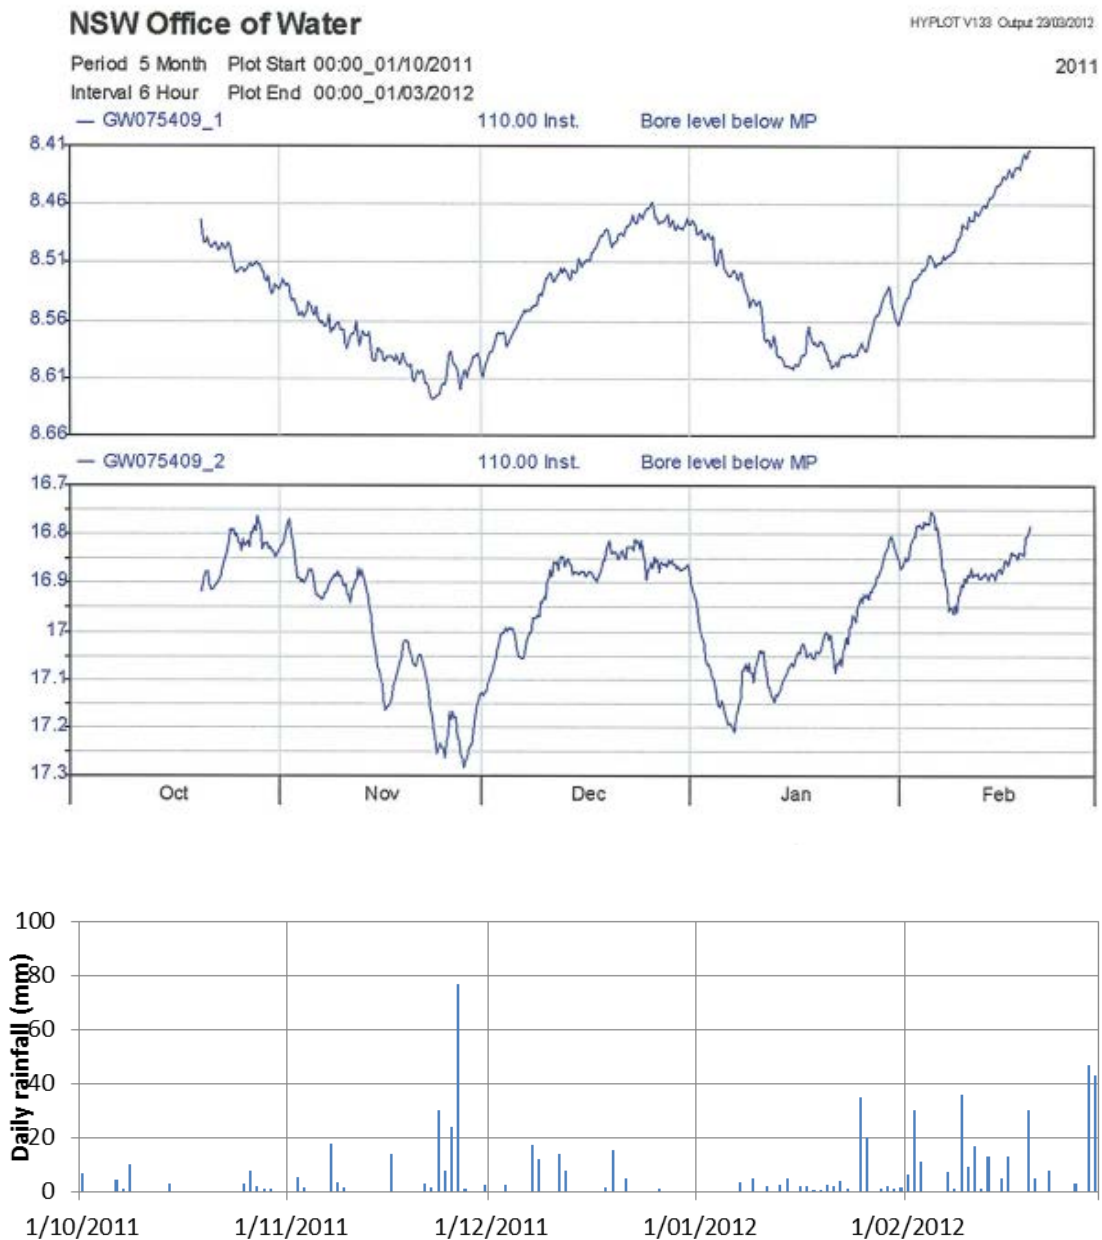
Figure 6-16. Hydrograph of groundwater levels in adjacent shallow and deep monitoring bores October 2011 to February 2012 (GW075409/1 and GW075409/2: from NSW Office of Water: with permission; copyright NSW Government) compared to daily rainfall from Maidla.

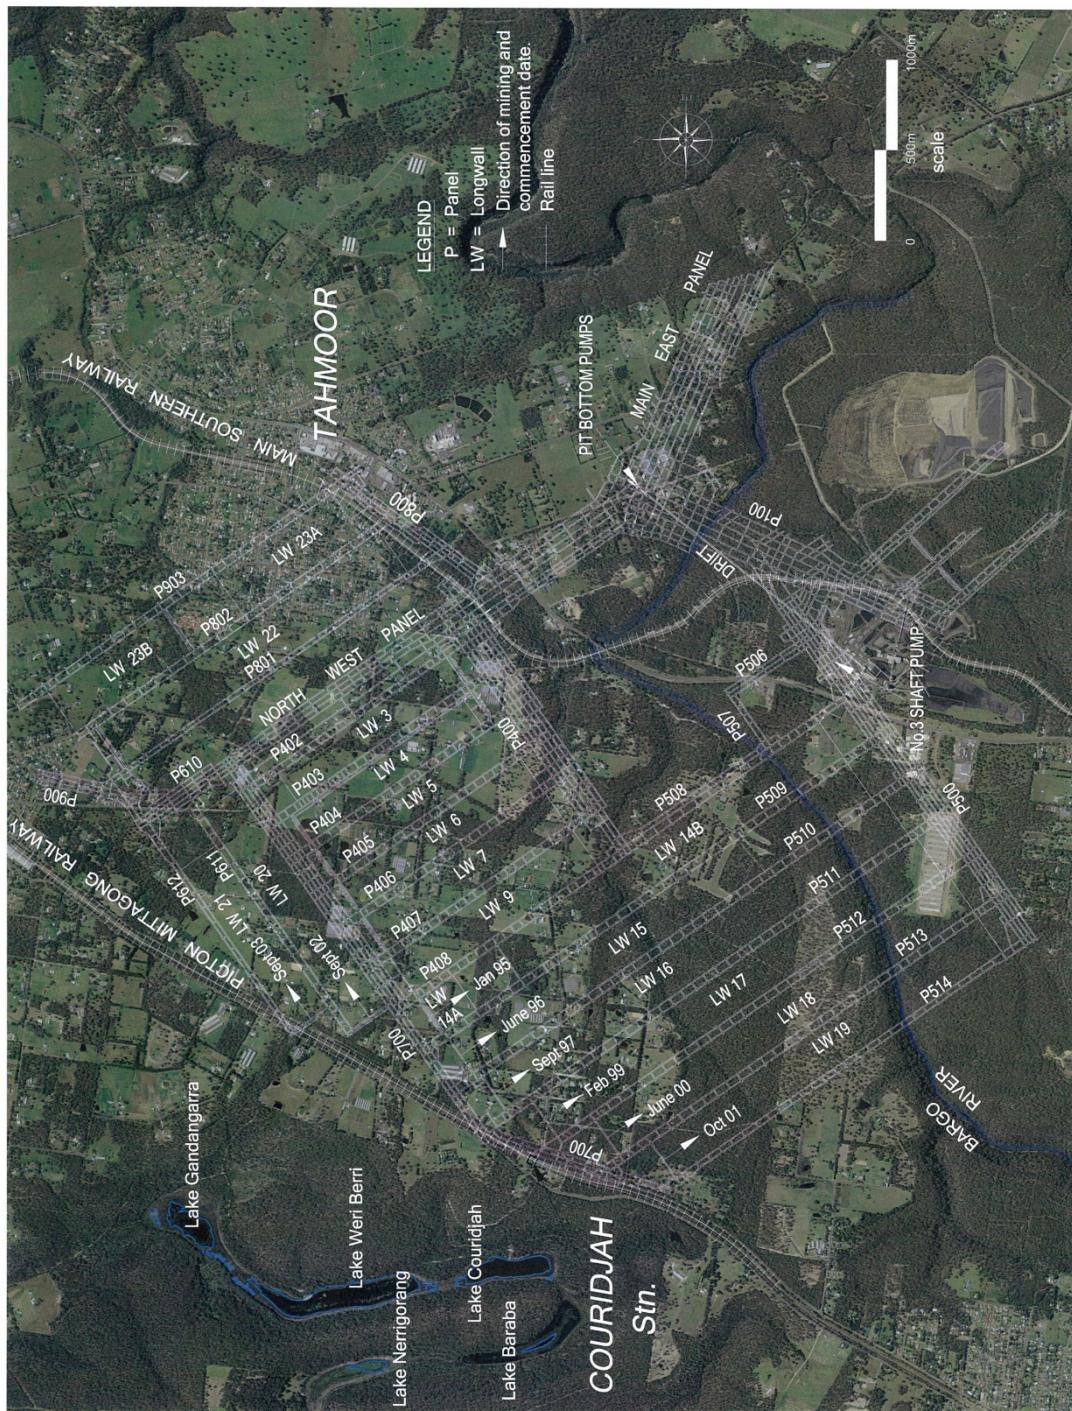
Figure 6-28. Layout of panels and longwalls of Tahmoor Colliery in the vicinity of Thirlmere Lakes, showing dates of commencement of mining of longwalls (Figure courtesy Xstrata, 2012).

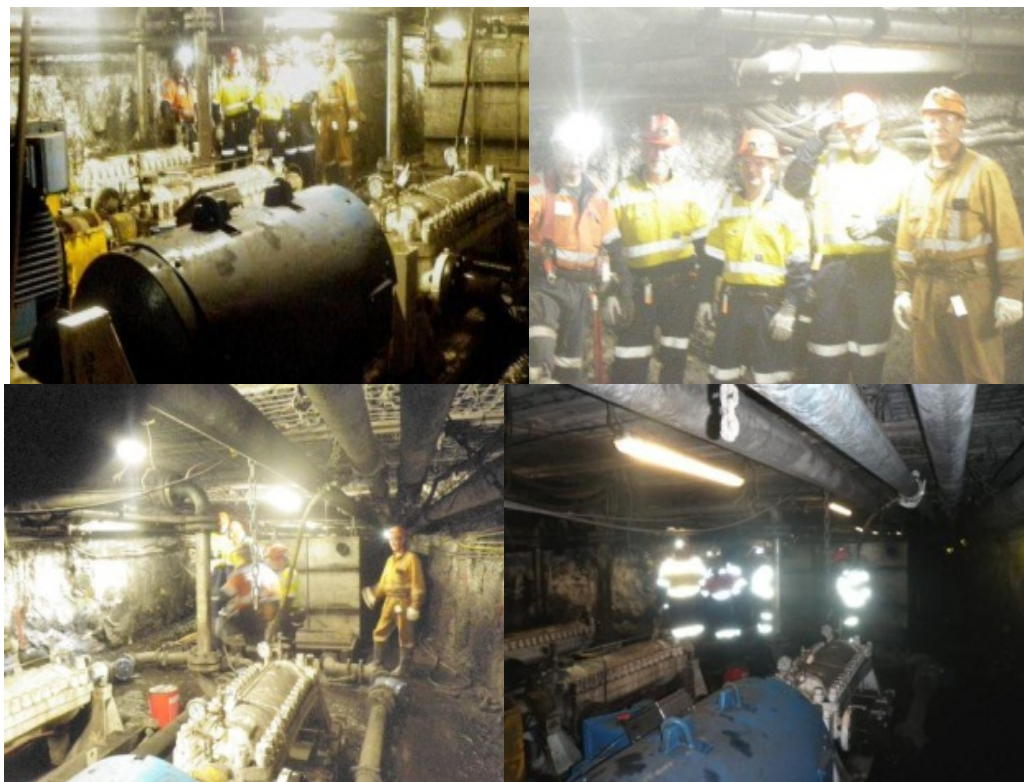
Figure 6-30. Committee inspection of Tahmoor Mine and Pit Bottom pump station.

In September 2012 two members of the Committee, accompanied by NPWS and Xstrata personnel inspected Panel 500, and the pumps at Pit Bottom and No.3 Shaft, and the mid-Drift Sump (Fig 6-30).

The Committee examined approximately 1.5 km of Panels 500 and 506, the blocked Panels along Panel 500 that previously provided access to longwalls 14 to 19. The majority of the floor, walls and roof of Panel 500 was dry and there was no continuous flow along the gutters or drains in Panel 500 nor was there discharge from the blocked access panels (Panels 509-514) to longwalls 14 to 19. Water was streaming down the walls of No.3 shaft, into a sump in its bed, consistent with the flow from the Hawkesbury Sandstone. The flow rate was not high and at the time the Shaft was undergoing upgrading.

The Committee noted the three pumps at Pitt Bottom, two pumps at No.3 shaft and some pumps in the intermediate sumps. The three pumps at Pit Bottom are not run concurrently (Fig 6-30). Only one or two pumps are in operation at any one time. The third pump is a backup. At the time of the visit the pumps were not working continuously, and it was evident that long periods of time elapse between pumping. The pumps are switched on and off with a float valve in the sump.
