Thirlmere Lakes Inquiry

Final Report of the Independent Committee

23 October 2012

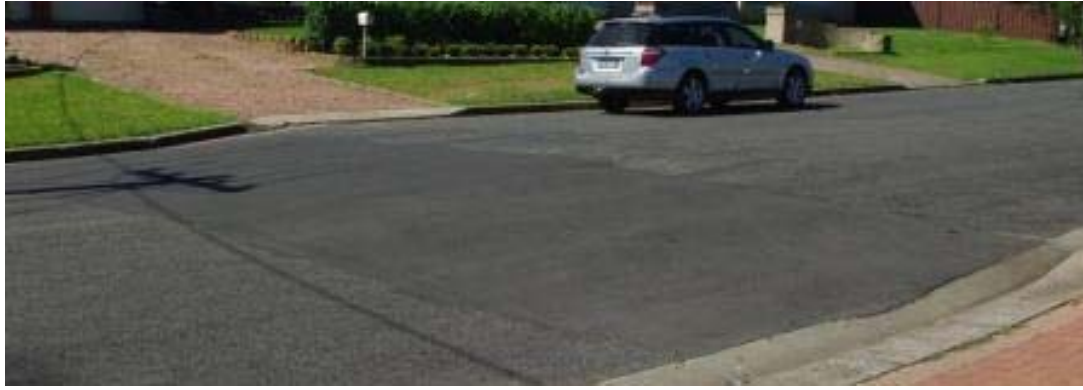
Figure 8-6. Result of mine subsidence in Tahmoor. The vertical offset is >500 mm on either side of the patch in the road.
