Department of Planning and Environment

Ecological Health Assessment of Victoria Creek and Tilba Tilba Lake, NSW

An interim report with baseline data

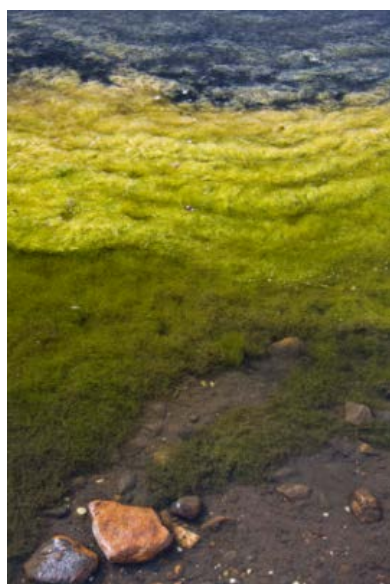
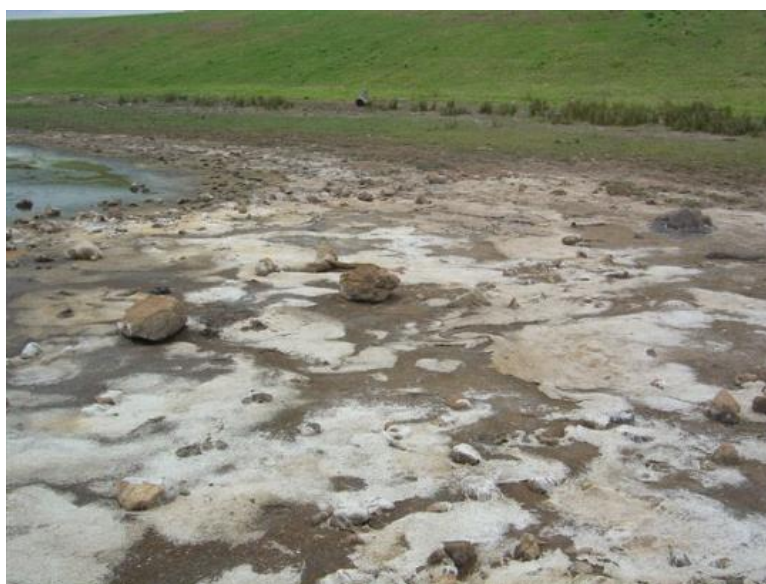
Photo 2 Tilba Tilba Lake in 2008

Left: dead seagrass, right: salt building up on the lake due to increased evaporation (J Potts, 2008)

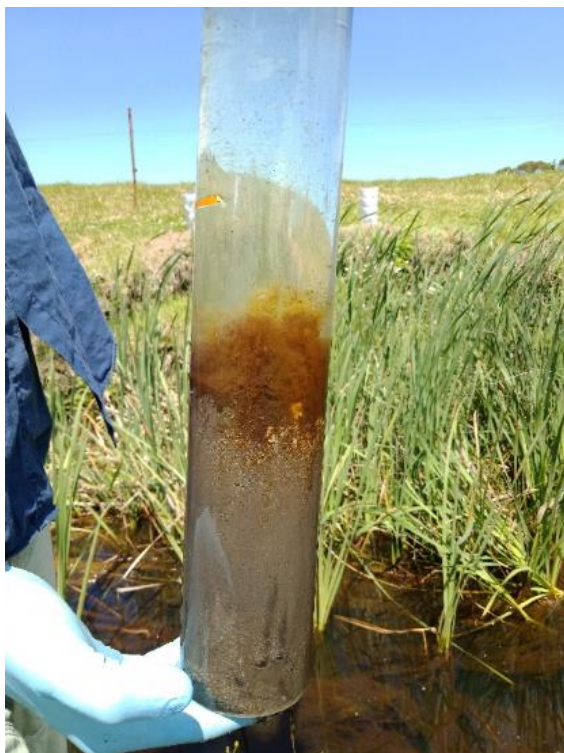
Photo 3 Taking a sediment sample from VC2 and VC3 (U Pinto, October 2020)

The sediment layer up to 20 centimetres was sampled during two visits. At each site, 100 grams of five sediment samples were collected from three random locations within a site (**Photo 3**). Sediment samples were analysed using an LA-960 laser particle size analyser following the manufacturer's instructions (HORIBA Scientific, 2020a). The analysis only included less than 3 millimetre fraction and grain-size was allocated into a category based on sizes of soil separated according to the US Department of Agriculture classification system (HORIBA Scientific, 2020b).

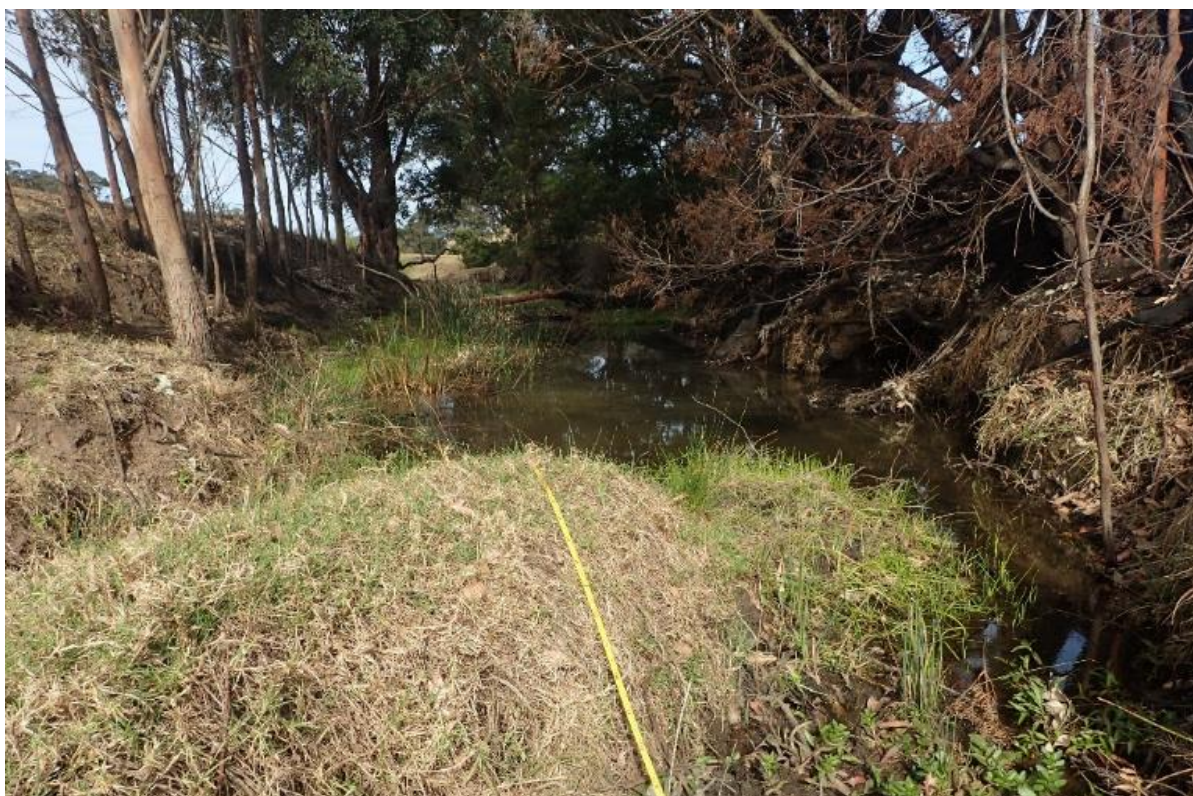
Photo 5 20 metre tape running through centre of 20 x 20 metre quadrat at VC2 (J Ling, 18 September 2019)

Extant vegetation plots were surveyed to better understand the current species composition of the vegetation on Victoria Creek. A fixed and random 20 x 20 metre plot (**Photo 5**) was surveyed at each of the sites between 18–20 September 2019, 24–25 February 2020 (VC1, VC2, VC3, VCR1) and 19–23 October 2020 (VC1, VC2, VC3, VCR2, VCR3). Fixed sites were located at the water quality location (where appropriate), while the random plot was located using a random number system within 100 metres downstream of the fixed plot. Species presence, abundance and cover was recorded in each plot as required by the Biodiversity Assessment Method (OEH 2018; Sivertsen 2009). Growth forms of native species were assigned using the lookup table developed in the BAM calculator (OEH 2018). Voucher specimens were taken for most species. Each species was allocated to its water plant functional group (WPFPG) and wetland plant indicator list (WPIL) status as identified in Ling et al. (2019). WPFPG are groups of water plants based on the species responses to depth and water-level change (Casanova & Brock 2000; Casanova 2011) and adapted to incorporate life history (i.e. annual vs perennial) and life form (Capon & Reid 2016). The WPIL is a list of plants with a strong association with wet conditions that can be used diagnostically (Ling et al. 2019).

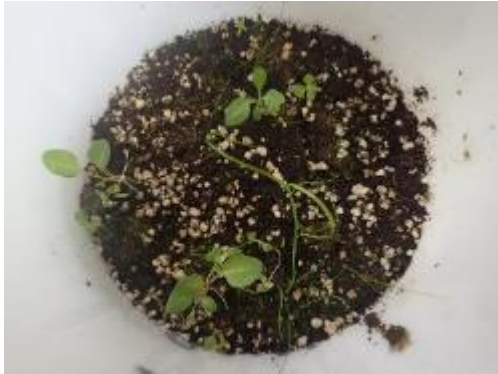
Photo 6 Germination of seed bank from VC1 – Zone B – rain (J Ling, 14 April 2020)

The plant-growth laboratory lights were set for 12 hours during the day and were switched off overnight for 12 hours. The laboratory is airconditioned to keep the air temperature at 26°C. Photos were taken at least fortnightly initially, and then monthly over the experimentation period (**Photos 6–8**), as well as checking for water levels and identification. Once counted and identified, the entire seedling was removed to avoid self-seeding, and preserved as a dried voucher specimen.

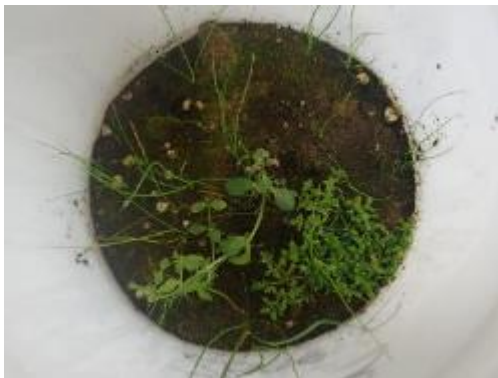
Photo 7 Germination of seed bank at VC3 – Zone C – waterlogged (J Ling, 14 April 2020)

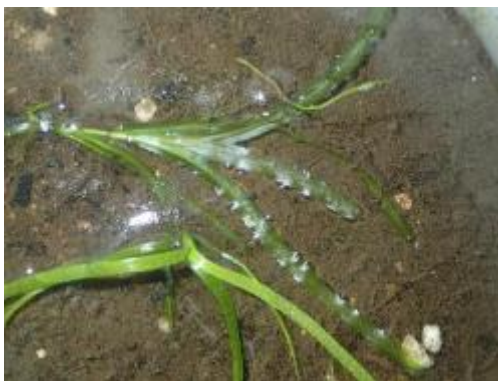
Photo 8 *Potamogeton ochreatus* germinated from VC2 – Zone A – waterlogged

Interestingly this species has not been recorded or observed at the site (J Ling, 2 April 2020)

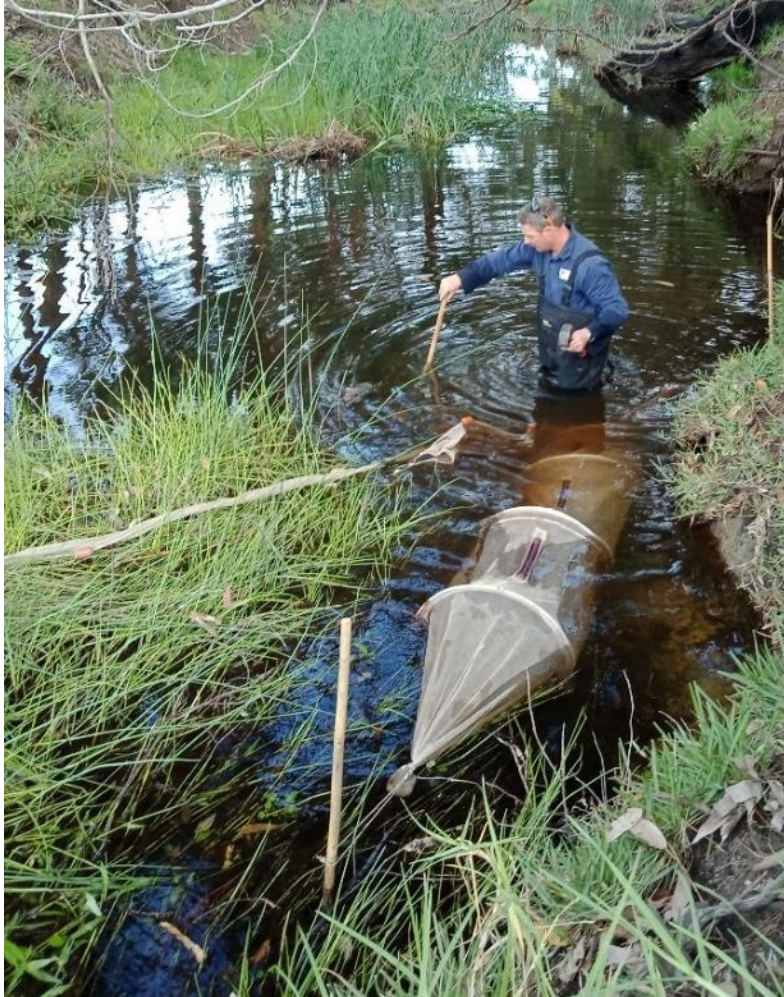
Photo 10 Setting up fyke nets at VC2 (U Pinto, October 2020)

Two downstream facing 4 millimetre mesh fyke nets were set for 24 hours at each site (**Photo 10**). All captured animals were identified on site and subsamples of the first 50 individuals of each species were measured (total length in millimetres) and if sexually dimorphic, sexed. Additional animals were identified and counted prior to release. All native fish were released following capture and non-native species (such as *Gambusia holbrooki*) were euthanised in AQUI-S® (50 parts per million).

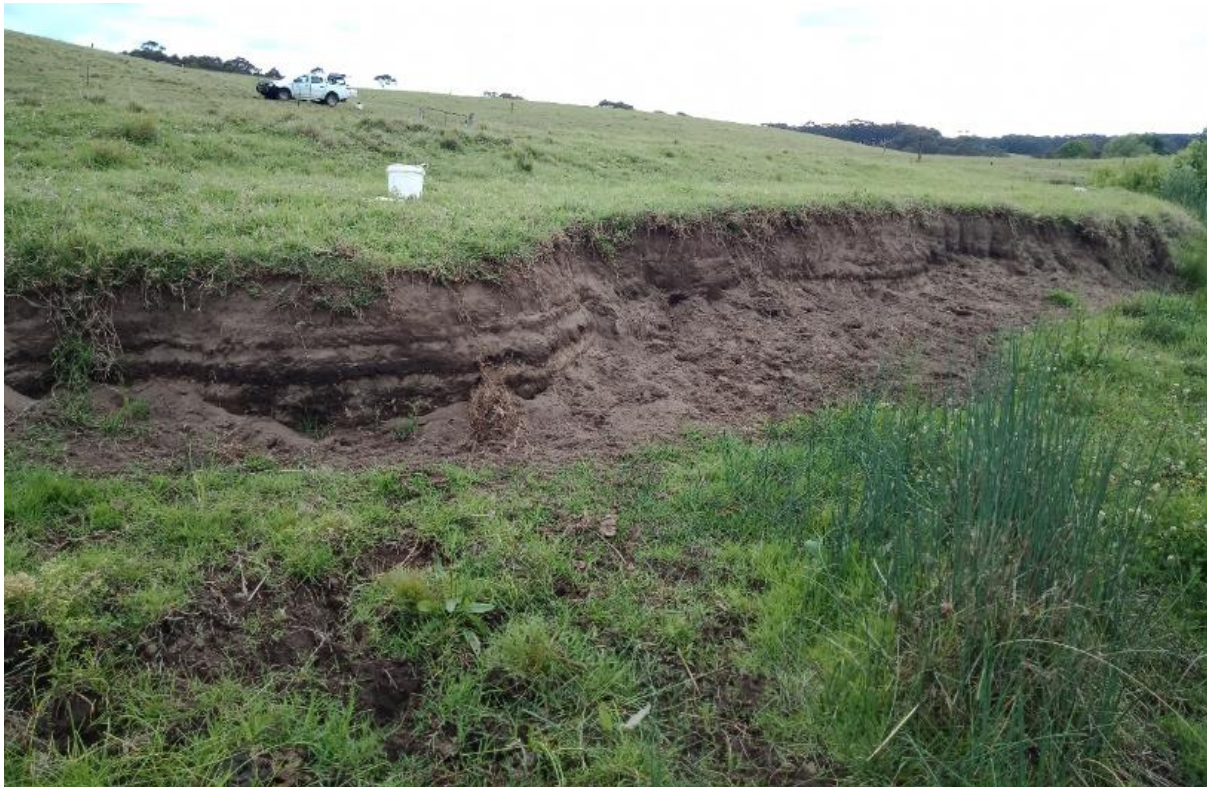
Photo 11 Bank erosion at site VC4 (U Pinto, 4 November 2019)

Instream condition was highest at VC1 and lowest at VC4 (**Figure 10C**). The lowest score was attributable to absence of macrophyte cover (emergent, submerged and floating types), leaf litter, large woody debris and in-channel habitat types. Five stream health issues were assessed on a binary scale (grease and oil, odours, rubbish, invasive weeds, filamentous green algae). On average, filamentous algae were present at all sites, invasive weeds at sites VC3 and VC4, odours at sites VC2 and VC4 and oil was noted at VC2. Rubbish was not present at any site.

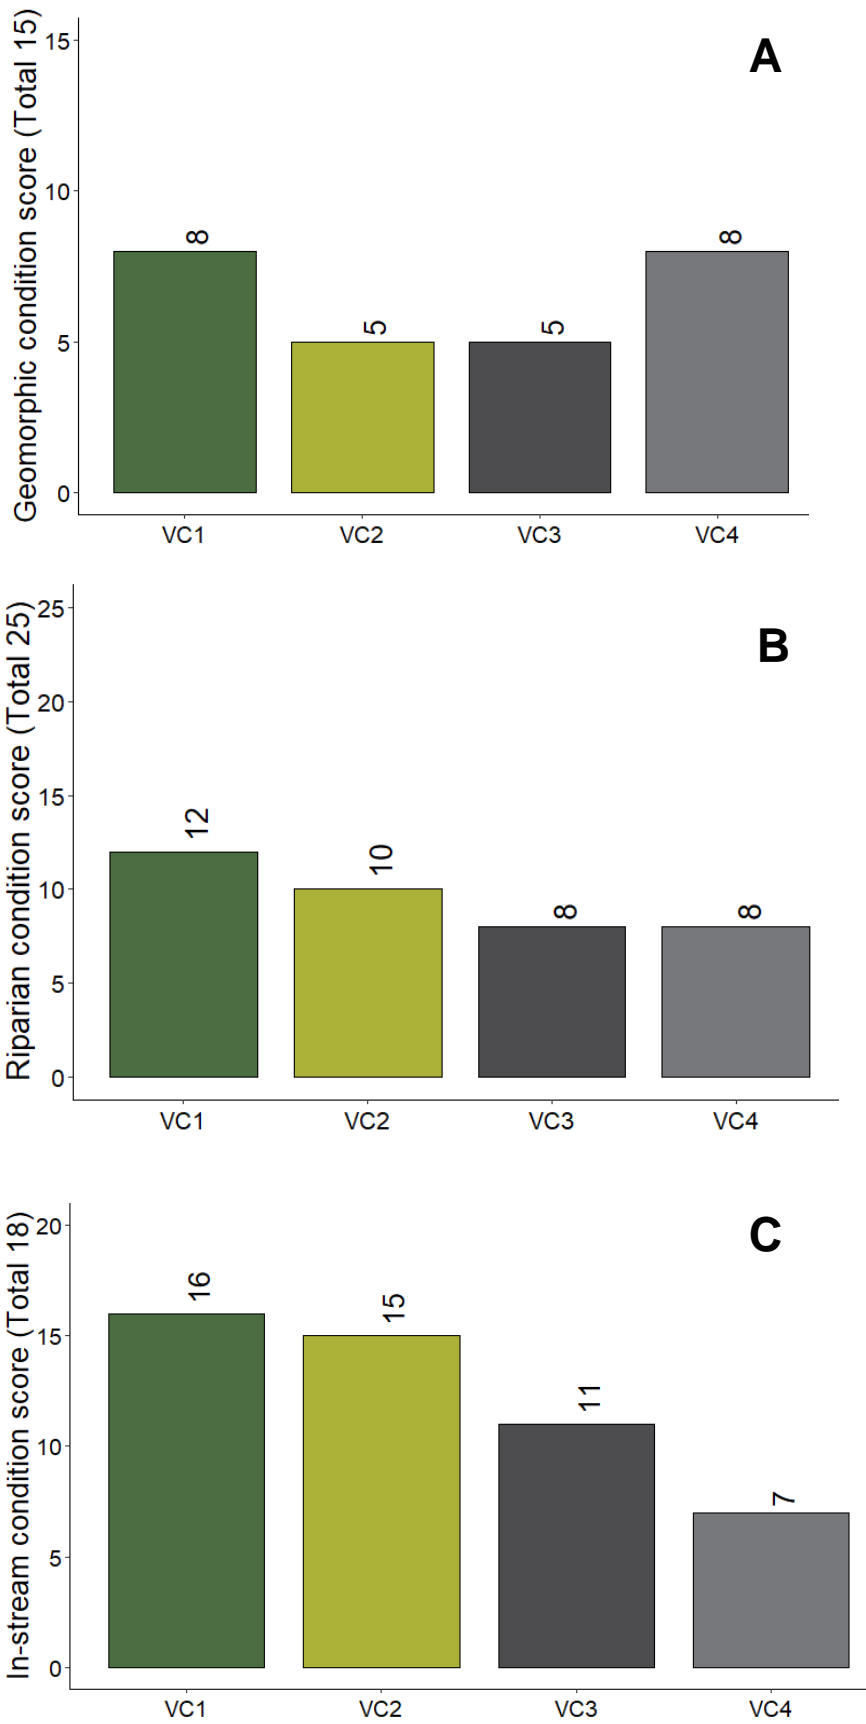
Figure 10 Mean visual assessment scores at four sites: (A) geomorphic condition, (B) riparian condition, (C) instream condition

Scores are averages of three surveys.

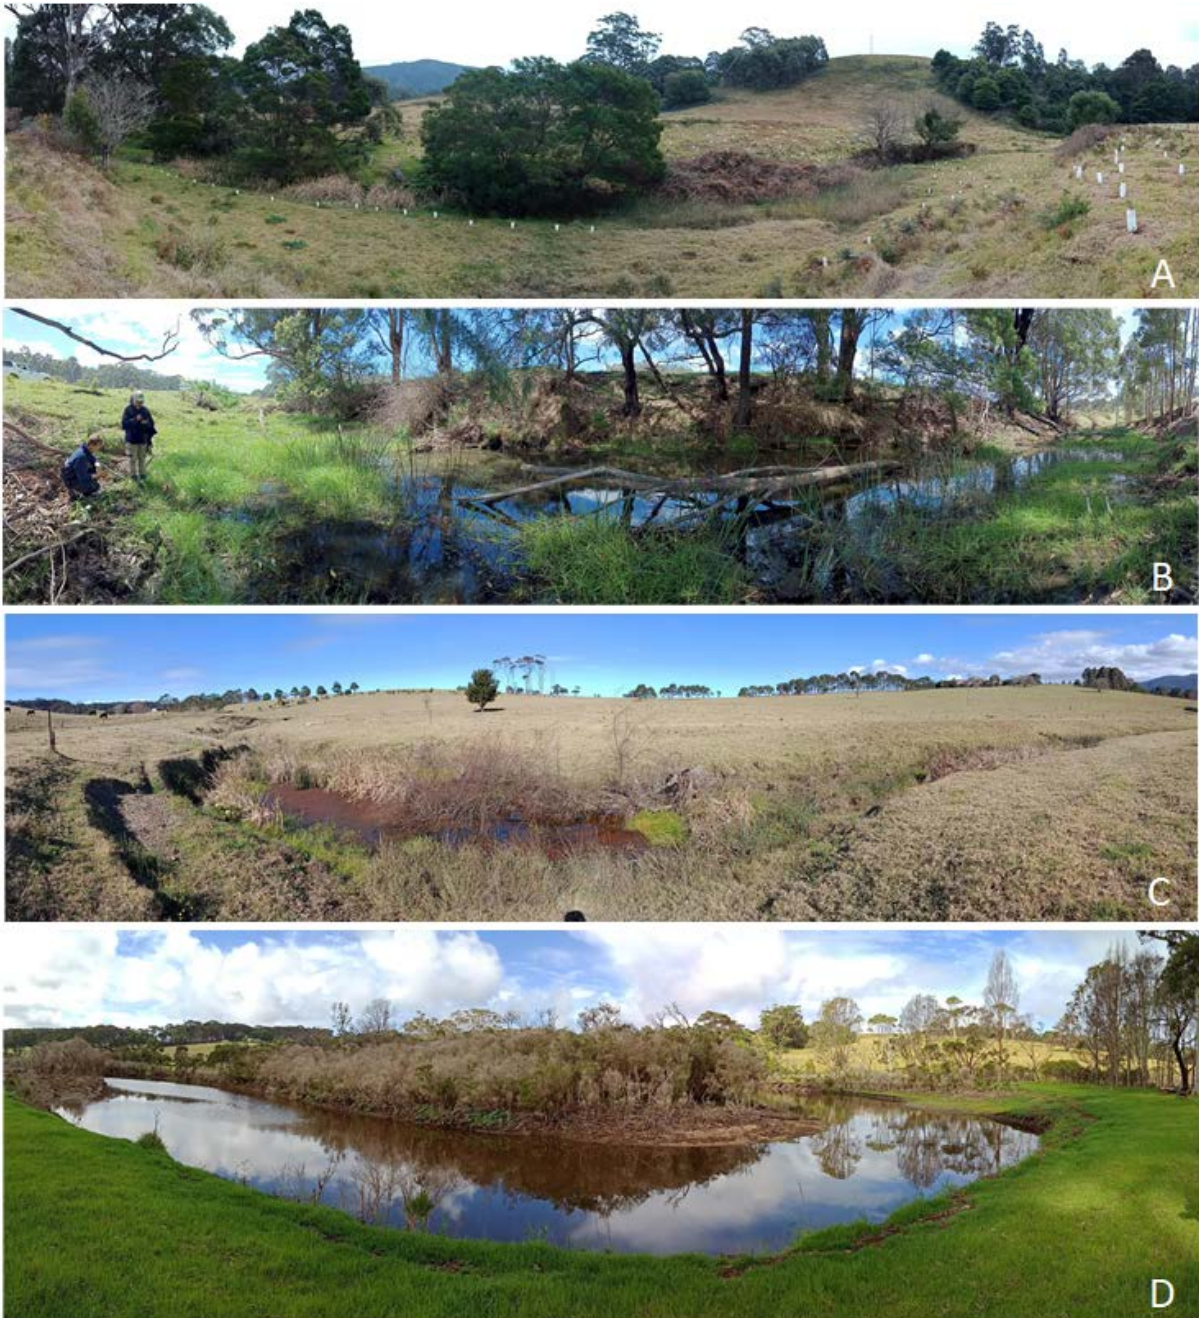
Photo 12 Photos of monitoring sites

(A) VC1, (B) VC2, (C) VC3, (D) VC4 (U Pinto, taken on different sampling trips in 2019).

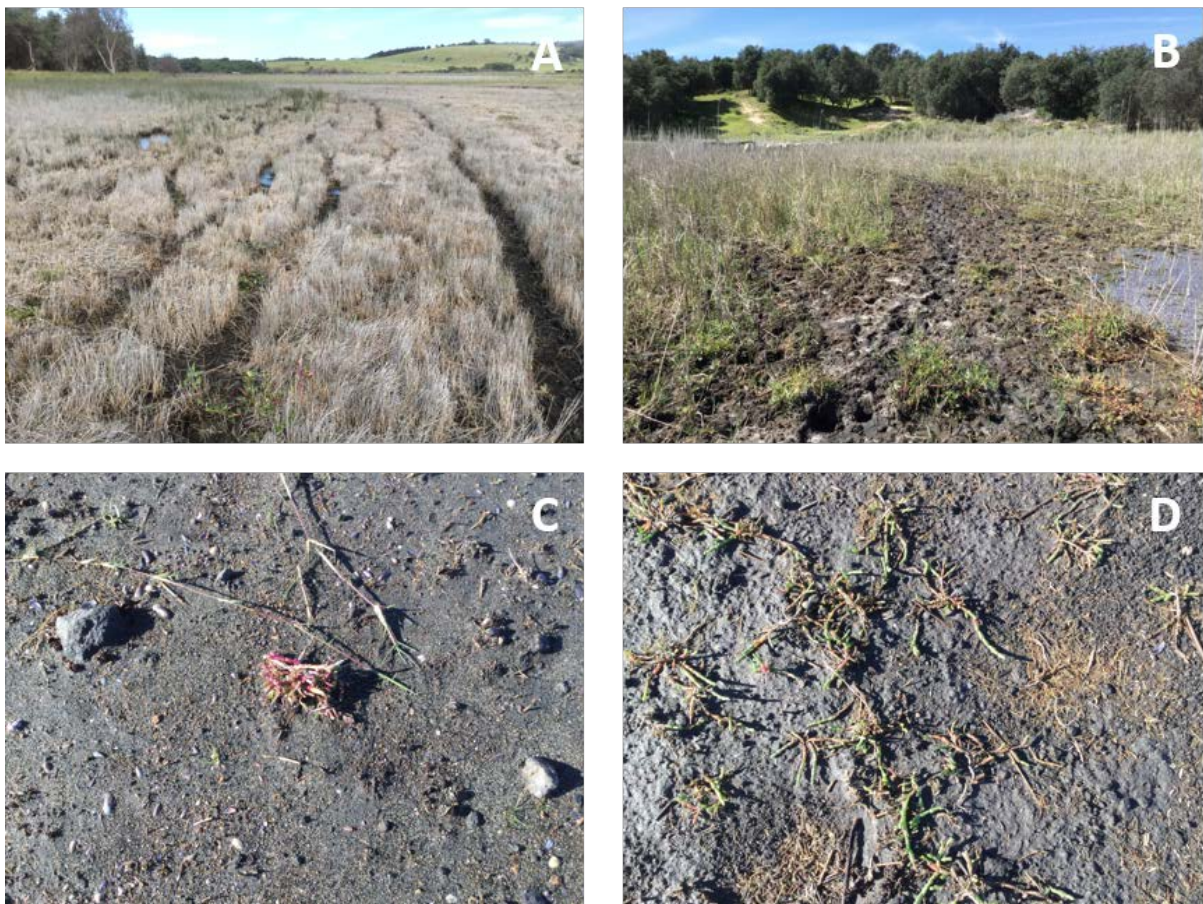
Photo 13 Photographs showing the impact of cattle on saltmarsh coverage and condition: (A) cattle tracks, (B) pug marks, (C) and (D) grazing

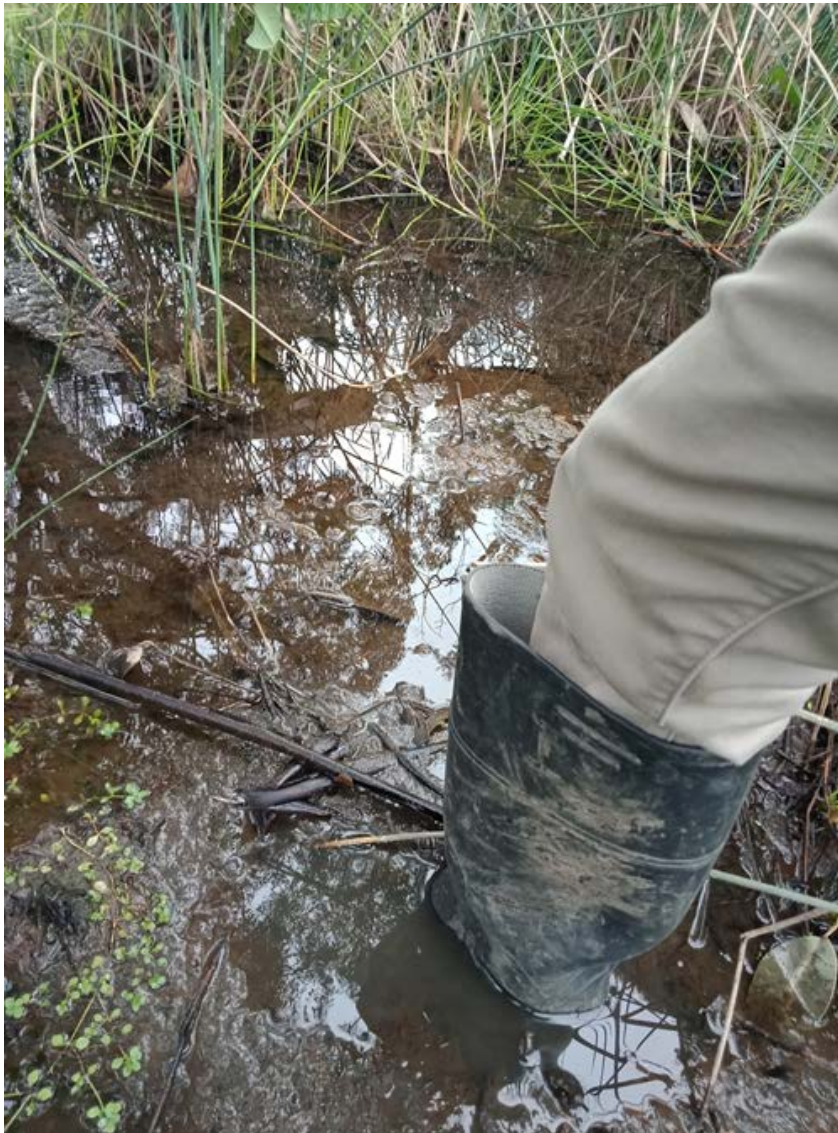
Photo 14 Dense fine sediment layer at site VC1 (U Pinto, 27 July 2019)

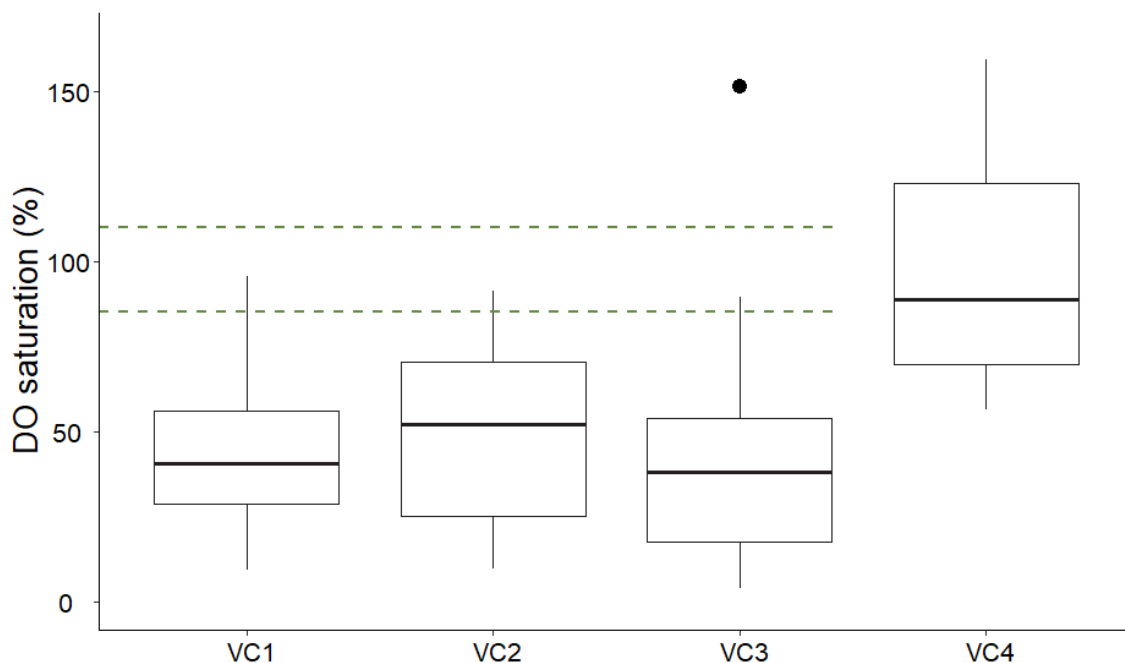
Figure 26 Box and whisker plots of DO saturation (%) across the four sites in Victoria creek. Dashed lines indicate ANZECC/ARMCANZ (2000) DO saturation (%) trigger value range 85–110%. Median is shown as a solid line and is based on results from 19 sampling surveys.

The ANZECC/ARMCANZ (2000) default trigger value for DO saturation has a lower and upper limit of 85–110% and these were used to compare the observed values. The lower value is set to protect a wide range of aquatic species. For example, many Australian aquatic invertebrate taxa living in both upland and lowland streams have been shown to withstand very low DO levels (<10%) for generally up to five days (Connolly et al. 2004). This study further suggested that moderately poor DO concentrations (25–35% and 10–20%) affect the drift response of macroinvertebrates, which experience sublethal effects that may be detrimental in the long-term.

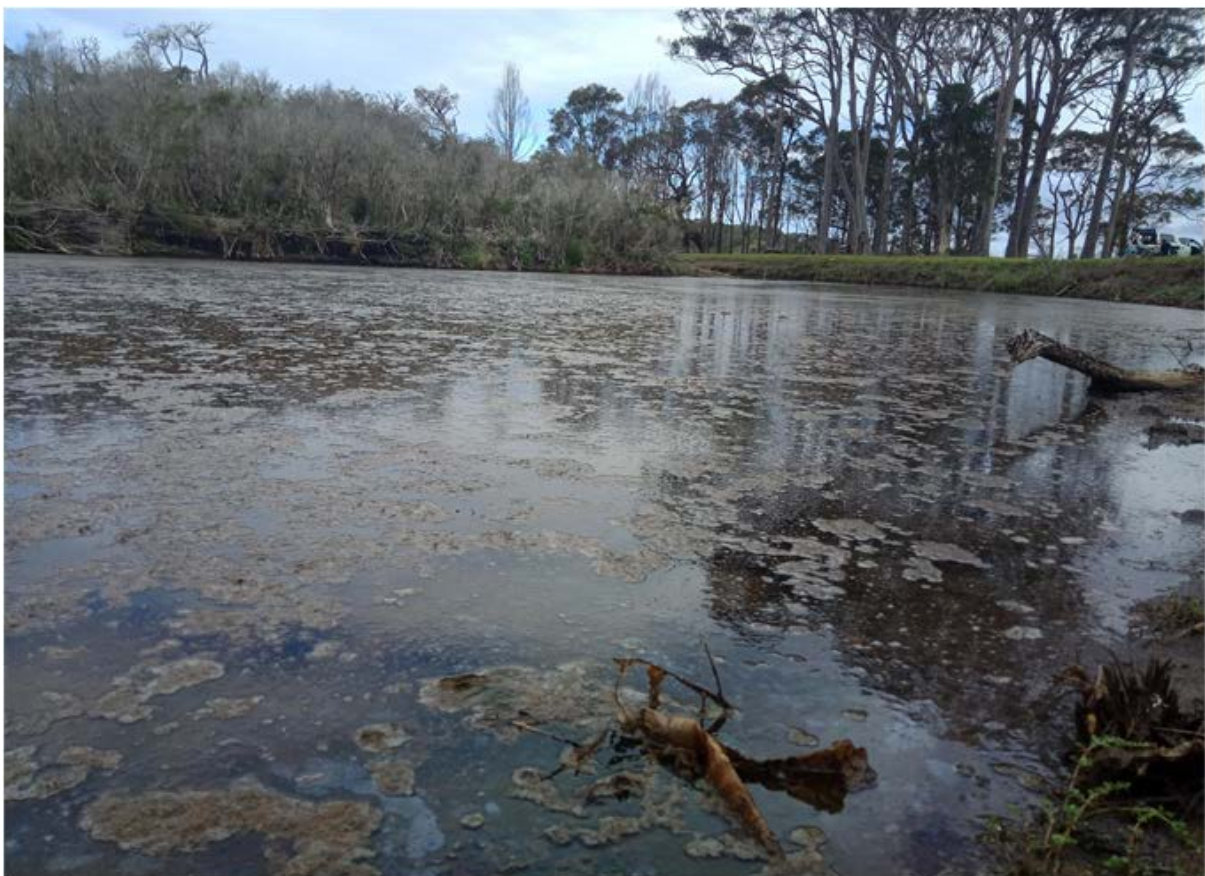
Photo 15 Mats of dead and decomposing macroalgae at site VC4 (U Pinto, 4 November 2019)

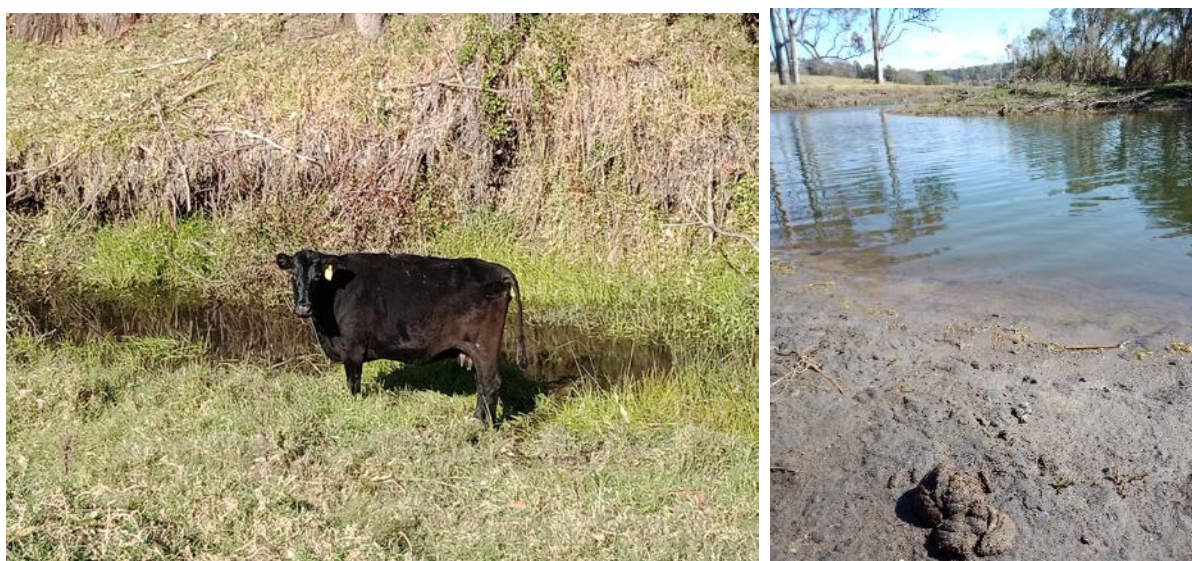
Photo 16 Site VC2 and faecal matter from cattle next to the creek (VC4) (U Pinto, left – June 2019, right – September 2019)
