Fort Denison

Conservation Management Plan

This conservation management plan was prepared by the NSW Office of Environment and Heritage in May 2018, to update and replace the previous conservation plan prepared by NPWS and endorsed by the Heritage Council of NSW in 1999.

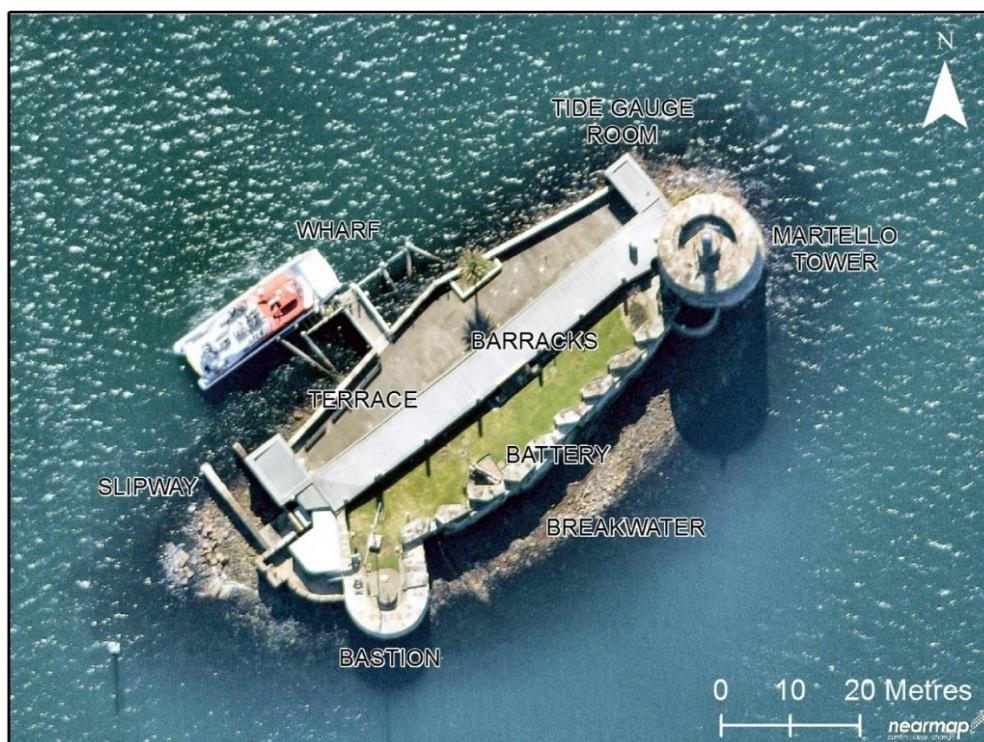
The island is aligned approximately north-east to south-west, with the Martello tower at the north-eastern end (**Figure 2**).

Figure 2 Site plan of Fort Denison showing the main features (base plan: Nearmap)

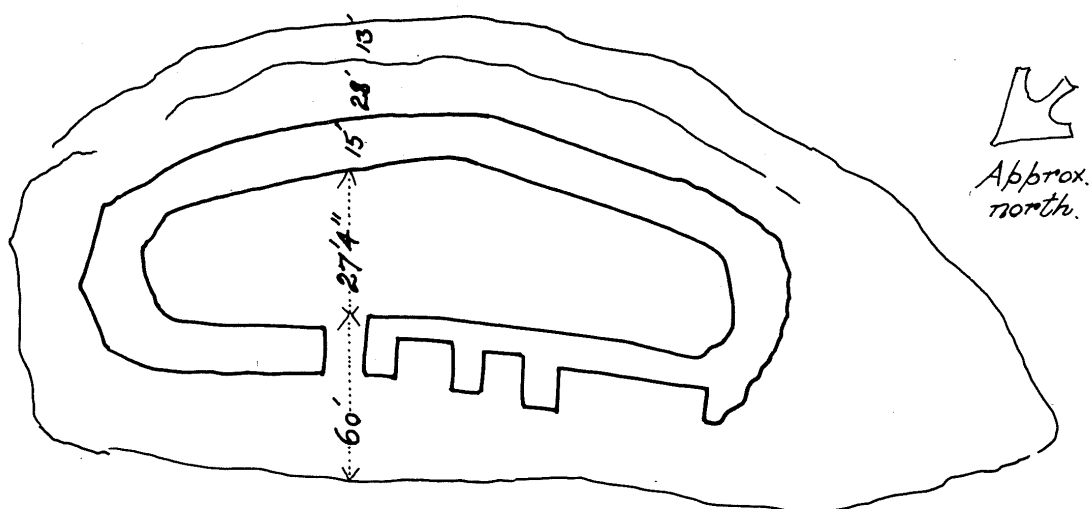
Under Barney's supervision the convicts transformed the island into a terreplein battery around 27 feet, four inches wide, with a 15-foot-wide parapet of bedrock (**Figure 6**). In May 1842 Barney advised Frederick Mulcaster, the Inspector General of Fortifications, that Pinchgut was capable of being armed, noting that 10 24-pounder smoothbore cannon had already been distributed.⁴⁹ The guns had in fact already been sent to the island as early as February 1842.⁵⁰ The extent to which the guns were mounted is unclear. James Glen Wilson's oil painting of Pinchgut circa 1850 shows only one gun and it is lying on the ground (**Figure 7**). The painting demonstrates a major flaw in the design of the battery. The height of the parapet is about the same height as the two men shown in the painting and was reported as only 16 feet above the high-water mark. As pointed out by Mulcaster, attacking ships could approach on all sides and rake the gunners with grapeshot.⁵¹ Much of the original parapet was incorporated into the terreplein and barracks building of Fort Denison and can still be seen today.

Figure 6 Sketch plan of Pinchgut battery, probably by Henry Lugard, between 1842 and 1844. Redrawn from ML B1441 by JS Kerr (Kerr 1986, p.12)

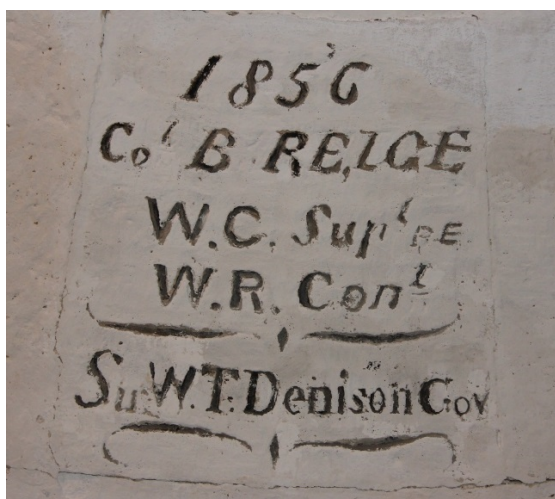
The keystone of the last arch of the tower basement was laid during a ceremony on the island in July 1856. The stone was inscribed with the names of those involved in the construction of the fort: Governor Denison, Barney, Coles, Randle, Price and J Carlisle (**Figure 8**). After the stone-laying, the workmen were provided with refreshments and allowed to take a holiday for the rest of the day, while Barney, Randle and friends took refreshments in one of the unfinished officers' rooms.¹⁰⁰

Figure 8 The keystone of the magazine arch (R Newton/OEH 2017)

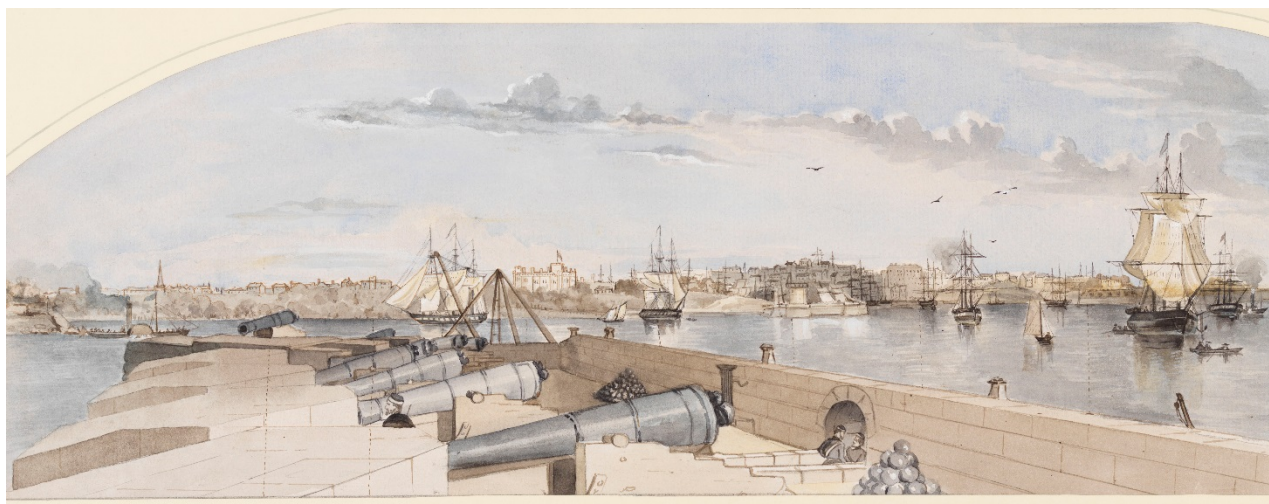
- one 8-inch shell gun on a traversing carriage on the top of the tower
- three 32-pounder shot guns on garrison carriages in the tower
- one 12-pounder carronade in the tower
- nine 32-pounder shot guns on dwarf traversing platforms in the terreplein battery (**Figure 9** and **Figure 10**)
- one 10-inch shell gun on a traversing carriage en-barbette
- one 10-inch shell gun on a dwarf traversing platform in embrasure.¹¹¹

Figure 9 The 10-inch shell gun (left of image) and 32-pounder gun battery on Fort Denison, circa 1859. The image shows several enlisted men of the Royal Artillery garrison and the water tank pump (Wilson, State Library of NSW, a5325001u)

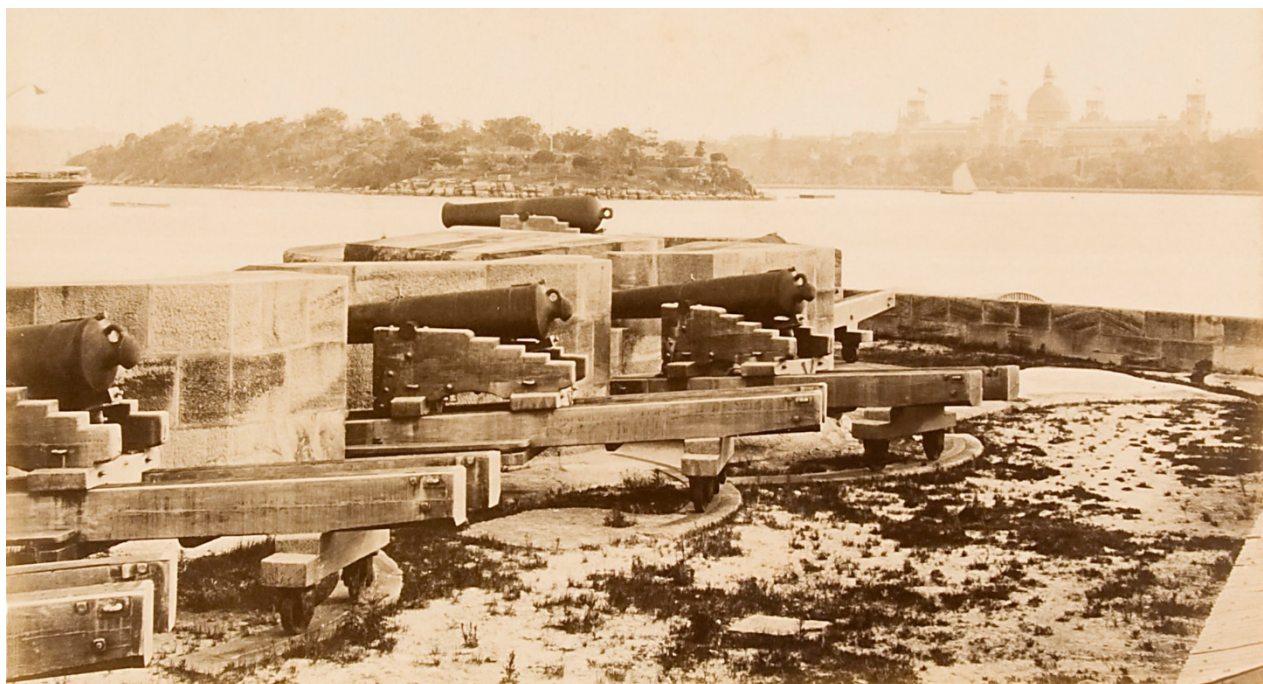
Figure 10 Fort Denison 1879, showing the 32-pounders on dwarf traversing carriages and the 10-inch shell gun en-barbette (91/1323-6 Collection: Museum of Applied Arts and Sciences. Photo: Chris Brothers)

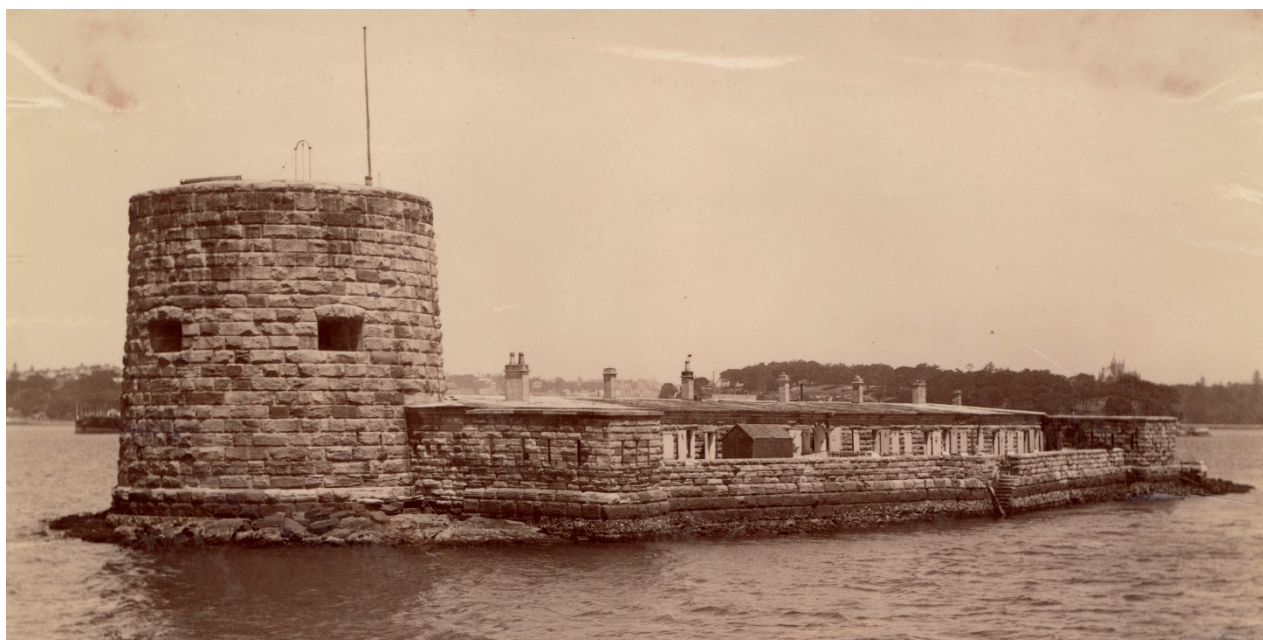
In May 1859 it was reported that Mr Goddard had recently completed the ditch and a solid seawall at the rear of Fort Denison, and was now constructing loophole flank defences consisting of guard houses and open buildings to protect riflemen.¹¹³ These chambers (now known as the Tide Gauge Room and West Room) were protected positions from which riflemen could direct small arms fire at enemy landing parties as well as providing additional accommodation¹¹⁴ (**Figure 11**). By the end of 1859 total expenditure on the fort had increased from the original estimate of £16,550 pounds to £26,962 pounds and the fort was still listed as unfinished.¹¹⁵

Figure 11 Fort Denison after completion of the 1859 loophole flank defences and seawall (Star Photo, State Library of NSW, a089117u)

The Martello tower was constructed from 1856 to 1858 (**Figure 11**). The tower is largely intact externally and internally, except for the removal of the gun from the terreplein in 1913 and construction of the light tower and mounted navigation aid. The cut-out step up and fixing points in the stonework in the south side of the tower parapet are evidence of the location of the earlier fixed navigation light, now on display in the barracks building. The purpose of the structure once located at the top of the cut-out stone steps (**Figure 15**) remains unknown. Framed glazed windows have been fitted to the middle level. The 32-pounder guns have been painted in several colours in past years including white and black. The interior of the tower was painted in 1971. Storage of display cases and wine barrels (simulating powder barrels) on the bottom level has permanently marked the Seysell asphalt floor surface.

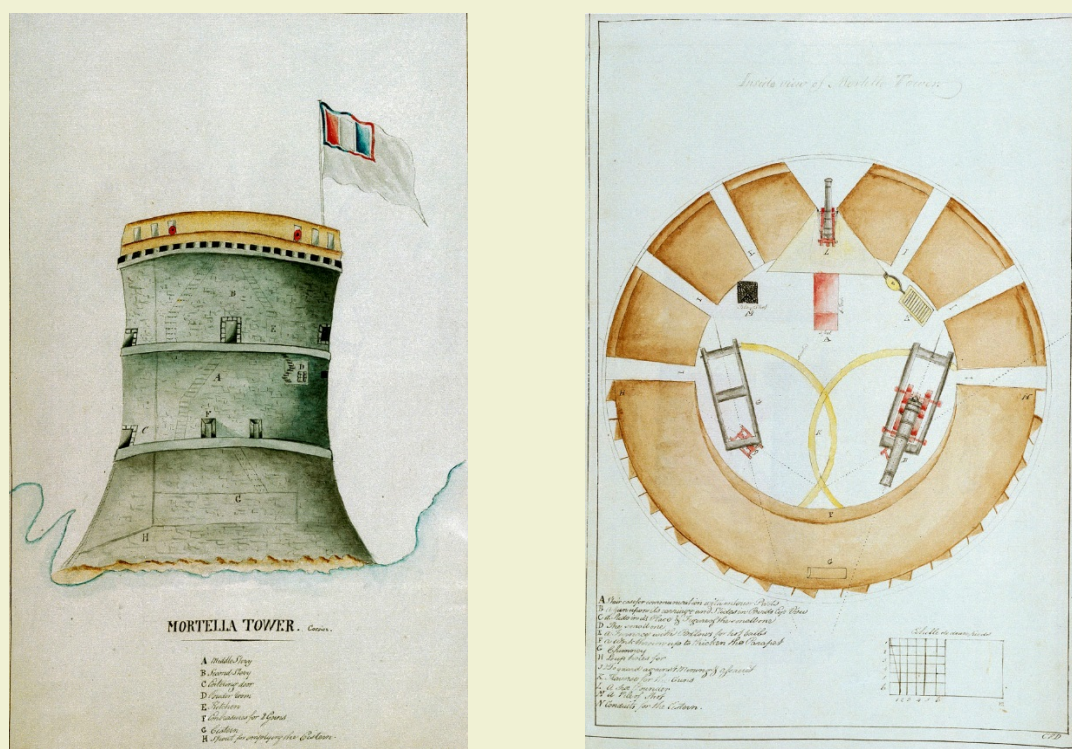
Figure 12 Elevation and inside view of the tower on Mortella Point which inspired the construction of over 100 British Martello towers (© National Maritime Museum, Greenwich, London)

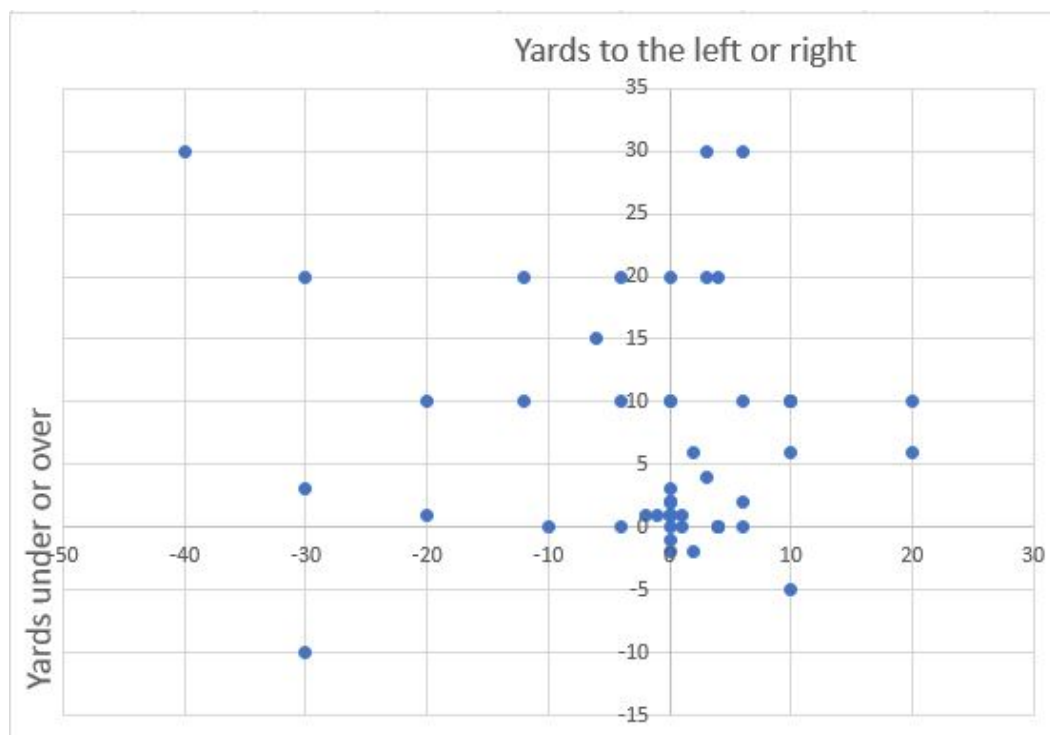
Figure 14 Results of shot practice, July 1864. Note: multiple hits on the same location are recorded only once

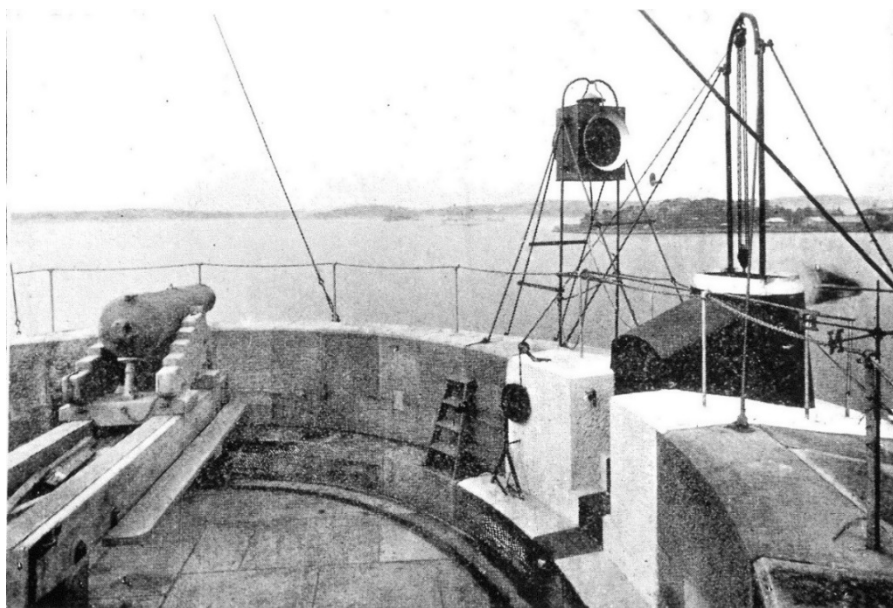
In May 1858 a red oil burning navigation light was placed on the top of the tower, trialled and found to 'answer its purpose admirably'¹⁵³ (**Figure 15**). The light was exhibited constantly after June 1858. From 21 June a sergeant of the fort's garrison was placed in charge of the light on an annual salary of £24 and five shillings paid for by the Colonial Government with a private as an assistant on £14 and 11 shillings.¹⁵⁴ This arrangement was apparently not fool-proof with Captain Paddle complaining in April 1861 that the light had been out twice that month.¹⁵⁵ The expense of maintaining the light rose in 1866 to £73 for both a sergeant and private in charge of the light and an additional £6 for the cost of sounding the gong during foggy weather.¹⁵⁶

Figure 15 The oil lantern on top of the tower. The 8-inch shell gun appears at left of image (Town and Country Journal 3 Aug. 1910, State Library of NSW, TN83)

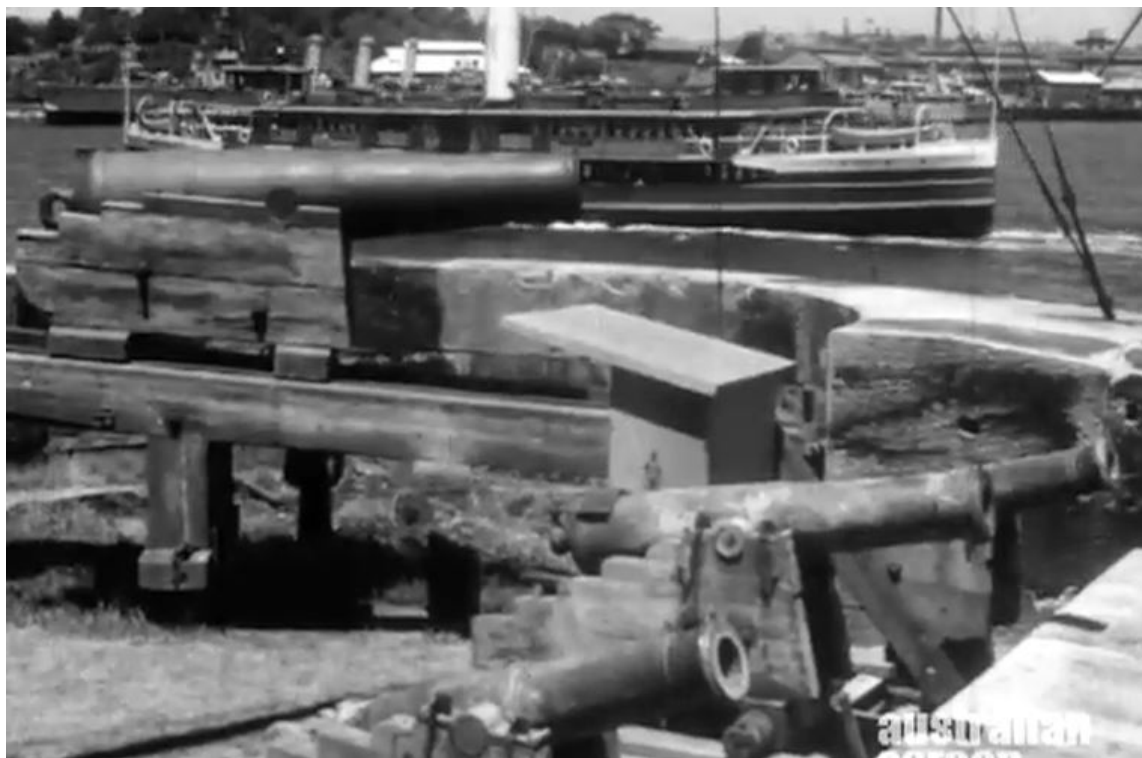
Figure 17 The 8-inch shell gun with original traversing carriage emplaced in the bastion. The brass howitzers, including the one o'clock gun, are on original garrison carriages (Australian Screensound 1936)

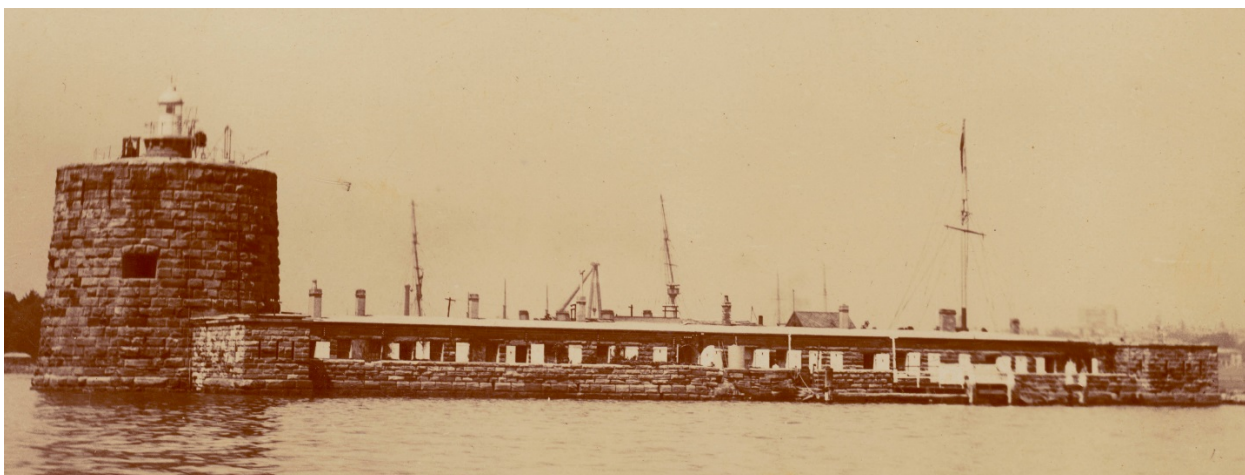
Figure 18 Fort Denison after 1915, showing the new light, reconstructed Tide Gauge Room and the new wharf (State Library of NSW, Star Photo a_089117u)

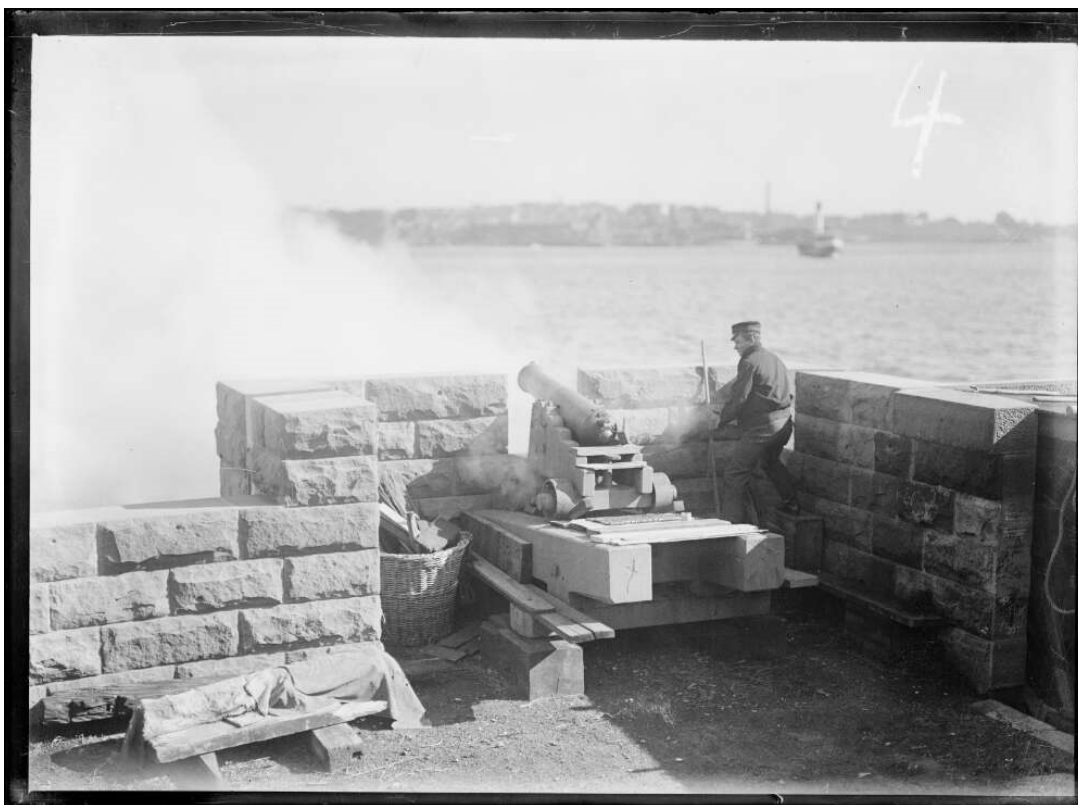
A boat slipway and yard with an ornamental parapet and embrasure for the one o'clock gun (**Figure 19**) and two water tanks were added to the southern end of the Island in 1917–18 (**Figure 20**). Garden beds were under development in 1910 and more elaborate garden beds were added to the courtyard in 1923¹⁸¹ as caretakers modified the fort to create a more domestic lifestyle.

Figure 19 The one o'clock gun, still on its original garrison carriage and standing atop remains of an old 32-pounder gun carriage (National Library of Australia, 'Man operating a canon [sic] at Fort Denison on Pinchgut Island', Sydney, ca 1930s, obj-162997492)

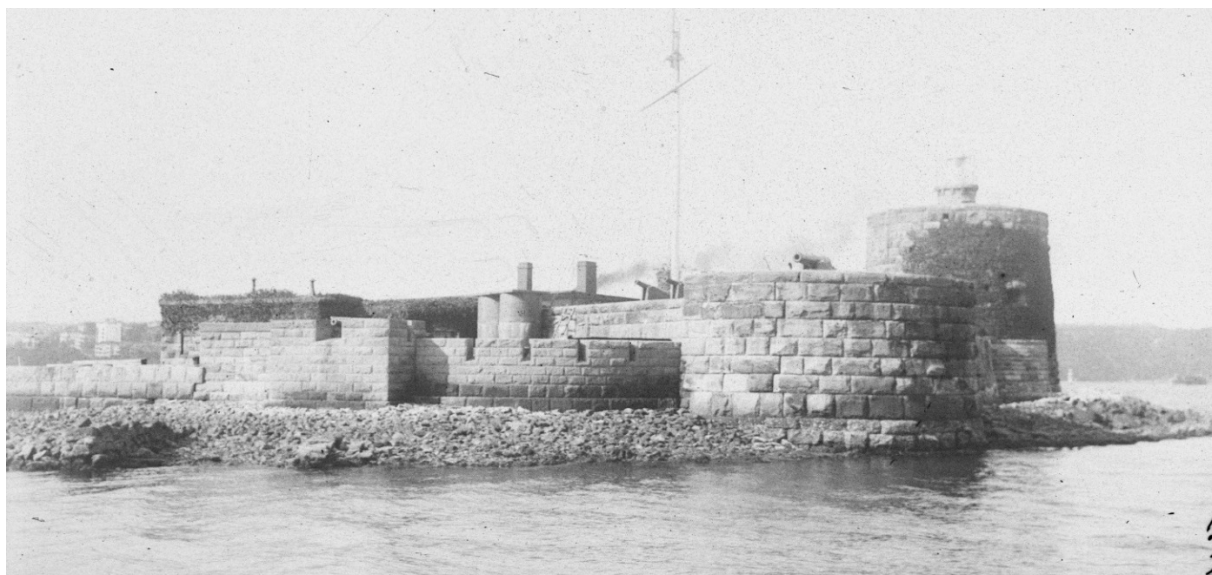
Figure 20 Fort Denison after 1917, showing the boat slip and yard, water tanks and one o'clock gun in the embrasure to the left of image (State Library of NSW, Government Printing Office, d_19107)

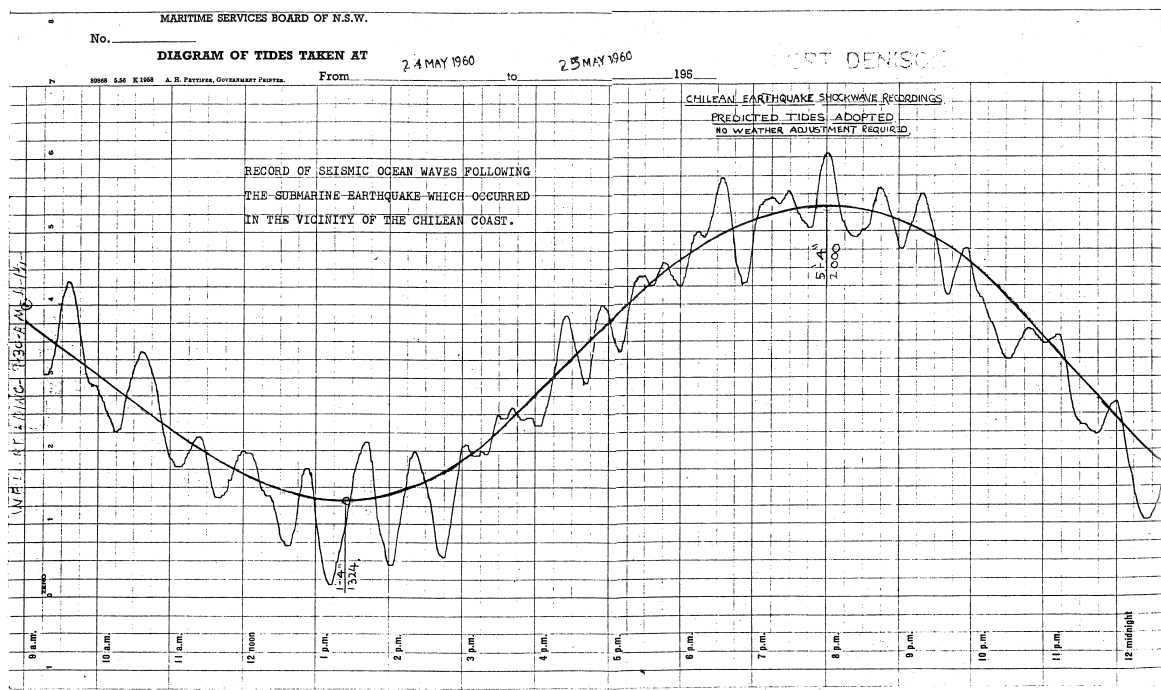
Figure 23 Tide chart showing effect of earthquake, May 1960 (OEH 2018)

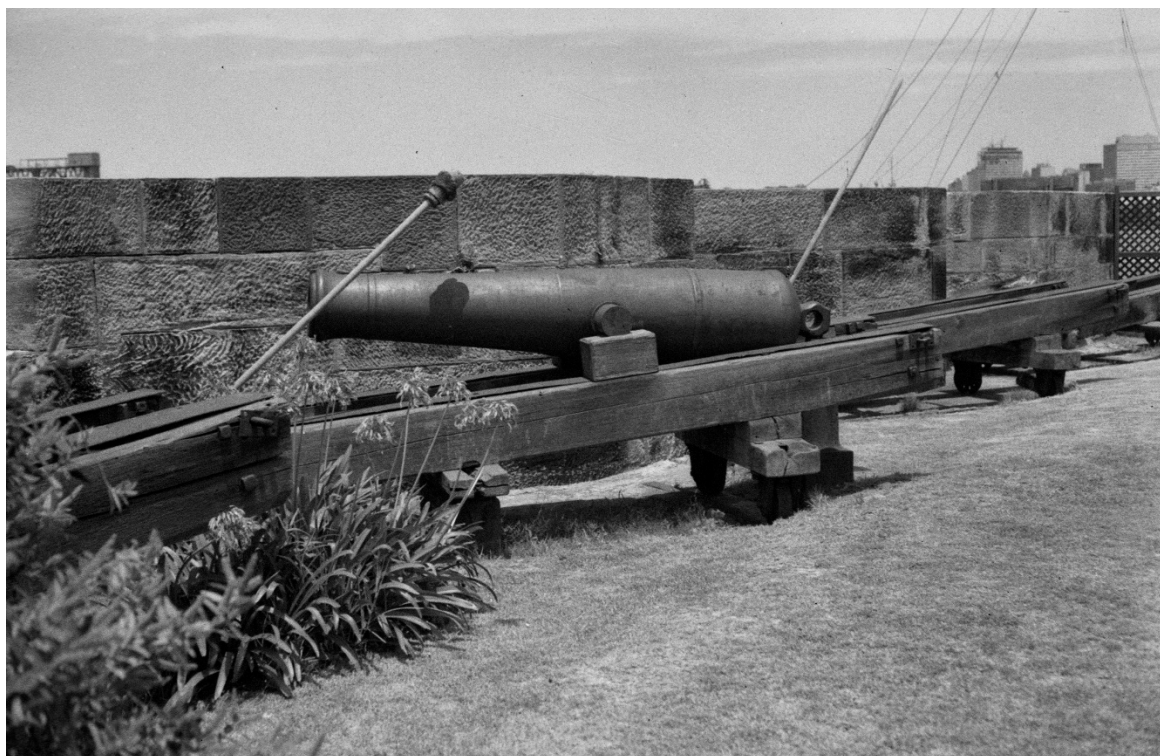
Figure 24 32-pdr gun carriages, 1964 (Government Printing Office, State Library of NSW, d1_10091)

The 32-pounder gun carriages were still present on the fort in early 1964 (**Figure 24**) but were probably removed when the 8-inch shell gun was removed from the island for reconstruction of the 32-pounder gun carriage on which it had been mounted. The gun carriage was reconstructed using ironbark, a cheaper alternative to the original teak.²⁰¹

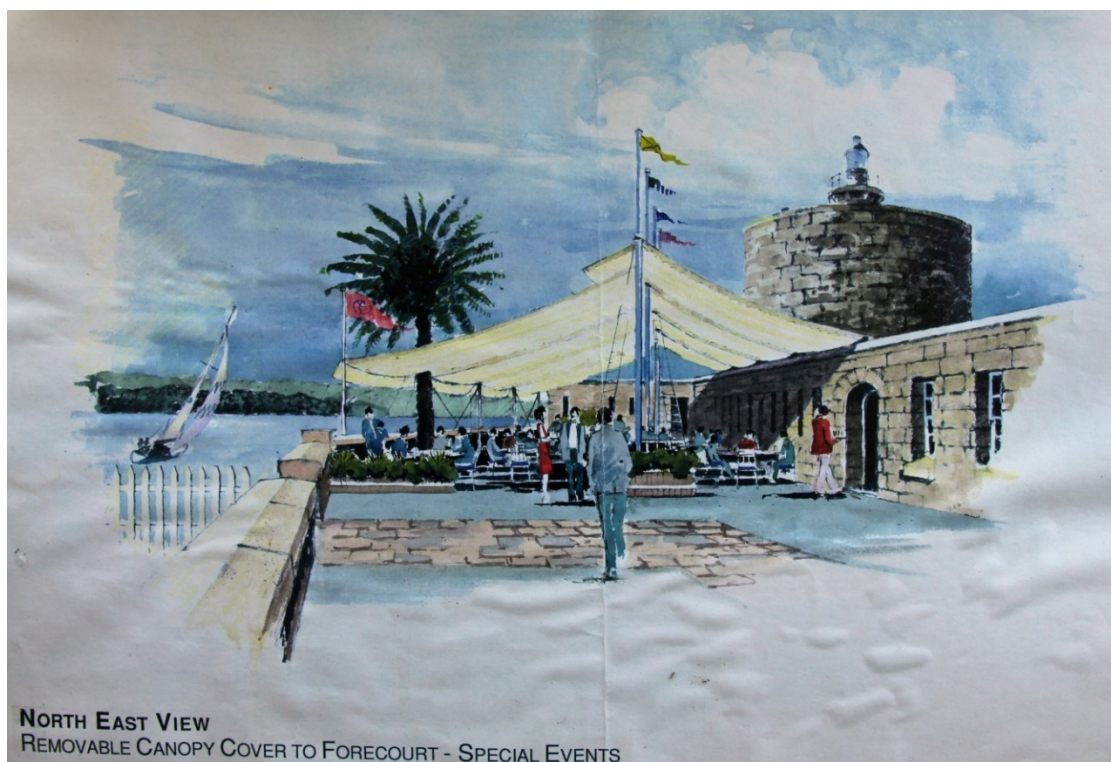
Figure 25 Pre-1992 proposal for a removable canopy for special events (NPWS Collection undated)

Visitation continued to increase from 16,000 in 1971²⁰⁵ to nearly 23,000 visitors in 1985.²⁰⁶ As early as 1974 consideration was being given to providing new visitor uses on the island including an outdoor café and restaurant²⁰⁷ and concept plans were prepared for a removable canopy for special events on the terrace (**Figure 25**).

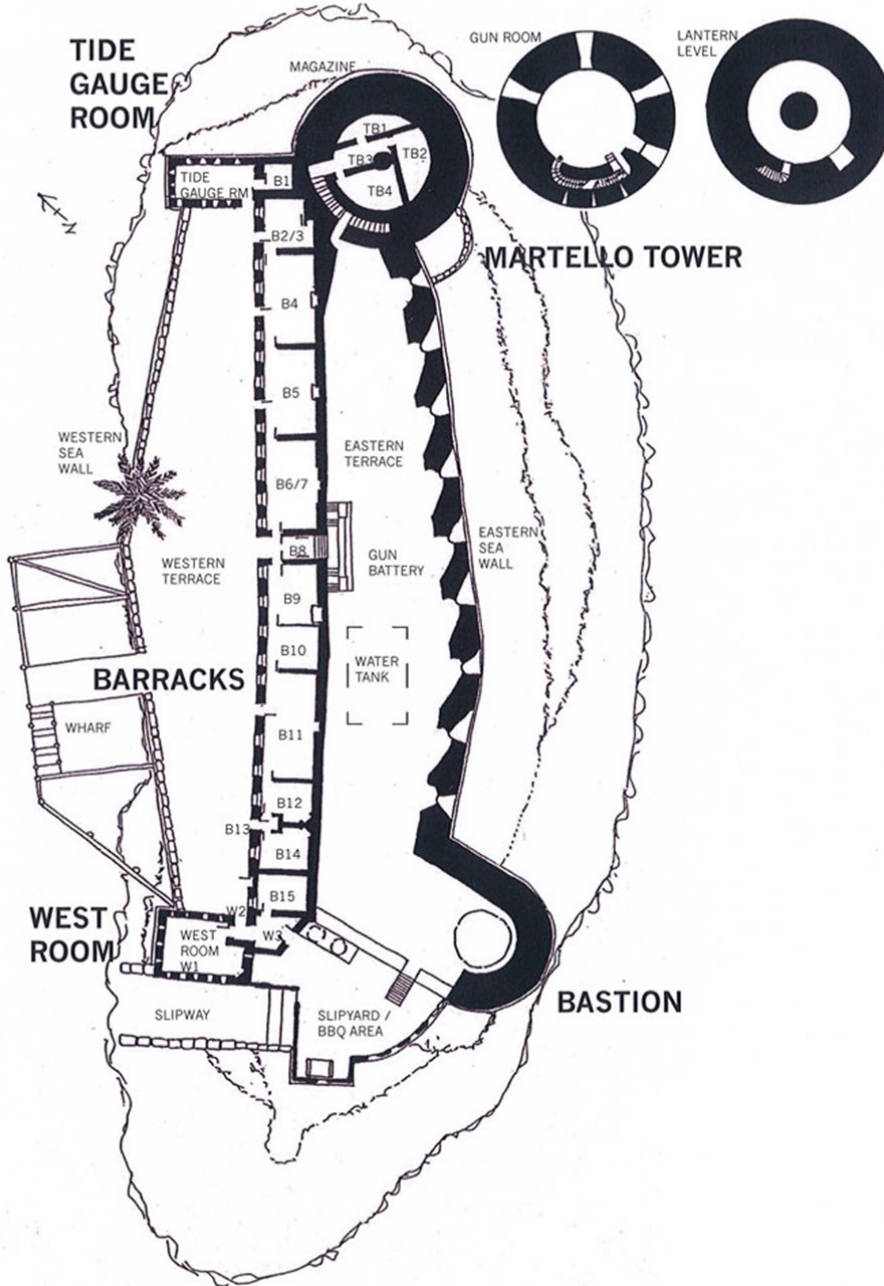
Plan not to scale

Figure 29 Plan of Fort Denison identifying physical elements

Analysis of physical fabric was based on visual inspection of in situ evidence with no opening up and analysis of historical research including archival drawings and plans. The physical elements of the fort are identified on **Figure 29**. Each element is described below.

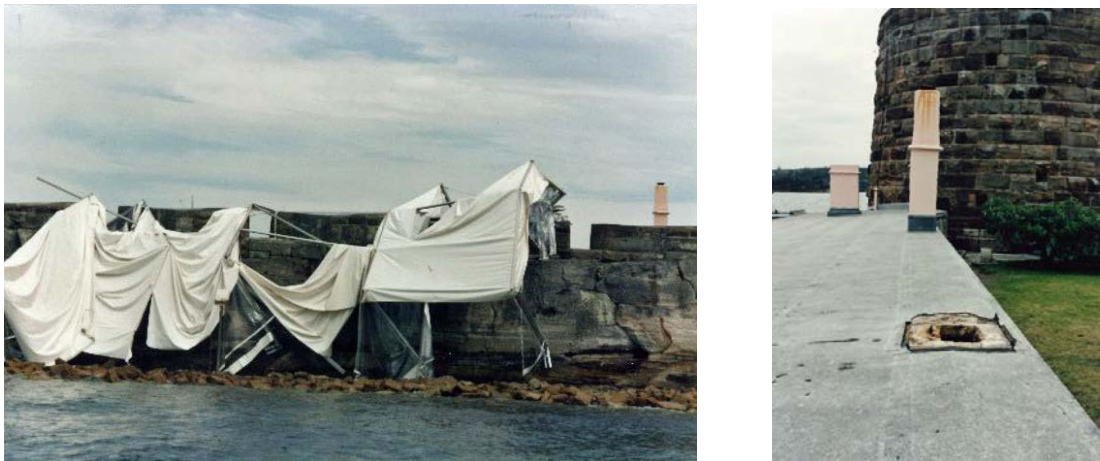
Figure 30 Storm damaged marquee (left) and detail of missing chimney demolished by the same storm (NPWS 1996)

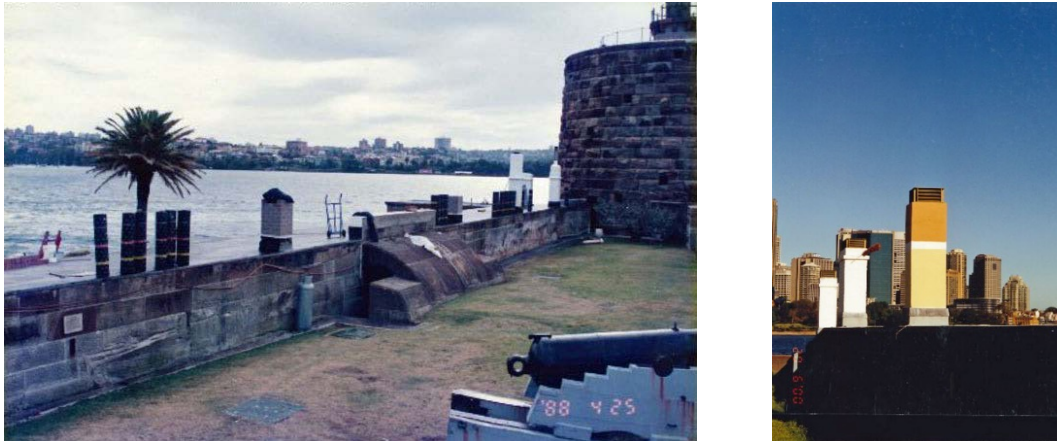
Figure 31 Installation of new membrane roof showing rebuilt chimney, 1997 (left) and detail of rebuilt chimney for kitchen exhaust, 2000 (NPWS 1997 and 2000)

Repairs in 1984 by the Maritime Services Board included indents to degraded window sills, and replacement of the malthoid and tar roof covering on the barracks. The roof membrane was replaced again by NPWS in 1997, as part of an extensive program of works that began in 1996. This work later included the replacement of one of the original chimneys which had been demolished in a storm that also destroyed a marquee erected on the terrace (**Figure 30**). The chimneys had originally been fitted with pots, which had mostly disappeared by the 1990s; as part of the repairs all chimneys were fitted with brass vent boxes. In 2000, the chimney above the commercial kitchen was rebuilt to take the new kitchen exhaust (**Figure 31**).

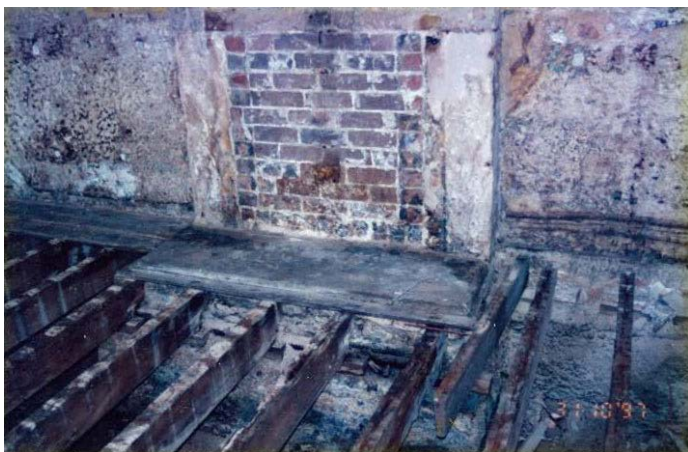
Figure 32 Floor structure in Room B6/B7 after removal of floorboards (NPWS 1997)

Progress photographs taken at the time show that all timber floorboards in the barracks room were removed to inspect the subfloor structure (**Figure 32**). It is evident that sound original wide boards were subsequently re-laid in Rooms B5 and B6. Some of these boards were pit-sawn while others were circular sawn (**Figure 33**), although both could be original to the building, as circular sawn boards were available from the 1840s. As part of the replacement work, brass ventilation grilles were installed along the walls of these rooms to improve subfloor ventilation, with protective brass railings in front of them (**Figure 44**). The original subfloor vents through the north-west wall had copper flues and wire mesh grilles installed. Floorboards in Rooms B9 to B12 were also partly removed and replaced in the late 1990s; these are narrower boards which probably date from the 20th century. Interestingly, the boards in Rooms B11 and B12 are laid across the room (north-west to south-east), whereas all other timber floors have the boards running parallel to the long walls of the barracks.

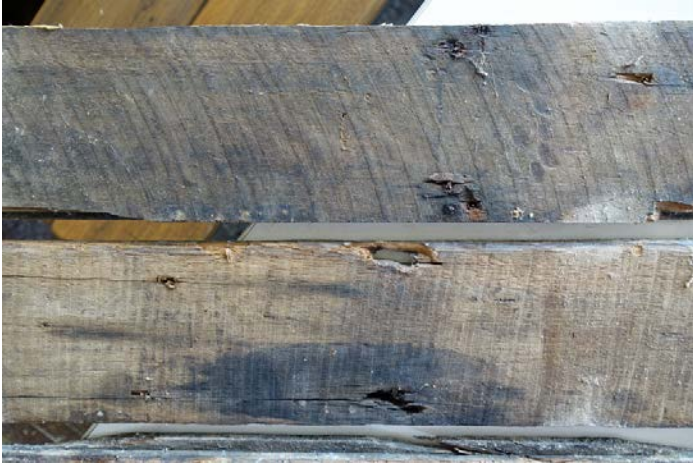
Figure 33 Underside of floorboards from access hatch in Room B6/B7, showing pit-sawn board below and circular sawn board above (Orwell & Peter Phillips 2018)

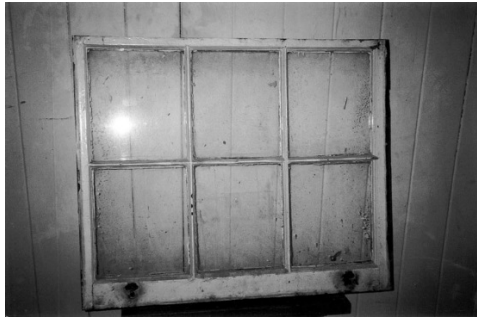
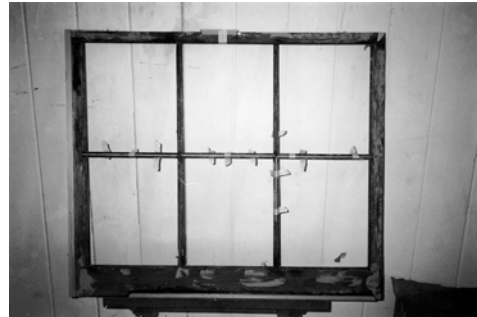
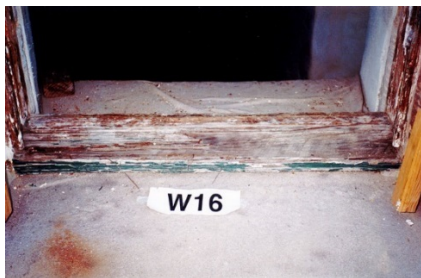
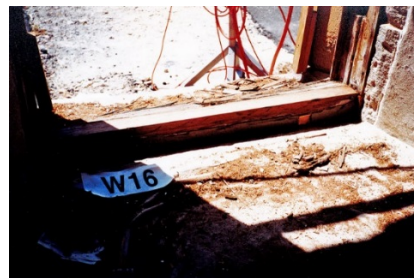
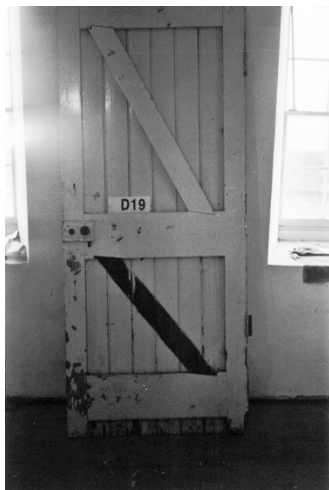
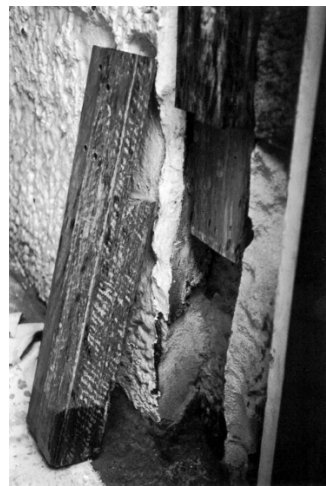
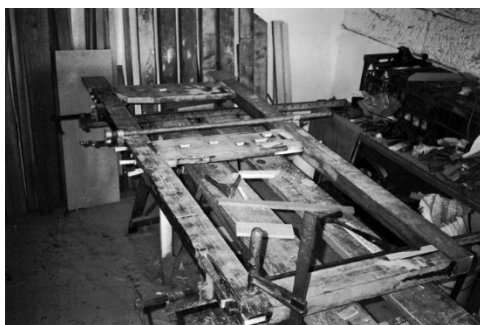
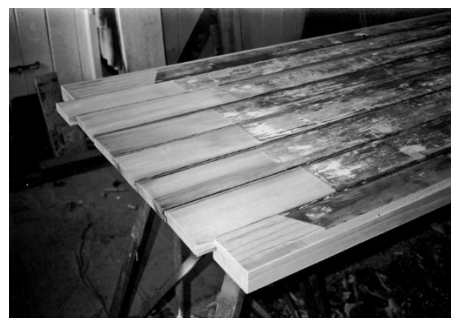
(a) Window sash removed

(b) Window sash patched

(c) External window sill

(d) Window sill patched

(e) Door removed

(f) Door jamb with new base ready to splice

(g) Door frame patched

(h) Door boards patched

Figure 34 Photographs of joinery repairs 1998–99 (Heath Larke)

The window and door joinery of the barracks was extensively repaired by Heath Larke over a 14-month period in 1998–99 (**Figure 34**). Window sashes were taken out, window glass removed, and sashes stripped of paint and patched, then reglazed with new glass, painted and reinstalled. Weathered sections of window sills were cut away and new timber pieces fitted over the remaining sill. Door leaves were similarly taken down, boarded linings removed, and both frames and linings patched and reassembled. Rotted sections of door frames and jamb linings were also patched before the repaired doors were rehung on new hinges.

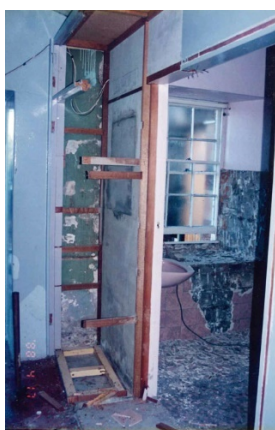
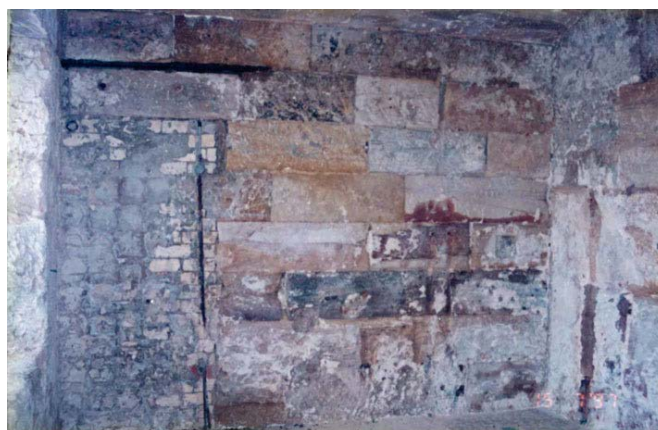
Figure 35 Room B2/B3 looking north (left) showing partition and tiling being removed, and north-east wall (right) after render removal, showing bricked up former doorway (NPWS 1997)

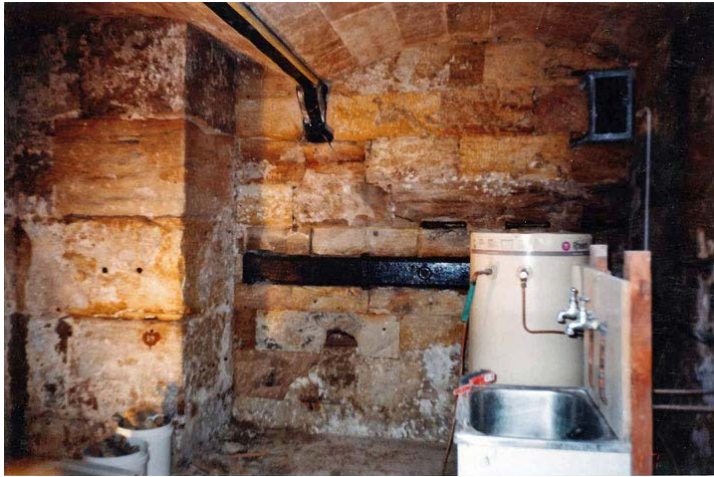
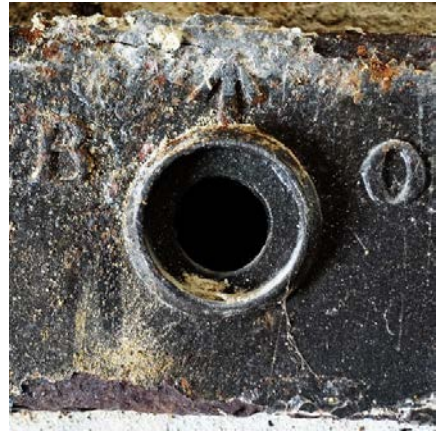
Figure 36 Room B2/B3 looking east (left), following the removal of render in 1997, showing the plumbing manifold embedded in the wall (NPWS 1997), and detail of the Board of Ordnance stamp on the plumbing manifold (right) (Orwell & Peter Phillips 2018)

Rooms B2 and B3: These two rooms were initially constructed as the gunners' kitchen, with three boilers for cooking, washing and laundering. A cast-iron horizontal flue stamped with the Board of Ordnance mark, probably forming part of the steam apparatus for the boilers, was chased into the south-east wall, and revealed when render was removed in the 1990s (**Figures 35 and 36**). The room also contained a fireplace, probably a large kitchen hearth on the south-west wall; the flue within the stone wall and the chimney above survive, although the fireplace and chimneybreast have been removed and the wall patched with brickwork through various alterations beginning with the insertion of the door to Room B4 probably in the early 20th century. Holes at the top of this wall may also have been part of the boiler flue system discharging into the chimney above. An original framed and braced (boarded) timber door (repaired in the 1990s) provides access to the terrace, with a later ledged and braced door and timber lined opening leading to Room B4. Original 12-pane double hung sash windows (repaired in the 1990s) and a small iron hatch and door located on the south-east wall also survive from the fortification period.

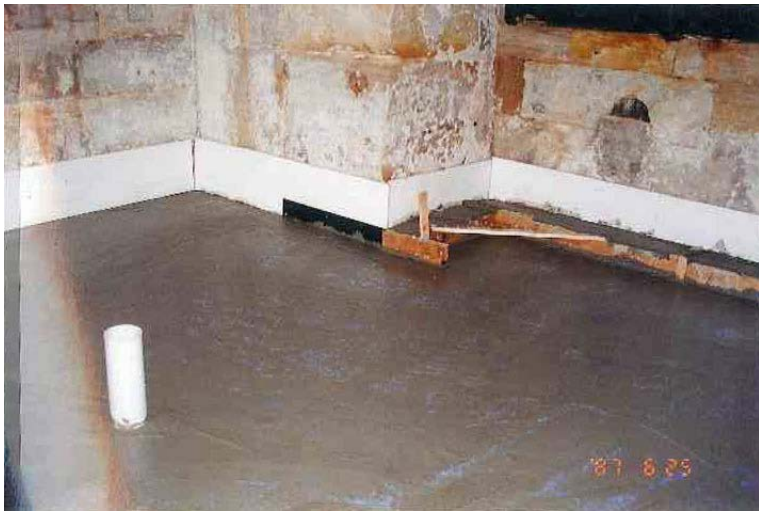
Figure 37 Room B2/B3 looking east, showing newly laid concrete topping and hob (NPWS 1998)

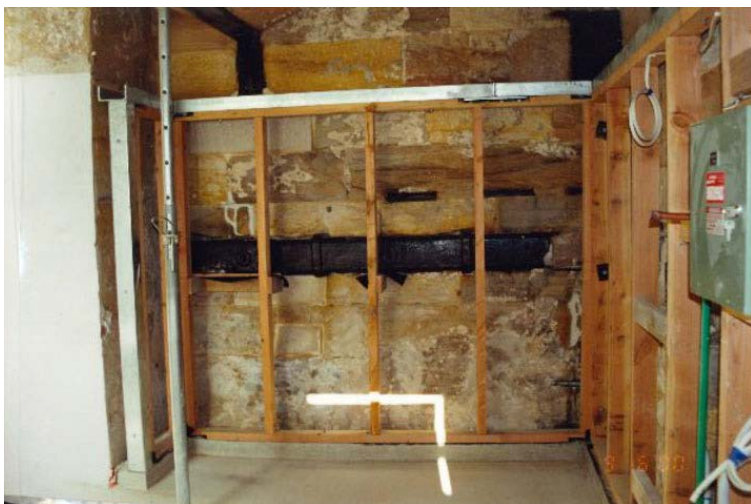
Figure 38 Room B2/B3 looking south-east, showing new framing to walls (NPWS 1998)

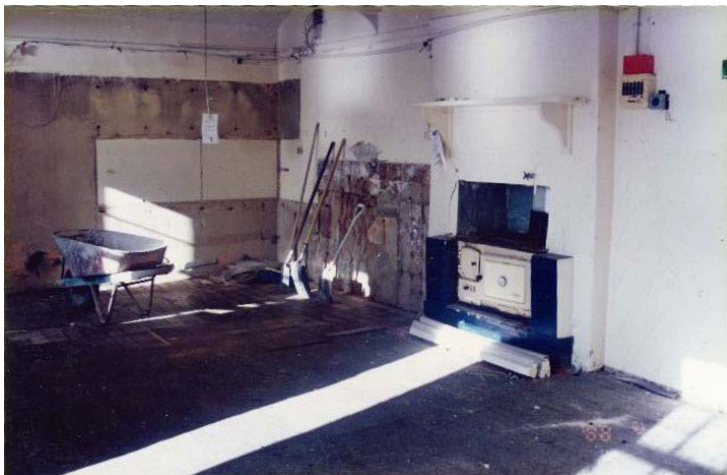
Figure 39 Room B4 looking east, after removal of kitchen sink and cupboards (NPWS 1997)

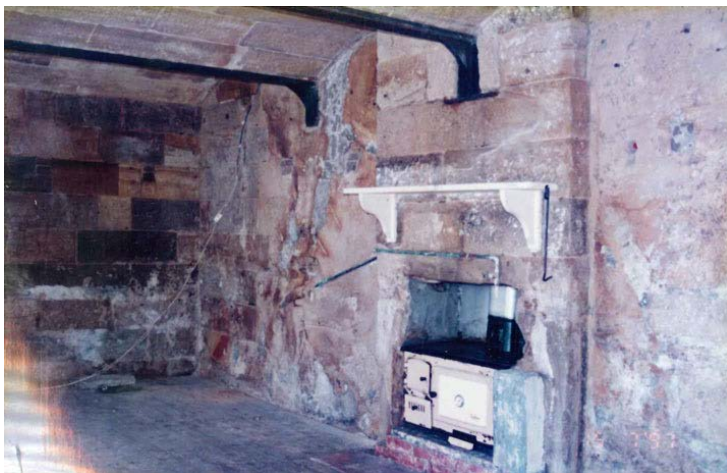
Figure 40 Room B4 looking east, after removal of render (NPWS 1997)

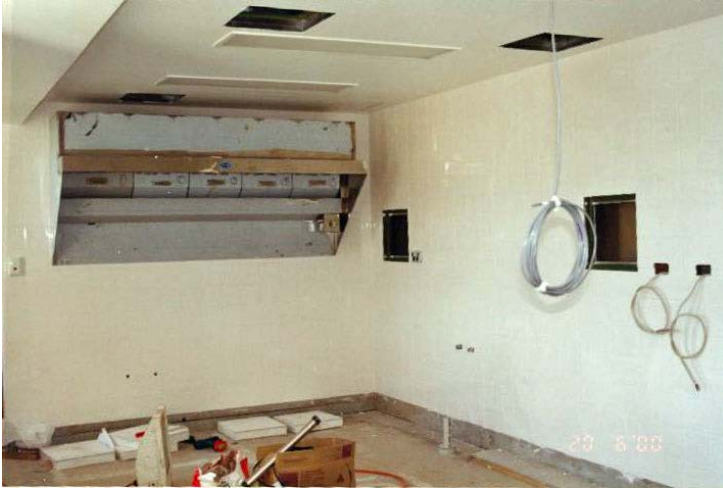
Figure 41 Room B4 looking east, showing over-sheeted walls and ceiling with access hatches (NPWS 2000)

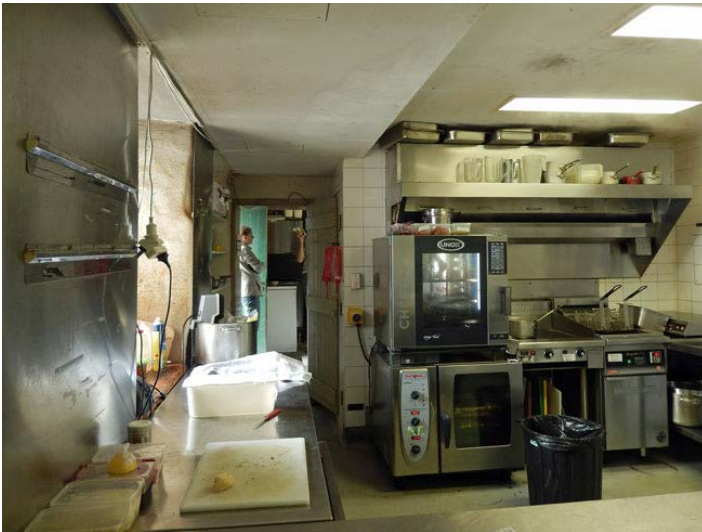
Figure 42 Room B4 looking north-east, showing kitchen fit-out (Orwell & Peter Phillips 2016)

Room B4: This room was constructed as one of five almost identical barracks rooms for the enlisted gunners. The room contains original 12-pane double hung sash windows (repaired in the 1990s, with new timber window boards installed over the internal stone sills) and an original external framed and braced timber door to the terrace (also repaired in the 1990s). The internal framed and boarded timber door to Room B5/B6 probably dates from the early 20th century, associated with the Sydney Harbour Trust. The 1923 plan shows the room undivided. The Metters 'Canberra' wood fuelled enamelled cooking range is presumably the one shown on the 1944 plan to be removed from the adjacent room and installed on a raised hearth in the original fireplace, from which all original elements have been removed. Water pipes previously channelled into the wall fabric, as part of the 20th century caretaker's conversion to supply the kitchen sink and tap outlet over the stove, were removed in the 1990s. A 1944 plan shows a dotted line through the centre of the room which may indicate the erection of a partition wall; if so, it had been removed by the 1970s. The walls were rendered and painted, a timber picture rail installed and the ceiling painted, probably on conversion to the caretaker's residence. The kitchen cupboards and sink unit were removed prior to the removal of cement render from the walls in 1997 (**Figures 39 and 40**). The floorboards were removed and replaced with compressed fibre cement sheeting in 2000, and the stone walls and ceiling protected and obscured by false walls and ceiling (**Figure 40**) prior to the fitting out of the room as a commercial kitchen (**Figure 42**). The kitchen fittings, false walls and ceiling were all removed in 2018.
