Fort Denison

Conservation Management Plan

This conservation management plan was prepared by the NSW Office of Environment and Heritage in May 2018, to update and replace the previous conservation plan prepared by NPWS and endorsed by the Heritage Council of NSW in 1999.

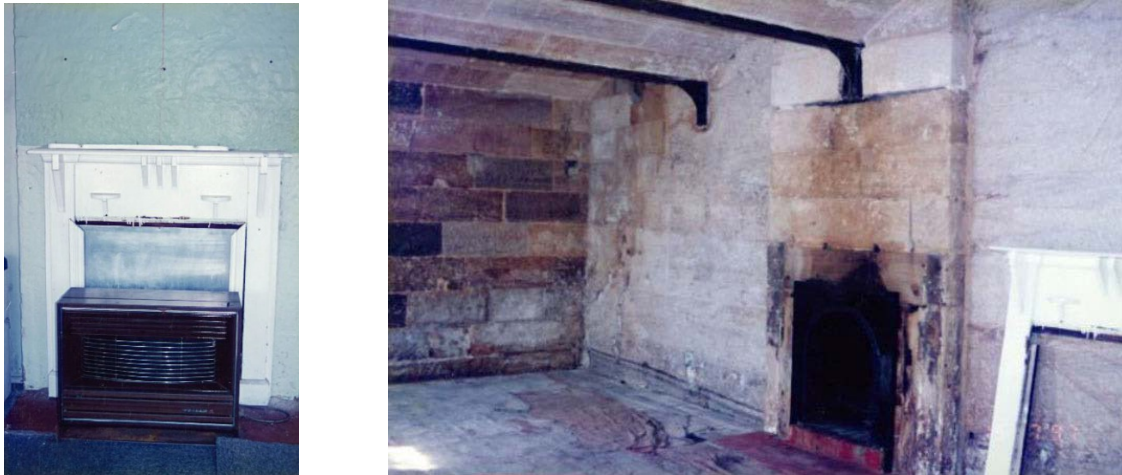
Figure 43 Room B5 fireplace detail (left), and Room B5 looking east (right), after render removal. Note the timber chimneypiece removed from the fireplace (NPWS 1997)

Room B5: This room was constructed as one of five almost identical barracks rooms for the enlisted gunners. The room contains original 12-pane double hung sash windows (repaired in the 1990s, with new timber window boards installed over the internal stone sills), and an original framed and braced external door (also repaired in the 1990s). Internal timber-framed and boarded doors giving internal access to Rooms B4 and B6 probably date from the early 20th century, most likely introduced after the change in use to caretaker's residence; these were also repaired in the 1990s. The room contains a central fireplace on the south-east wall; the stone hearth is original although the raised brick hearth and cast-iron surround are later elements. Nothing remains of the original Board of Ordnance hob grate or chimneypiece. A 1923 plan shows a partition dividing the room; the 1944 plan shows this room as the Living Room with the partition no longer present. The plan also indicates construction of a new hearth. During the MSB period this room was referred to as the Living Room and the walls were rendered and painted with a timber picture rail, and the vaulted ceiling was painted. A photograph taken in 1997 shows an early 20th century timber chimneypiece in front of a boarded over fireplace (**Figure 43**). In 1997 the chimneypiece was removed (and is no longer on site) revealing the present cast-iron surround. During the same period the render and paint were removed, the floorboards were all taken up, the subfloor structure recorded and repaired, and the original floorboards were re-laid, with brass grilles inserted along the walls to assist with subfloor ventilation and treatment of rising damp

(**Figure 43**). Brass balustrades were installed around the walls for protection. Some evidence remains of the original limewash finish.

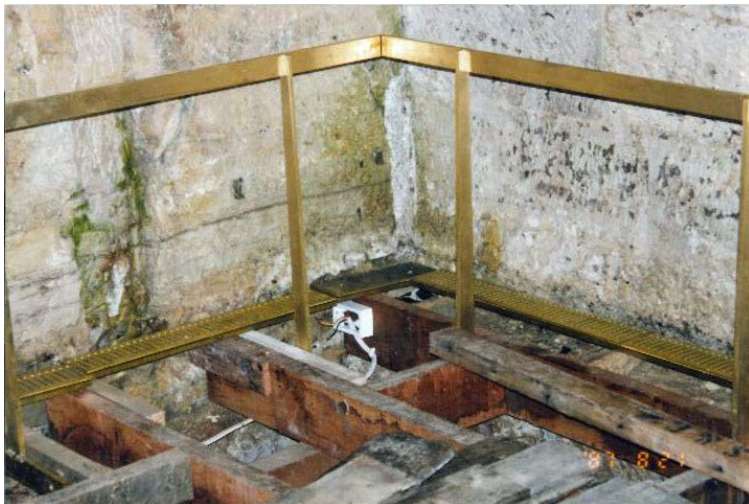
Figure 44 Installation of brass ventilation grilles and balustrades, Room B5 (NPWS 1999)

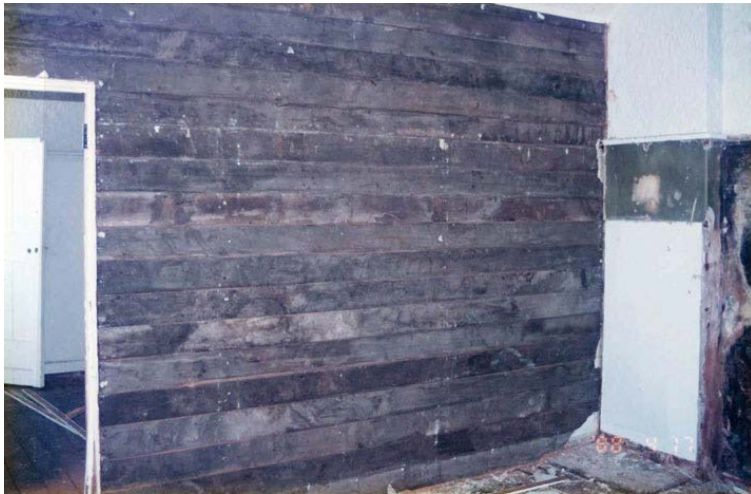
Figure 45 The timber partition formerly dividing Rooms B6 and B7 (NPWS 1997)

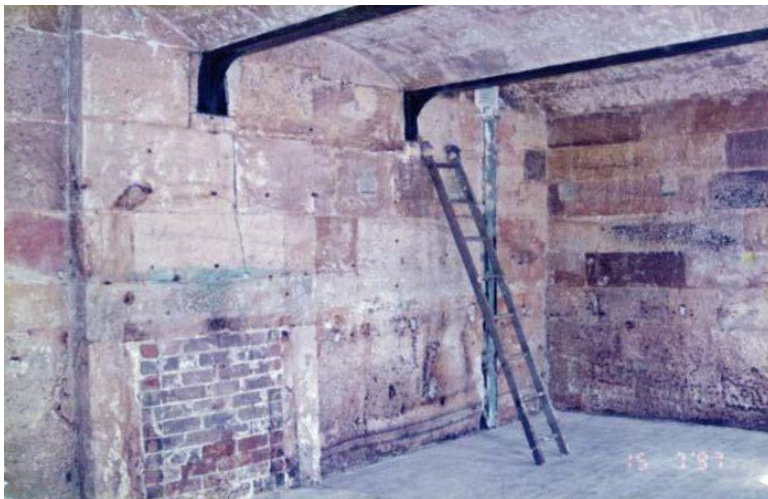
Figure 46 Room B6/B7 after removal of render, showing bricked up fireplace (NPWS 1999)

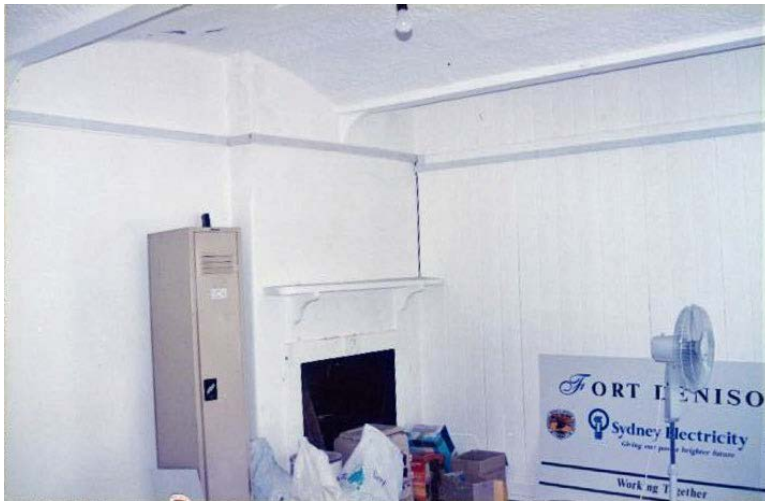
Figure 47 Room B9/B10 before conservation, showing timber partition, picture rail and solid fuel stove in front of later fireplace (NPWS 1997)

commonly manufactured and sold. In 1997 it was found in the fireplace of Room B9 (**Figure 47**) and was probably moved to its present location shortly afterwards.

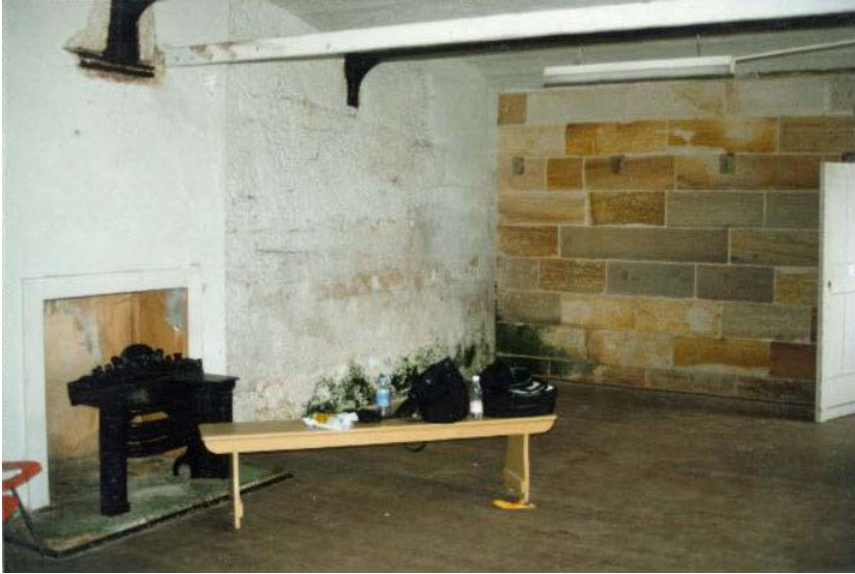
Figure 48 Room B11 after metal conservation, showing high level timber rail (NPWS 1997)

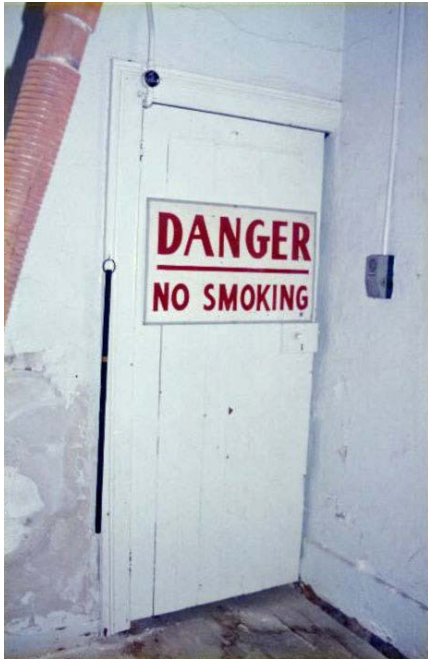
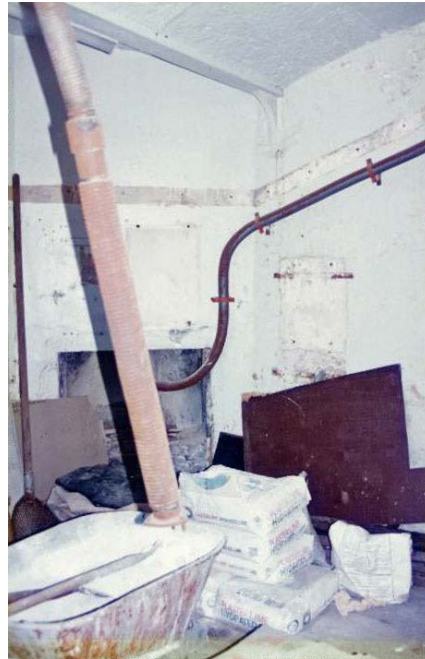
Figure 49 Room B14, showing former door to Room B15 (left) and work in progress to remove services (right) from former use as generator room (NPWS 1997)

Room B14: This room was originally constructed as one of two rooms in the officers' quarters and contains original 12-pane double hung sash windows (repaired in the 1990s). The internal four-panel Victorian timber door to the lobby (Room B13) and its moulded architraves appear to date from the original fort, and were more elaborate joinery elements appropriate to the officers' quarters. During the early 20th century, a door opening was made to the adjoining Room B15, as shown on the 1923 and 1944 plans, but by 1970 (when Room B15 had been converted to a female visitors' toilet) the opening had been closed up on the other side of the wall, although the door and its moulded architraves (similar to that between Rooms B11 and B12) were still in position (**Figure 49**). In 1999–2000, the room was adapted for use as the men's toilets, with steps up from the door to a raised false floor, and false walls for mounting and concealing services. The original fireplace with remnants of the hob grate and cast-iron chimneypiece have been preserved behind a glass vision panel.

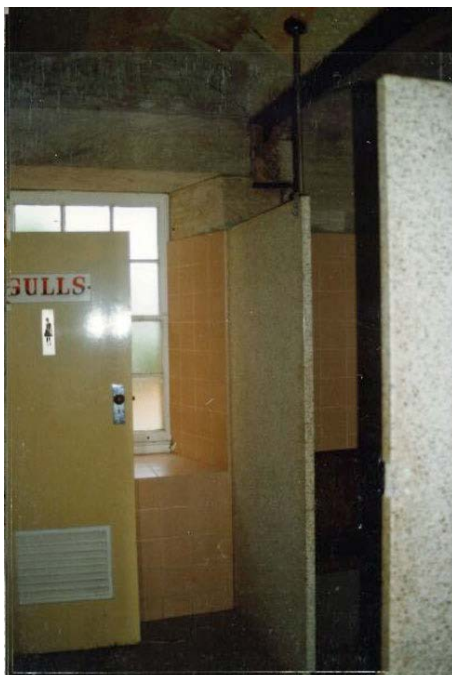
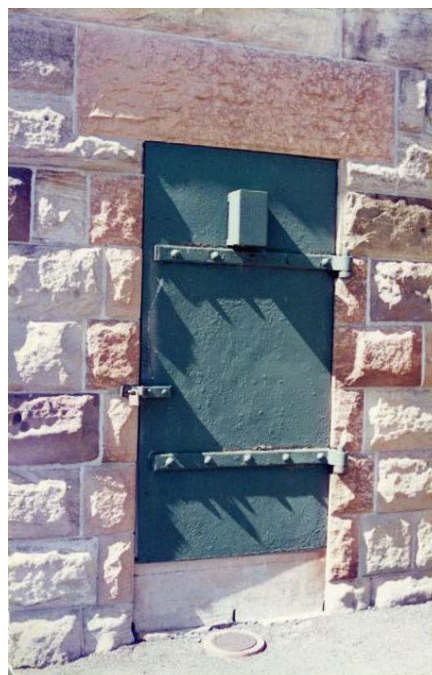
Figure 50 Room B15 (left) before conservation and fitting out, and the former external door to this room converted for an explosives store with a reused iron shutter (NPWS 1997)

Room B15: The 1856 plan notes this room as the Officers' Kitchen and shows an external door through the north-west facing wall. A new opening into the room from the lobby adjoining the West Room (Room W3) is likely to have been made in the early 20th century, at the same time as other openings for internal circulation. The room was shown as a store on the 1944 plan, but by the 1970s had been converted to the female visitors' toilet (**Figure 50**). The current concrete floor may have replaced an earlier timber floor. The original external door was converted in 1985 to an explosives store for the one o'clock gun, reusing an iron shutter from one of the windows as a door.

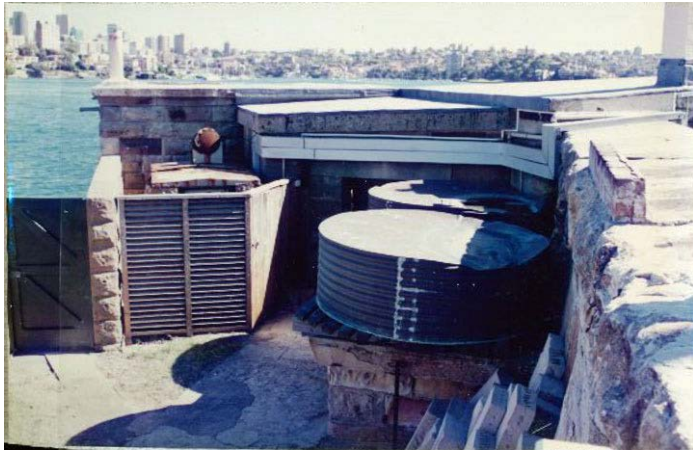
Figure 51 Looking north-west over the West Room roof, showing the corner flue. Note also the former substation and corrugated metal water tanks (NPWS 1996)

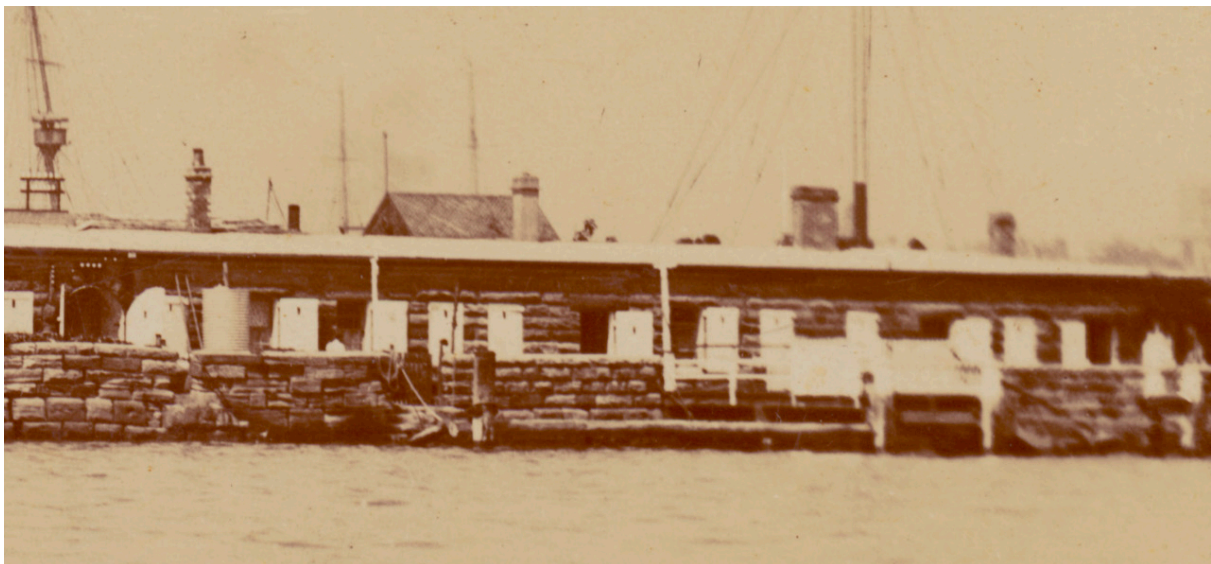
Figure 52 Photo taken after 1913 showing original landing steps on left and 1901 wharf on right (Detail from State Library of NSW, Star Photo a_089117u.)

According to the 1856–57 plan, the original landing place for the fort prior to construction of the seawall was located at the south-eastern end of the island. This plan shows the location of an intended wall along the north-western side of the island, but the retaining wall eventually built had an angled configuration, with a double set of landing steps at the change of direction, opposite the centre of the barracks and in line with the archway (**Figure 52**). The timber wharf was constructed to one side of the steps in 1901 after transfer of ownership to the Sydney Harbour Trust, and the landing steps were subsequently removed and the wall reconfigured (with a stone pier at the junction) between 1913 and 1923 (**Figure 53**). There is no visible evidence of the original steps, although their location is indicated by a change in the lowest course of the wall. Although the form of the present wharf was established in the early 20th century, it has since been rebuilt at least once.

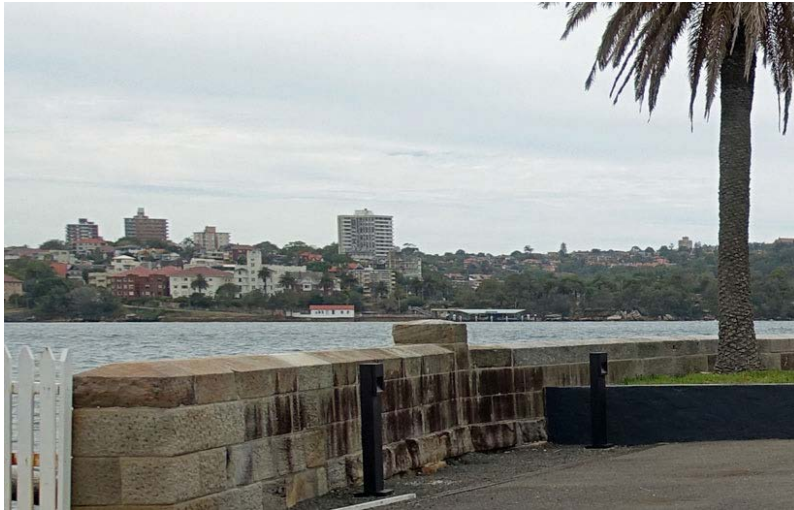
Figure 53 The location of the former landing place viewed from the terrace, marked by changes in the stone base course. This view also shows the sole surviving palm tree (Orwell & Peter Phillips 2018)

There is little evidence of any planting or vegetation during the military period, and indeed it is unlikely that there would have been any, particularly not on the battery. The island was extensively planted during the early and mid-20th century (**Figure 22, Figure 53**) but much of this planting has since been removed. The fig tree on the battery appears to be close to the end of its life, but the palm tree on the terrace (which may be 100 years old) appears reasonably healthy. From an interpretation point of view, it may be desirable not to replace the fig tree when it eventually dies. The grass cover to the battery could also be removed in future to improve interpretation by revealing surviving gun races and other archaeological evidence, whereas the grass enclosed by the former ficus bed against the wall of the Martello tower is entirely appropriate for interpretation of this early 20th century addition. The palm tree could be allowed to remain (and be replaced in due course) as evidence of the 20th century period that does not unduly interfere with interpretation of the 19th century military period.

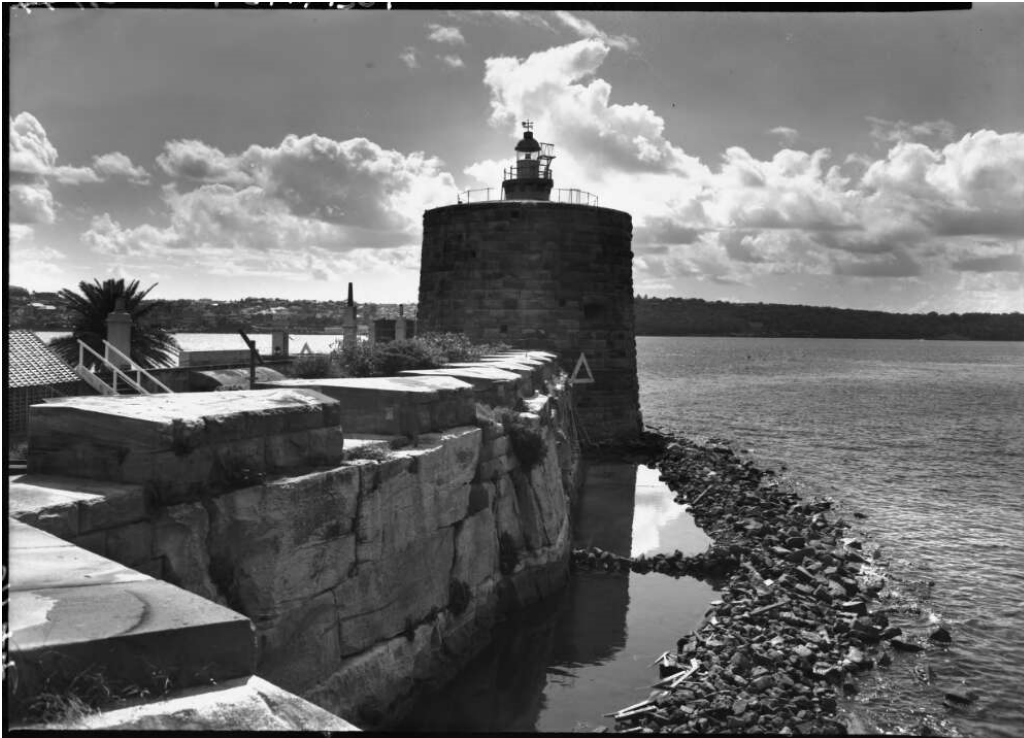
Figure 56 The defensive ditch in 1962 (National Library of Australia, Fort Denison [3] picture, obj-160050208) Note the roof of a shed on the battery, and the roof access steps

The 1862 defensive ditch was still functional 100 years after it was constructed (**Figure 56**) but has deteriorated greatly since that time presumably due to increasing vessel wash and wave action. The ditch is now only visible at low tide.

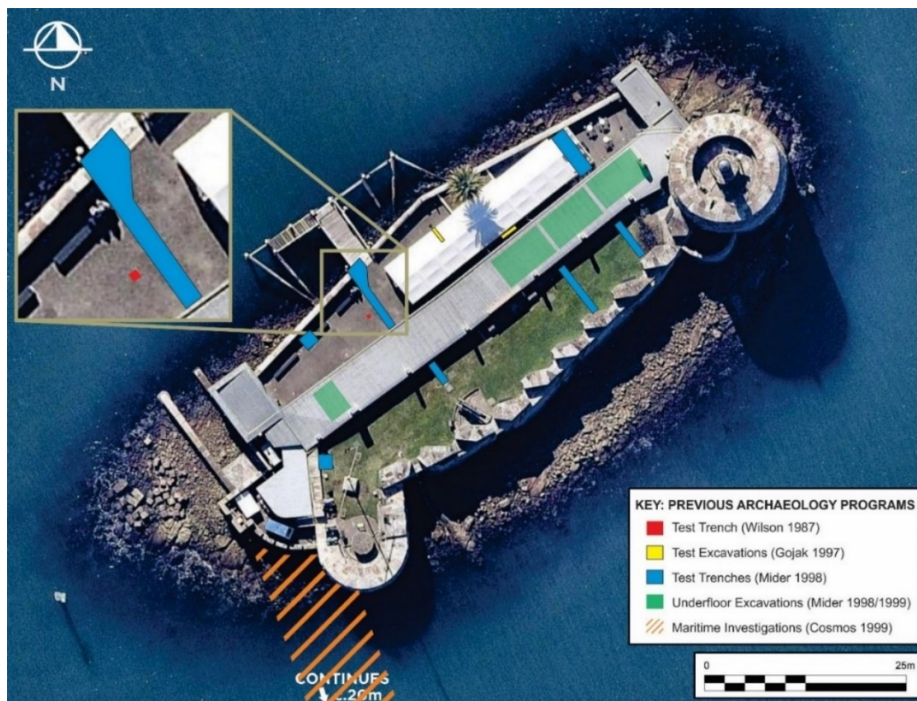
Figure 58 Plan of Fort Denison showing areas that have undergone archaeological excavation, testing or maritime inspections. Excavation has focused on the terrace, barracks and battery. Note that the maritime investigation (marked with orange hatching) extended for c.50 m to the south-east, although only c.20 m of this surveyed area is depicted here²²⁰

Those areas on Fort Denison that have undergone archaeological excavation or salvage investigation are illustrated in **Figure 58**. The following discussion examines the results of archaeological investigations by each area on the island, specifically the terrace, the barracks, the battery and maritime.

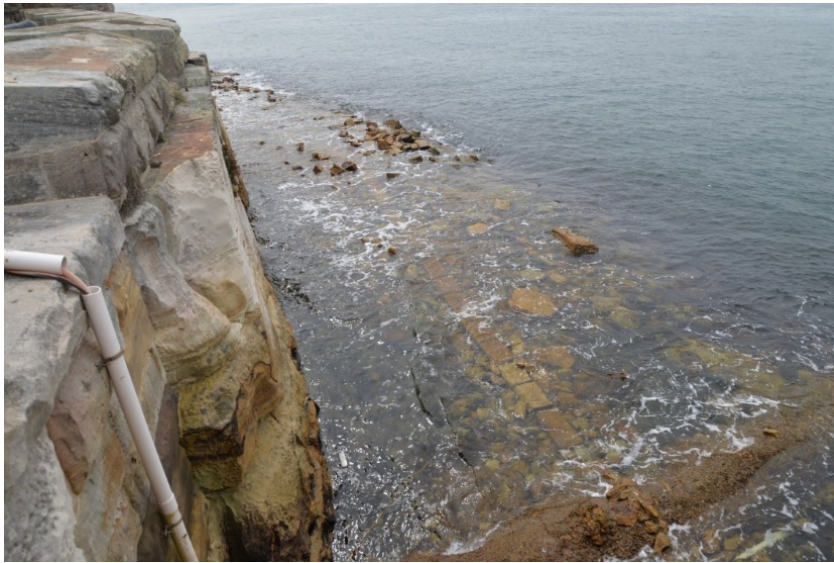
Figure 60 View looking north-east over the south-east face of the battery (from the bastion), showing the wet ditch and breakwater. Sandstone bedrock is visible underlying the parapet at left (Casey & Lowe 2018)

By 1986 Kerr noted that much of the ashlar retaining wall (holding the breakwater rocks out of the wet ditch) had been robbed and a number of ashlar blocks were visible dumped to the west of the slip yard. This dump is observable today, although the breakwater wall extends at least half the length of the battery (**Figure 60**).

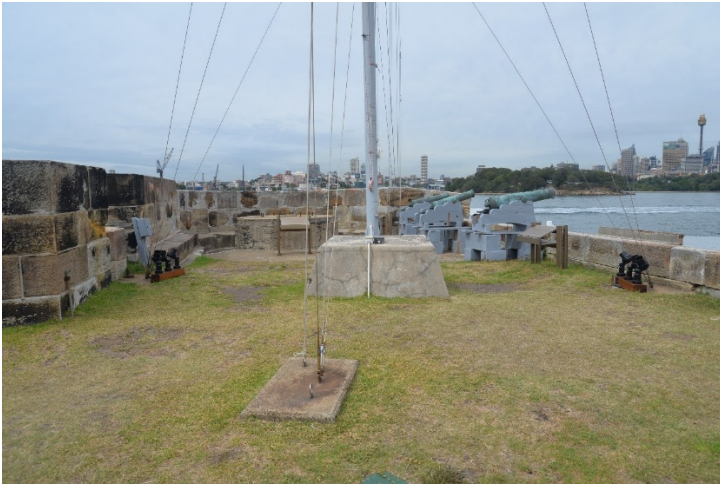
Figure 62 View of the bastion looking south, showing the concrete gun mount (installed c.1942) and flagpole. Several mounted guns have been installed along the western wall (Casey & Lowe 2018)

The original surface of the battery terreplein is now covered with turf (**Figure 61**), and the installation of several 20th century landscaping features (including garden beds and drainage channels, as well as modern services and the concrete gun mount) (**Figure 62**, **Figure 63**, **Figure 63**) are expected to have impacted earlier deposits here. A single gun race, and mounted gun, is installed within a (modern) concrete pad along the terreplein (**Figure 63**). Additionally, several 'ghost' gun races are visible at the modern surface level, and excavations suggest more subsurface features can be expected.

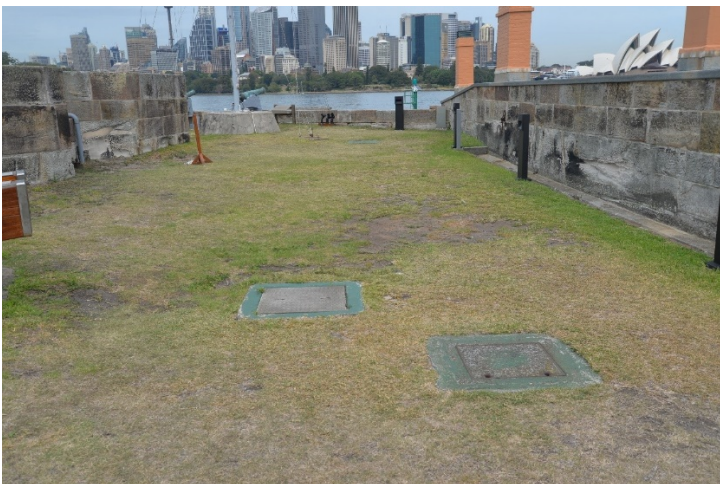
Figure 63 View south-west along the battery towards the bastion, with the barracks to the right. Several service and tank access points are visible in the foreground (Casey & Lowe 2018)

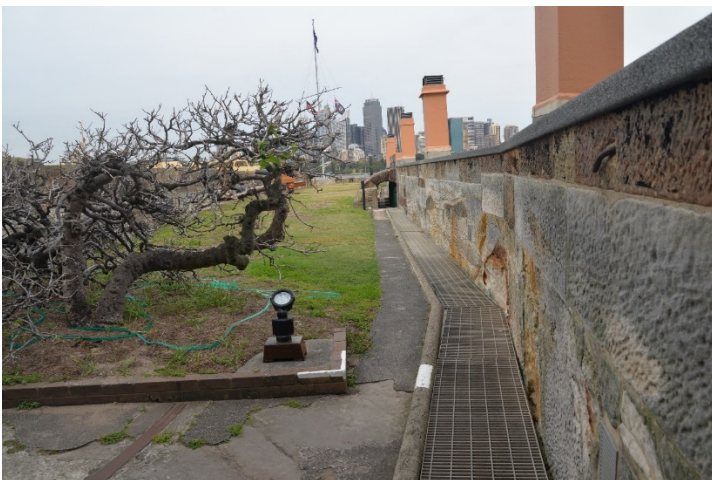
Figure 64 View south-west along the battery, showing the c.1923 drain installed against the barracks to prevent rising damp in the walls. An early 20th century garden bed (with fig tree) is in the foreground (Casey & Lowe 2018)

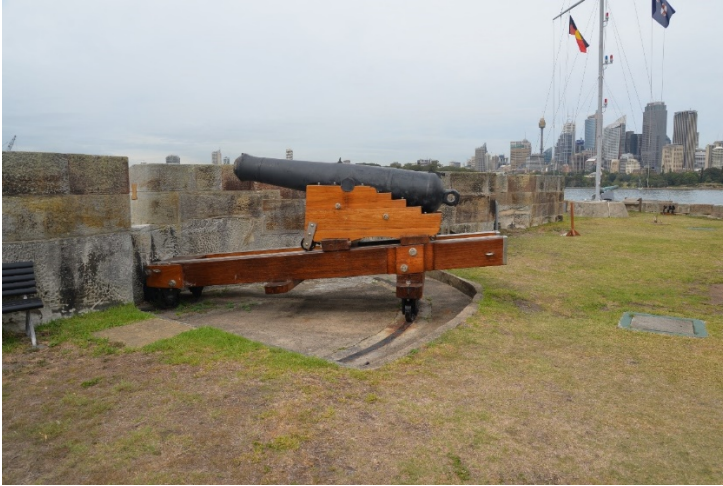
Figure 65 Gun race along the battery terreplein, looking south. Several ‘ghost’ gun races are visible at the modern surface level and testing excavations suggest more subsurface features can be expected underlying the 20th century fills (Casey & Lowe 2018)

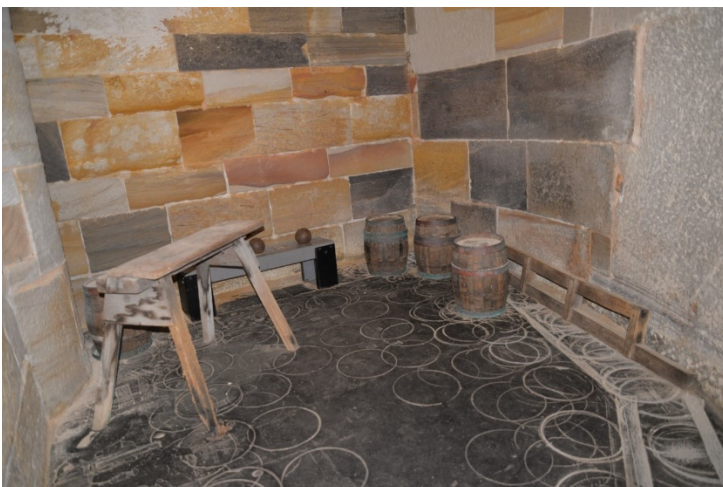
Figure 67 Interior of Room TB4, at the lowest (magazine) level of the Martello tower, looking south. The impressions of later display items (barrels and cases) are visible in the Seysell asphalt coat on floor (Casey & Lowe 2018)

The casemated Martello tower demonstrates largely original masonry and fittings (**Figure 66**), except for the 1913 light tower and its mechanisms. The impressions of former displays are visible in the Seysell asphalt coat on the lowest level magazine floor (**Figure 67**).

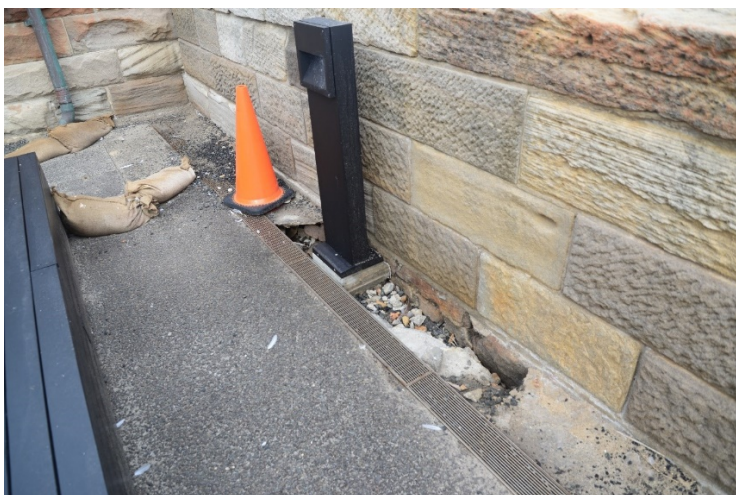
Figure 69 View looking west along the north-west seawall (the terrace), showing damage caused by wave erosion. Note also the recently installed bollard light (Casey & Lowe 2018)

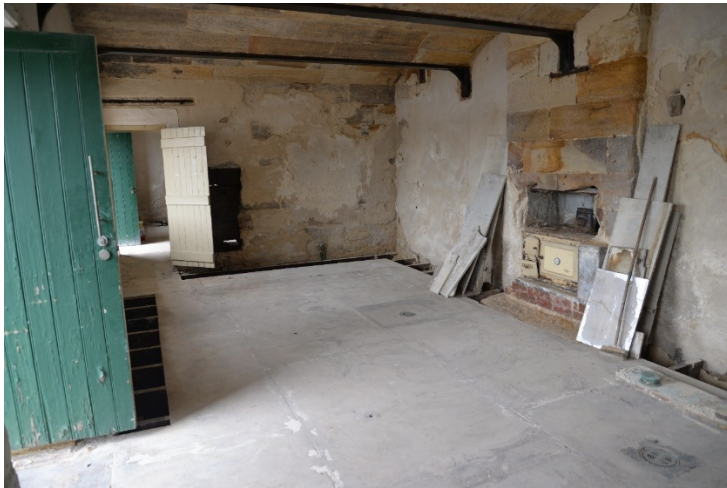
Figure 70 Interior view of barracks Room B4 looking east. Excavations were undertaken in this room during 1997–98 and consisted of the complete removal of floorboards and all subsurface deposits. The room served as the Fort Denison café/restaurant kitchen from 2000 (when the floor was replaced) until mid-2017 (Casey & Lowe 2018)

Archaeological excavations in the barracks Rooms B4 (**Figure 70**) and B5 (**Figure 71**), consisted of the complete removal of floorboards and all subsurface deposits. These rooms (in addition to Room B6/B7) were utilised by the Fort Denison café/restaurant until mid-2017.

Room B4 served as the restaurant kitchen and underwent significant alterations to the built fabric, specifically the replacement of original floorboards and installation of a new chimney along the eastern wall. Several of the barrack rooms remain unexcavated, including those now serving as the Fort Denison museum (**Figure 72**). Much of the internal fabric of these rooms was updated prior to the 1990s. Subsurface deposits are, however, expected, although the addition in some rooms of concrete flooring (**Figure 73**) and services will have disturbed these deposits.

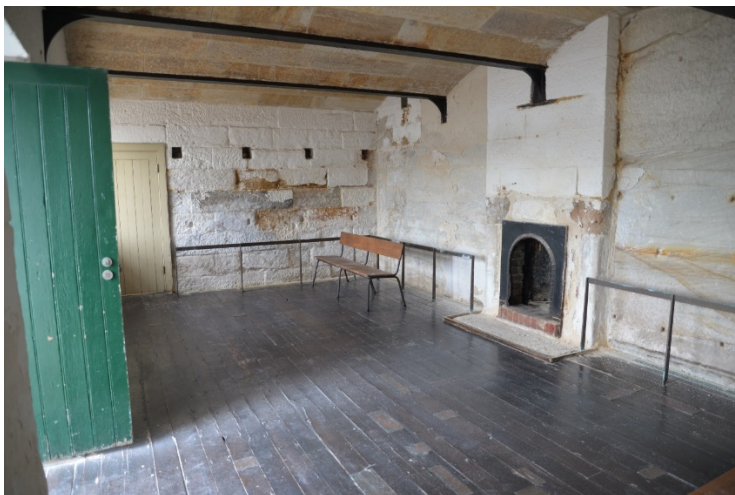
Figure 71 Interior view of barracks Room B5 looking east. Excavations were undertaken in this room during 1997–98 and consisted of the complete removal of floorboards and all subsurface deposits. The room was used as dining space for the café/restaurant until mid-2017 (Casey & Lowe 2018)

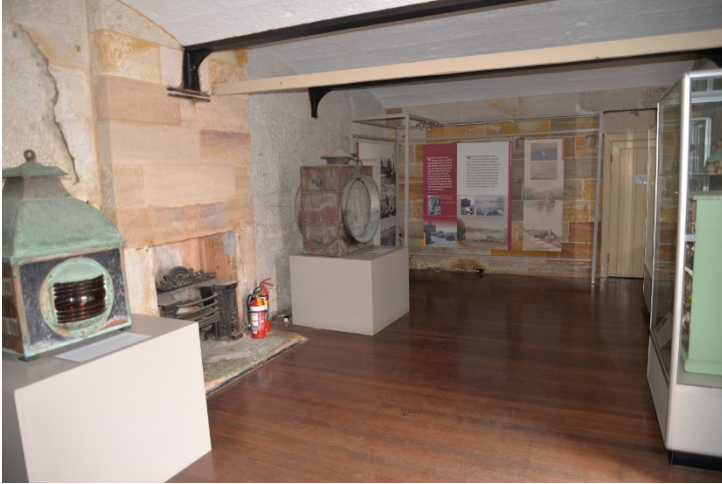
Figure 72 Interior view of barracks Room B11, now the museum, looking south. Floorboards were replaced at an unknown time prior to the 1990s (Casey & Lowe 2018)

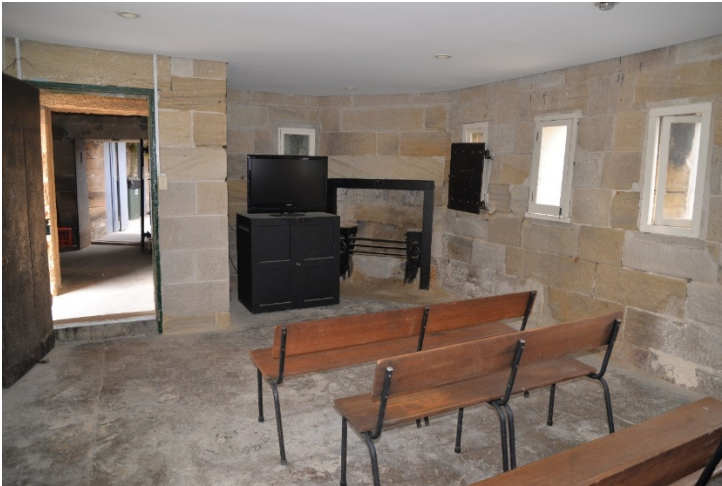
Figure 73 Interior view of West Room W1, looking south. Most of the interior fabric, including the sandstone wall surfaces, was replaced in the 1970s and a new concrete floor installed in 1983 (Casey & Lowe 2018)

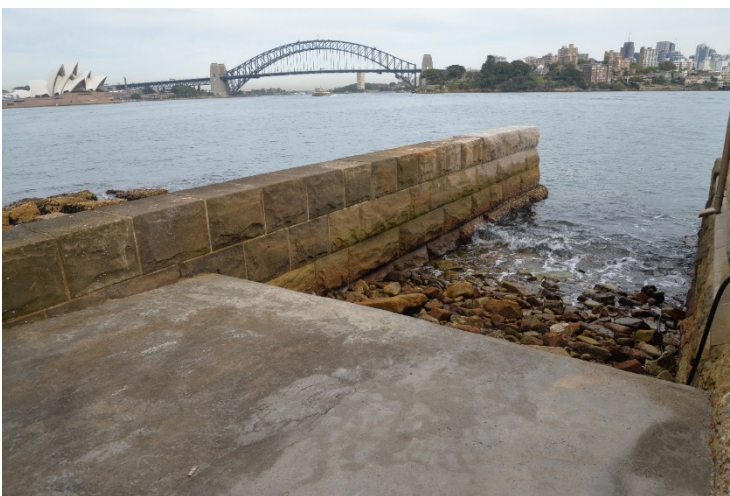
Figure 74 The 1917 slipway, looking west. The boat slips were removed in the late 1940s and the area used as a swimming pool afterwards (Casey & Lowe 2018)

The 1917 slipway (**Figure 74**) and yard (**Figure 75, Figure 76**) are largely preserved, and the installation of a modern shelter in the yard is unlikely to have had any impact on the original structure. While archaeological evidence related to these features may remain intact, the resource is assessed as not meeting the threshold for local or state significance.

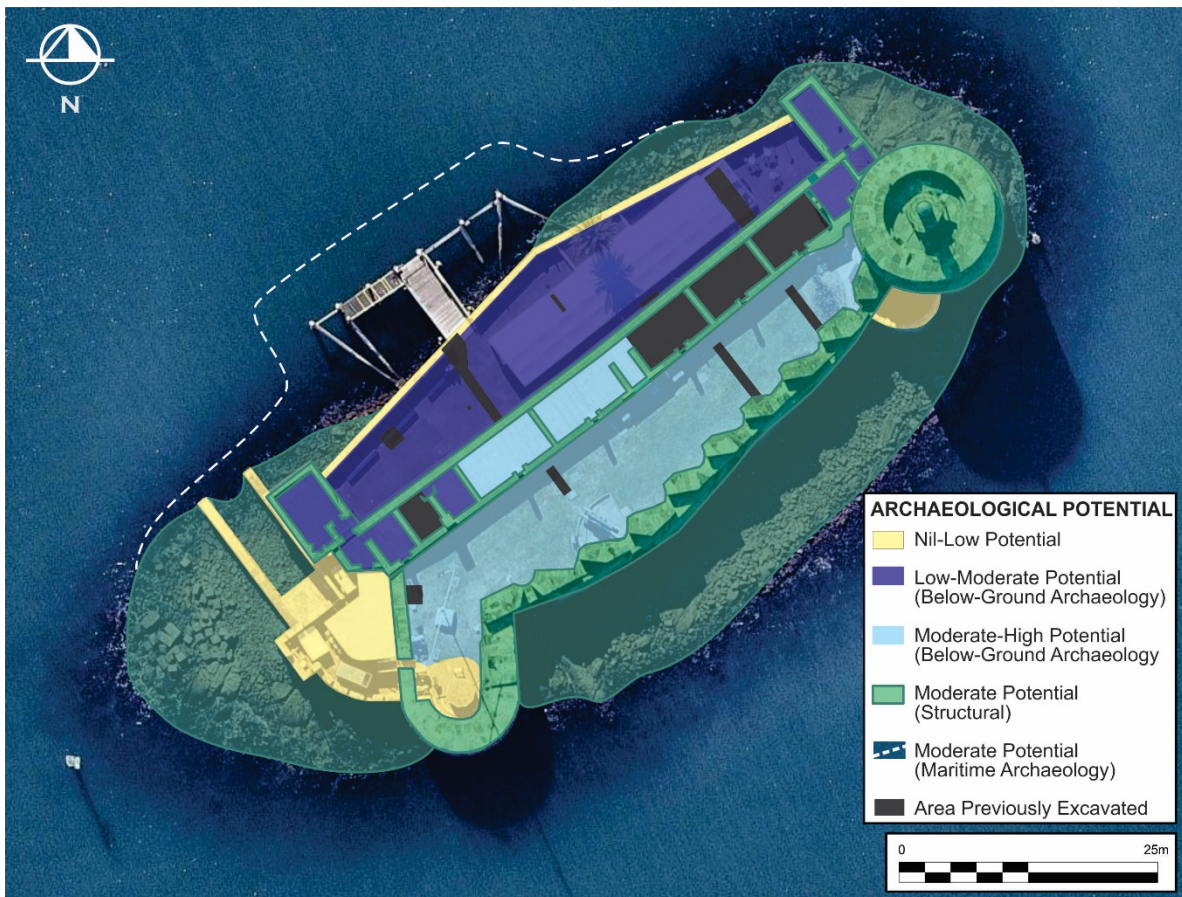
Figure 77 Overlay plan of the study area indicating the levels of archaeological potential. Standing archaeological remains with moderate to high potential are marked with green shading. Areas with moderate to high potential for subsurface archaeological remains are marked in light blue, and areas with low to moderate potential for subsurface archaeological remains are marked in dark blue. Areas shaded yellow were constructed post-1917 and are considered to have nil to low potential for state or locally significant archaeological remains. Areas shaded in black have been subject to archaeological excavation programs and the archaeological resource has subsequently been removed (Plan of potential by Casey & Lowe, Near Maps base plan accessed 28/02/2018)

Archaeological potential has been determined using a series of gradations (**nil–low**, **low–moderate** and **moderate–high**) to indicate the degree to which archaeological remains are likely to survive. The types of potential historical archaeological remains identified within the study area are summarised below in **Figure 77** and **Table 3**.

There is a **moderate to high** potential for evidence relating to the original masonry, fittings and construction of the fort. This includes built fabric associated with the original ‘convict shaped rock’ battery (constructed 1840–42 and still extant), the southern bastion, casemated barracks and tower, the wet ditch and breakwater (c.1856–58), as well as the loophole chambers and terrace (c.1858–62). Some restoration and repair work to the original fabric and fittings is evident, although this is largely sympathetic replacement of stonework. The two loophole chambers (the Tide Gauge and West Rooms) have been significantly remodelled (or rebuilt) in the 20th century, and there is **low to moderate** potential for archaeological evidence related to the original built fabric here.

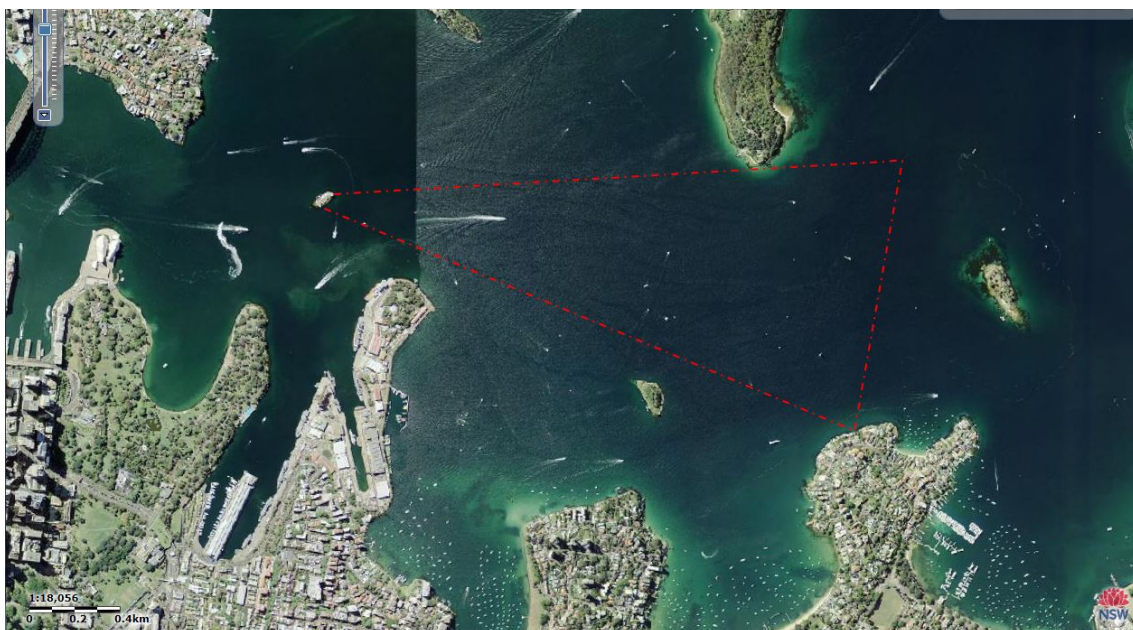
The field of fire of the Fort Denison guns in which the guns would engage with an enemy warship is intact (**Figure 79**). This includes the 360-degree view from the top of the Martello tower, the 180-degree view from the bastion and the 90-degree view from the battery.

Figure 79: View of the Fort Denison field of fire (SixMaps, 2019)

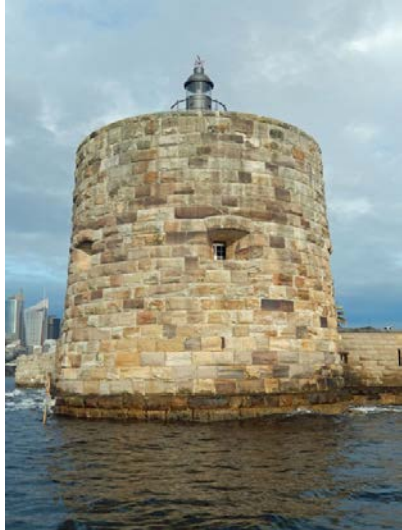
(a) Martello tower from north

Tower exterior		Date	Significance	Condition	Figure
Walls	Sandstone with granite joggles	1850s	Exceptional	Fair	79a
Embrasures	Sandstone	1850s	Exceptional	Good	79a
Retaining wall	Sandstone	1910s	High	Fair	
Loopholes	Stepped sandstone	1850s	Exceptional	Poor	
Door from battery	Timber-framed and braced, painted; reconstructed	1920s?	High	Good	79b
Windows	Refer to Gun room				
Roof	Refer to Tower terreplein

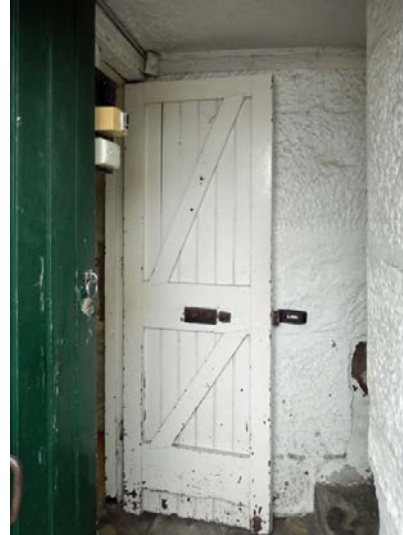
(b) External door to Martello tower (left) and door to basement rooms (centre)

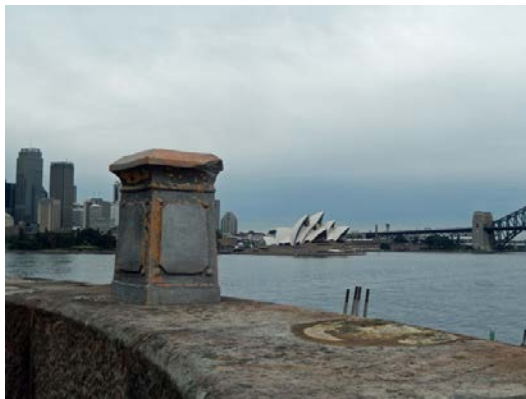
(c) Parapet and chimney on tower terreplein

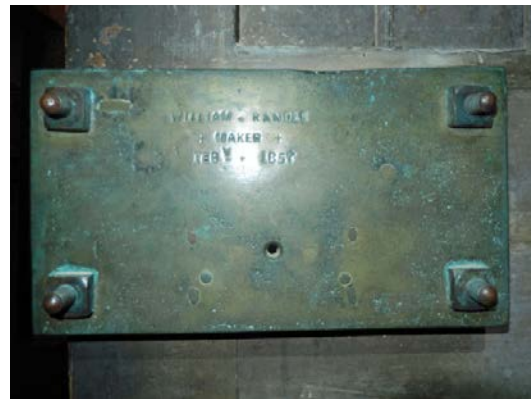
(d) Detail of original lock to door on Room TB4

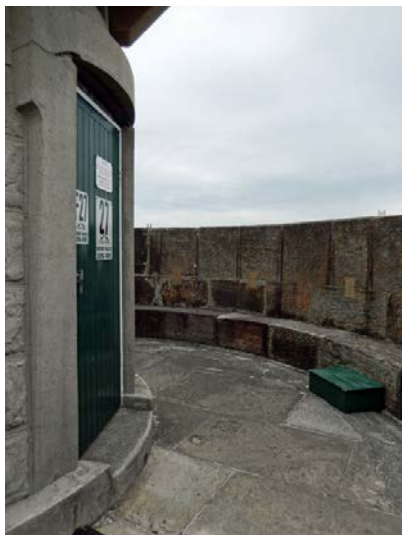
(e) Tower terreplein and parapet, with lantern structure (left) and firing step

Tower terreplein (Lantern level)		Date	Significance	Condition	Figure
Floor	Stone flags and drain	1850s	Exceptional	Fair	79e
Parapet	Sandstone with granite joggles	1850s	Exceptional	Fair	79e
Door from stairs	Timber-framed and braced, painted, half glazed	1920s?	High	Good	79b
Firing step	Sandstone	1850s	Exceptional	Fair	
Lantern	Concrete, sandstone	1910s	High	Fair	79e
Chimney	Iron and terracotta	1850s	Exceptional	Fair	79c
Gun fixtures	Wrought iron, concrete filled chase for gun race	1850s	Exceptional	Fair	79e
Navigation light and fixtures	Steel, painted	1850s–1920s	High	Good	89f

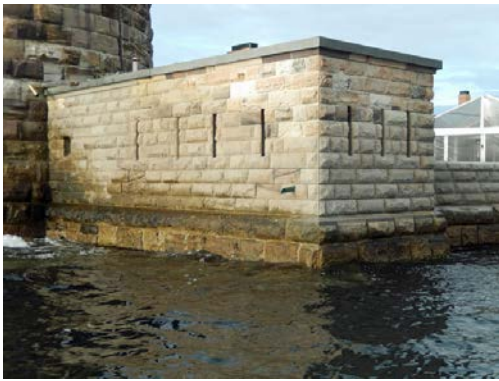
(c) Tide Gauge Room exterior from north

Tide Gauge Room exterior		Date	Significance	Condition	Figure
Walls	Sandstone	1850s	Exceptional	Fair	81c
Loopholes	Stepped sandstone	1850s	Exceptional	Fair	81c
Door from terrace	Timber-framed and braced	1920s?	High	Poor	81f
Windows	Refer to interior				
Roof	Bituminous membrane	1990s?	Little/low	Good	81c

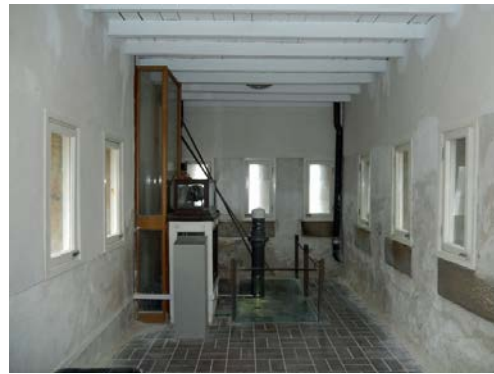
(d) Tide Gauge Room looking north-west, showing tide gauges

The original gauge was a Smalleys chart recorder. It was subsequently replaced with a Russels gauge in 1872, and a Harrisons Gauge in 1914. A Vetac acoustic sensor was installed in 1996 providing digital one-minute records and this was upgraded to a SeaRanger acoustic sensor in 2007.²⁴⁹

Tide Gauge Room interior		Date	Significance	Condition	Figure
Floor	Concrete	1910s	Intrusive	Fair	81d
	Quarry tiles	1970s?	Little/low	Fair	
Walls	Sandstone, south-east end	1850s	Exceptional	Fair	81f
	Sandstone, remainder	1910s	High	Poor	81d
	Sacrificial render	1990s	Little/low	Poor	81d
Loopholes	Sandstone, stepped	1850s	Exceptional	Good	
Ceiling	Timber joists and boards	1910s	High	Good	81f
Door	Timber-framed and braced	1910s?	High	Poor	81f
Windows	Timber-framed casements	1970s?	Moderate	Fair	81d
	Fixed glazing	1910s?	High	Fair	
Contents	Early tide gauge machine	1870s?	High	Good	81d

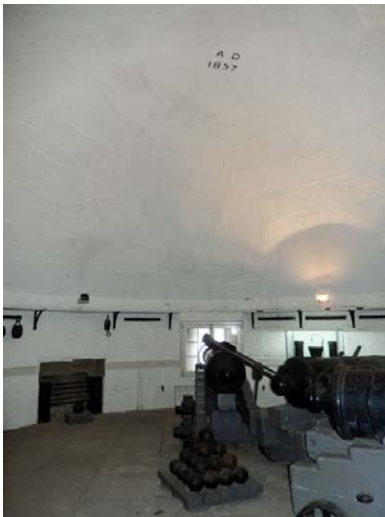
(e) Gun room looking north, showing fireplace and inscription on dome

Gun room	Casemate	Date	Significance	Condition	Figure
Floor	Stone flags	1850s	Exceptional	Fair	81b
Steps	Sandstone	1850s	Exceptional	Fair	81a
	Concrete topping	1920s?	Intrusive	Fair	
Walls	Sandstone, painted	1850s	Exceptional	Fair	81e
Ceiling	Sandstone, painted	1850s	Exceptional	Good	81e
Inscription	Engraved and painted	1850s	Exceptional	Good	81e
Door	Timber-framed and braced	1850s	Exceptional	Good	81b
Windows	Timber-framed casements	Before 1901	Moderate	Good	81e
Fireplace	Cast-iron	1850s	Exceptional	Good	81e
32-pounder guns	Iron 56 cwt guns (serial nos 70, 117, 121 and 135) and timber and iron garrison carriages	Before 1850s	Exceptional	Good	81e
Other contents	Refer to moveable items list				81e

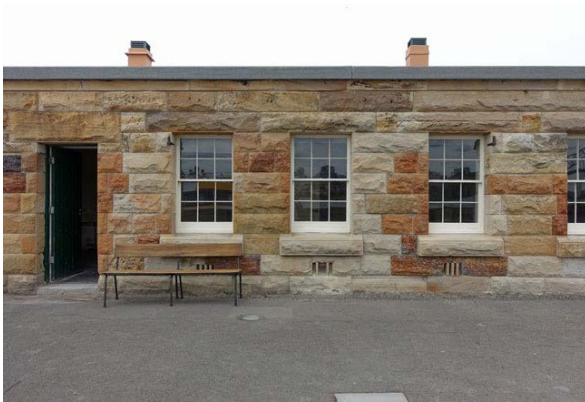
(c) Typical elevation of barracks outside Room B5 (2018)

Barracks exterior		Date	Significance	Condition	Figure
Walls	Sandstone	1850s	Exceptional	Fair	82c
	Indent repairs	1960s– 1990s	Moderate	Fair	
Windows	Timber-framed, double hung	1850s	Exceptional	Fair	82c
	Repairs to windows	1990s	Moderate	Good	
Doors	Timber-framed and braced	1850s	Exceptional	Fair	82c
	Repairs and hardware	1990s	Little/low	Fair	
Wall vents	Brass	1990s	Moderate	Fair	82c
Shutter	Wrought iron	1850s	Exceptional	Fair	82f
Shutter fixings	Wrought iron	1850s	Exceptional	Fair	82c
Roof	Bituminous membrane	1990s	Little/low	Good	88a
Chimneys	Brick, painted	1850s	Exceptional	Good	88a
	Replaced chimneys and pots	2000	Moderate	Good	
	Brass vents on chimneys	1990s	Little/low	Good

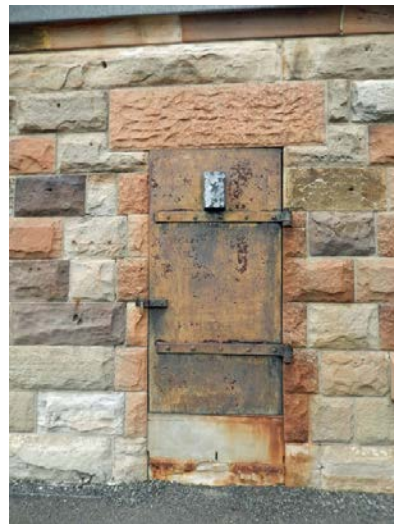
(f) Iron shutter, barracks wall (2016)

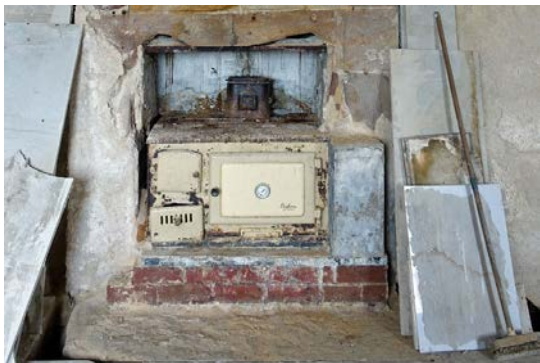
(e) Detail of fireplace in Room B4

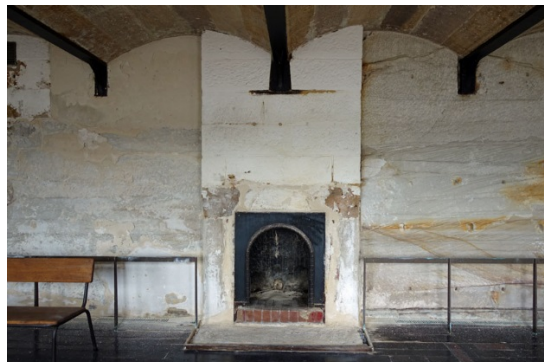
(h) Detail of fireplace in Room B5

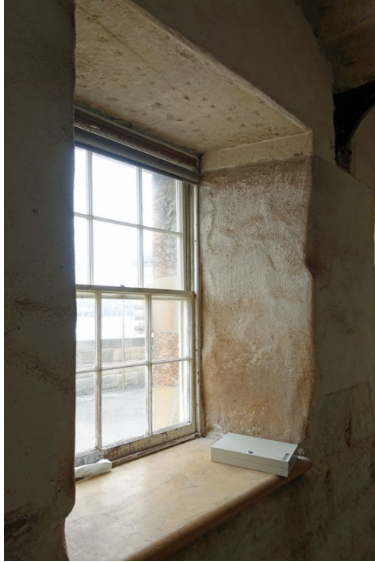
(a) Window in Room B4 showing oil damage to plaster reveals (2018)

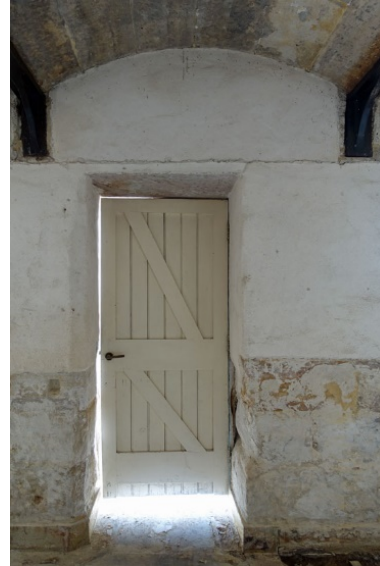
(b) External door to Room B4 (2018)

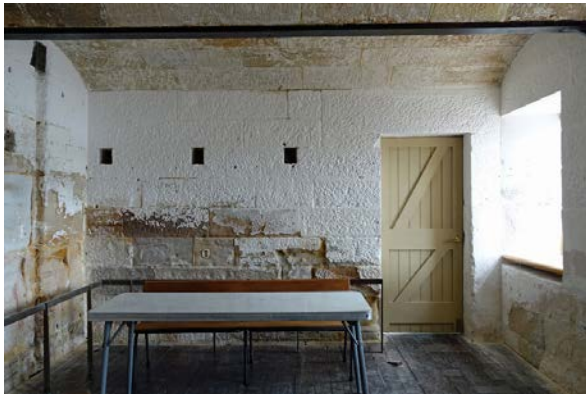
(c) Room B6/B7 looking south-west (2018)

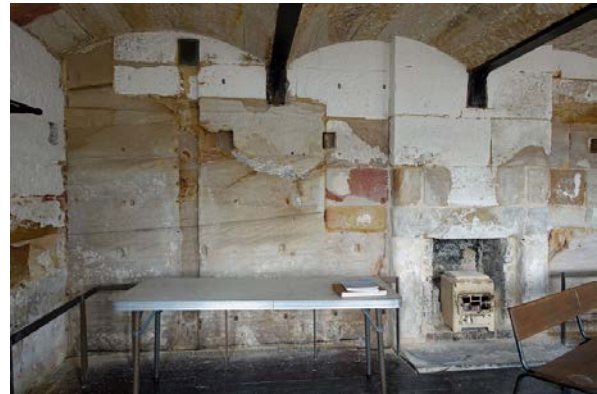
(d) Room B6/B7 looking south-east, showing fireplace and chases for floor vents (2018)

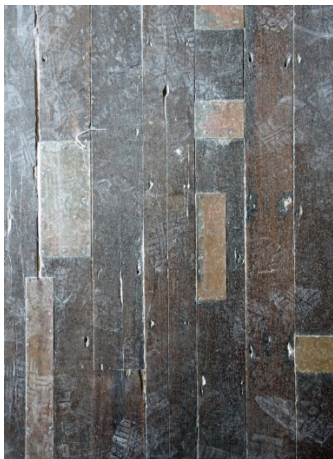
(e) Detail of floorboards in Room B5 (2018)

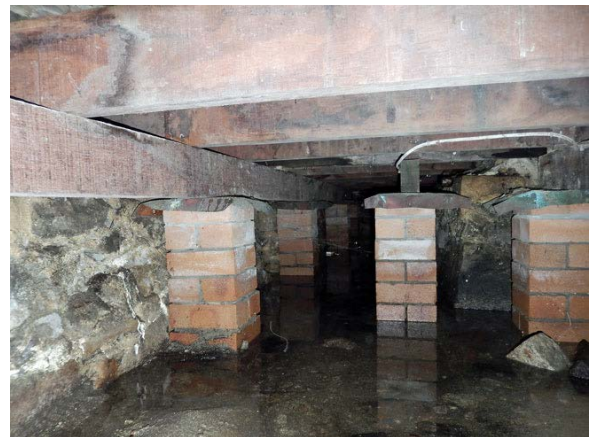
(f) Subfloor area under Room B6/B7 showing standing water at high tide (2016)

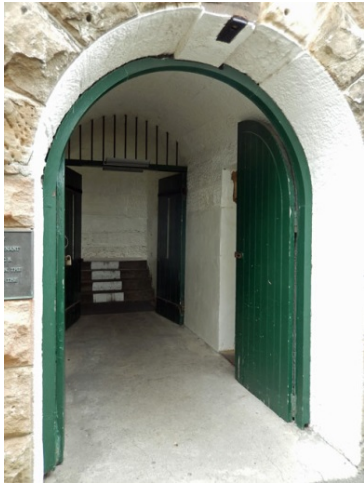
(a) Archway through to Room B8

Archway	Date	Significance	Condition	Figure
Floor	Concrete	1920s?	Moderate	Good	85a
Walls	Sandstone, painted	1850s	Exceptional	Fair	85a
	Cement render	1920s?	Intrusive	Fair	
	Sacrificial render	2000s	Little/low	Fair	
Ceiling	Sandstone vault, painted	1850s	Exceptional	Fair	85a
Doors	(Entry) Timber-framed and braced, arched head	1900s?	High	Fair	85a
