Fort Denison

Conservation Management Plan

This conservation management plan was prepared by the NSW Office of Environment and Heritage in May 2018, to update and replace the previous conservation plan prepared by NPWS and endorsed by the Heritage Council of NSW in 1999.

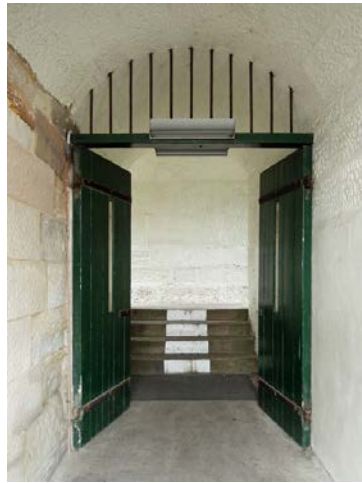
(b) Room B8: doors and steps to battery

Room B8	Entry to battery	Date	Significance	Condition	Figure
Floor	Concrete	1920s?	Moderate	Good	85b
Steps	Stone	1850s	Exceptional	Good	85b
Walls	Sandstone, painted	1850s	Exceptional	Fair	85c
	Cement render	1920s?	Intrusive	Fair	85b
	Sacrificial render	2000s	Little/low	Poor	85b
Ceiling	Sandstone vault, painted	1850s	Exceptional	Fair	85b
Doors	Double timber-framed and braced, wrought iron bars and hardware	1850s	Exceptional	Fair	85b
	Vision panels to above	1960s?	Intrusive	Fair	85c
	Single timber-framed and braced doors to battery	1850s?	Exceptional	Fair

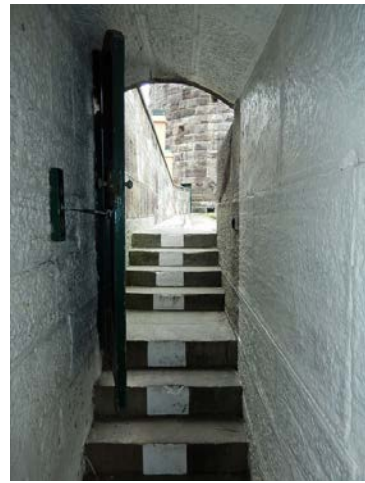
(c) Room B8: door to battery looking north-east

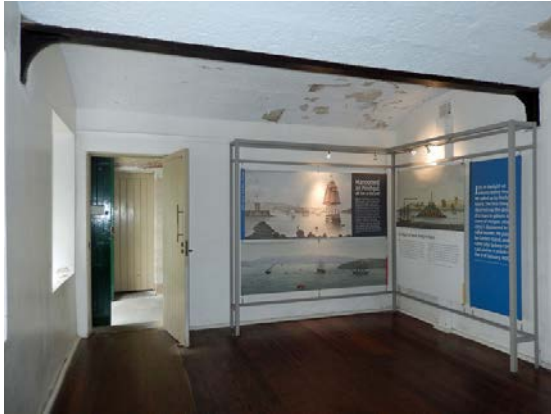
(d) Room B9 looking east

Room B9	Exhibition	Date	Significance	Condition	Figure
Floor	Timber boards	1980s?	Little/low	Good	85d
Skirting	Timber quad	1920s?	High	Fair	85d
Walls	Stone	1850s	Exceptional	Unknown	85d
	Cement render, painted	1920s?	Moderate	Good	
	Metal vent shaft, painted	1920s?	High	Good	
	V-jointed timber boarding	1920s?	High	Good	85e
Ceiling	Sandstone vault on iron beam	1850s	Exceptional	Fair	85d
Doors	Timber-framed and braced	1850s	Exceptional	Good	85d
	Repairs and hardware	1990s	Moderate	Fair	
	Timber ledged and boarded	1920s?	High	Good	85e
Windows	Timber-framed, double hung	1850s	Exceptional	Good	
	Repairs to windows	1990s	Moderate	Fair	
Fireplace	Stone hearth and cast-iron VR chimneypiece	1850s	Exceptional	Fair	85e
	Brick hearth, cast-iron surround and timber mantel shelf	1900s?	High	Fair

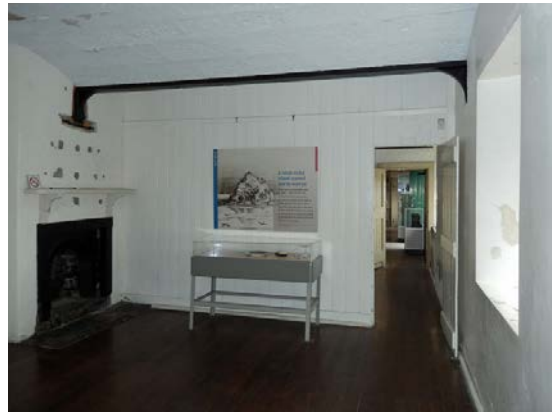
(e) Room B9 looking south

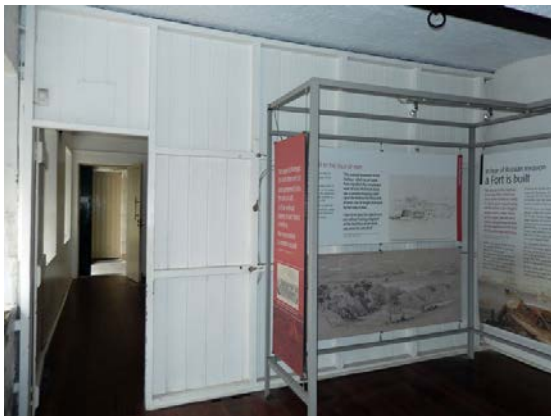
(f) Room B10 looking east

Room B10	Exhibition	Date	Significance	Condition	Figure
Floor	Timber boards	1980s?	Little/low	Good	85f
Skirting	Timber quad	1980s?	Little/low	Good	85g
Walls	Stone	1850s	Exceptional	Fair	85g
	Cement render, painted	1920s?	Little/low	Poor	85g
	V-jointed timber boarding	1920s?	High	Good	85f
Ceiling	Sandstone vault on iron beam	1850s	Exceptional	Fair	85g
Doors	Timber-framed and braced	1900s	High	Good	85g
	Repairs and hardware	1990s	Moderate	Fair	
	Timber ledged and boarded	1920s?	High	Good	85e
Windows	Timber-framed, double hung	1850s	Exceptional	Good	85g
	Repairs to windows	1990s	Moderate	Fair	
Fittings	Iron brackets in walls	1850s	Exceptional	Fair	85g

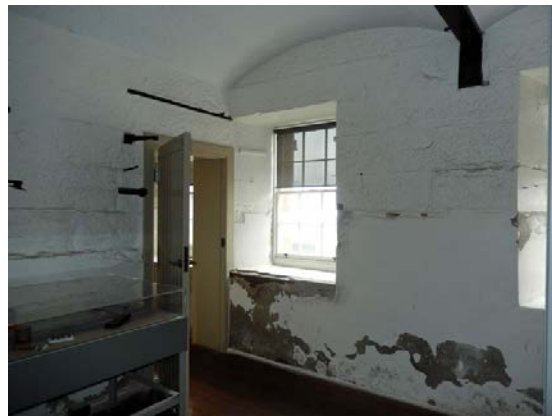
(g) Room B10 looking west

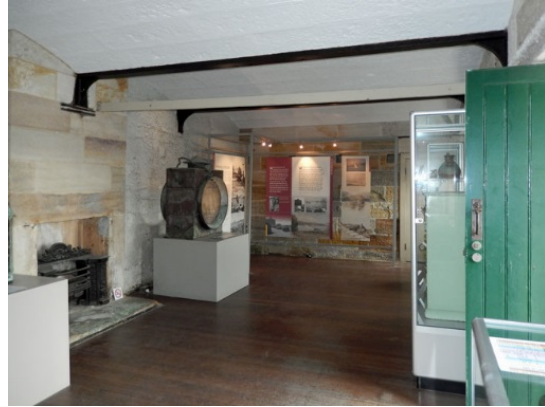
(b) Room B11 looking south, showing non-military hob grate

Room B11	Exhibition	Date	Significance	Condition	Figure
Floor	Timber boards	1980s?	Little/low	Good	86a
Walls	Natural rock and sandstone	1850s	Exceptional	Fair	86b
	Sandstone indents	1990s?	Moderate	Good	
Ceiling	Sandstone vault on iron beam	1850s	Exceptional	Fair	86a
Doors	Timber-framed and braced	1990s?	Moderate	Good	86b
Windows	Timber-framed, double hung	1850s	Exceptional	Good	
	Repairs to windows	1990s	Moderate	Fair	
Fittings	Iron brackets in walls	1850s	Exceptional	Fair	86a
Fireplace	Stone chimneybreast and hearth	1850s	Exceptional	Good	86b
	Cast-iron hob grate	1850s?	High	Good

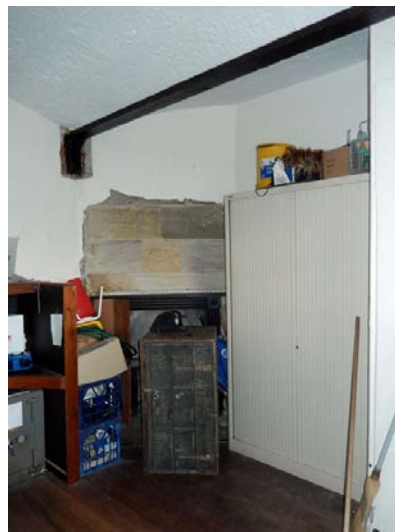
(d) Room B12 looking south to fireplace

Room B12	Office	Date	Significance	Condition	Figure
Floor	Timber boards	1980s?	Little/low	Good	86d
Walls	Sandstone	1850s	Exceptional	Unknown	86c
	Plaster and staff mould	1850s	Exceptional	Fair	
Ceiling	Sandstone vault on iron beam	1850s	Exceptional	Fair	86d
Doors	Timber-framed and braced	1990s?	Moderate	Good	86c
	Timber four-panelled	1850s	Exceptional	Good	86e
Windows	Timber-framed, double hung	1850s	Exceptional	Good	86c
	Repairs to windows	1990s	Moderate	Fair	
Fireplace	Stone chimneybreast and hearth	1850s	Exceptional	Fair	86d
	Cast-iron hob grate	1850s	Exceptional	Fair	
	Cast-iron chimneypiece	1850s	Exceptional	Good

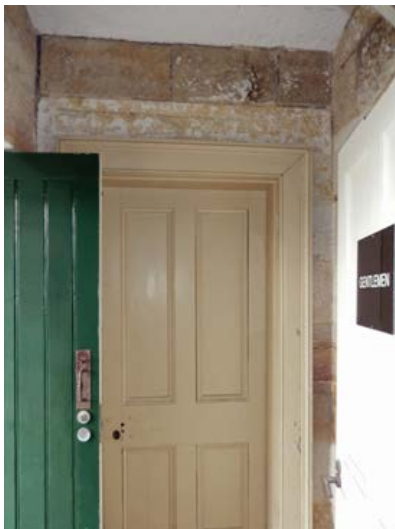
(e) Room B13 looking north-east, showing panelled door to former officers' quarters

Room B13	Lobby	Date	Significance	Condition	Figure
Floor	Timber boards	1980s?	Moderate	Good	
Walls	Sandstone	1850s	Exceptional	Fair	86e
Ceiling	Sandstone vault	1850s	Exceptional	Fair	86e
Doors	Timber-framed and braced	1850s	Moderate	Good	86e
	Timber four-panelled	1850s	Exceptional	Good	
	Repairs and hardware	1990s	Moderate	Fair

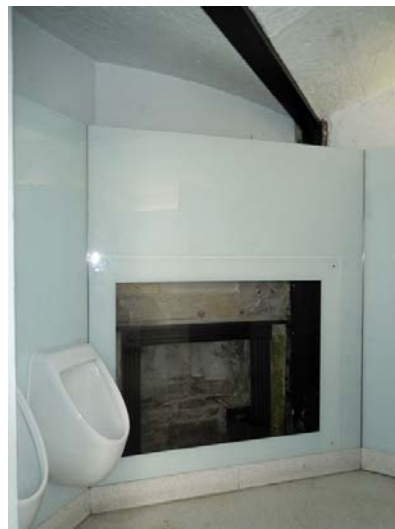
(f) Room B14 looking east, showing raised floor and false walls in front of fireplace

Room B14	Male WCs	Date	Significance	Condition	Figure
Floor	Terrazzo tile	2000	Little/low	Good	86f
Walls	Sandstone, painted	1850s	Exceptional	Poor	86f
	False terrazzo and glass panels	2000	Intrusive	Good	
Ceiling	Sandstone vault on iron beam	1850s	Exceptional	Fair	86f
Doors	Timber-framed and braced	1990s?	Moderate	Good	
Windows	Timber-framed, double hung	1850s	Exceptional	Good	
	Repairs to windows	1990s	Moderate	Fair	
Fireplace	Stone chimneybreast and hearth	1850s	Exceptional	Fair	86f
	Cast-iron chimneypiece	1850s	Exceptional	Fair	
	Remnant of hob grate	1850s	Exceptional	Poor	
Fittings	Sanitary fittings and cubicle	2000	Little/low	Good	86f

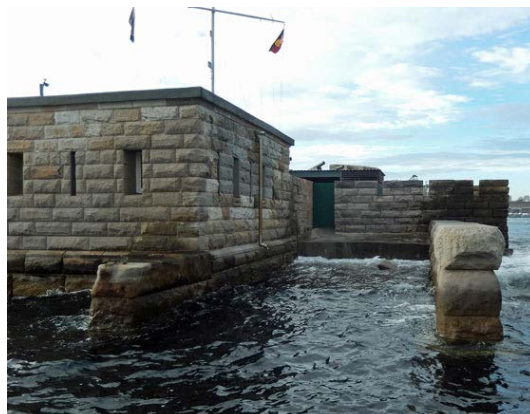
(f) Exterior of West Room, slipway and slip yard looking east

West Room exterior		Date	Significance	Condition	Figure
Walls	Sandstone	1850s	Exceptional	Fair	87f
Loopholes	Stepped sandstone	1850s	Exceptional	Fair	87f
Roof	Bituminous membrane	1990s	Little/low	Good	88b

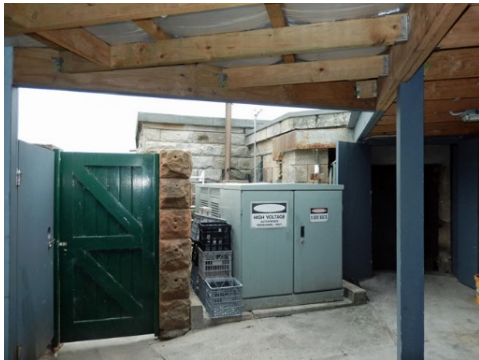
(c) Substation in former slip yard (2016)

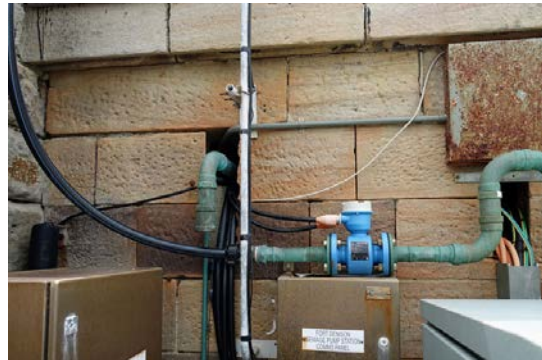
(d) Services behind substation (2018)

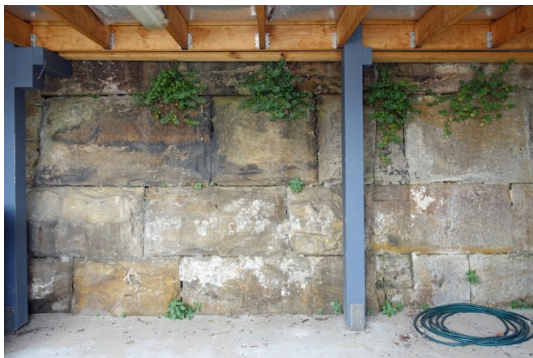
(e) Slip yard shelter and battery wall (2018)

Slip yard		Date	Significance	Condition	Figure
Paving	Crushed sandstone	1910s	Moderate	Fair	74
	Concrete	1940s?	Moderate	Good	88c
Walls	Outer sandstone	1917	Moderate	Fair	74
	Inner (to battery)	1850s	Exceptional	Fair	88e
	Wall and doorway between slipway and slip yard	1980s?	Little/low	Fair	
Shelter	Timber structure, steel roofing	2010s	Little/low	Good	88e
Steps	Timber	1940s?	Little/low	Fair	76
Services	Electrical substation and pumps	2000s	Little/low	Good	88c–d
Barbecue	Stone structure (previous location of one o'clock gun)	1970s	Little/low	Poor	75

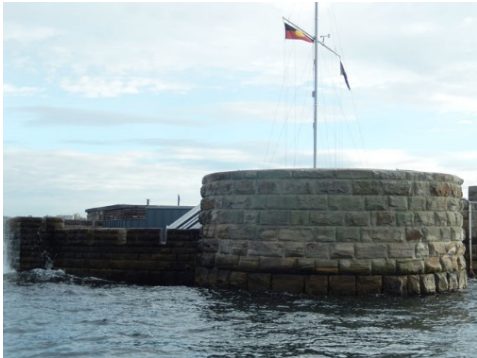
(c) Bastion from the south

Bastion		Date	Significance	Condition	Figure
Surface	Grass	1910s?	Moderate	Good	62
Walls	Sandstone	1850s	Exceptional	Fair	89c
Flagpole	Steel on concrete base	1980s?	Little/low	Fair	89d
Gun mount	Concrete mounting for 3-inch anti-aircraft gun	1942	Moderate	Good	62
One o'clock gun	Brass 12-pounder smoothbore muzzle-loading howitzer 9 cwt, serial no. LXXIII	1850	Exceptional	Good	62
	Timber gun carriage	1990s	Little/low	Poor	
Gun	Brass 12-pounder howitzer 6 cwt, serial no. LXIV	1848	Exceptional	Good	62
	Timber gun carriage	1960s	Little/low	Fair	
Gun	Brass 12-pounder howitzer 6 cwt, serial no. CLI	1841	Exceptional	Good	62
	Timber gun carriage	1960s	Little/low	Fair

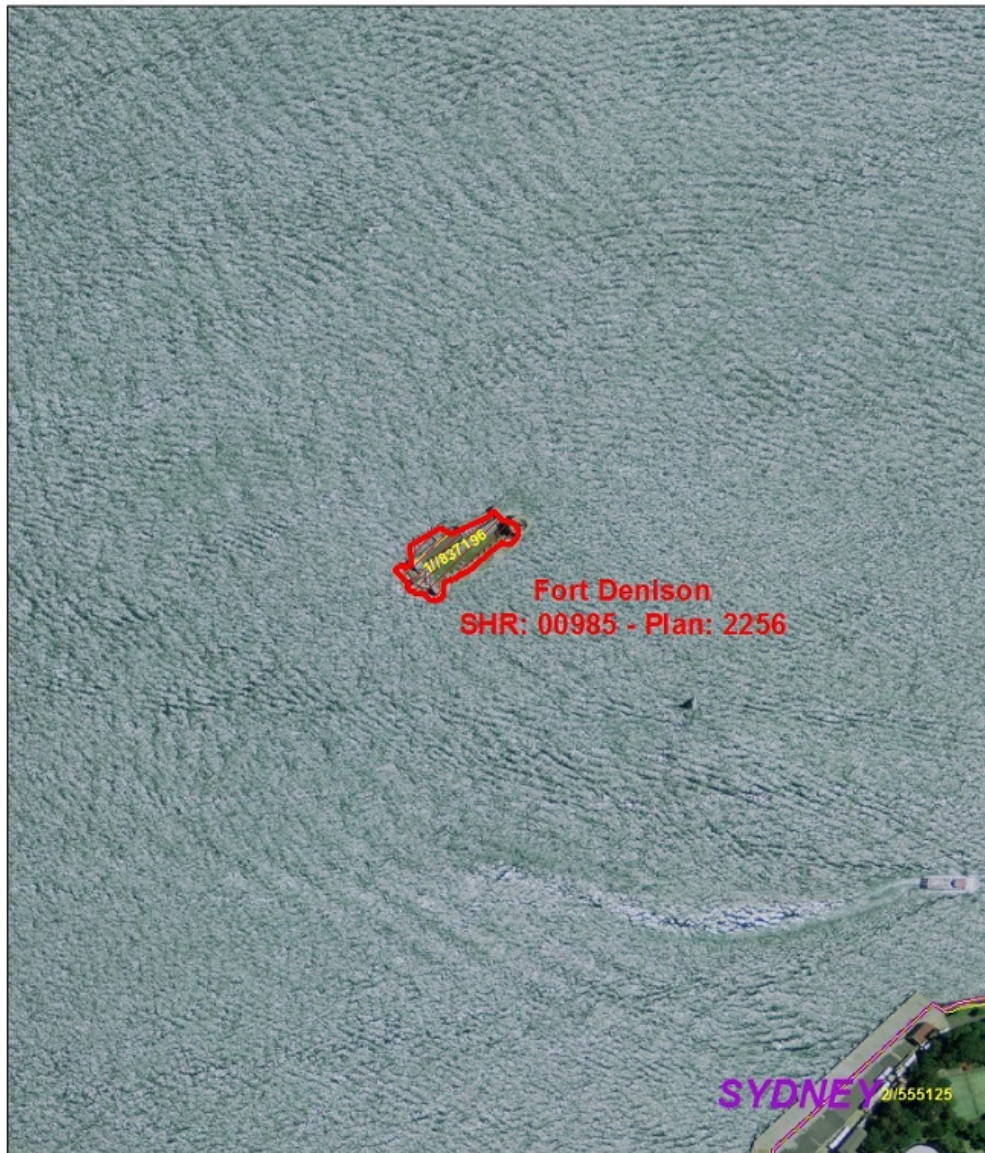
Figure 96: State Heritage Register listing plan for Fort Denison (Source: OEH)

State Heritage Register - SHR 00985, Plan 2256
Fort Denison
