Title
Erosion and recession hazard zones - Present Day: Woody Head Campground

Project
2021s1471 - Hydrosphere - CVC CMP Stage 2 - 4

Client
Hydrosphere Consulting

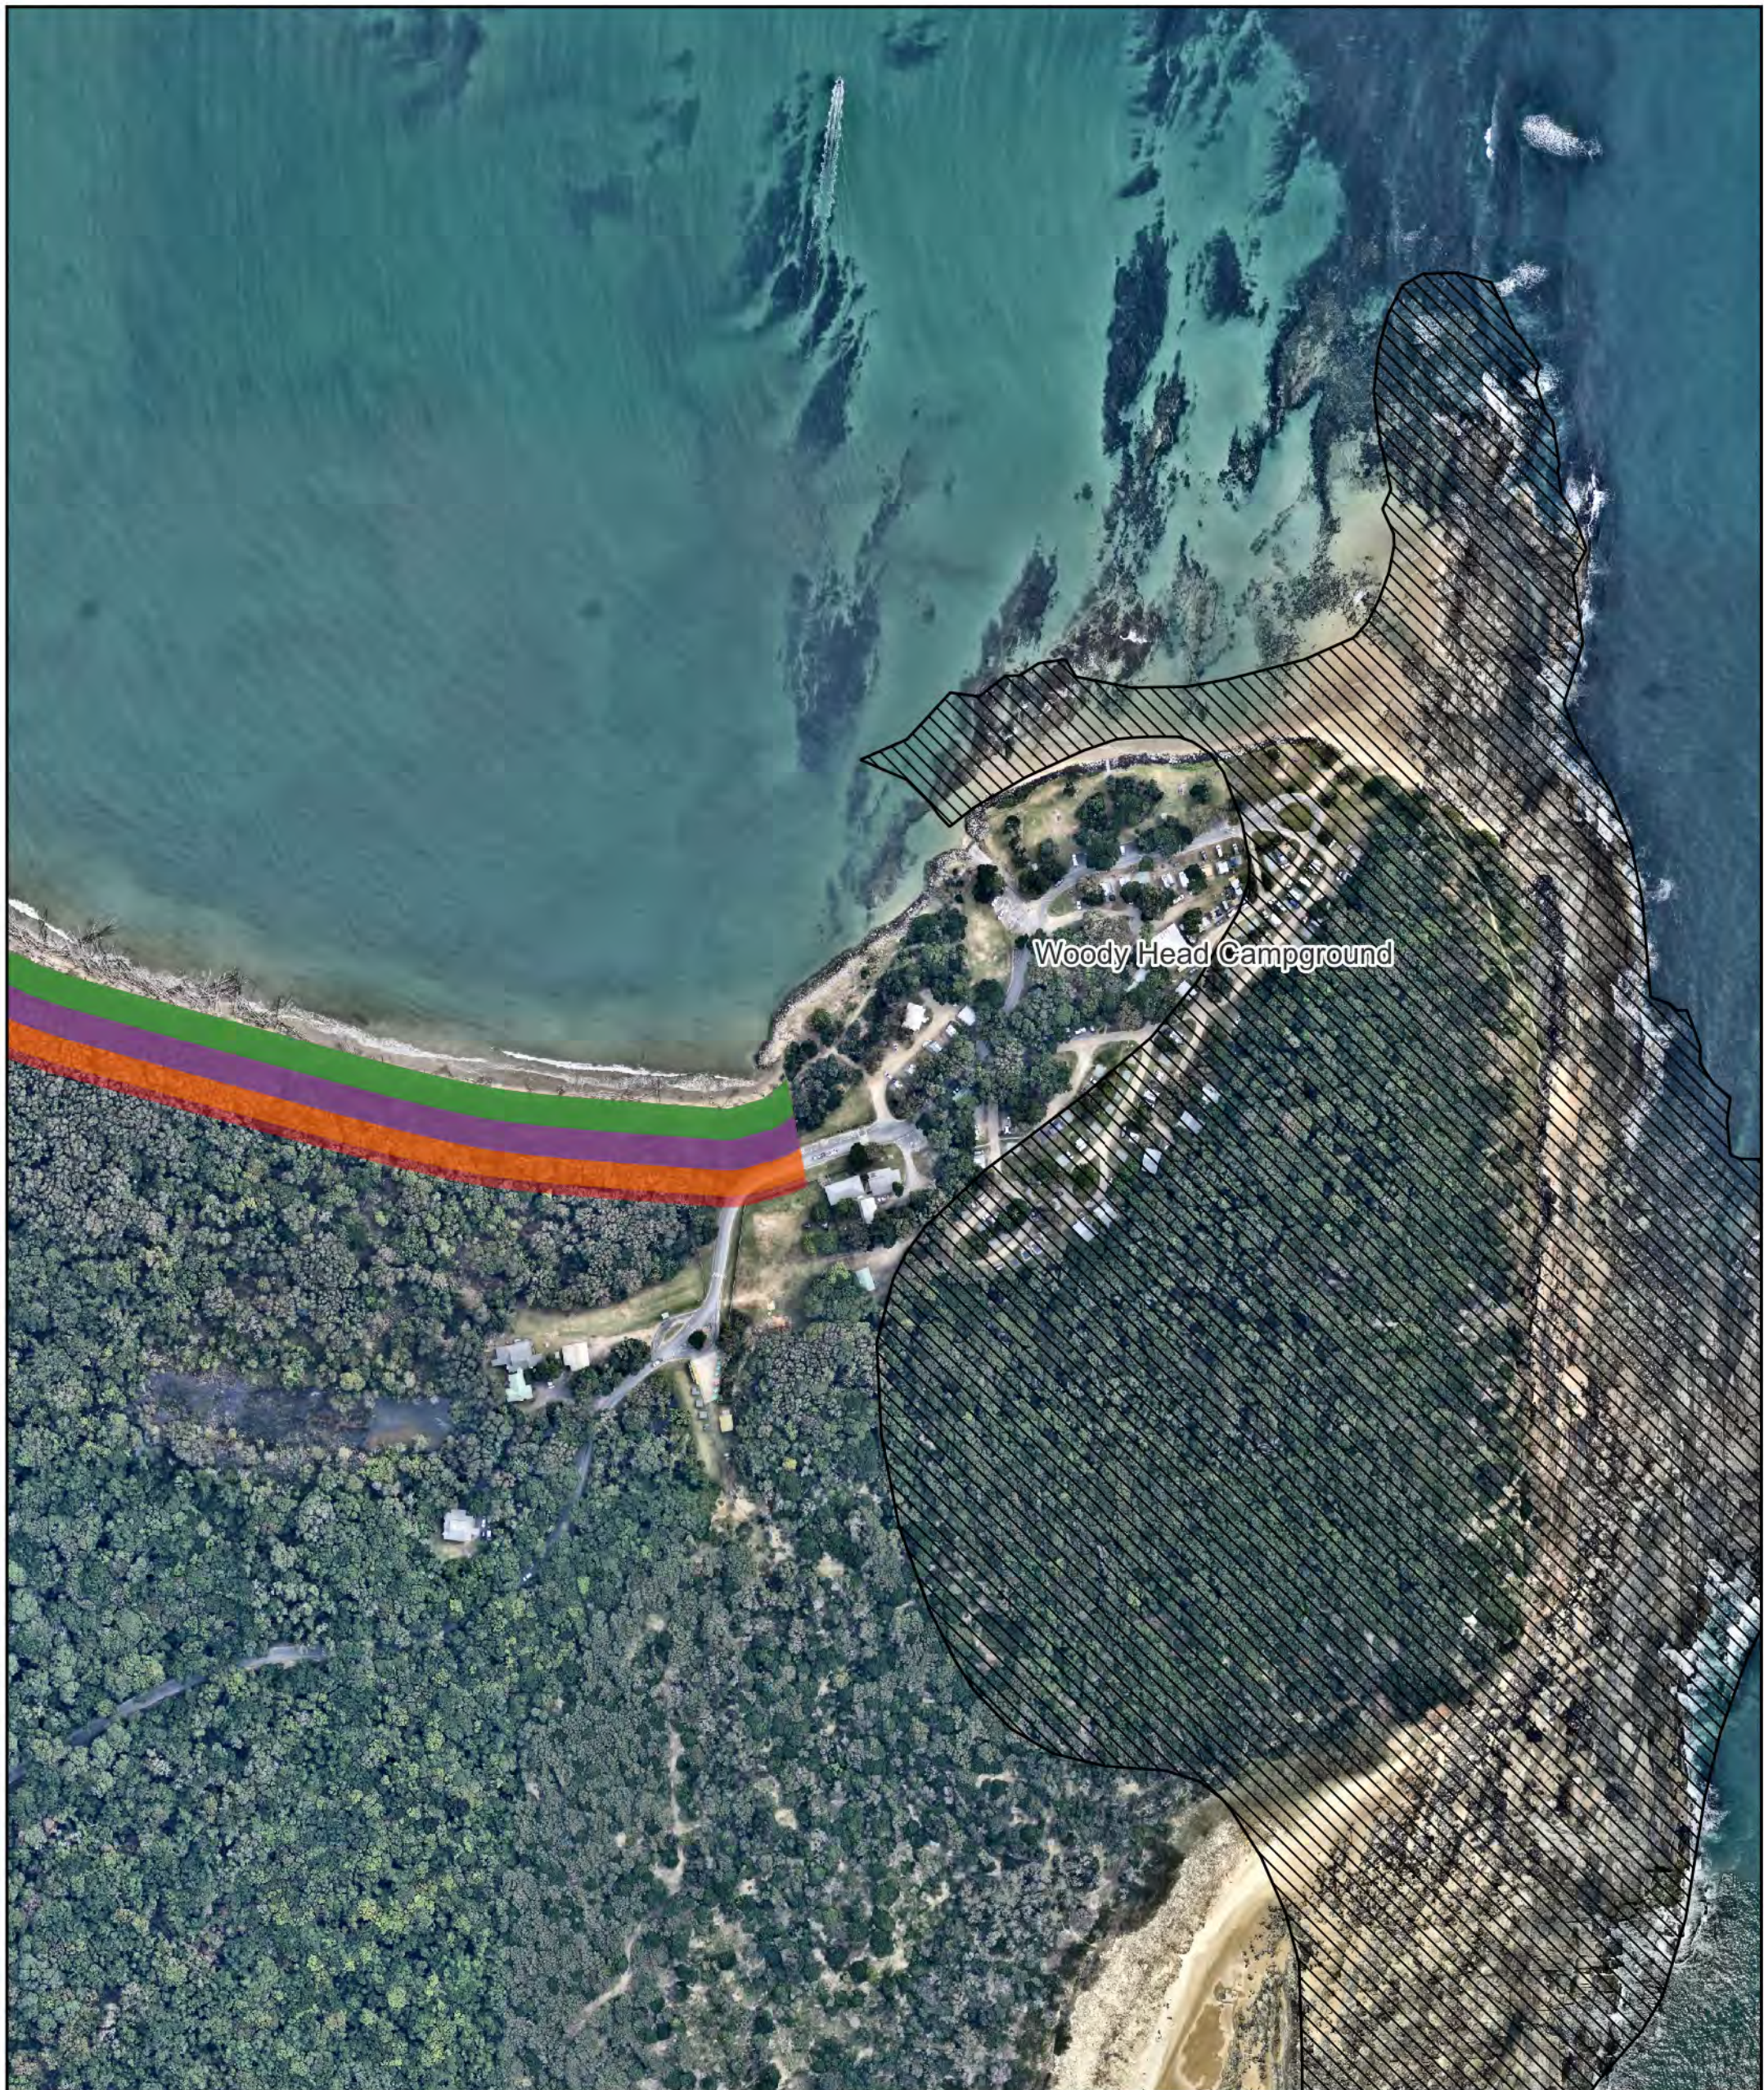
- Erosion and recession hazard zones (without protection)
- 50% exceedance probability

- 10% exceedance probability

- 2% exceedance probability

- 1% exceedance probability

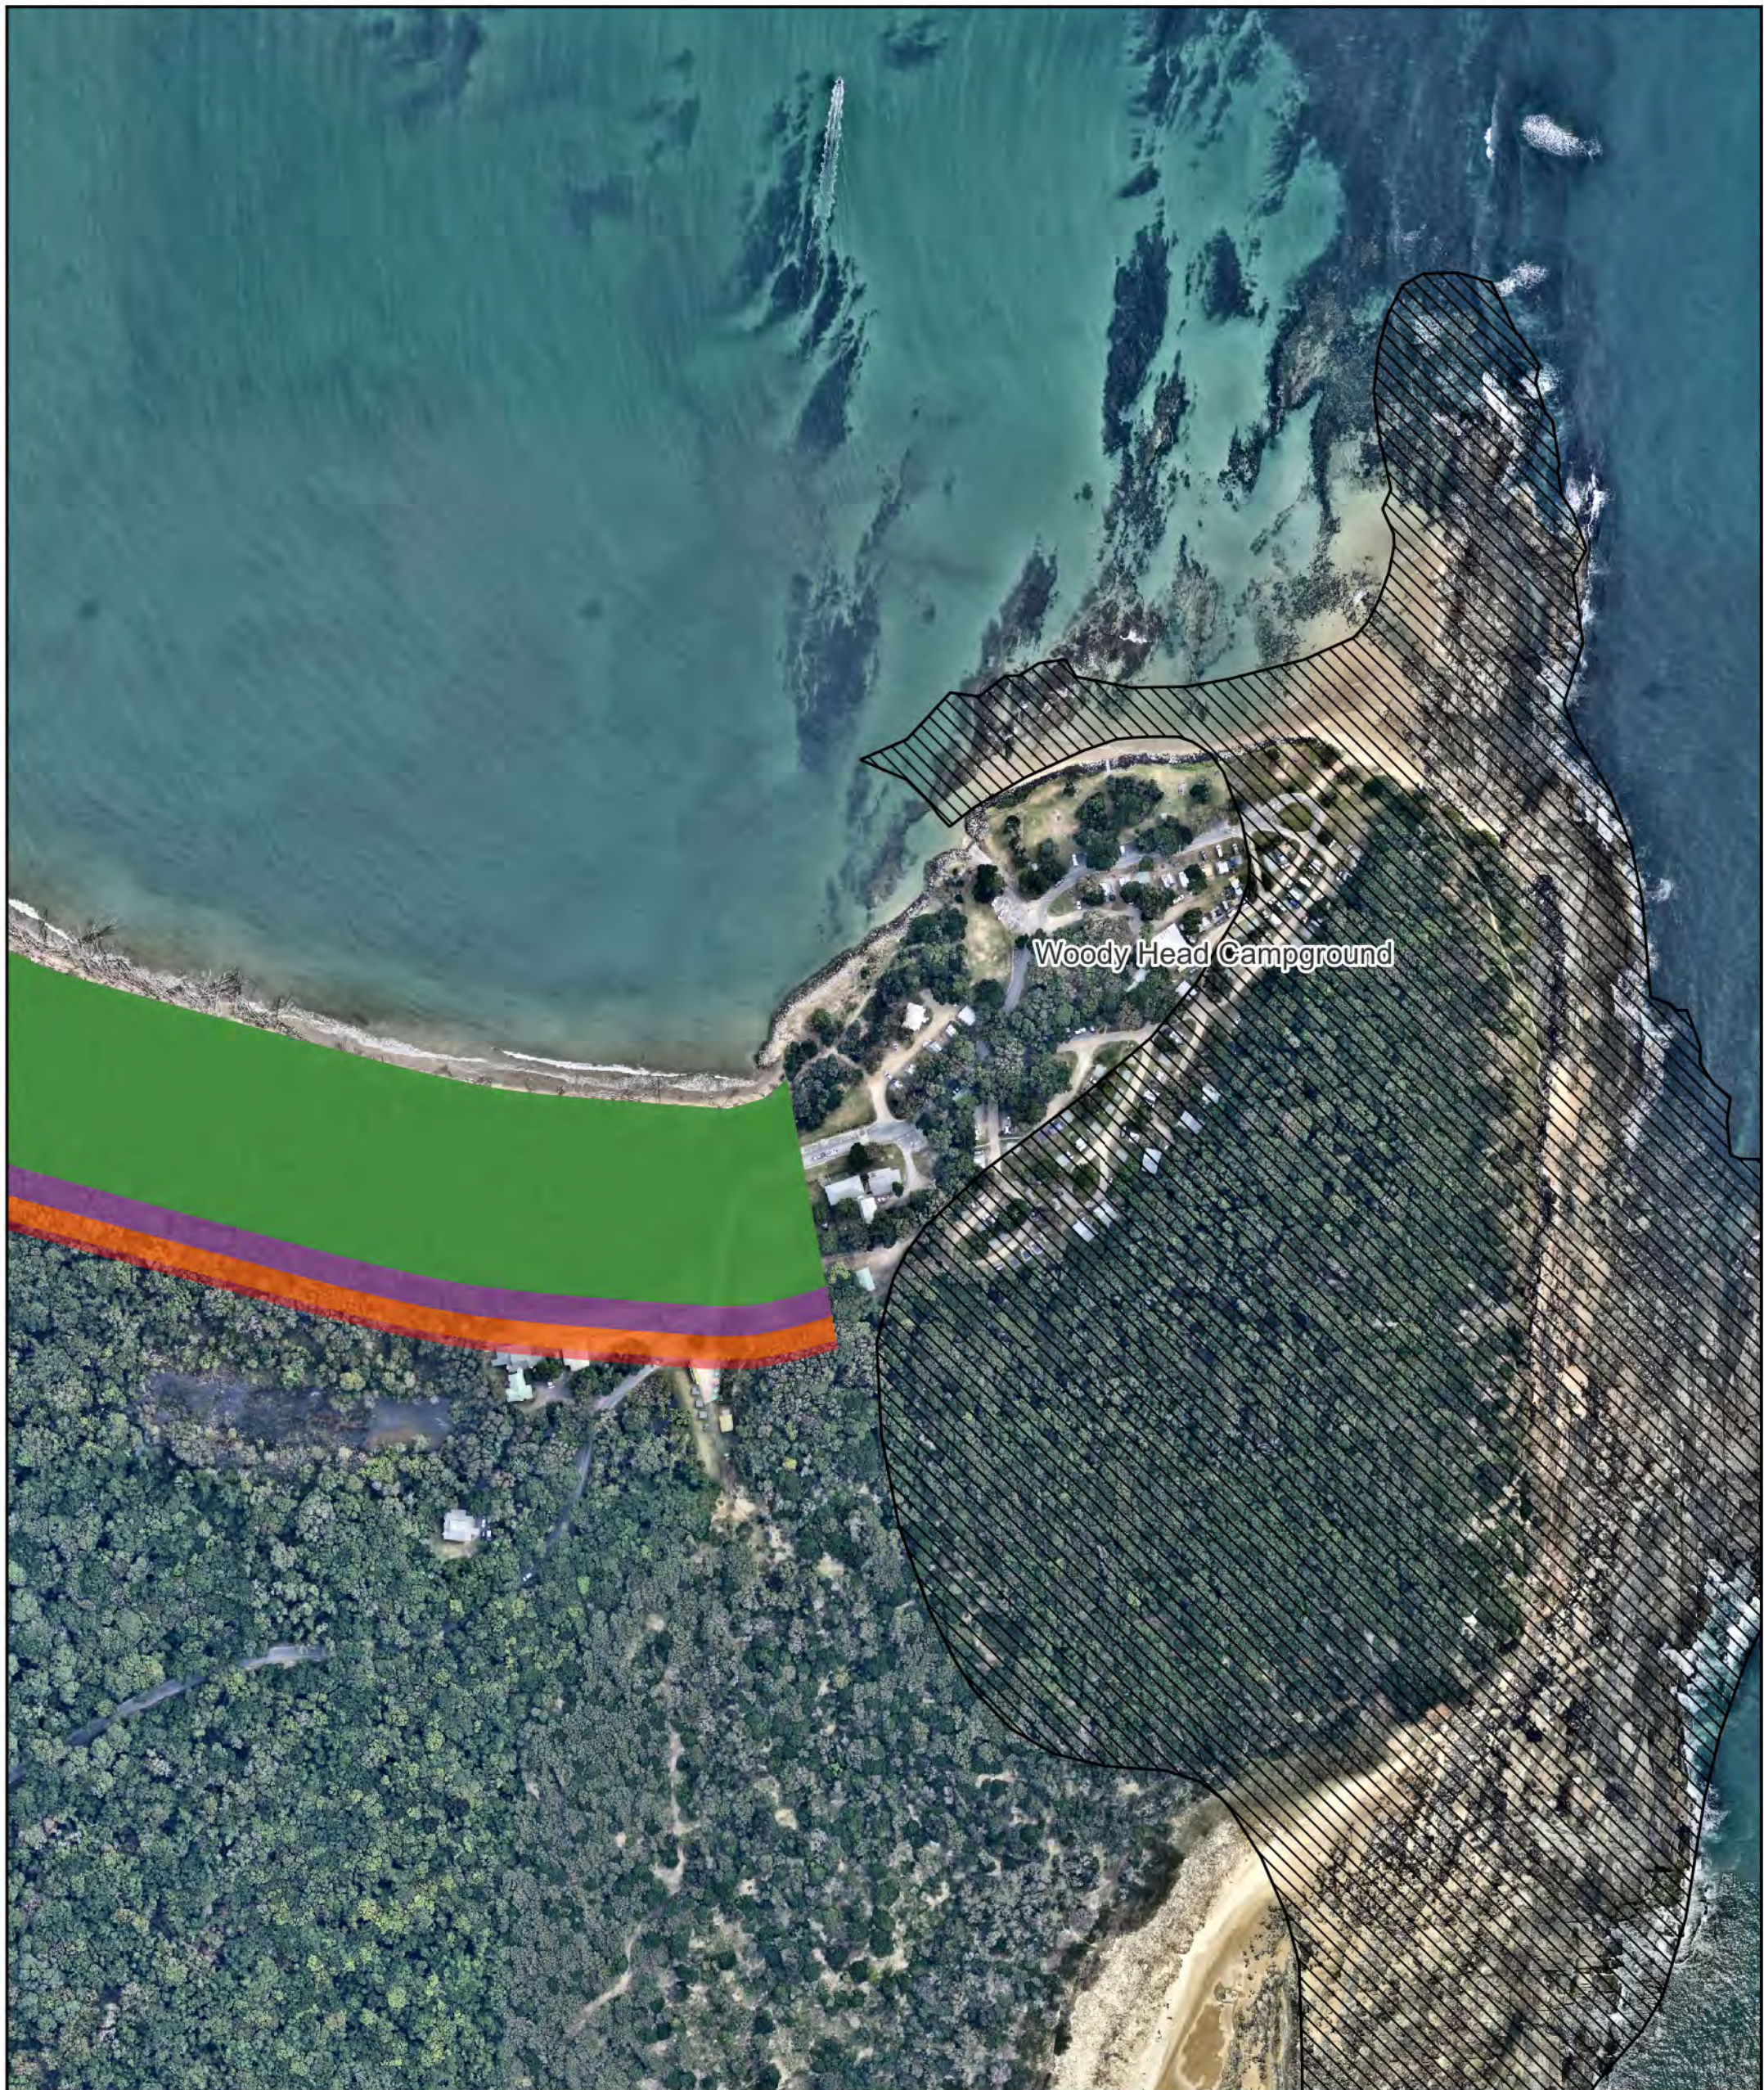
- Erosion and recession hazard zones (without protection)
- 50% exceedance probability ■
 - 10% exceedance probability ■
 - 2% exceedance probability ■
 - 1% exceedance probability ■
 - Bedrock

Title
Erosion and recession hazard zones -SSP2 2043: Woody Head Campground

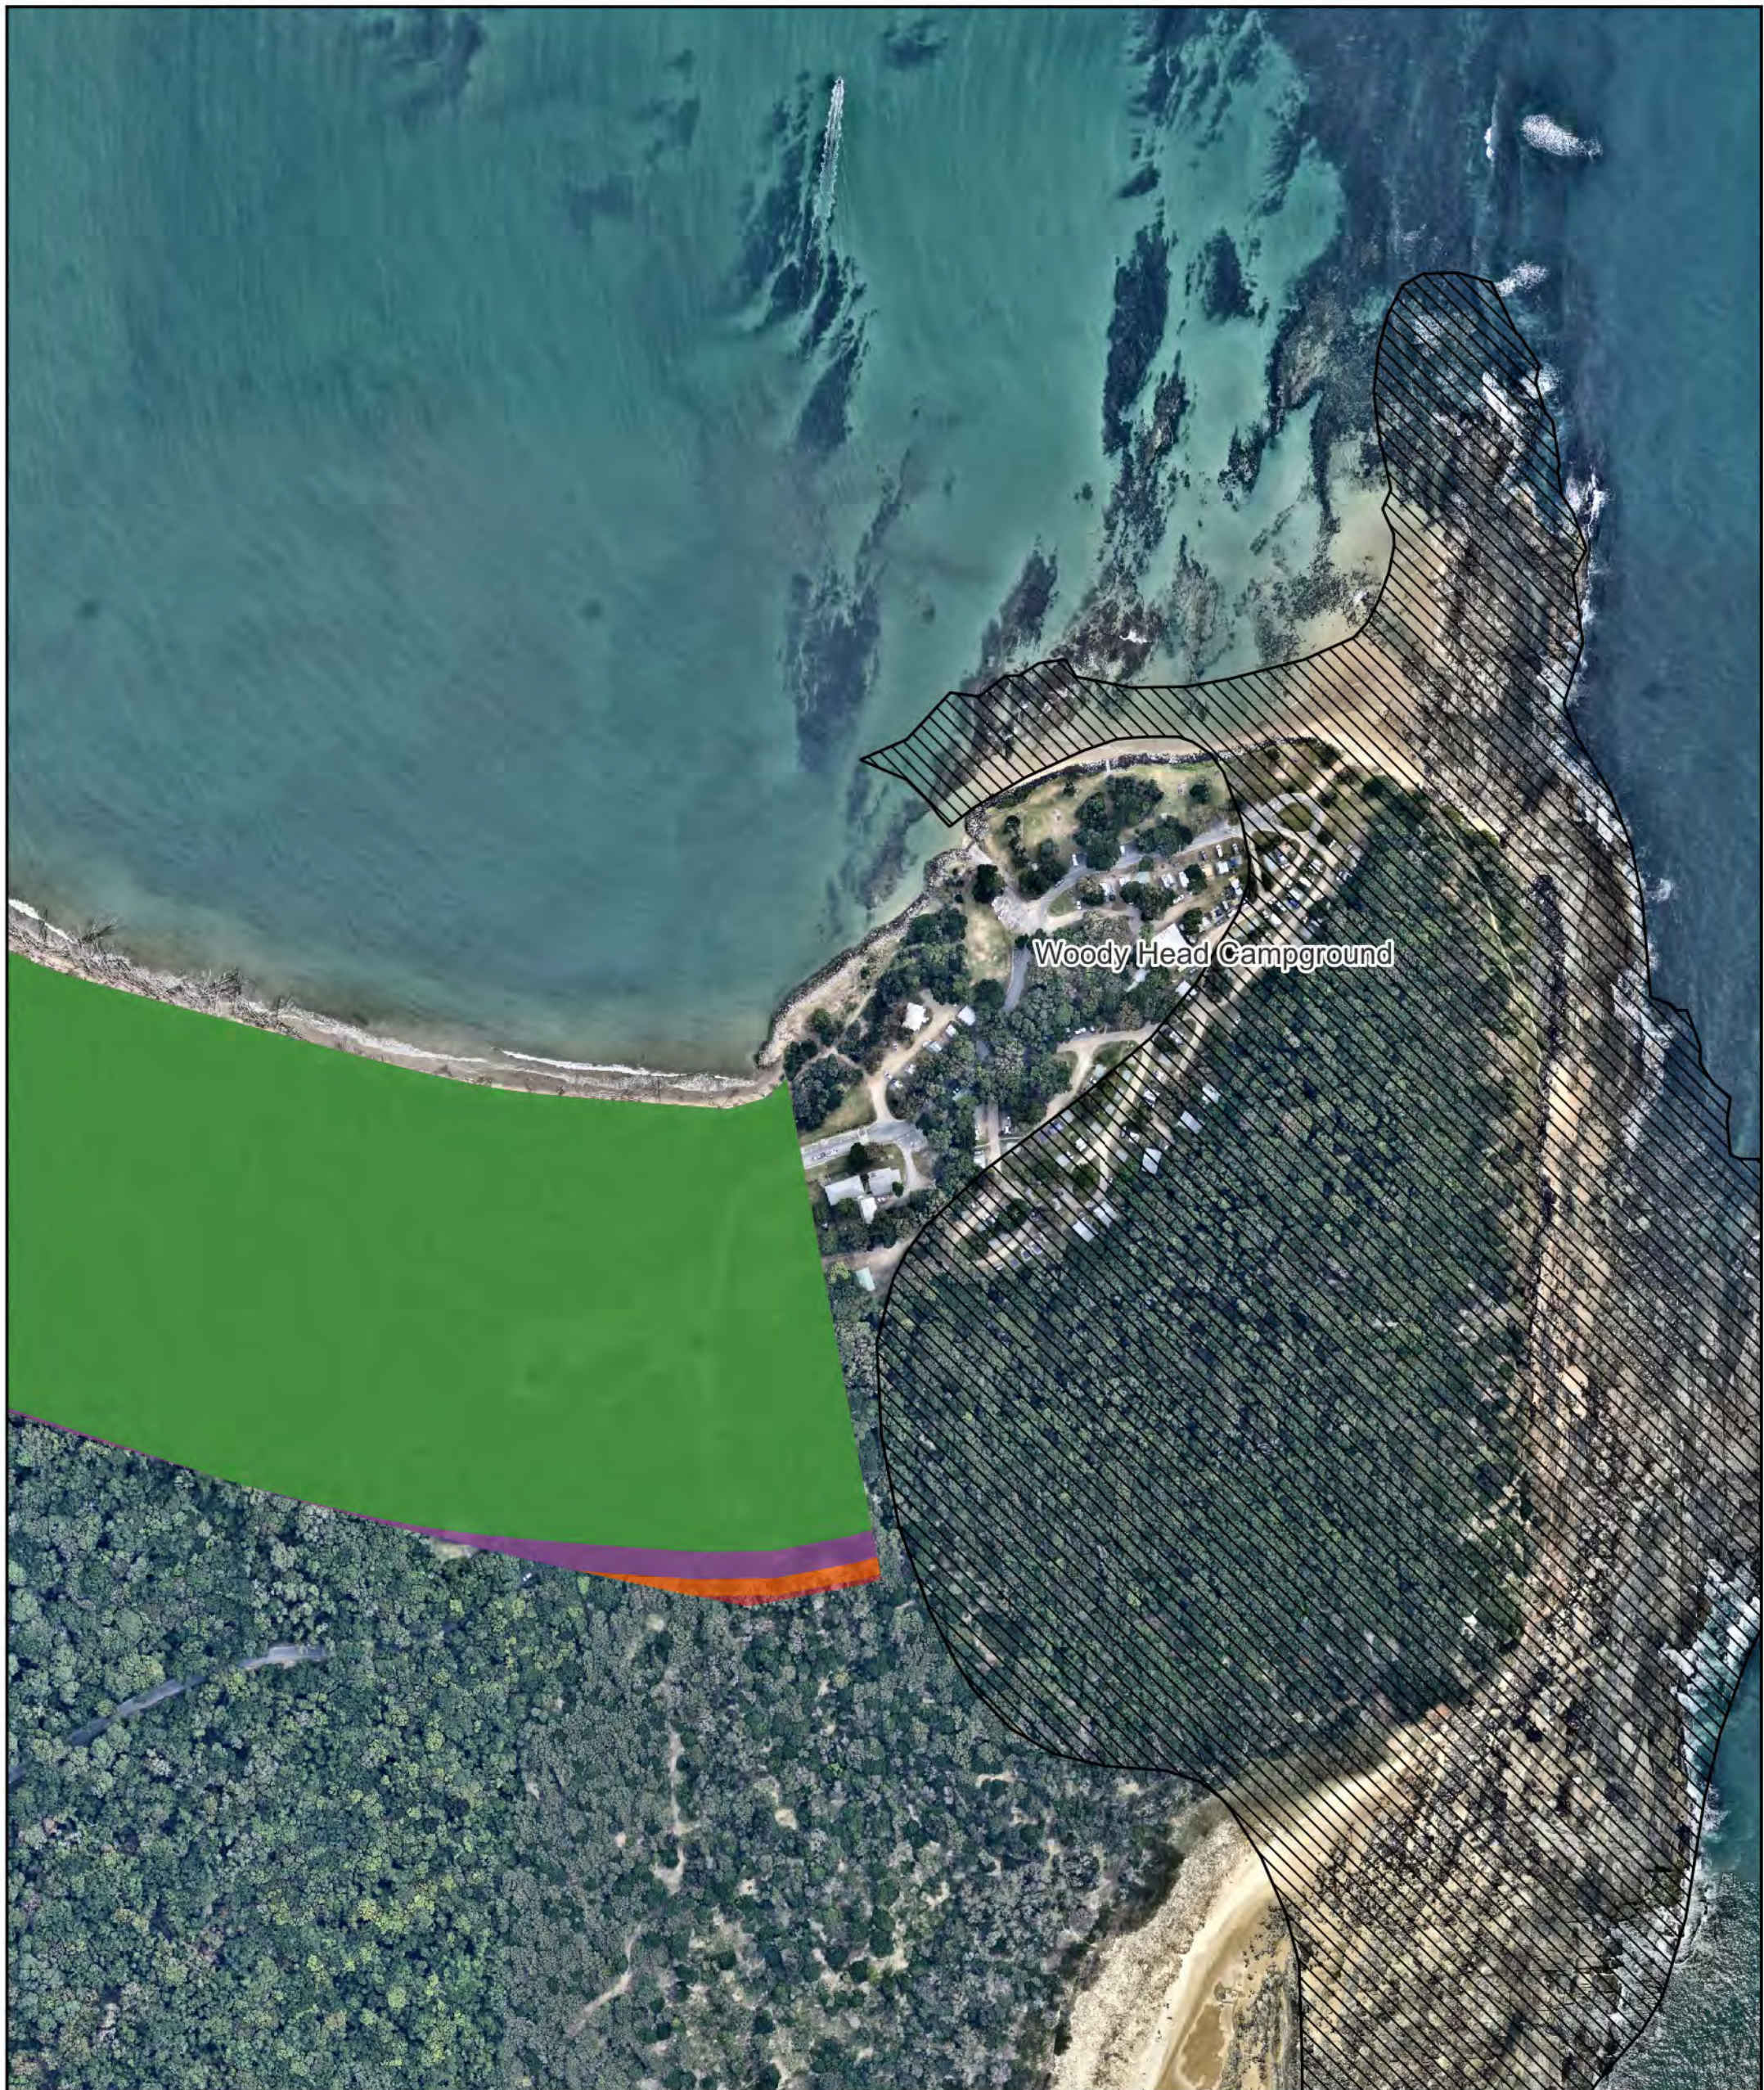
- Erosion and recession hazard zones (without protection)
- 50% exceedance probability

- 10% exceedance probability

- 2% exceedance probability

- 1% exceedance probability

Title
Erosion and recession hazard zones -SSP2 2073: Woody Head Campground

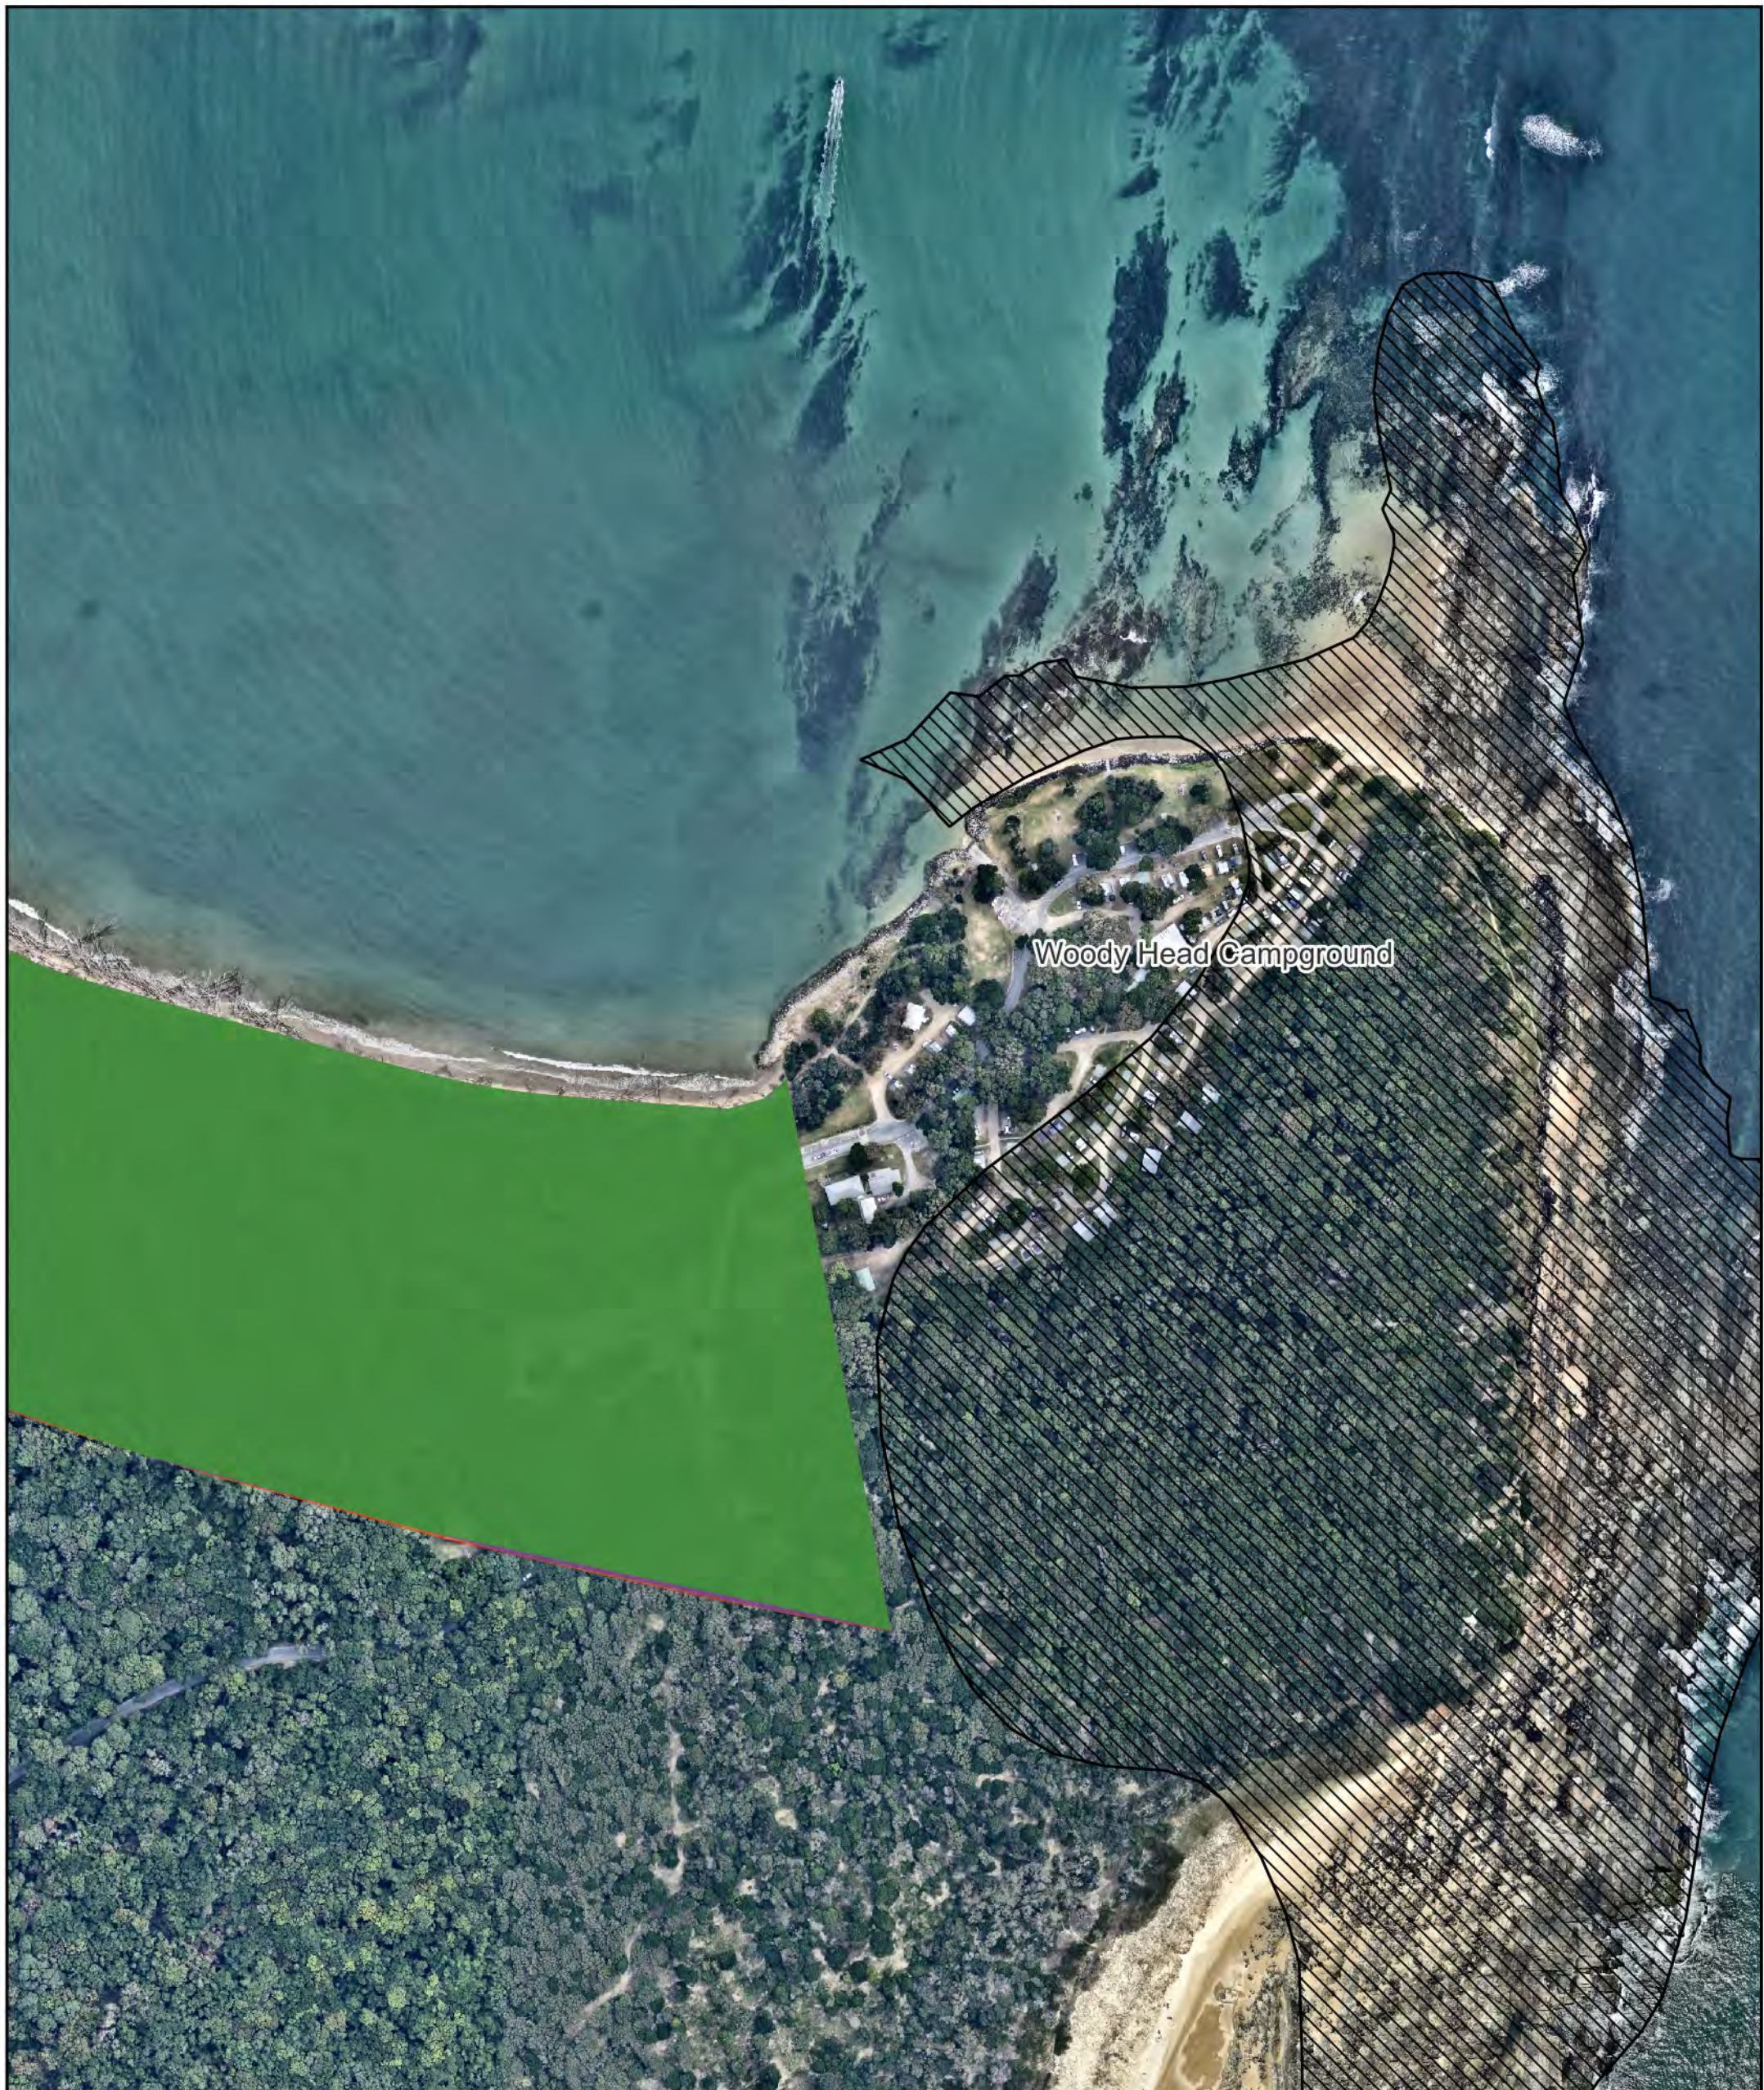
- Erosion and recession hazard zones (without protection)
- 50% exceedance probability

- 10% exceedance probability

- 2% exceedance probability

- 1% exceedance probability

Title
Erosion and recession hazard zones -SSP2 2123: Woody Head Campground
