**NSW National Parks and Wildlife Service**

# **Draft coastal hazard response plan**

**Sandon River campground, Yuraygir National Park**

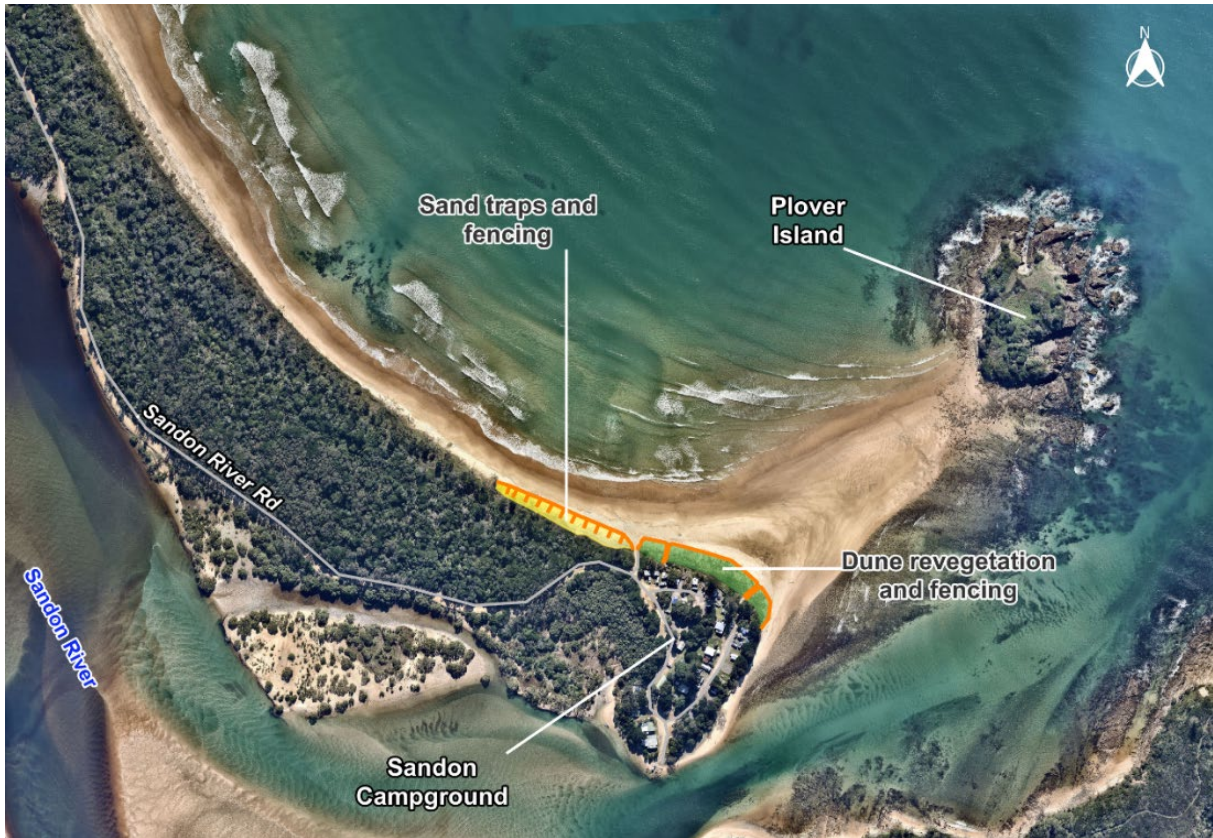
Figure 1 Existing dune stabilisation works, Sandon River campground, 2024

Coastal management actions such as coastal erosion mitigation measures at Sandon River campground are currently implemented on a case-by-case basis in response to coastal erosion events. For example, in response to the 2017 storm event that resulted in coastal erosion of the sand dunes, the NPWS constructed sand-trap fences and revegetated the dune (Figure 1, Photos 3 and 4).

**Dune area revegetation.** Revegetation works have been undertaken next to the north of the campground, east of the 4WD access track (Figure 1). These areas should be improved and maintained with further infill plantings to increase the diversity and stability of the area.

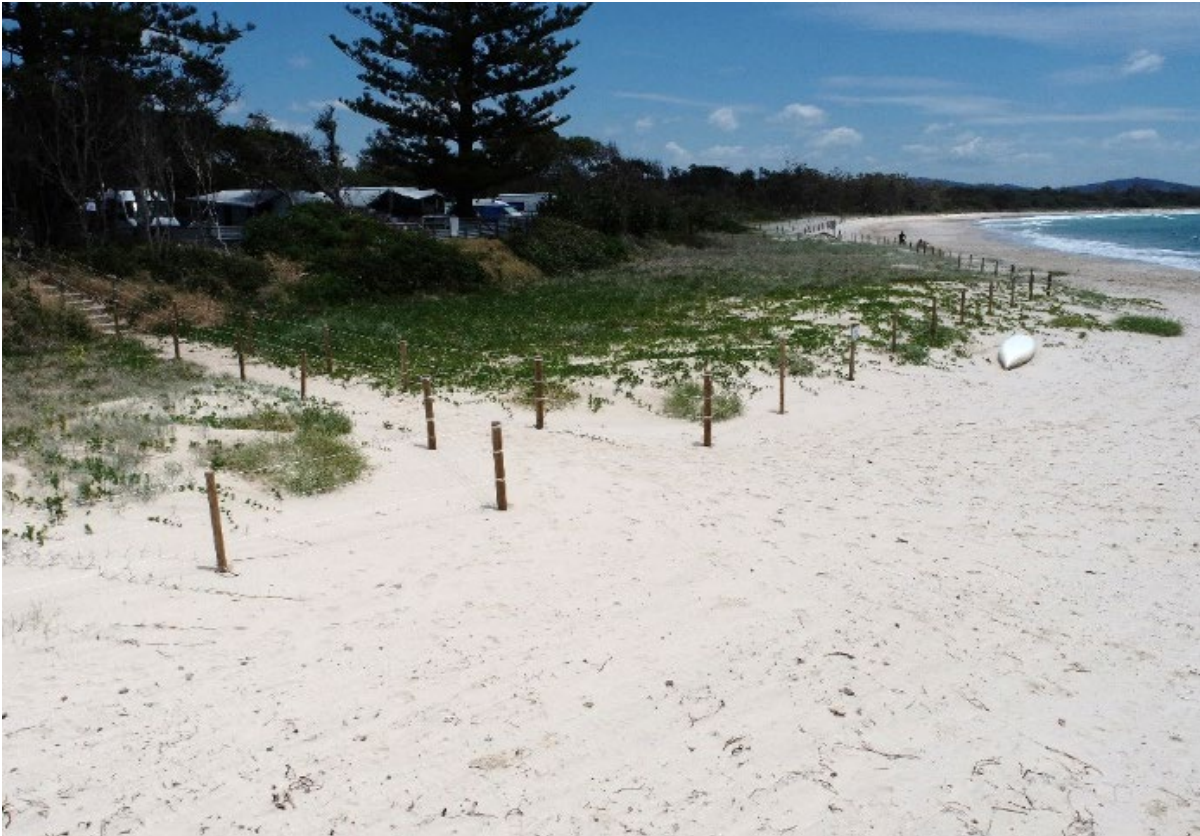
**Photo 3** Dune rehabilitation area adjacent to Sandon River campground, 2022

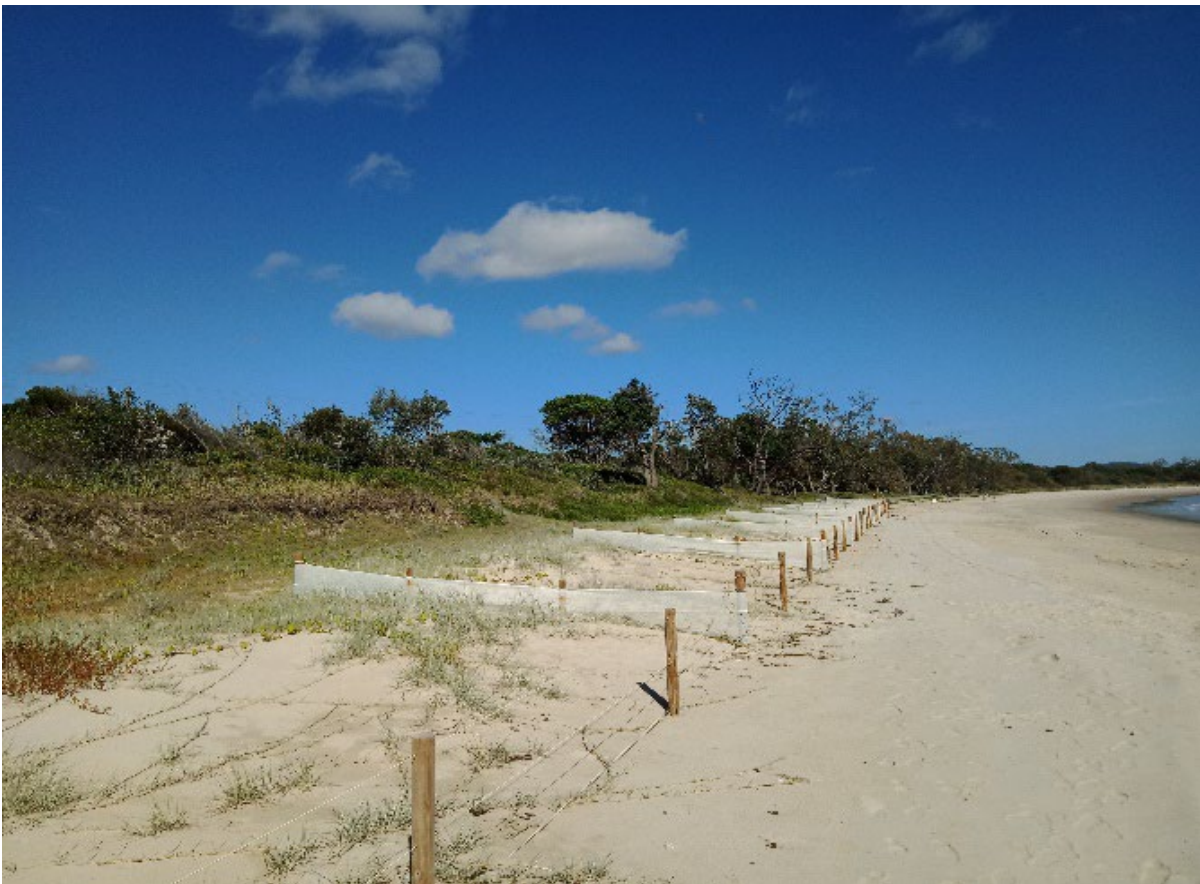
**Photo 4** Dune rehabilitation area adjacent to Sandon River campground, 2023

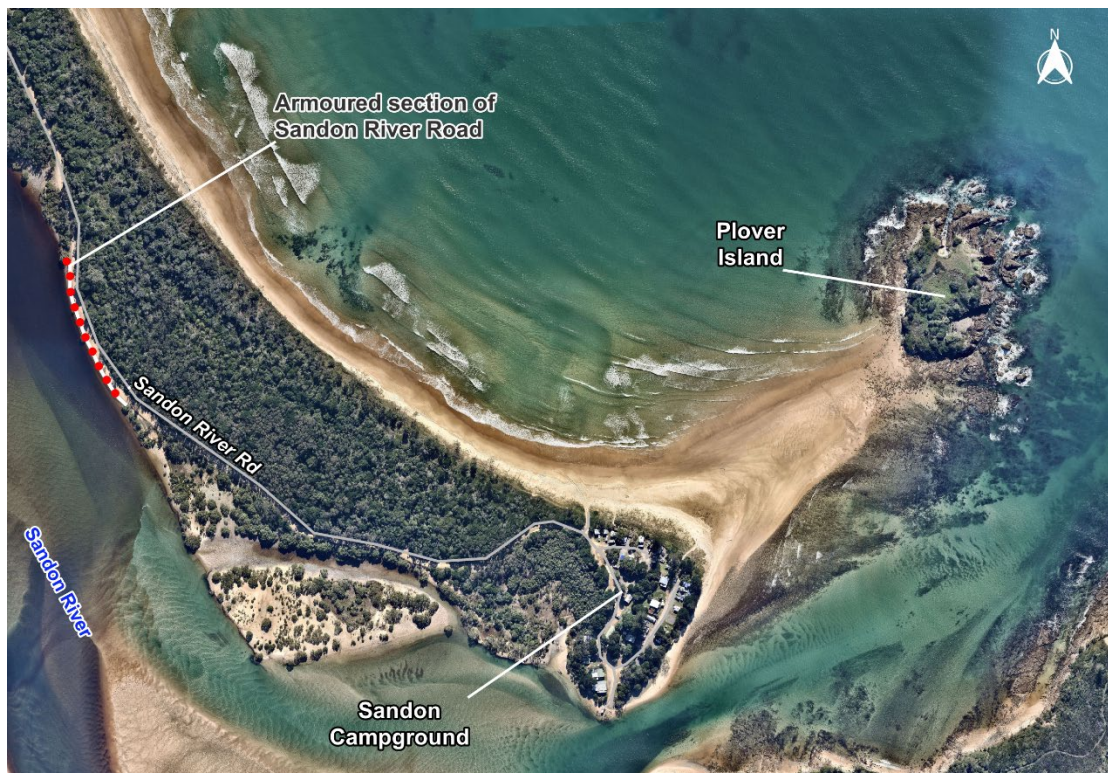
Figure 2 Aerial view showing section of Sandon River Road armoured with rock protection, 2024

On the western side of the peninsula, much of Sandon River Road is located close to the riverbank, where it is impacted by high tides and small waves that also cause bank erosion. A section of the road (approximately 150 m in length) has been armoured with rock revetment to prevent further riverbank erosion (see Figure 2 and Photo 5). With extreme high tides, the road can currently be inundated with water from the river rising above the banks.

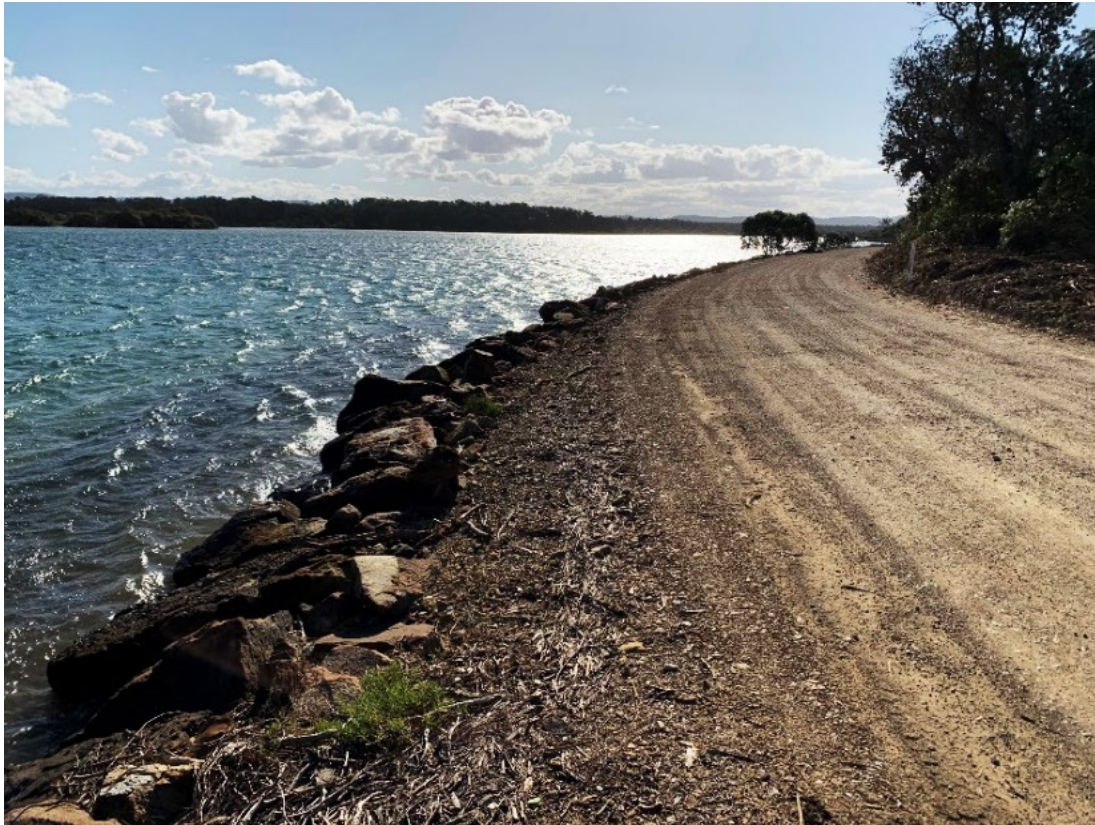
Photo 5 Section of Sandon River Road armoured with rock protection, 2020

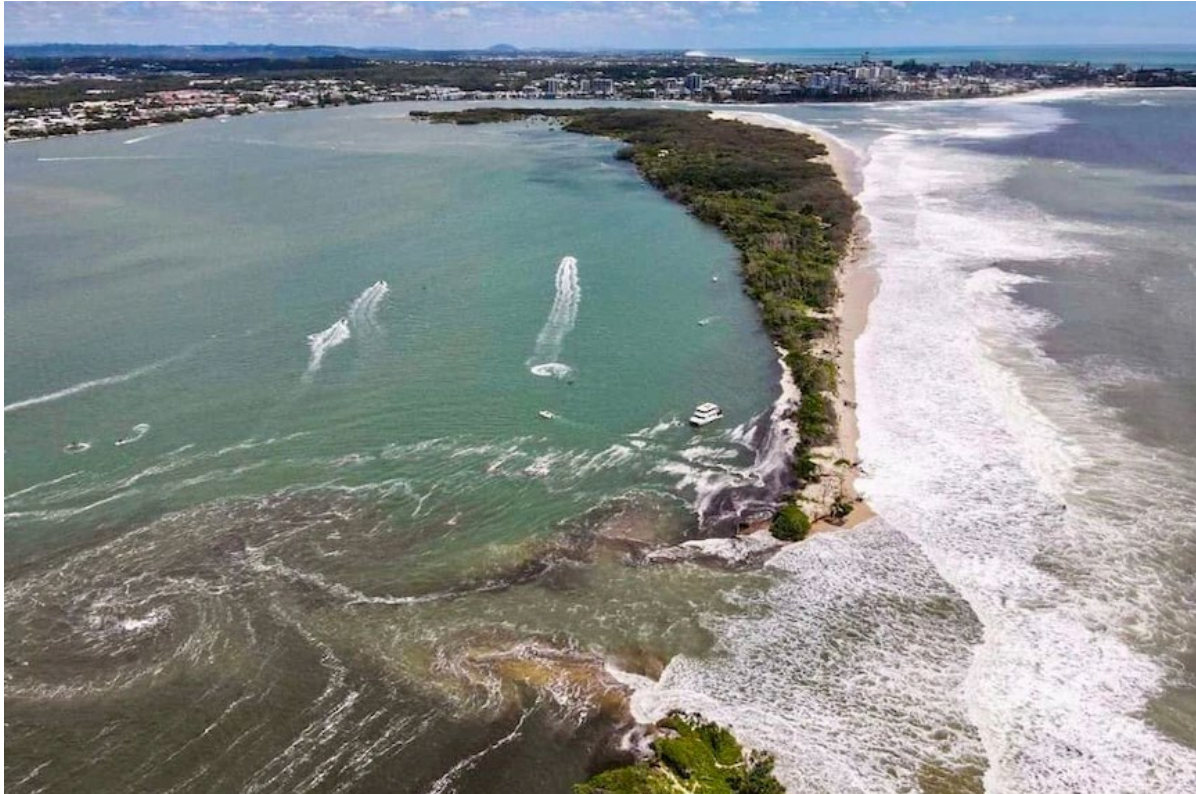
**Photo 6** Aerial view of 'break through' caused by natural coastal processes, Bribie Island, Queensland, 2022. Source: Blueys Photography

This type of impact occurred in 2022 on Bribie Island in Queensland. A combination of ongoing erosion and recession and coastal inundation led to the breakthrough of a narrow section of Bribie Island (Photo 6). This event created an area of significant exchange between the ocean and Pumicestone Passage and a channel resulting in broader geomorphic and tidal impacts.

If a similar event occurred at Sandon River, it would not only impact assets within the direct footprint of the breakthrough but would prevent road access to any areas to the south of the break-through point.

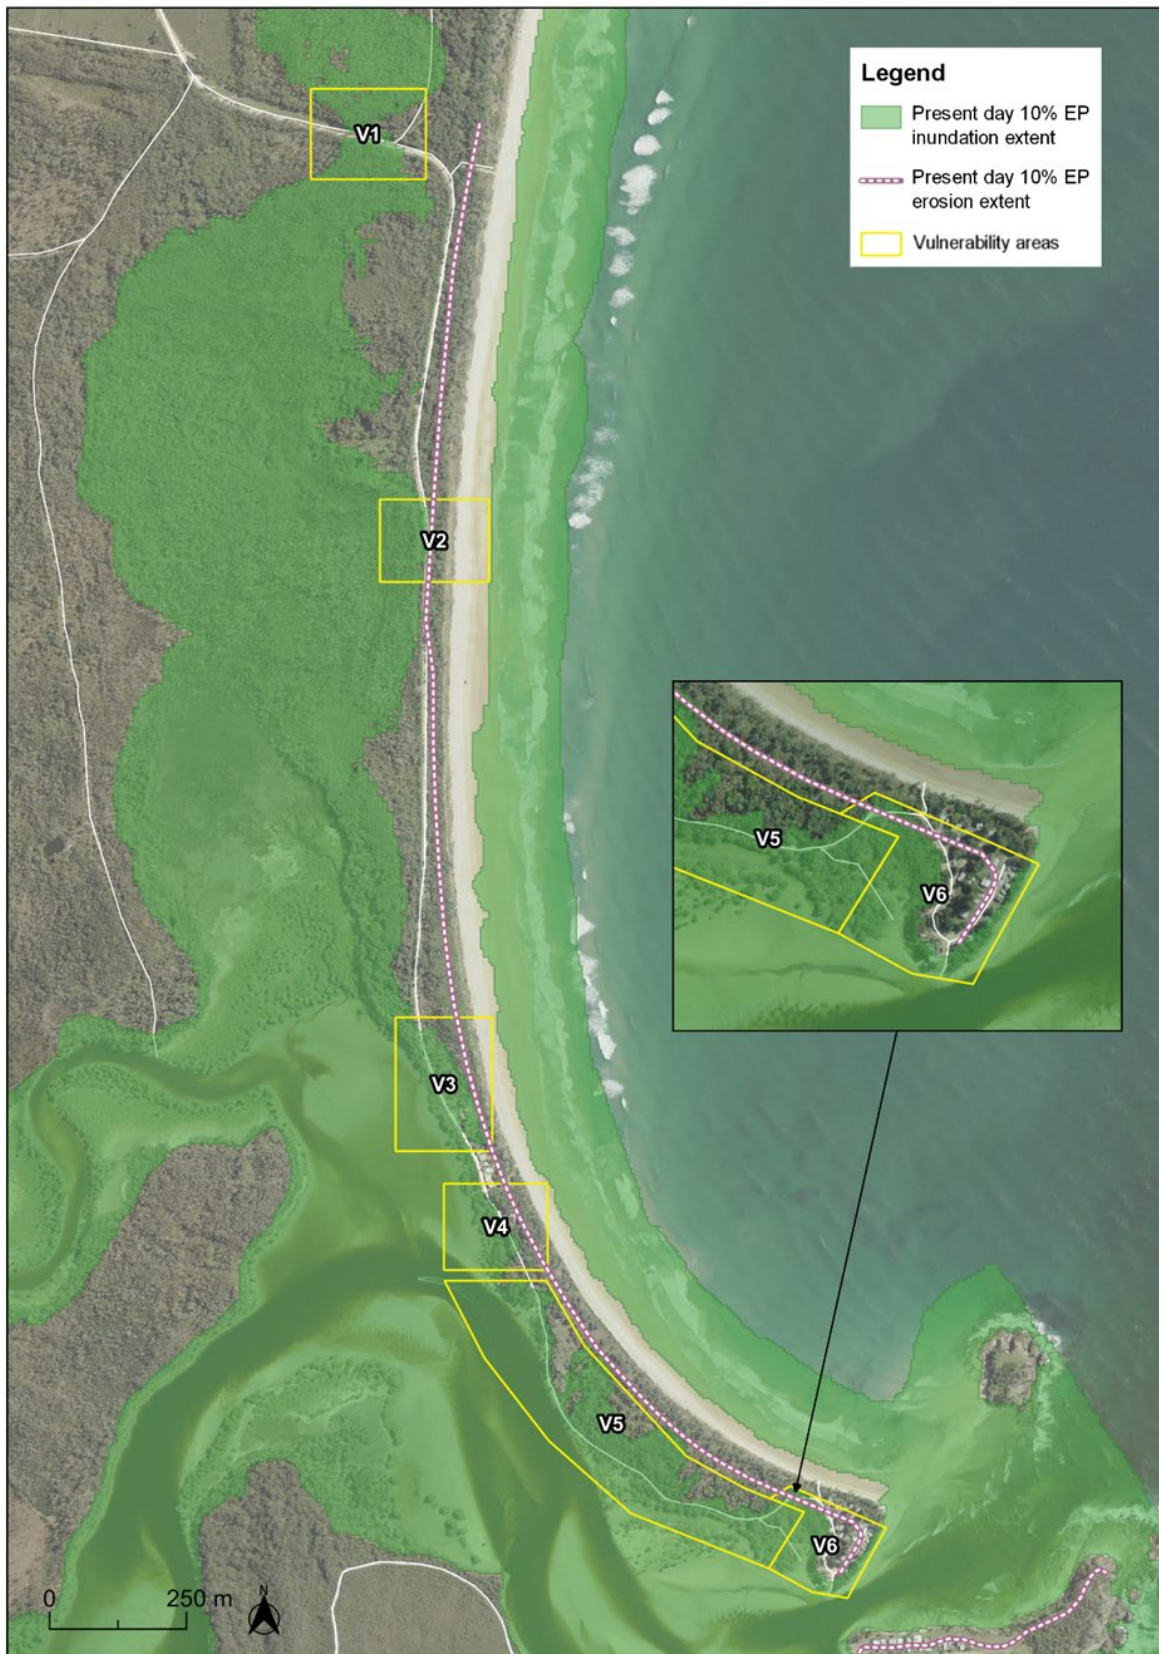
**Figure 8 Coastal hazard vulnerability zones V1 to V5 (along Sandon River Road) and V6 (Sandon River campground area) for present day (2024) inundation and erosion events**

Note: 10% EP = exceedance probability risk of less than 10% (frequent to rare).

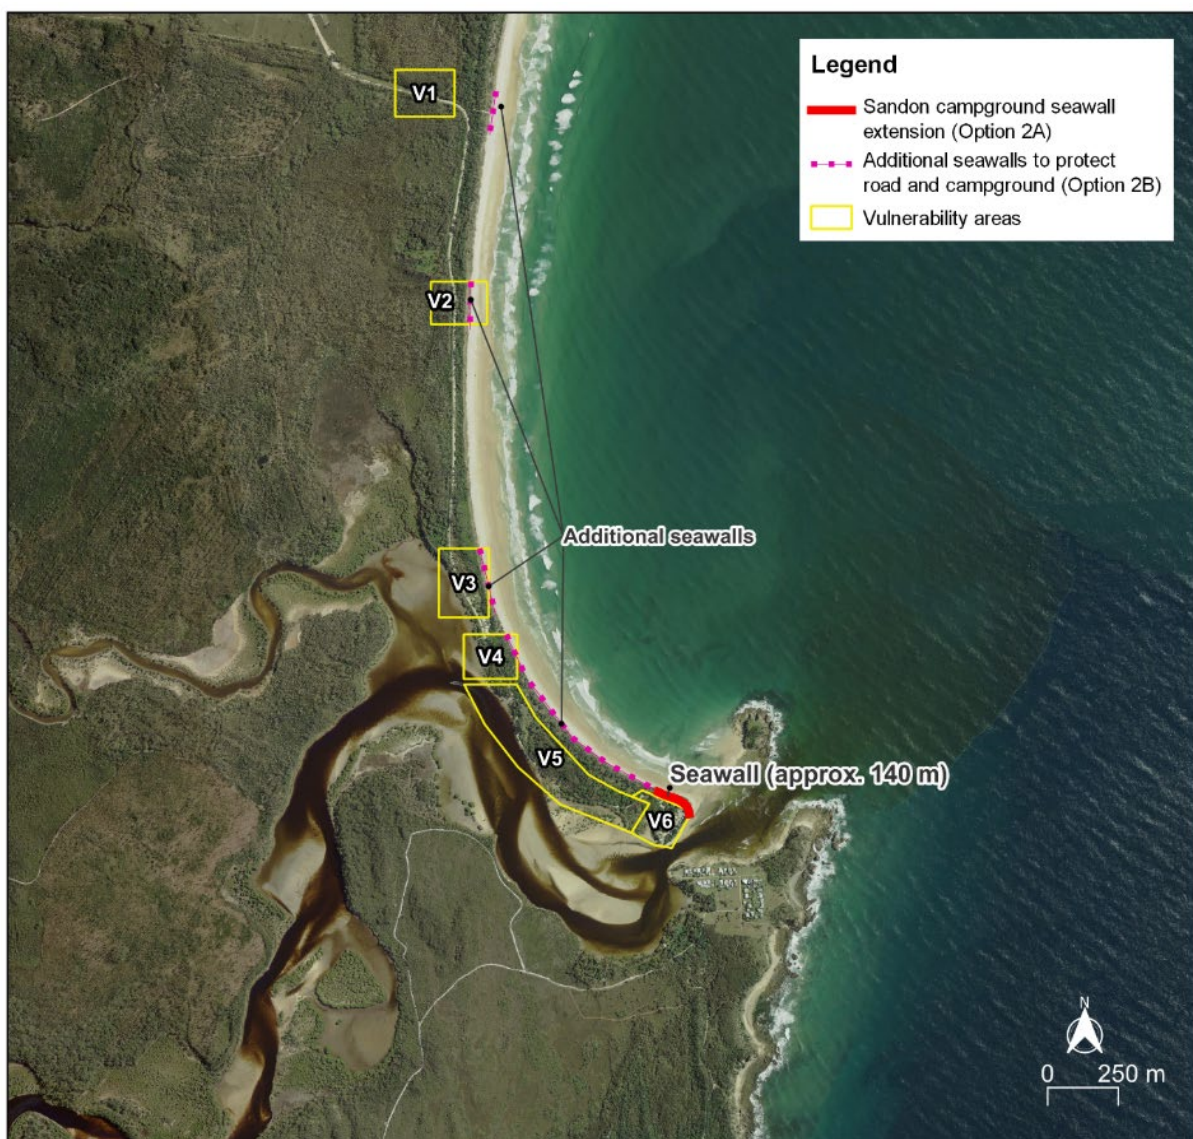
**Figure 10** Aerial view of locations for proposed seawall to protect Sandon River campground (option 2A) and the campground and access road (option 2B)

Seawalls are costly and may adversely impact the natural values of the area as well as the scenic amenity. Hard engineering structures would significantly affect natural coastal processes and potentially exacerbate erosion at the tombolo. While seawall options would provide erosion protection, they would not protect the campground and road from marine and estuary inundation unless they are constructed higher than current and projected inundation levels. Higher seawalls would further impact local amenity. More detailed modelling and analysis of coastal processes would be required if seawall options are pursued.

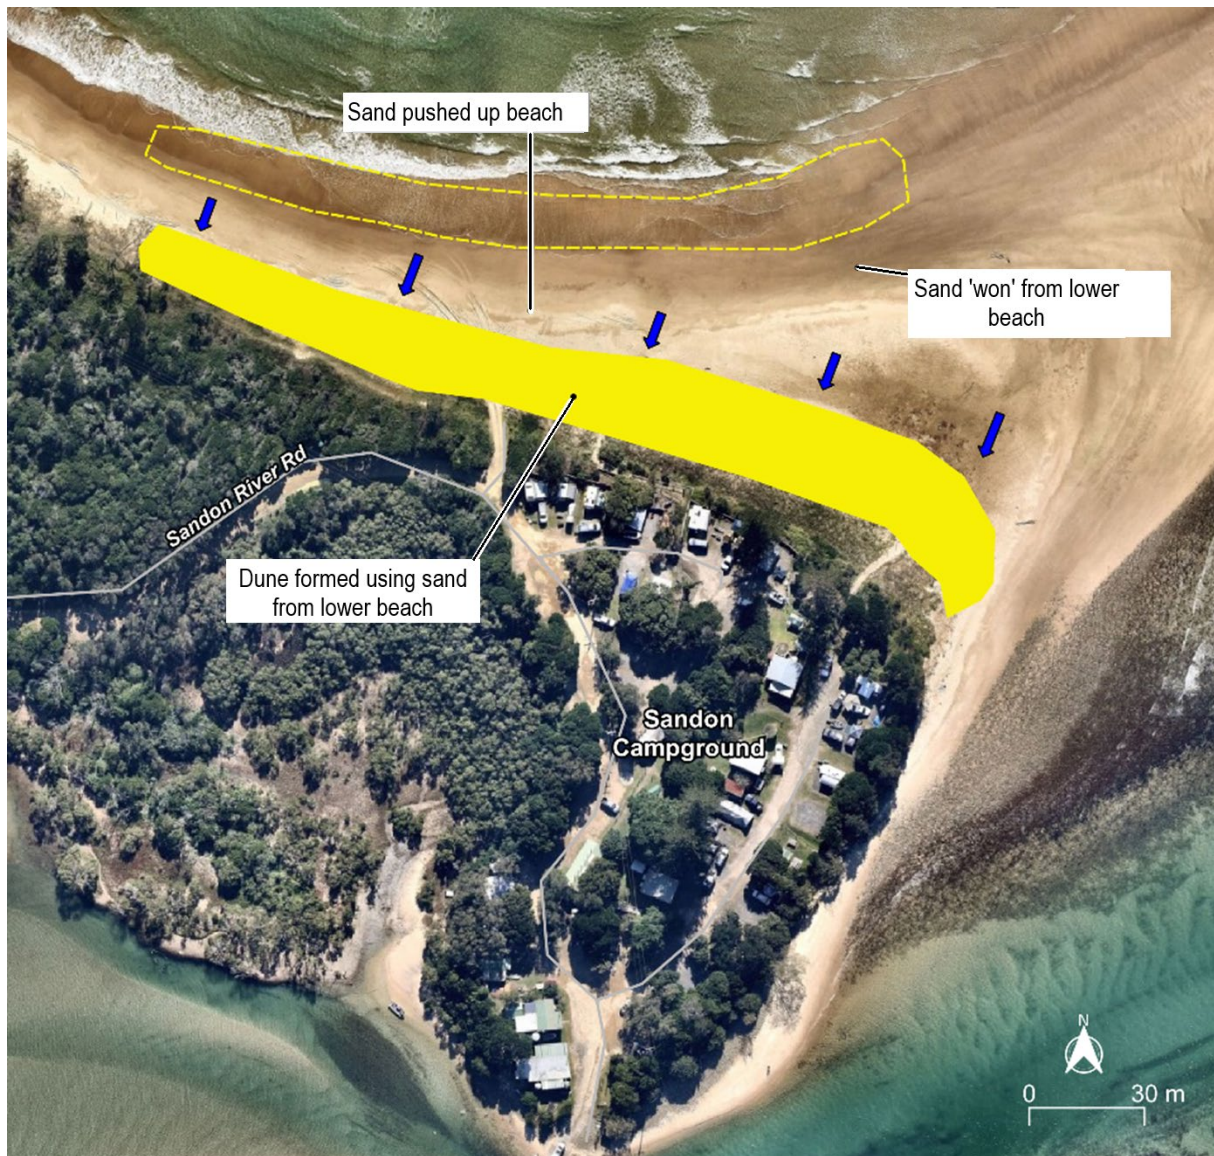
Figure 11 Aerial view showing location of potential beach scraping area to protect against erosion

Analysis of historic beach profiles, a feasibility assessment, a strategy for beach scraping and environmental assessment would be required before scraping could commence. The feasibility assessment would determine whether sufficient sand reserves would become available, and how and when scraping could occur, including triggers for each scraping event. Monitoring and a construction methodology including detailed costings need to be completed.

Sand won from a single scraping campaign may provide a buffer from a small erosion event. If multiple scraping campaigns could be undertaken in relatively quick succession – that is, with no erosion in between – larger volumes of sand could be accumulated to provide a buffer against more significant erosion events. This option could temporarily extend the life of the campground and provide a buffer to facilitate retreat options.

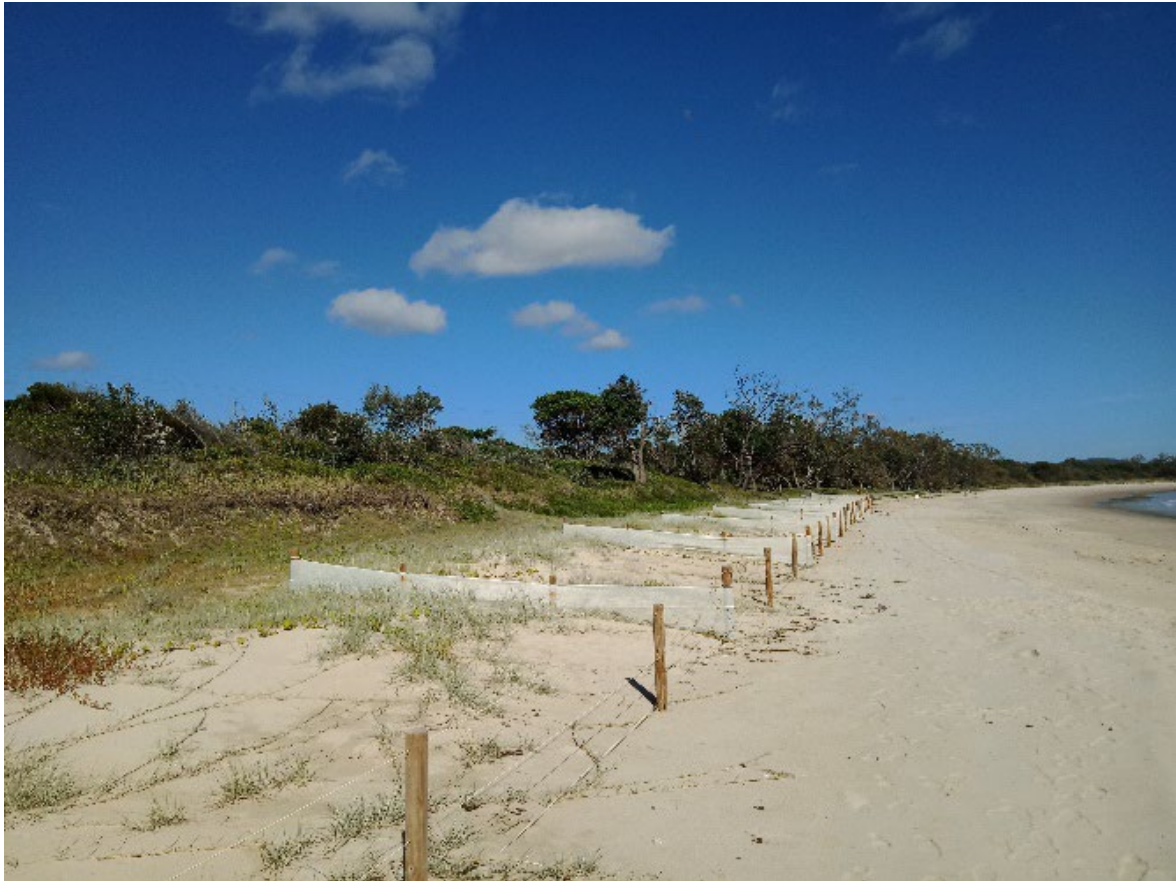
**Photo 7 North-easterly alignment of existing sand-trap fencing, Sandon Beach, 2023**

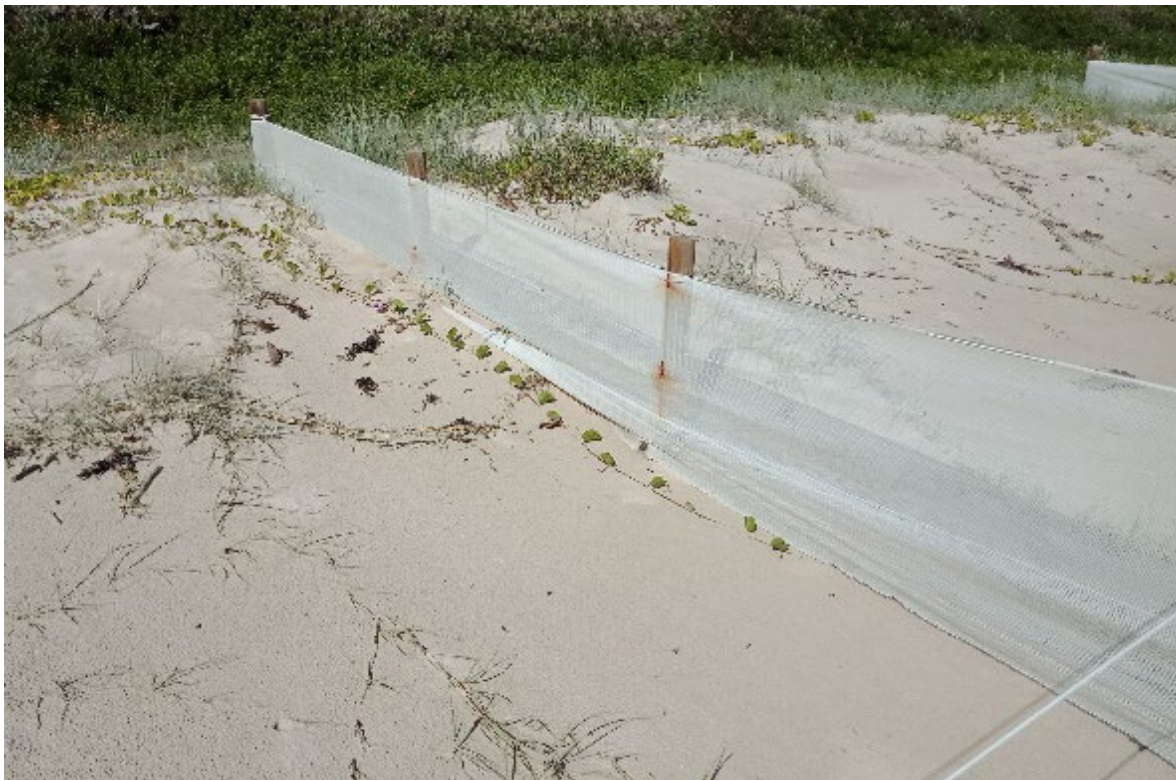
**Photo 8 Close-up view of a sand-trap fence, Sandon Beach, 2023**

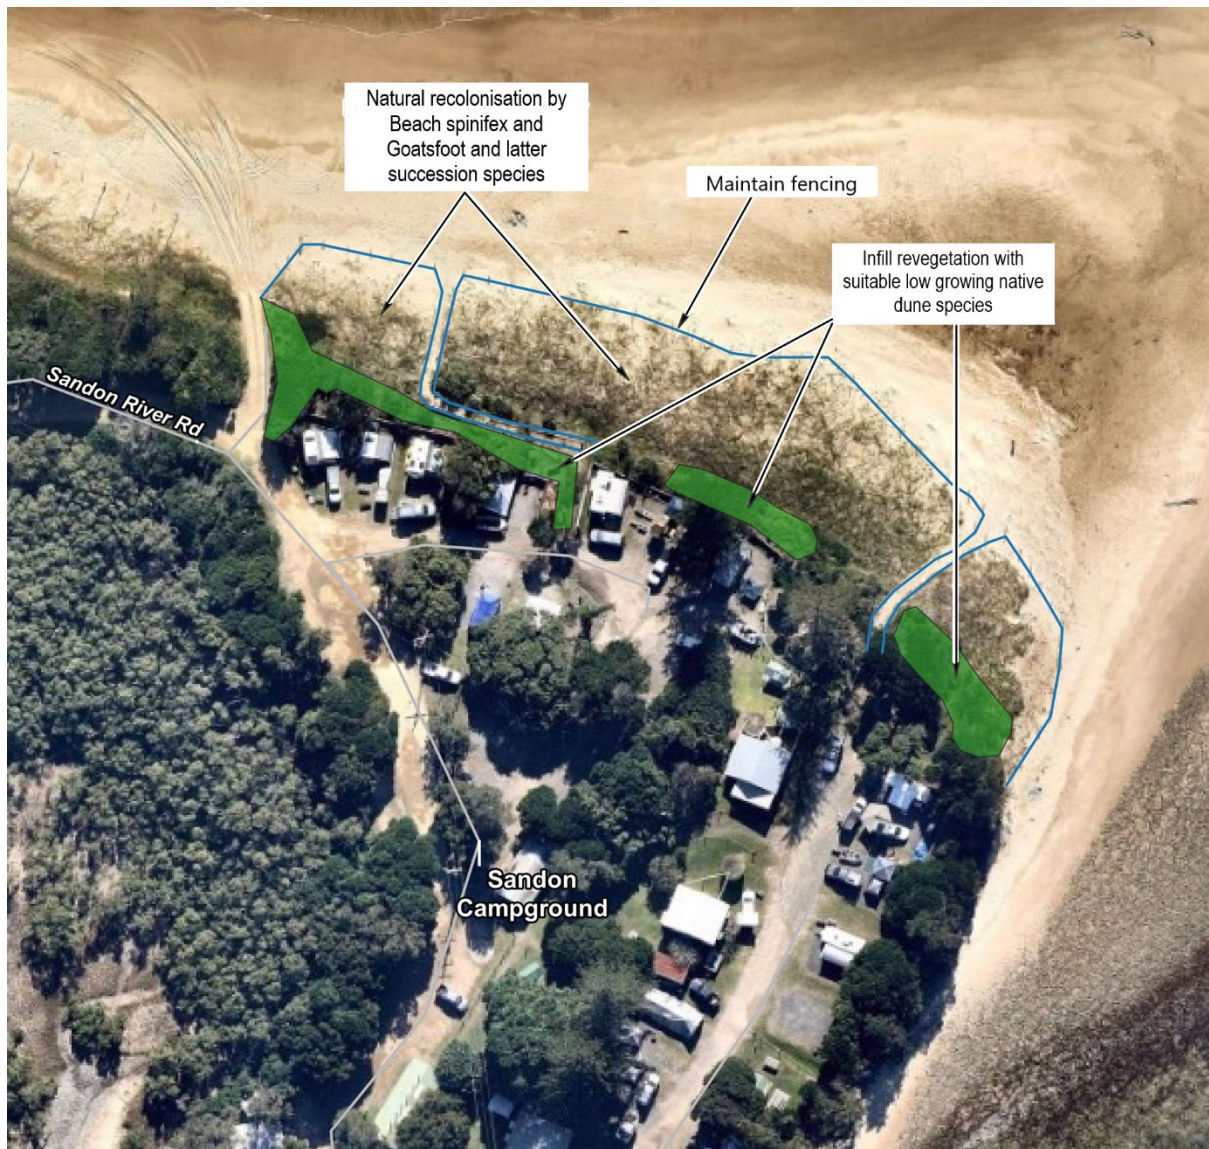
Figure 15 Aerial view of proposed revegetation plan for Sandon River campground, 2024

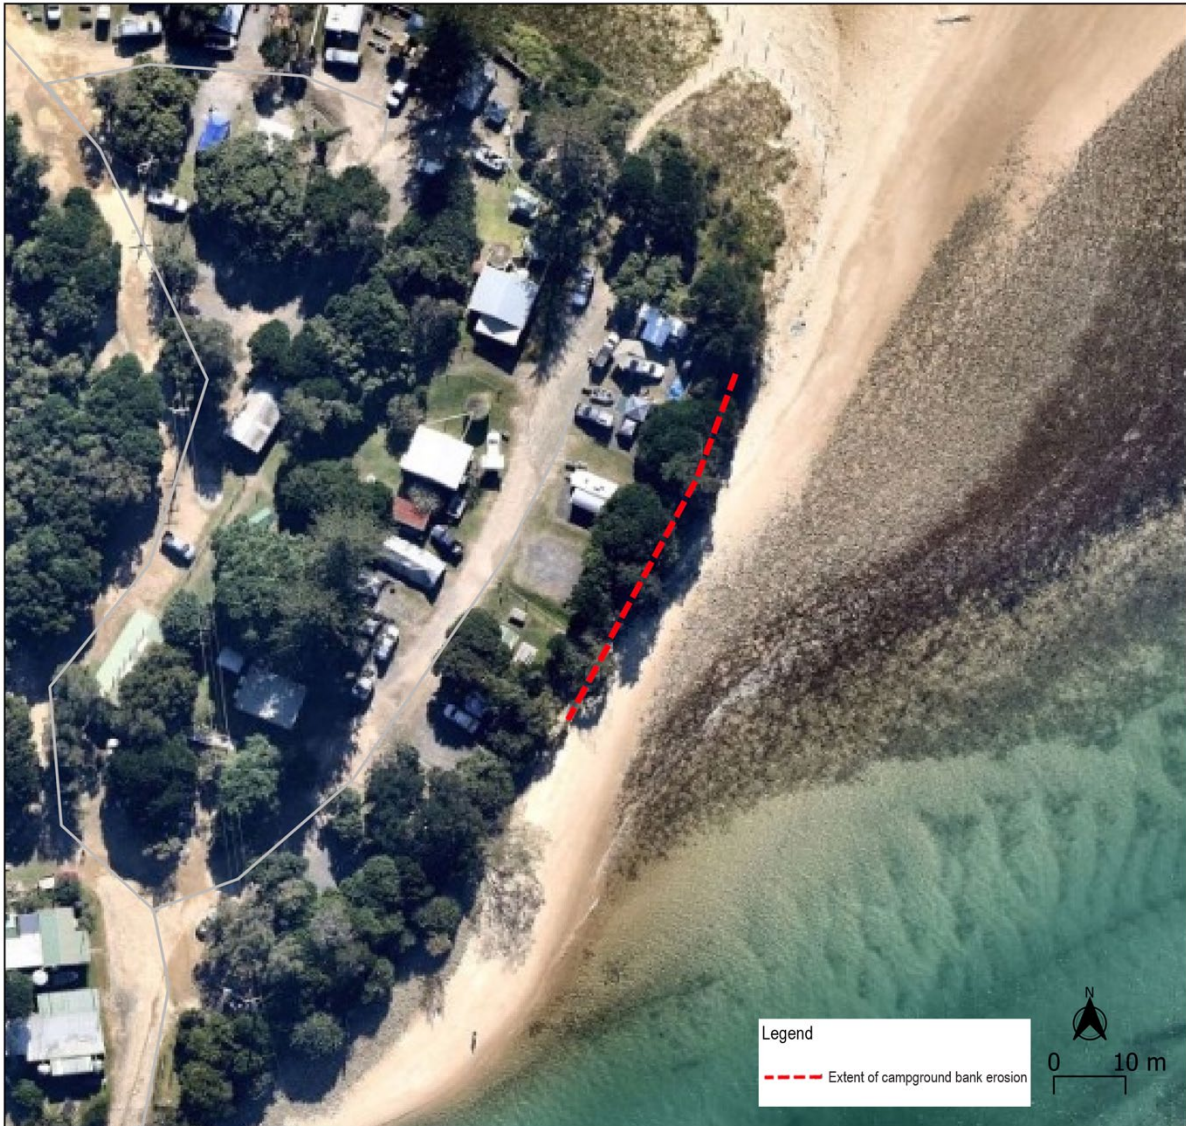
Figure 16 Aerial view showing the location of intermittent erosion (red dash line) of the eastern riverbank, Sandon River campground

The riverbank along this section is well fenced along the perimeter of campsites. A formalised access point includes a set of stairs for public access. Ad-hoc public access does not appear to be contributing to erosion.

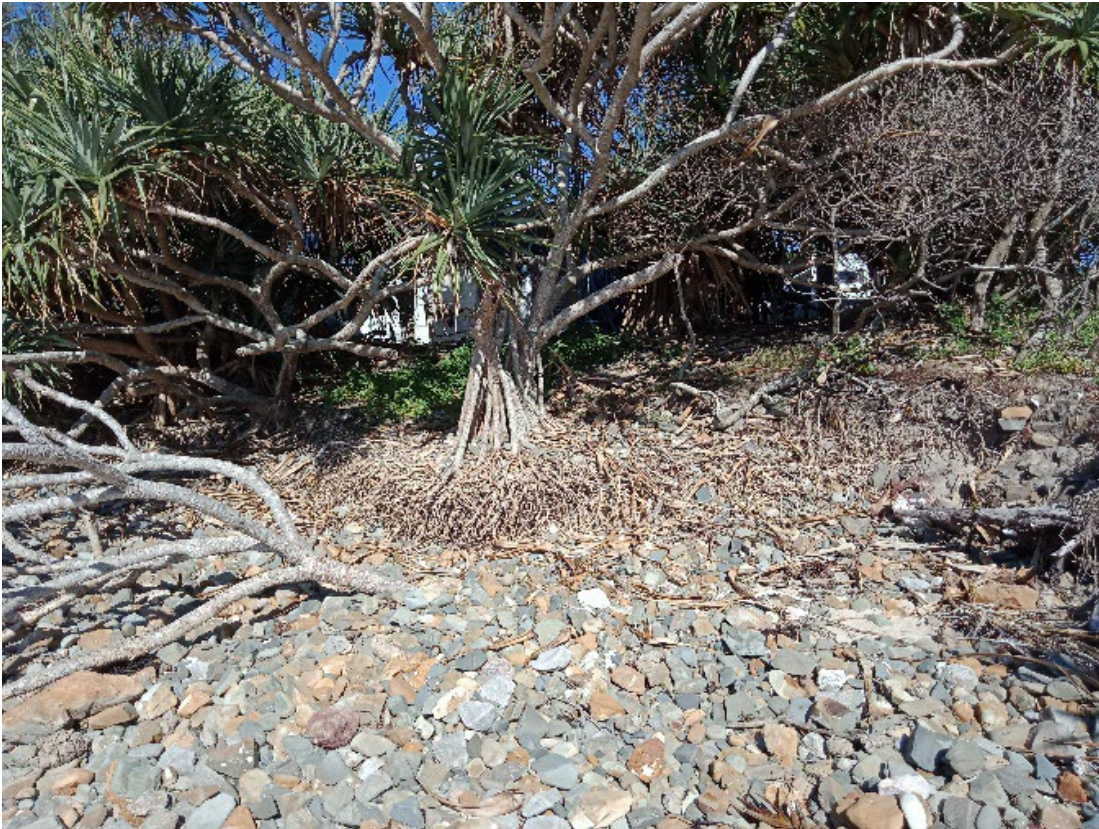
**Photo 9 Riverbank erosion occurring 10 metres south of access stairs, Sandon River campground, 2023**

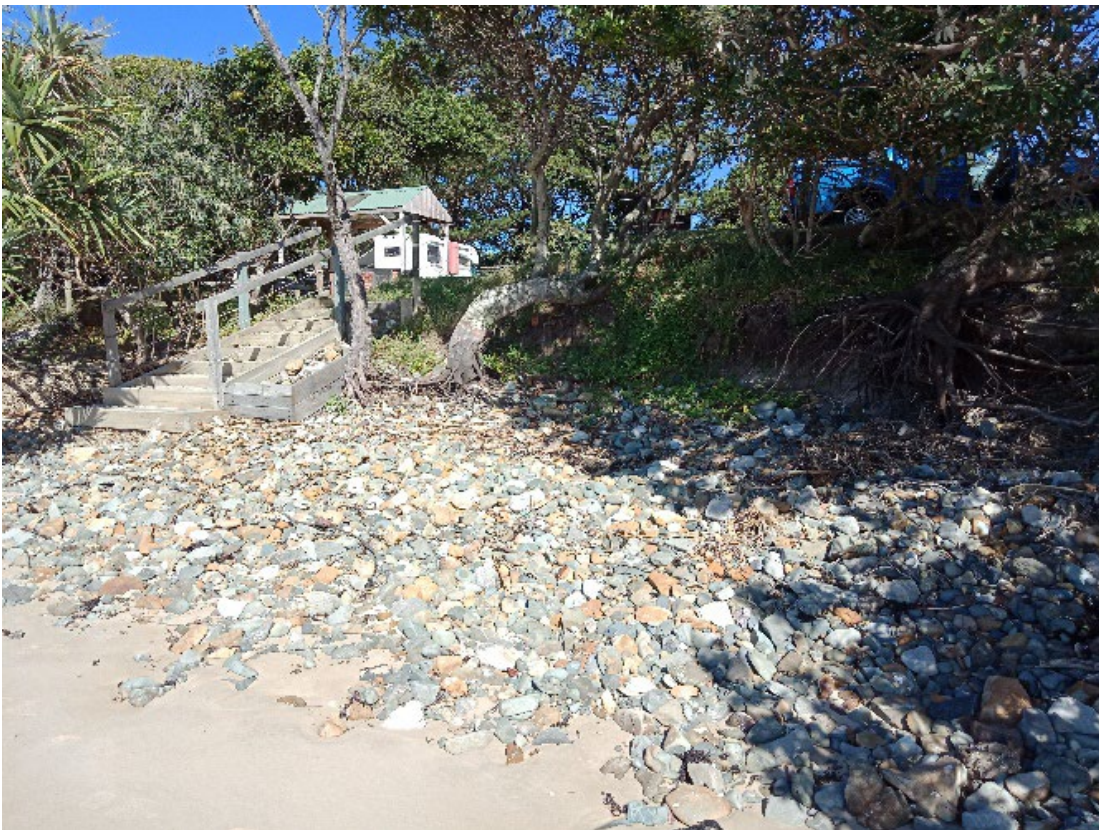
**Photo 10 Riverbank erosion occurring immediately north of access stairs, Sandon River campground, 2023**

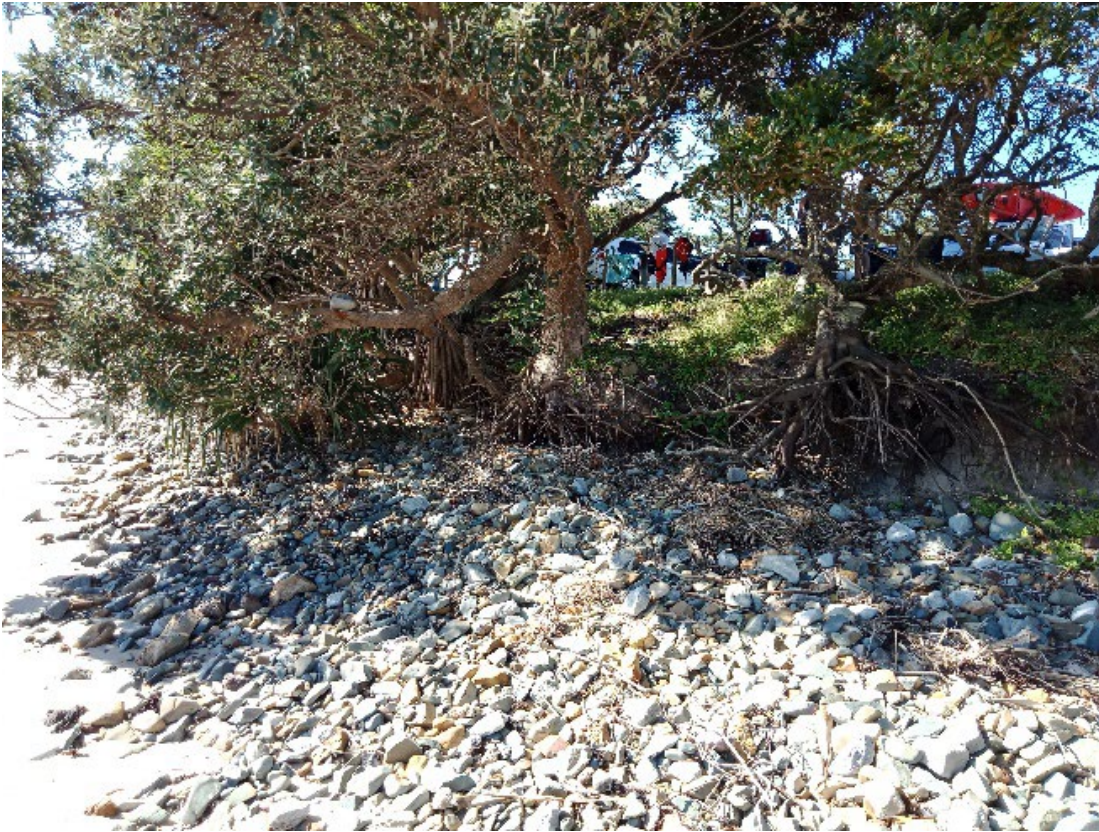
**Photo 11 Riverbank erosion occurring approximately 15 metres north of access stairs, Sandon River campground, 2023**

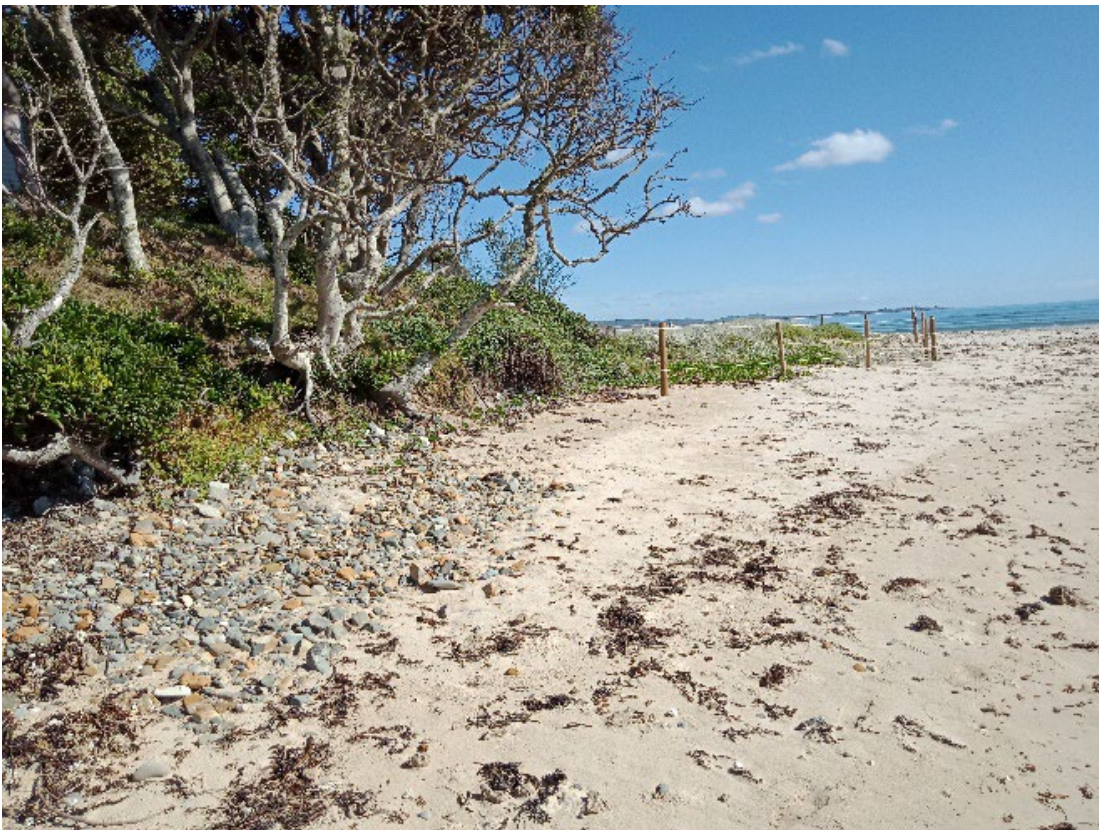
**Photo 12 Riverbank erosion occurring near the sand dune fencing, 45 m north of access stairs, Sandon River campground, 2023**

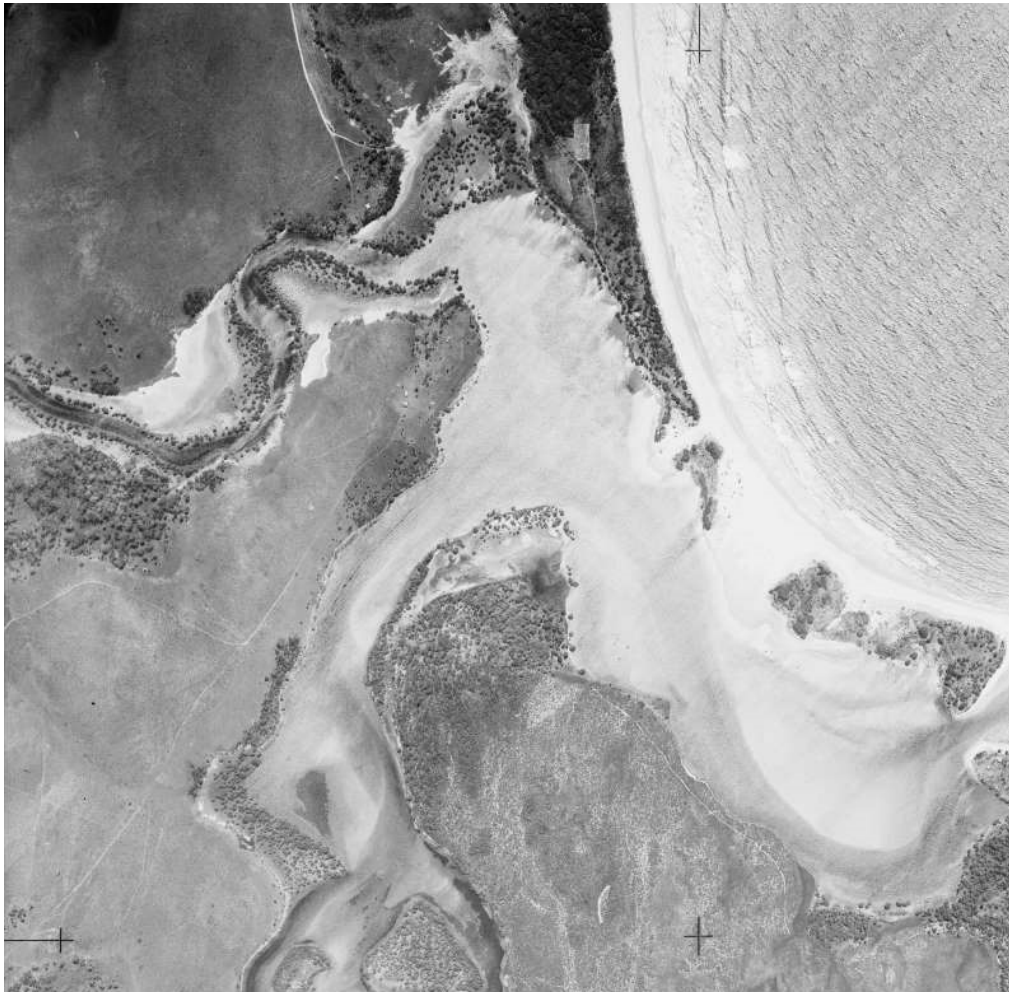
**Figure B.1 1942 – showing potential wave overwash at 2 locations and substantial sand accretion along Sandon Beach and within Sandon River**

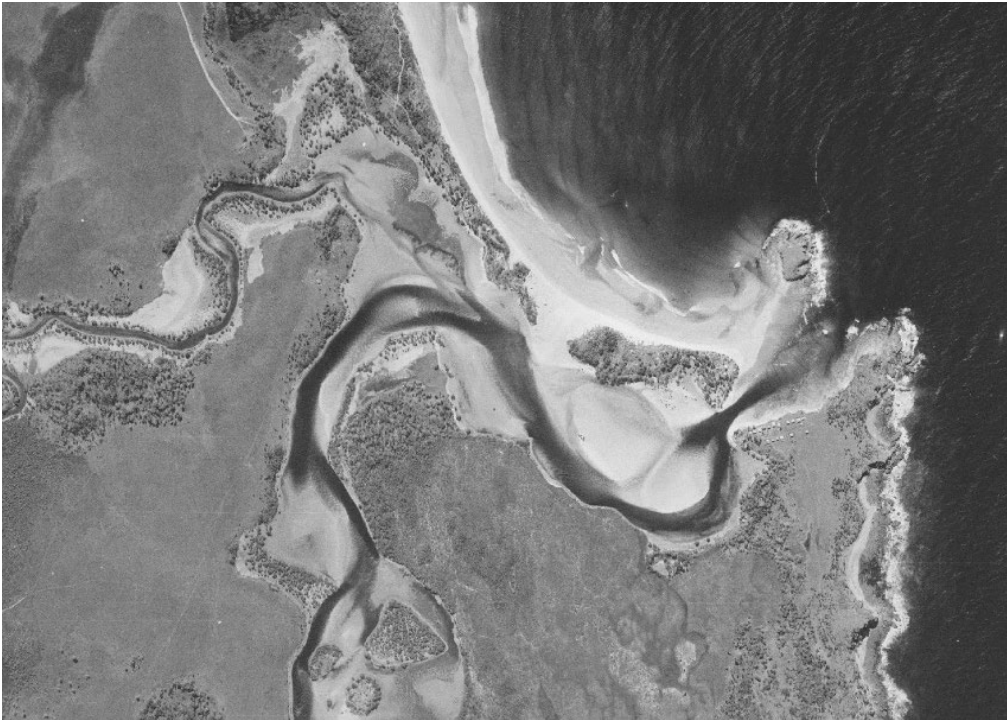
**Figure B.2 1958 – showing potential wave overwash at one location and substantial sand accretion along Sandon Beach and within Sandon River**

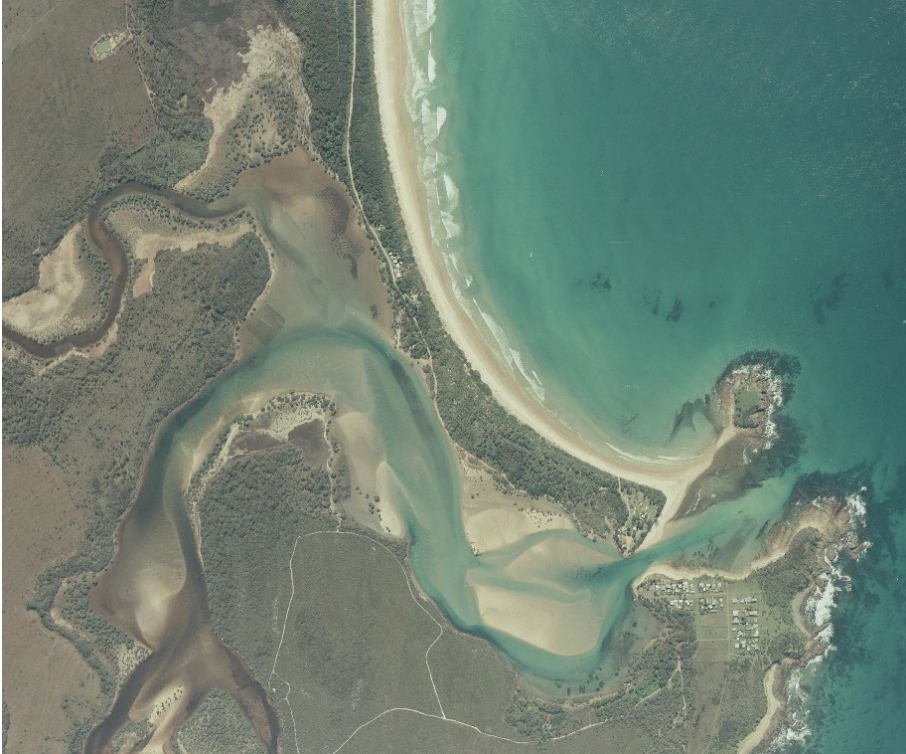
**Figure B.4 1993 – Sandon River campground established and expanded area of vegetation along Sandon River Road**
