**NSW National Parks and Wildlife Service**

# **Draft coastal hazard response plan**

**Sandon River campground, Yuraygir National Park**

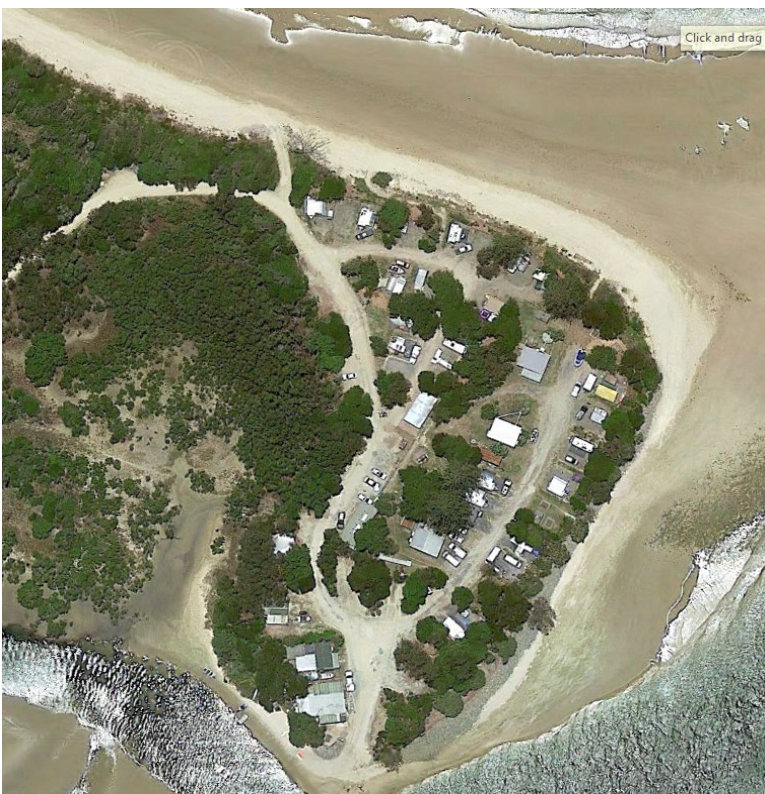
**Figure B.7 December 2017 – loss of dune and vegetation along northern section of Sandon River campground**
