NSW National Parks and Wildlife Service

Draft coastal hazard response plan

Woody Head campground, Bundjalung National Park

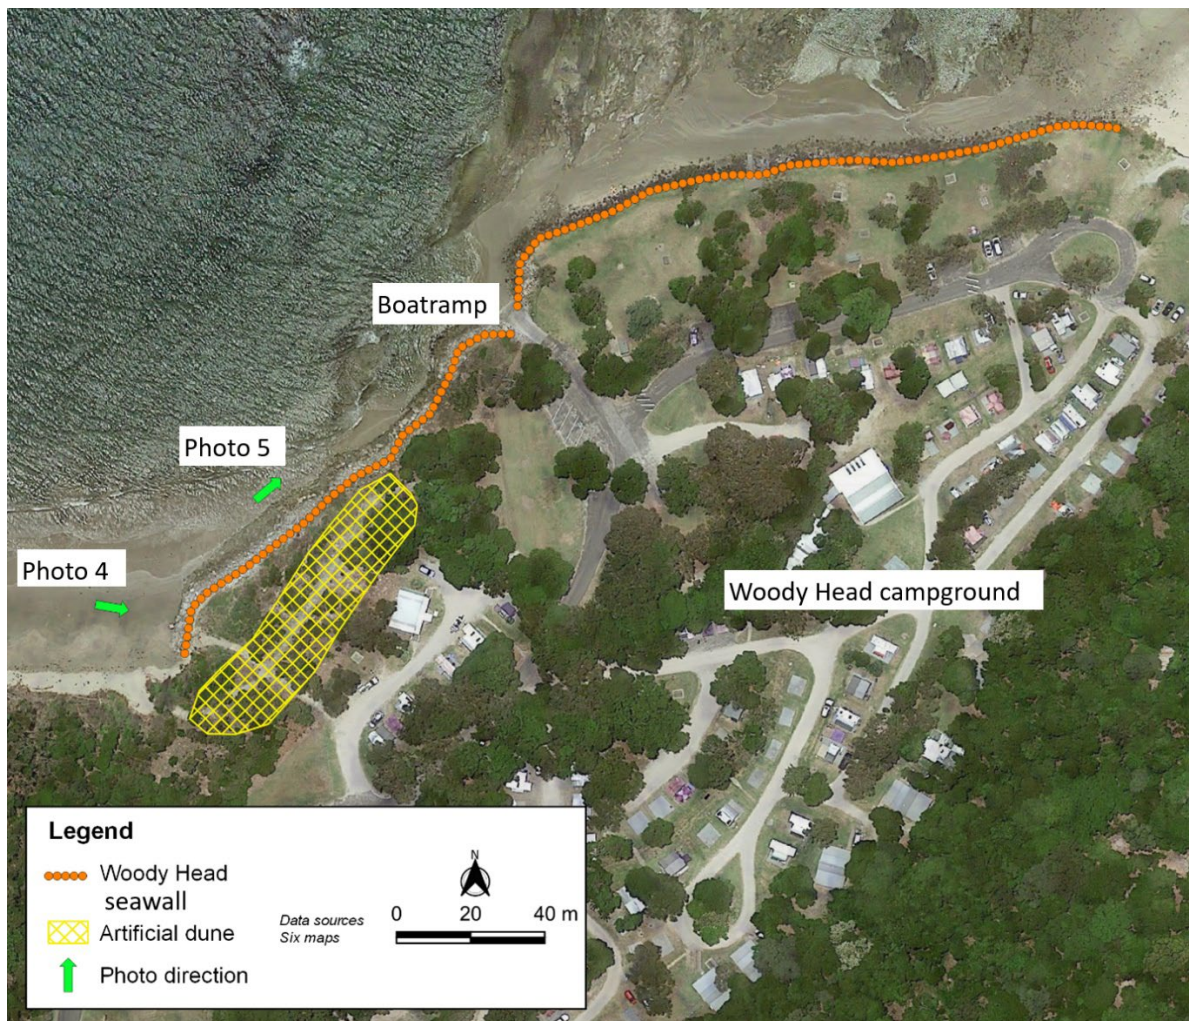
Figure 2 Location of seawall and artificial dune at Woody Head

A seawall was constructed along the shoreline of the Woody Head campground by NPWS (**Figure 2**) to provide protection against beach erosion and shoreline recession. The section east of the boat ramp is an older seawall founded on bedrock (constructed in the late 1980s and 1999). The section to the west of the boat ramp was constructed from 2006 and built progressively west from the boat ramp in several sections (**Photo 4** and **Photo 5**). The aim

An artificial dune was constructed at Woody Bay in 2004. The dune is approximately 100 m in length, 25 m wide and 2.5 m in height and has been revegetated with local dune species (**Figure 2**). The purpose of this dune was to limit wave overtopping and coastal inundation of low-lying areas of the campground and provide protection to the facilities from foreshore erosion.

These works were seen as a management option to permit the natural processes to proceed, while affording protection to the main areas of the campground. The north-western 'node' of the campground was relinquished at the time of the dune construction. Part of the management strategy was to allow for the natural realignment of the front of the dune while subsequently building up the back to allow the dune to move further landward. However, the location of the amenities block and sewer pumping station behind the eroded section of the dune has prevented dune replenishment occurring (DECCW, 2012). Instead, the seawall fronting the dune has been progressively extended as required to provide protection for the site (Hydrosphere Consulting, 2021). The existing seawall is maintained by NPWS and will continue to require maintenance and/or upgrade for all management options into the future.

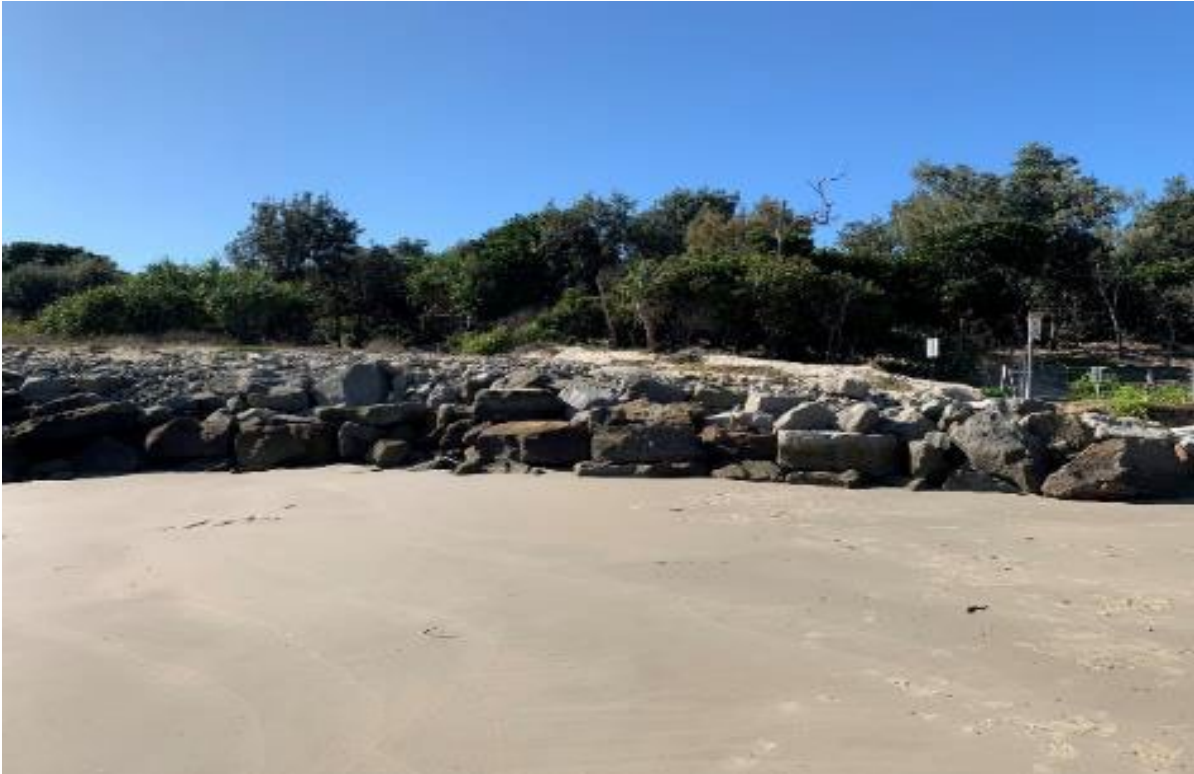
Photo 4 Seawall at Woody Head – photo locations indicated in Figure 2 (July 2020)

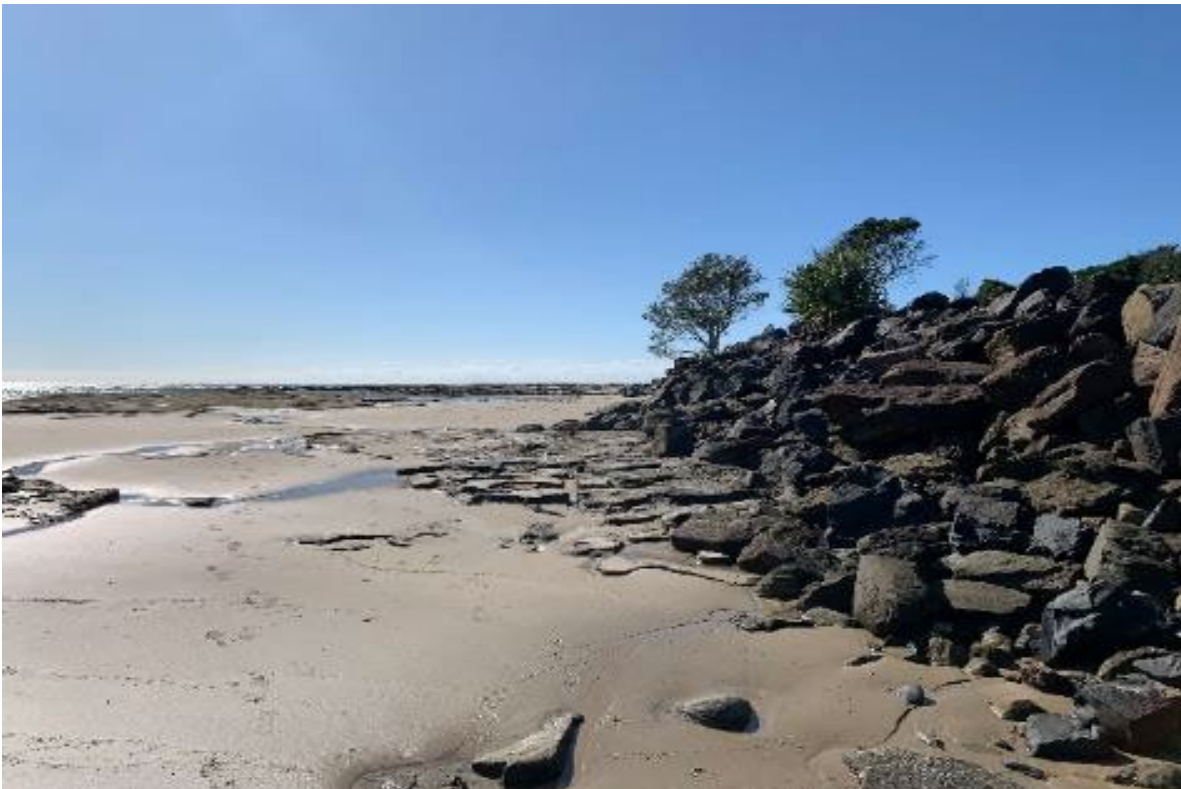
Photo 5 Seawall at Woody Head – photo locations indicated in Figure 2 (July 2020)

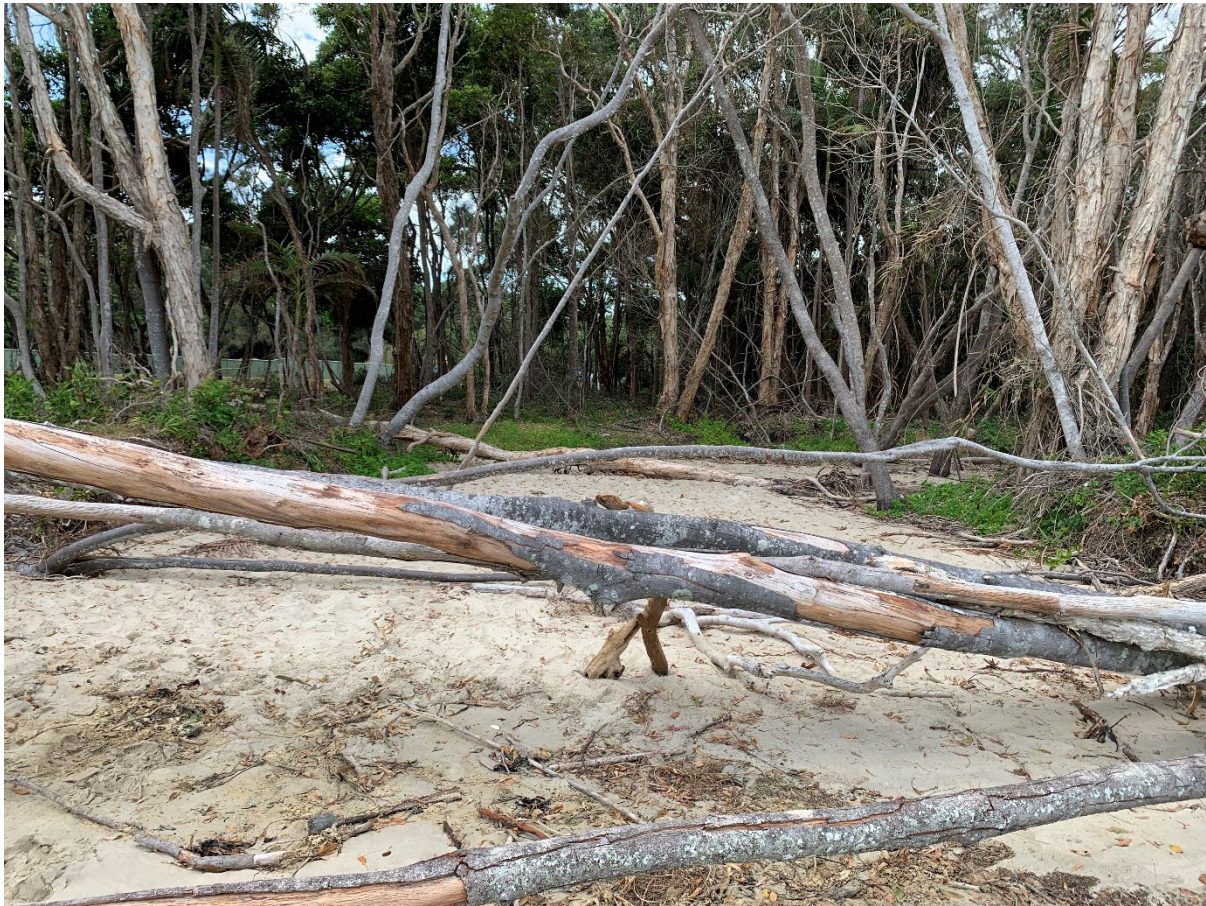
Photo 6 Surface water breakout to beach (November 2022)

Heavy rainfall, including floods in February and March 2022, has resulted in Iluka Road and Woody Head Road being flooded and impassable in some sections. This is a result of surface drainage deficiencies rather than tidal/coastal inundation and was common along much of the east coast due to the severe weather event. Heavy rains experienced in early 2022 resulted in increased surface runoff to the beach and caused a breakout through the dune between the campground entrance road and the seawall (**Photo 6**). The path of this surface water runoff allows waves to penetrate the rainforest vegetation, damage dune vegetation and increase dune erosion.

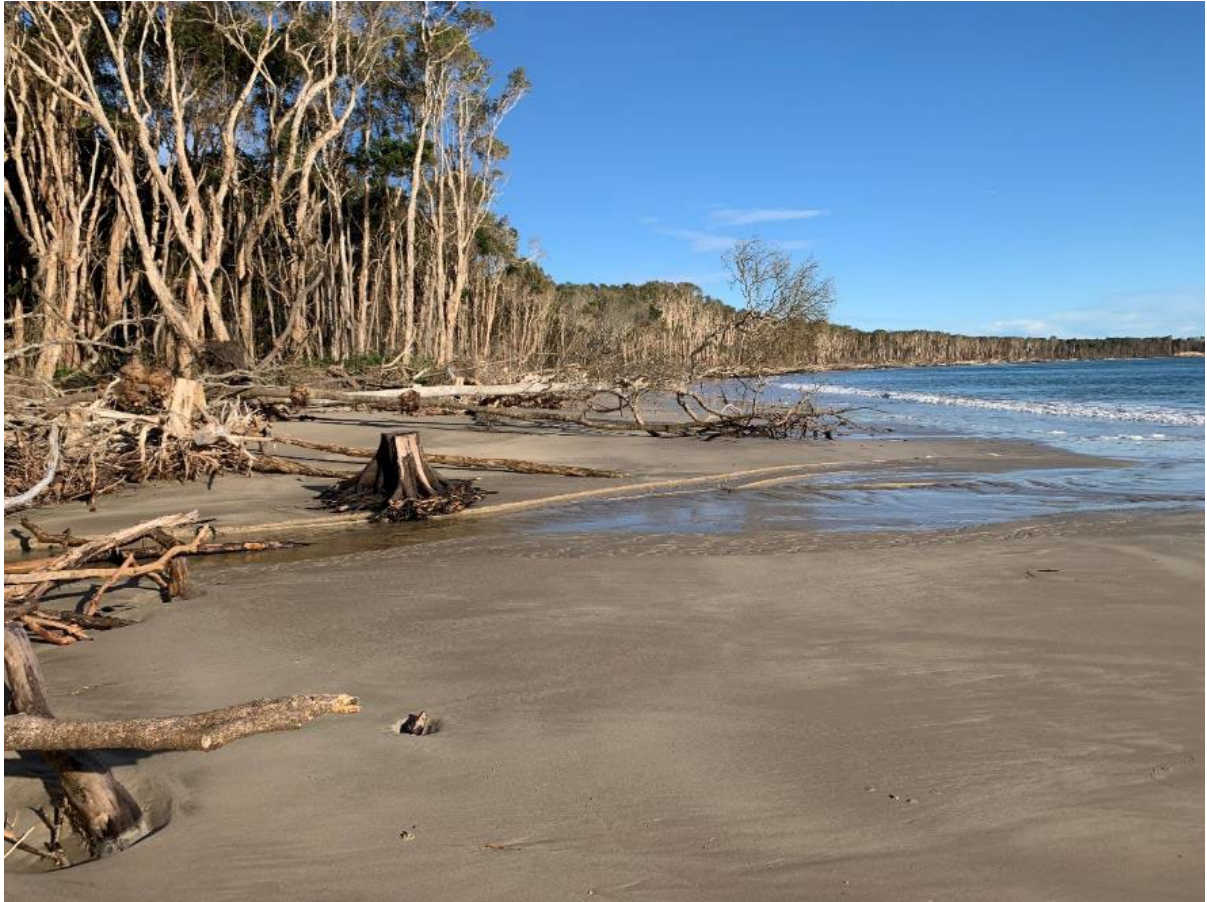
Photo 7 Woody Bay shoreline recession impacting littoral rainforest – looking west from seawall (June 2022)

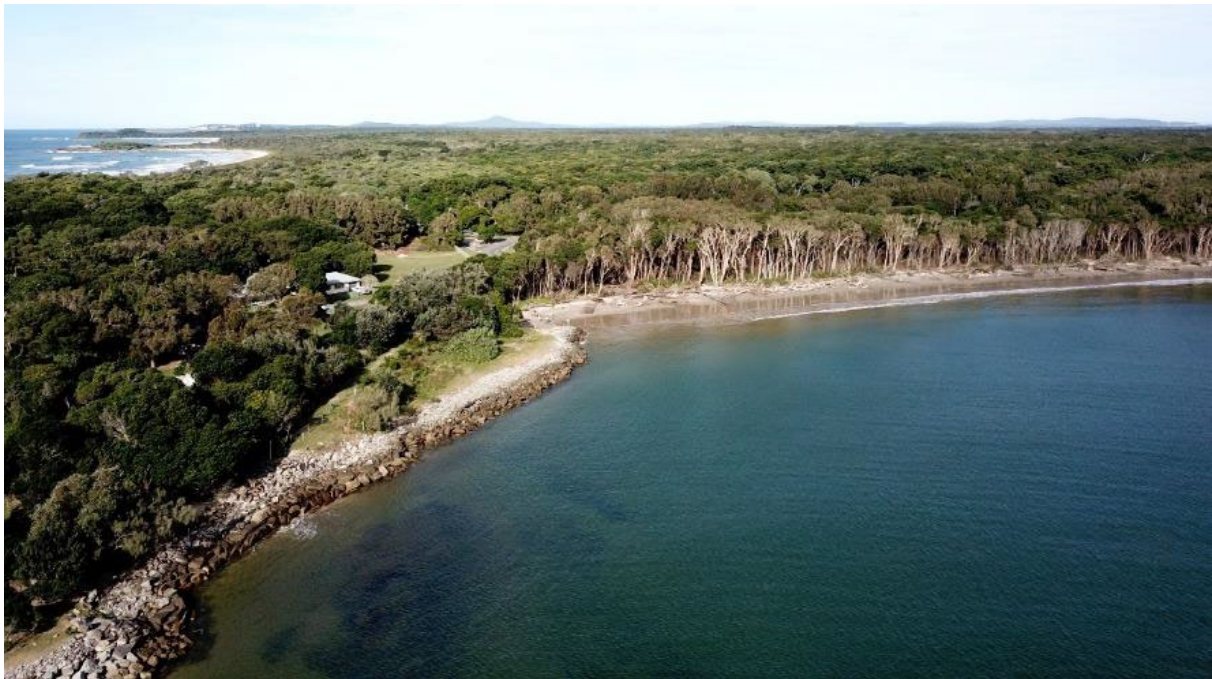
Photo 8 Woody Bay shoreline recession aerial view showing seawall and impacts on vegetation (June 2022)

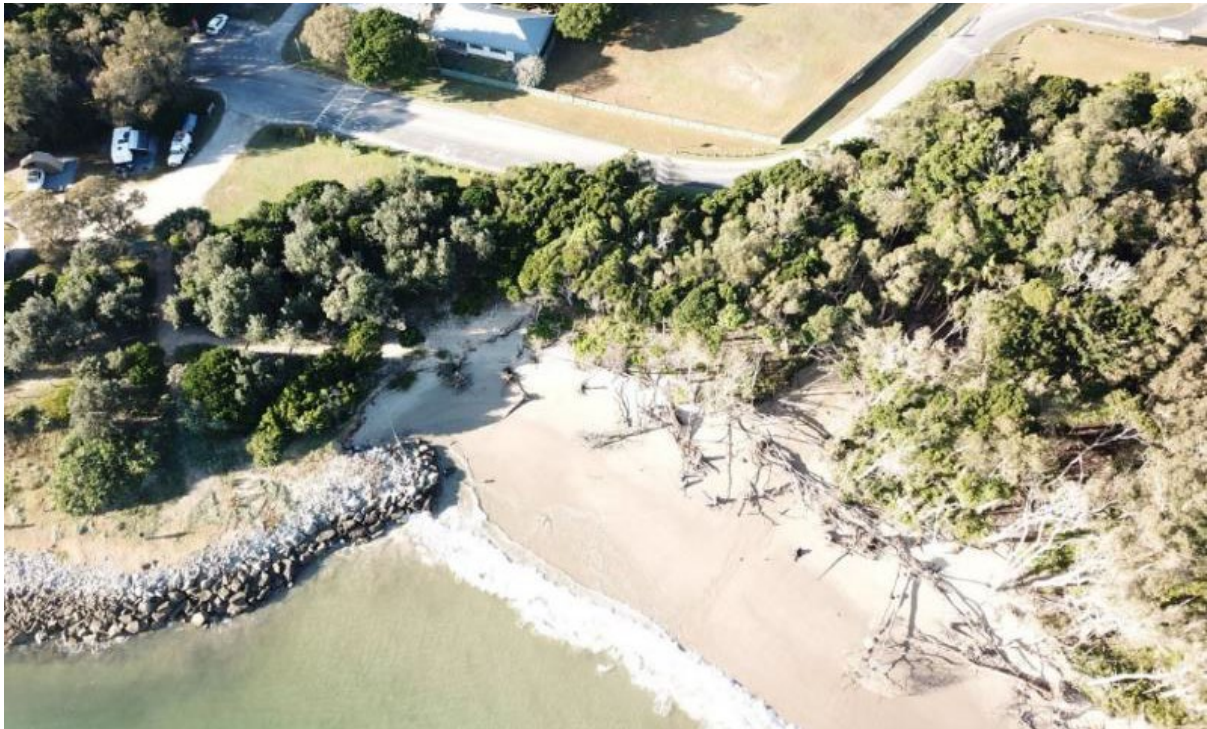
Photo 9 Woody Bay seawall end effects (June 2022)

place, restricting the longshore movement that would normally replace sand. Seawalls tend to reflect wave energy more strongly than a beach, which leads to offshore transport of sand from the toe of the wall. This sand is then more readily transferred by longshore drift and rip currents. While local sand transport processes are moving sand downdrift at the end of the seawall, there is no natural supply of sand to compensate for the loss. The net effect is that the foreshore immediately downdrift of the seawall erodes (Water Technology, 2018).

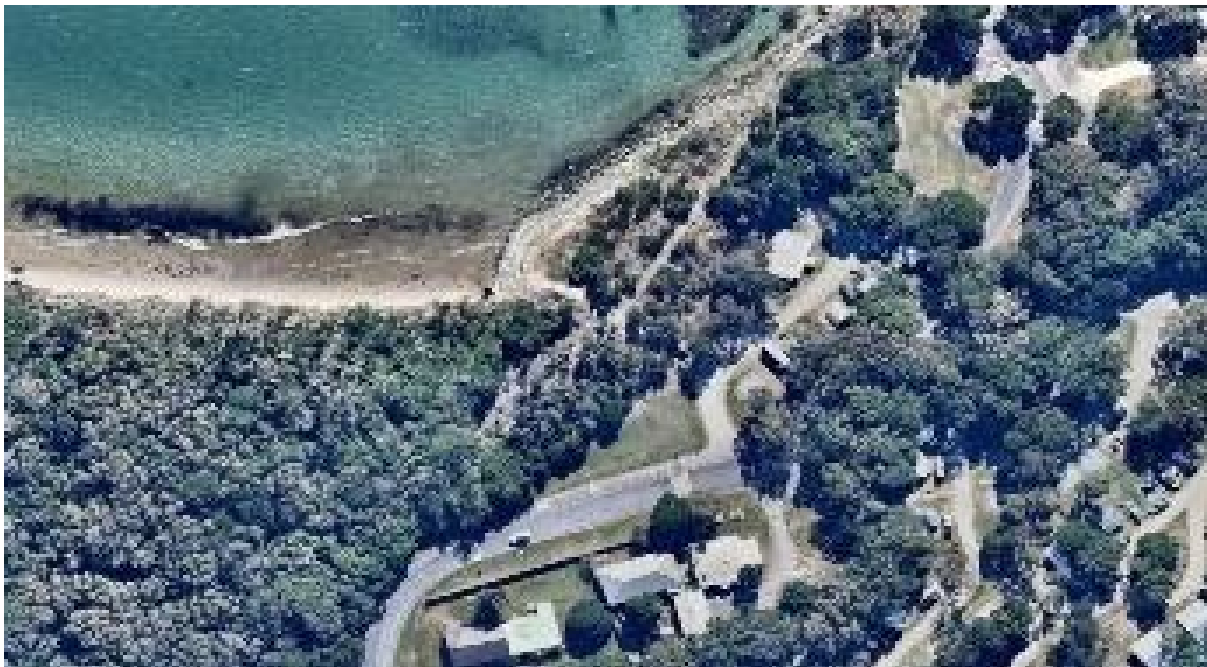
Photo 10 End effect erosion at the western end of the seawall in 2016. Source: Nearmap, 28 May 2016

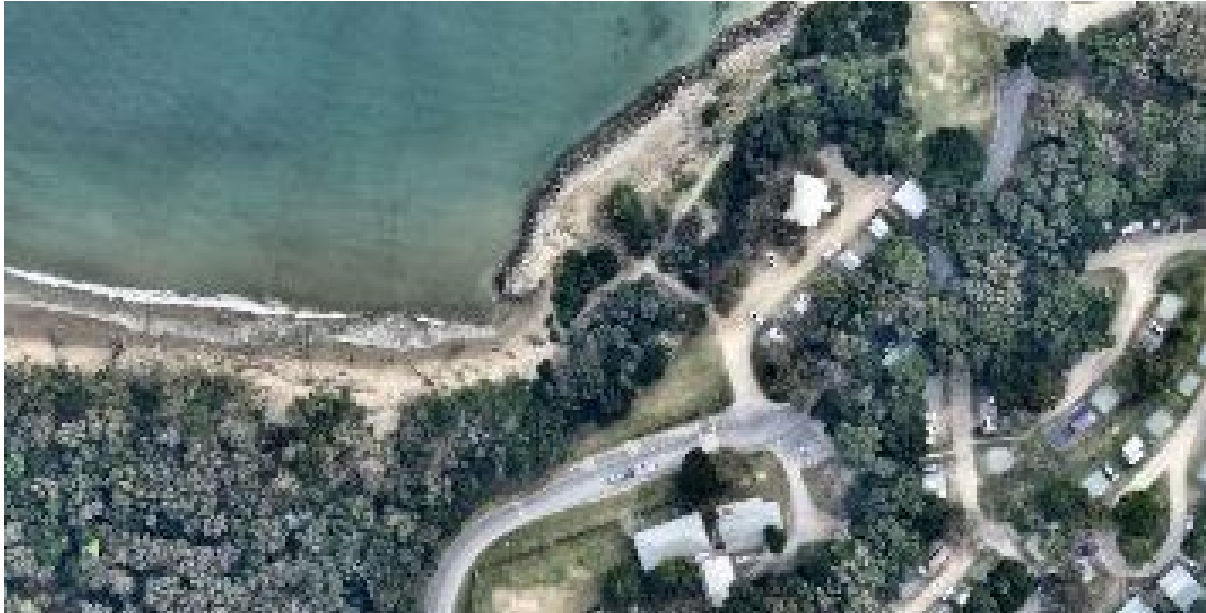
Photo 11 End effect erosion at the western end of the seawall in 2022. Source: Nearmap, 11 September 2022

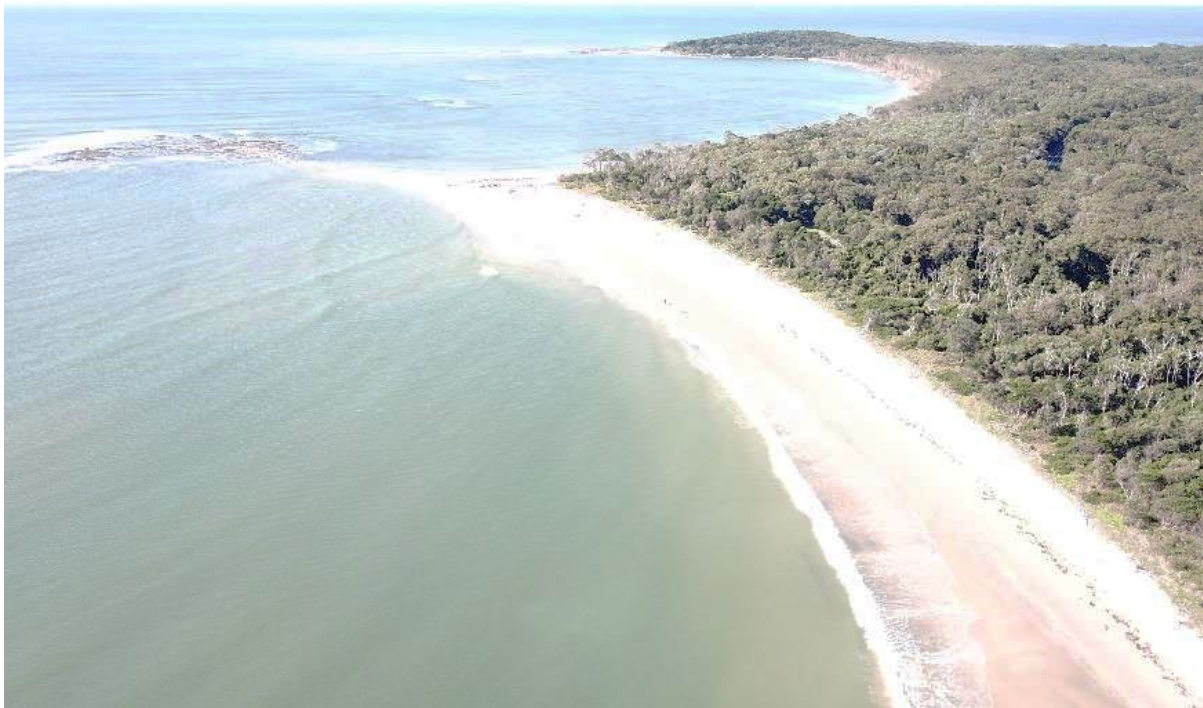
Photo 12 Tombolo between Woody Bay and Shark Bay (looking east, June 2022)

Nevertheless, there is inherent uncertainty in the predicted tombolo impacts due to climate change and the future shoreline alignment. The extent of intervention required to mitigate possible tombolo impacts is expected to be significant and the options in this report do not address this risk.

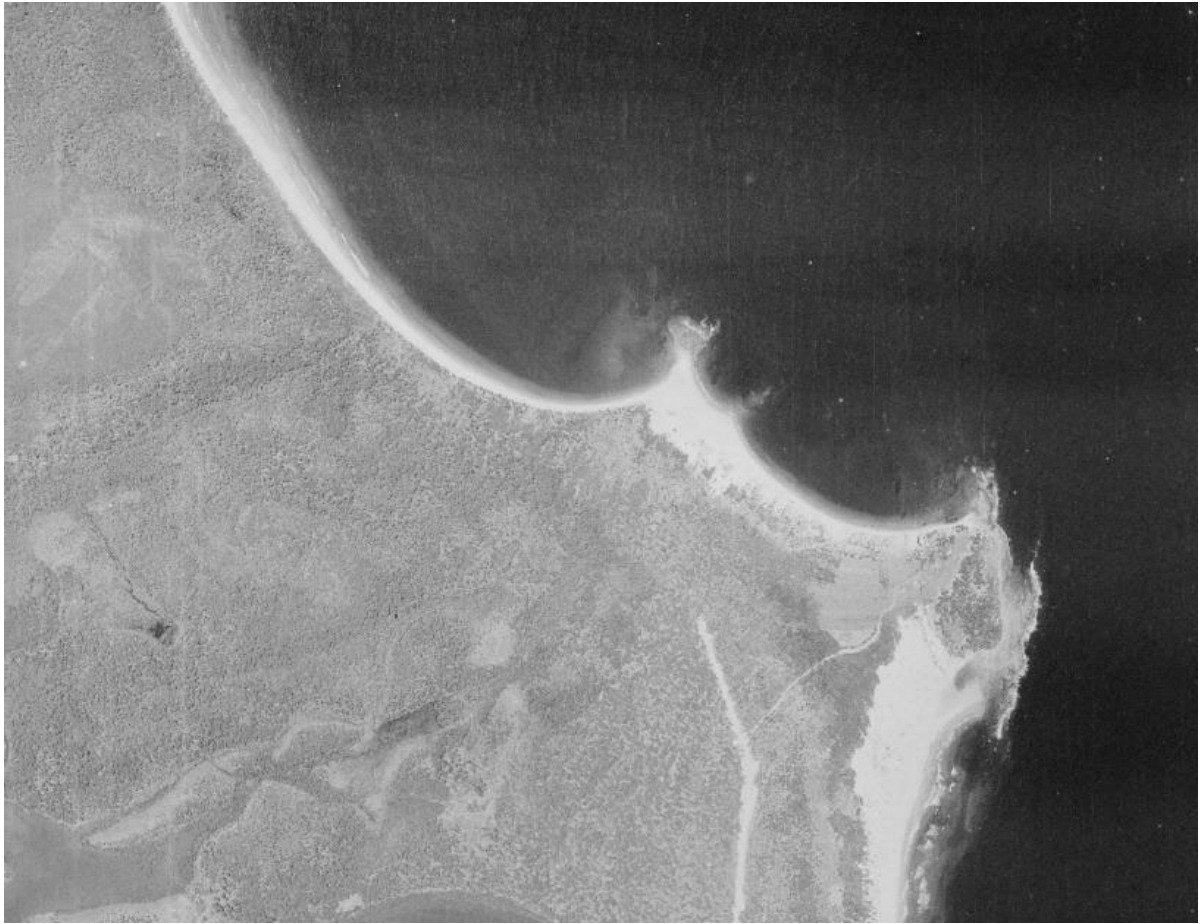
Photo 17 1958 – showing sand accretion at the western end of Woody Bay and the tombolo, north of the campground site and south of Iluka Bluff

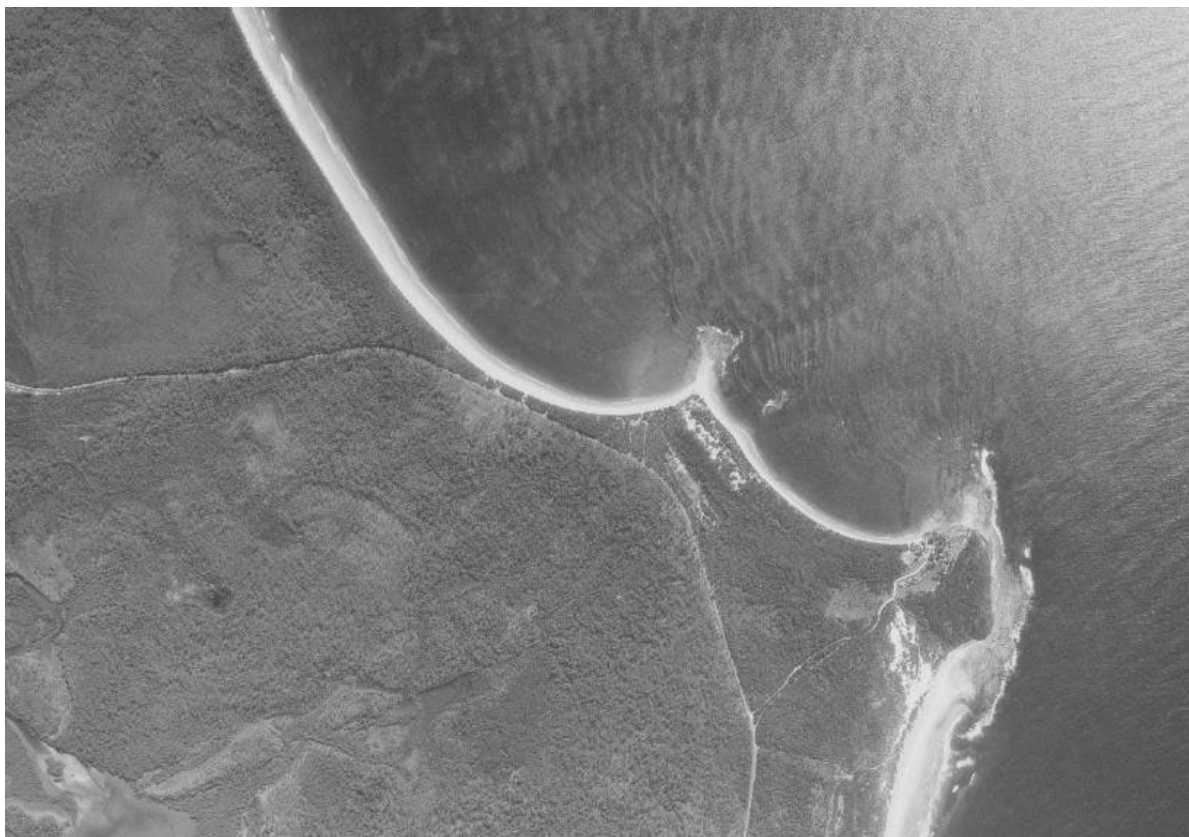
Photo 18 1980 – expanded area of vegetation at the western end of Woody Bay dune

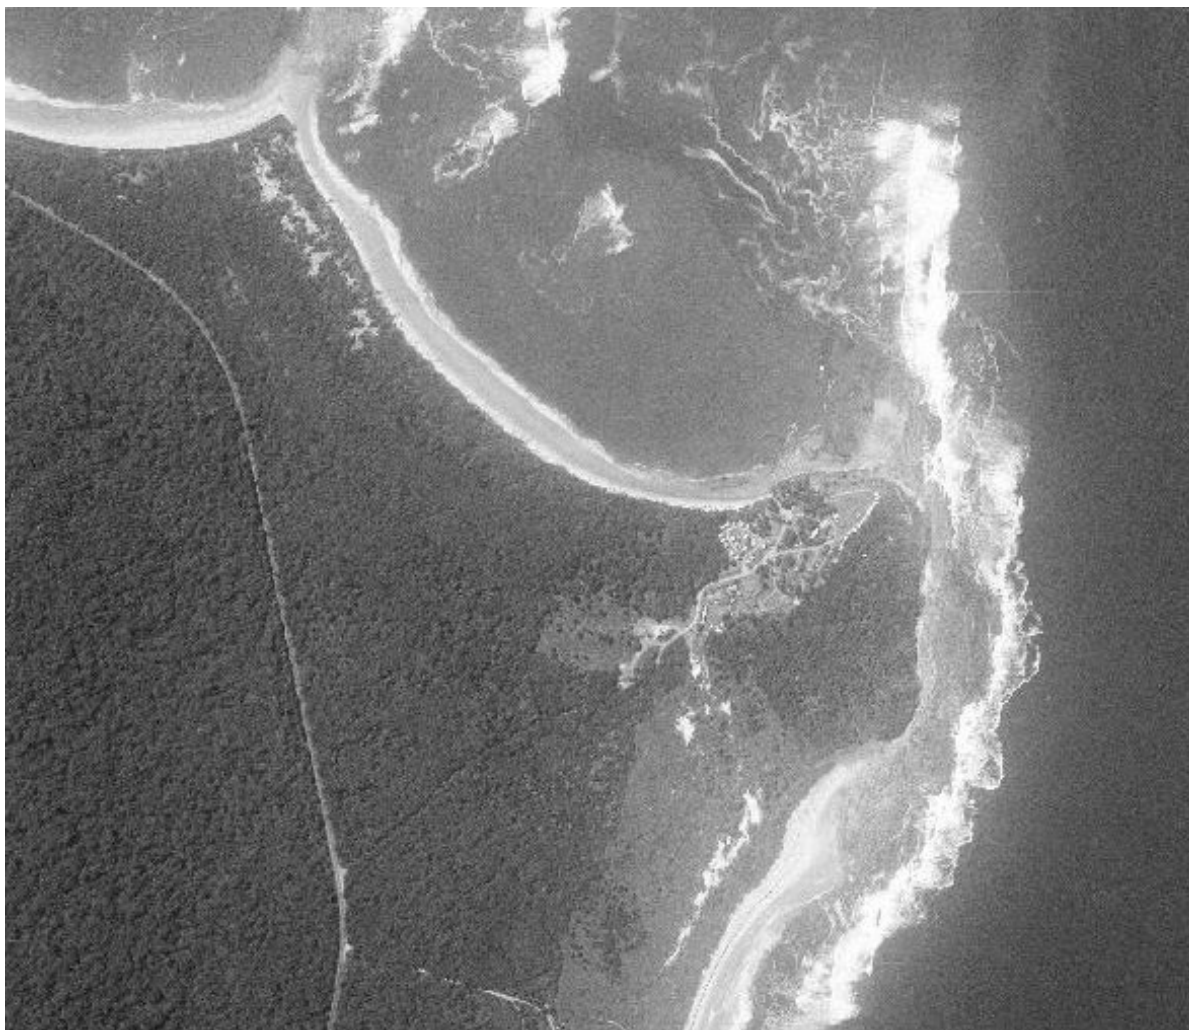
Photo 19 1989 – prior to construction of the seawall and artificial dune at western node campsite in the 1990s

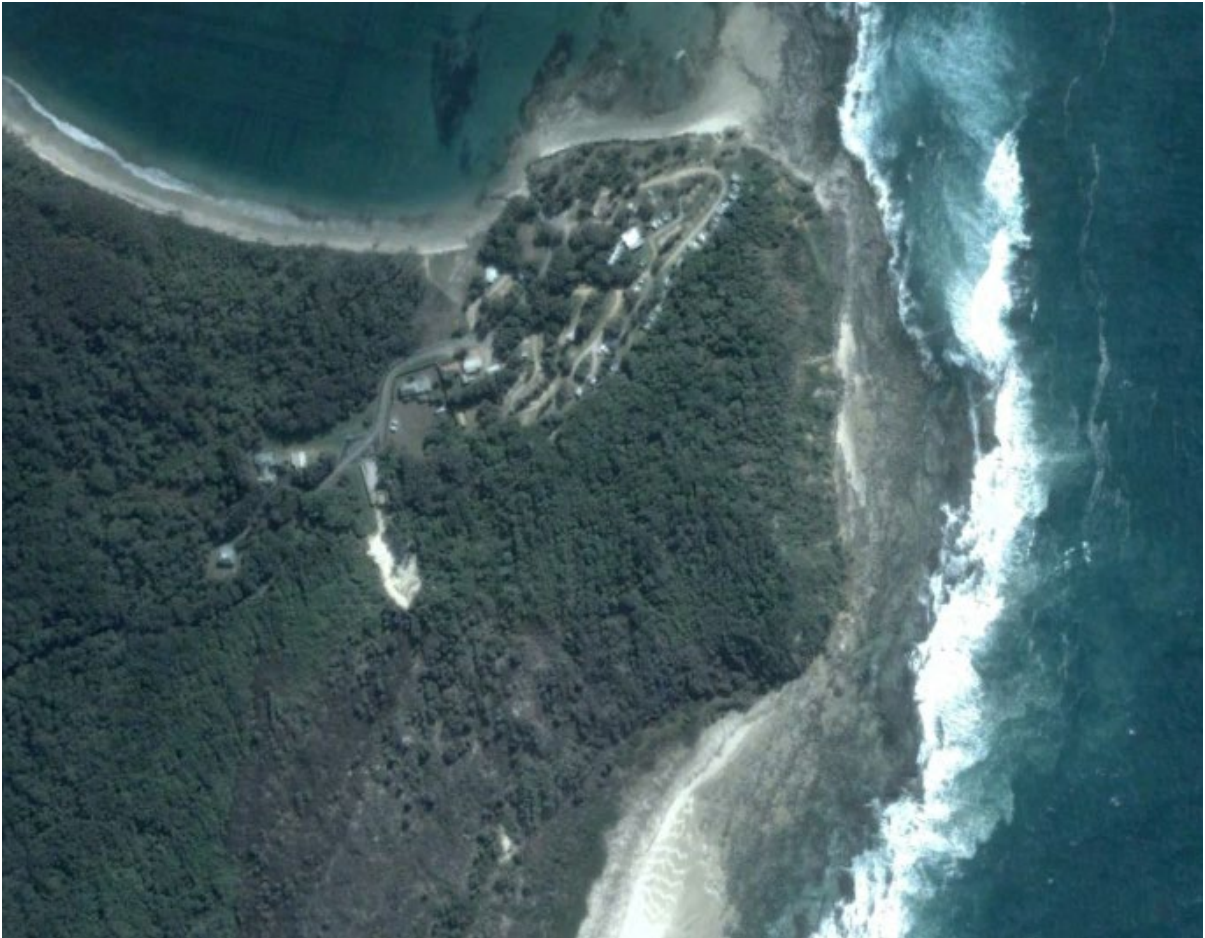
Photo 21 July 2006 – showing clearing for construction of artificial dune (western extent of Woody Bay is not included in the aerial photograph)

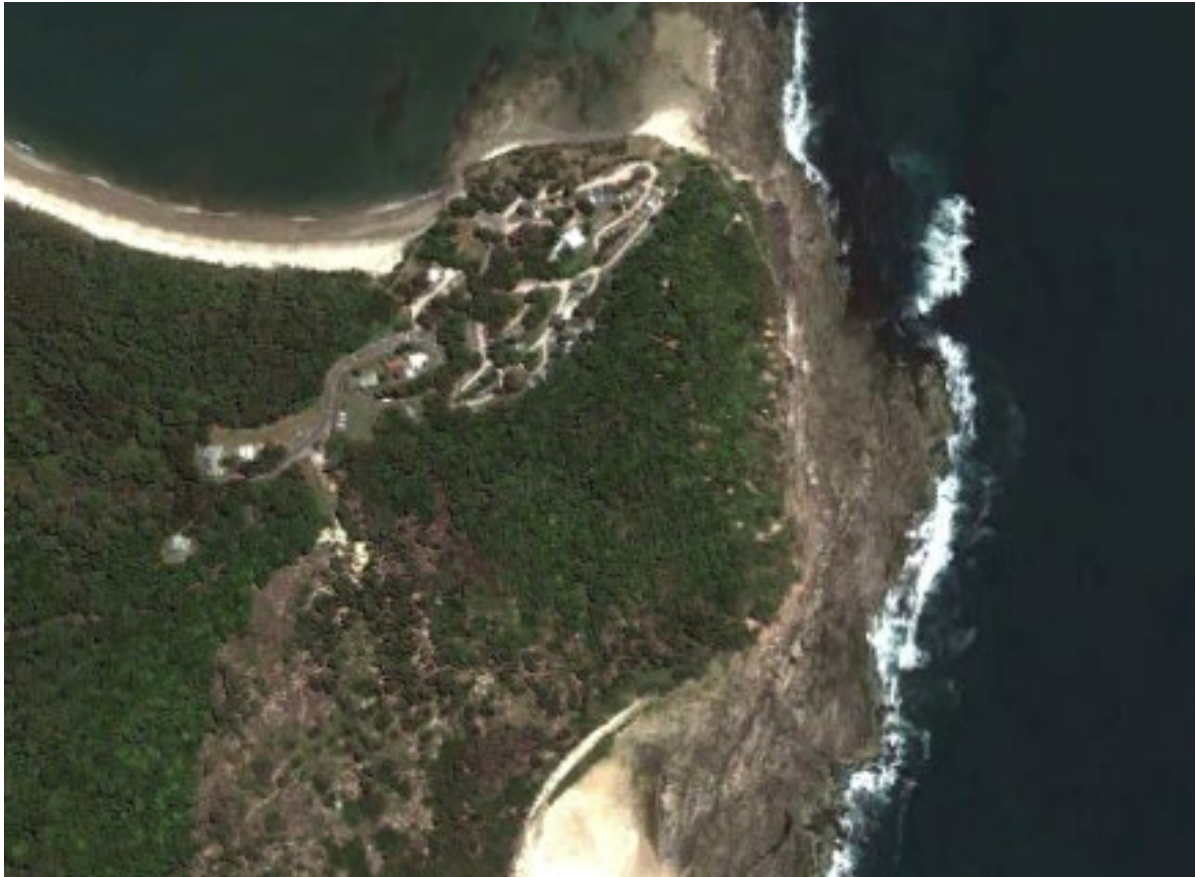
Photo 22 February 2011 – vegetation extended across artificial dune, seawall end effects are evident

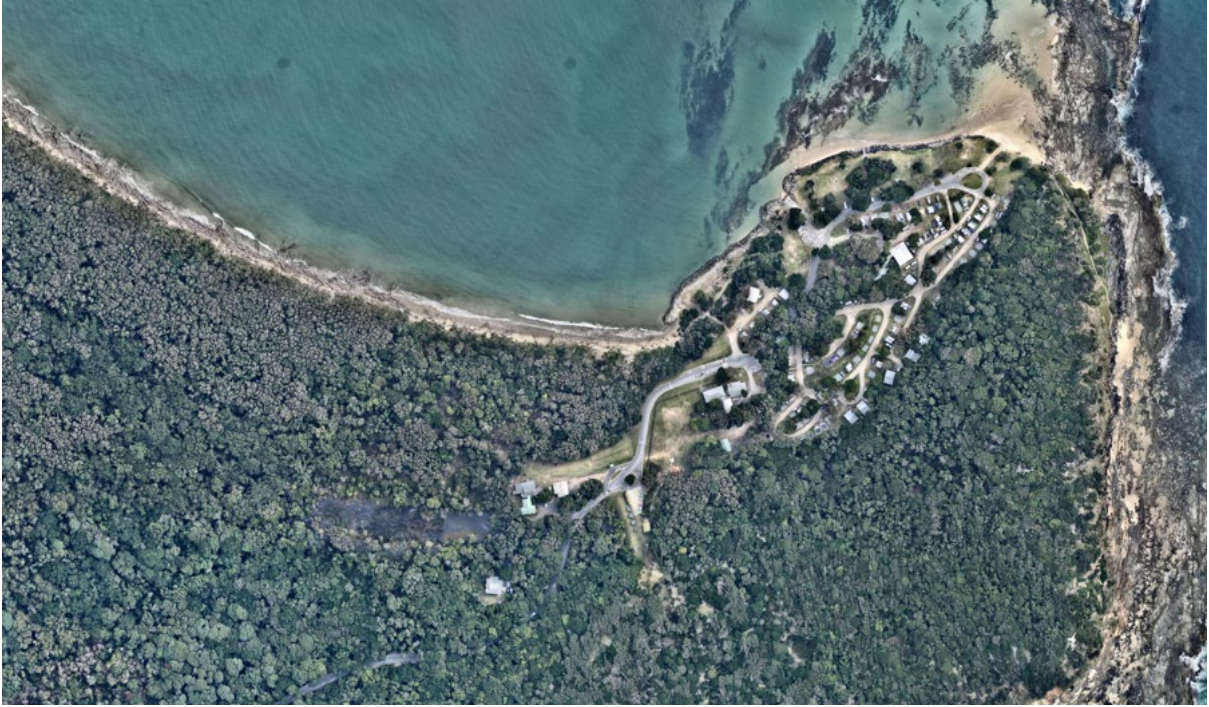
Photo 24 September 2022 – visible beach recession and increasing seawall end effects
