NSW National Parks and Wildlife Service

Baliiga precinct plan (Never Never picnic area)

Dorrigo National Park

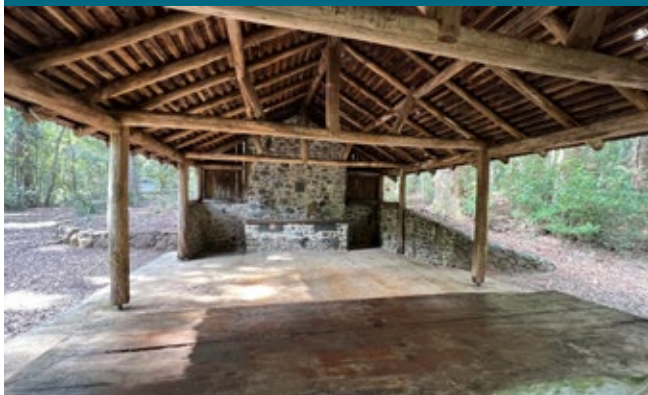
Never Never picnic shelter (Fisher Design + Architecture)

- replace the shingle roof with improved details
- repair the round timber-post roof frame
- repair the timber wall posts and the steel support brackets
- repair existing slab rot – cut back surfaces as required or replace the slab if too rotted
- investigate the extent of any earth build up on the eastern wall and remove earth buildup
- investigate the extent of drainage provided behind the lower section of this east wall of the shelter and the 2 curved stone retaining walls
- investigate the impact of tree roots behind the cracked curved retaining wall and identify any mitigative works required for these 2 defects

- provide a narrow full-length fixed skylight immediately to the south of the ridge line to heritage assessment recommendations
- provide gas barbecue cooking and the reuse of the fireplaces to recover their significance, but with an adaptation to provide for an enclosed fire place for warmth, while minimising risks from fire, to heritage assessment recommendations.

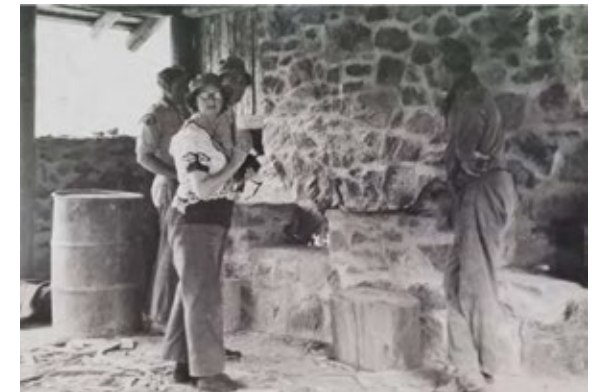
Testing the barbecue chimney before the opening of the picnic area in 1975 (Ruth Holmes)

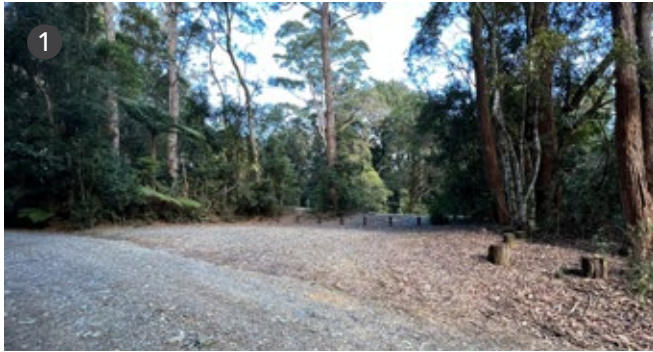
Entry and car parking area

- entry road in fair condition requiring minor upgrade, definition of roadside drainage, and filling of potholes
- need improved site orientation and information
- need formalisation of car parking areas for day use and camping, defined parking and turning
- bollards generally degraded and require replacement.

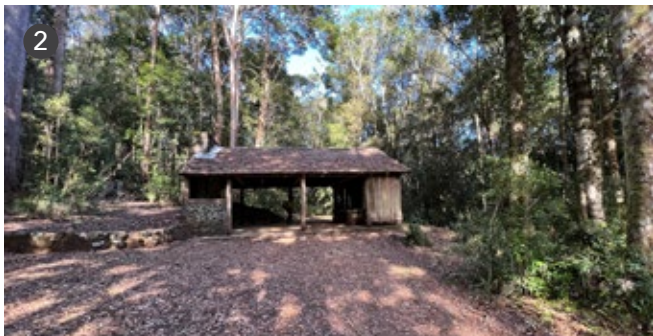
Heritage picnic shelter

- weathered and degraded due to ongoing deterioration of timber fabric from water damage and lack of maintenance.

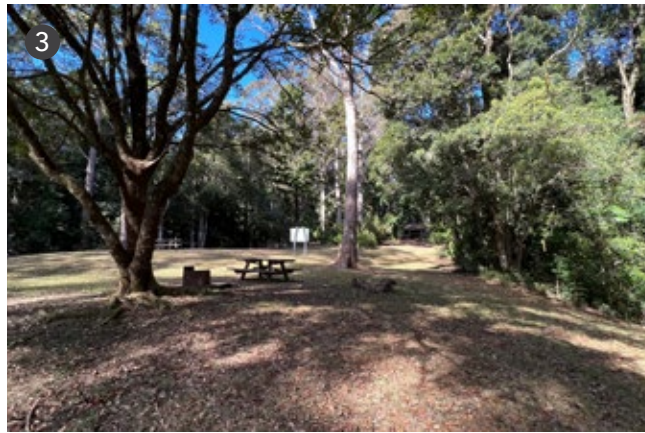
Day use area

- need definition of day use and camping areas
- loss of views around picnic area from vegetation growth
- abundance of fallen trees and debris
- poor layout and condition of picnic and barbecue settings.

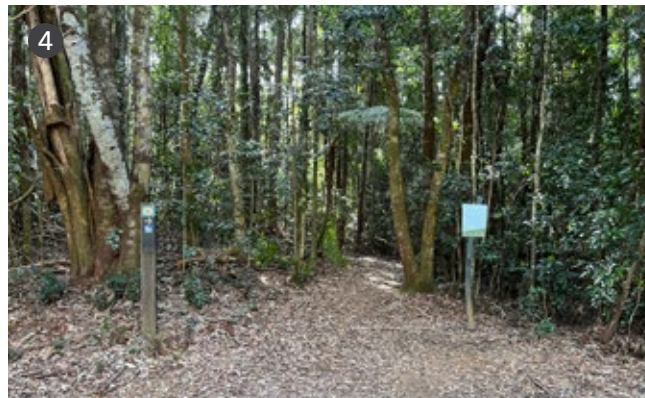
Track heads

- poor definition of tracks and trail heads
- inadequate trail head signage.

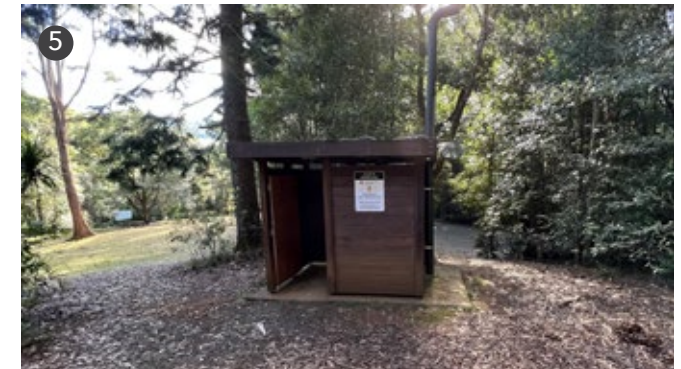
Amenities

- existing amenities tired and insufficient for future increased visitation
- accessible circulation requires upgrade.

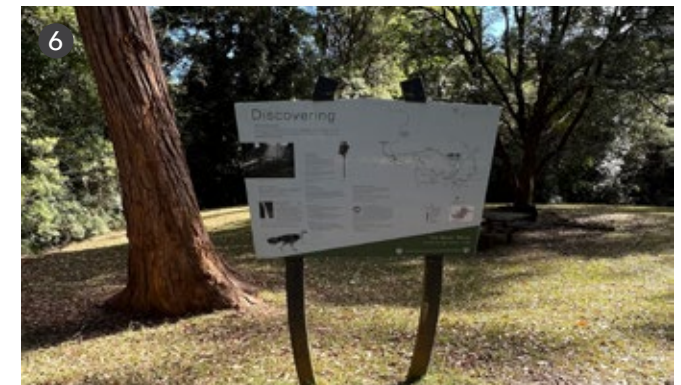
Signage

- interpretive signage poorly located and needs update
- precinct entry sign requires updated information – day use area, camping area, vehicle turning
- poor wayfinding signage
- need for new camp site sign posts to new layout.

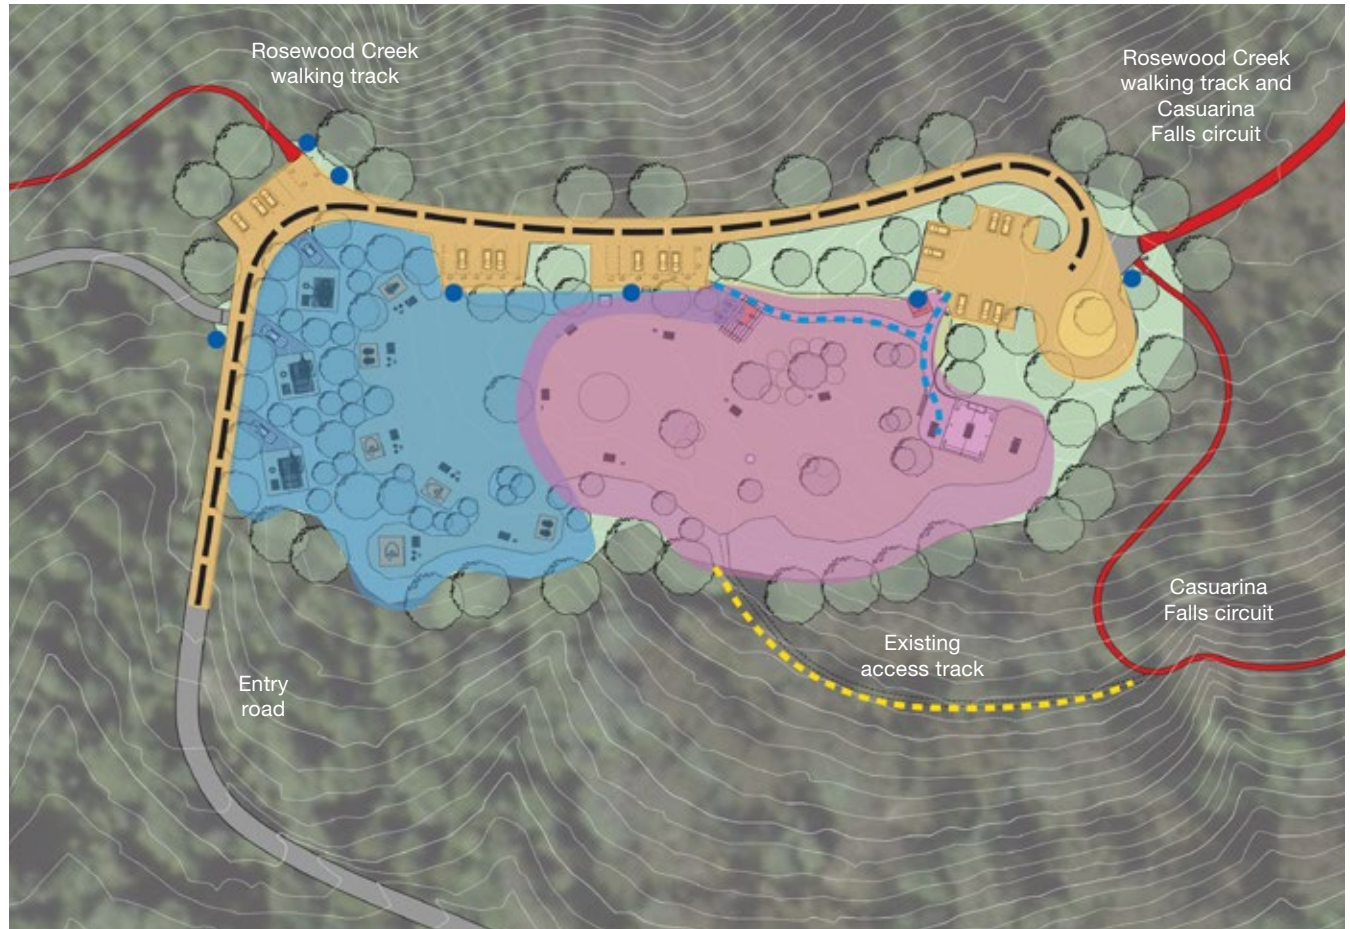
2.2 Site plan – overview

1. Car park – camping
2. Car park – day use
3. Precinct entry sign
4. Information signage shelter
5. Walking track head and sign
6. Locked gate – management access only
7. New accessible pathway
8. Heritage picnic shelter
9. New paved seating area
10. Amenities building
11. Day use area with picnic settings and barbecues
12. Camping area – walk-in camp sites
13. Camping area – vehicle camp sites
14. Camping platforms
15. Consider closing existing access track and diverting to track head to the south

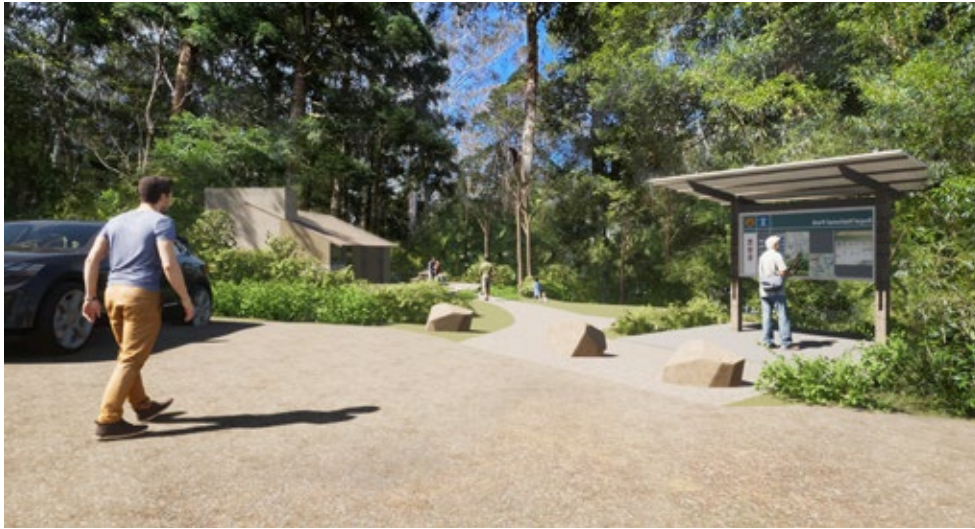
Artists impression: Day use area entry with increased parking capacity, new interpretation shelter and all-access pathway to picnic shelter

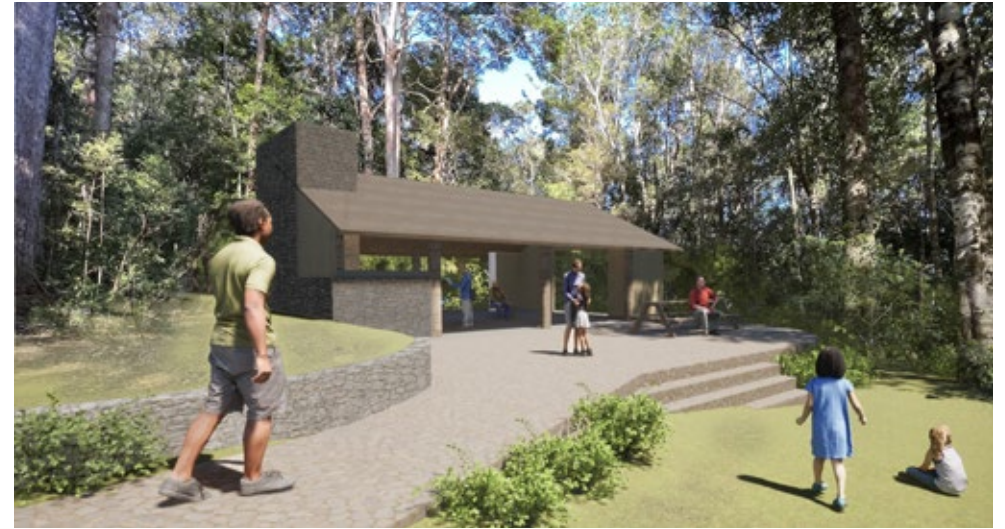
Artists impression: Renovated historic Never Never picnic shelter, new access pathway and paved level area outside

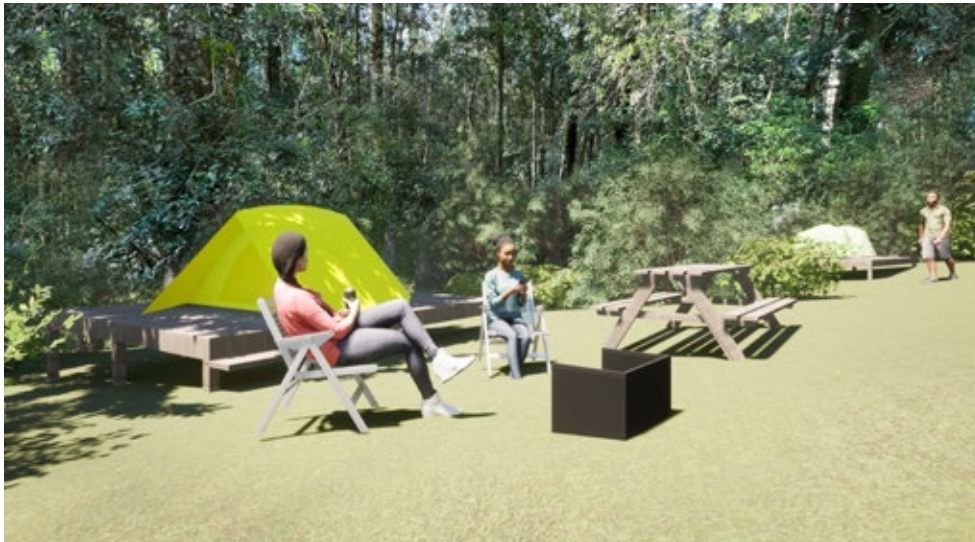
Artists impression: Camping platforms

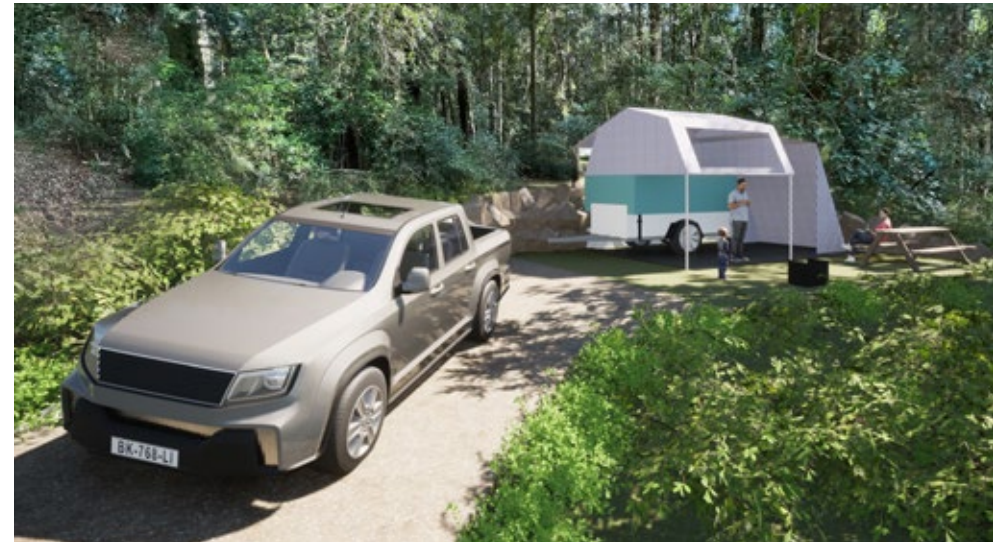
Artists impression: 3 new proposed vehicle camping sites on the lower section of the precinct
